TECHNICAL ORDERS

NENE INSTRUCTIONS

Issued May, 1949

NOZZLE GUIDE VANES - LIMITS OF CRACKING AND DISTORTION

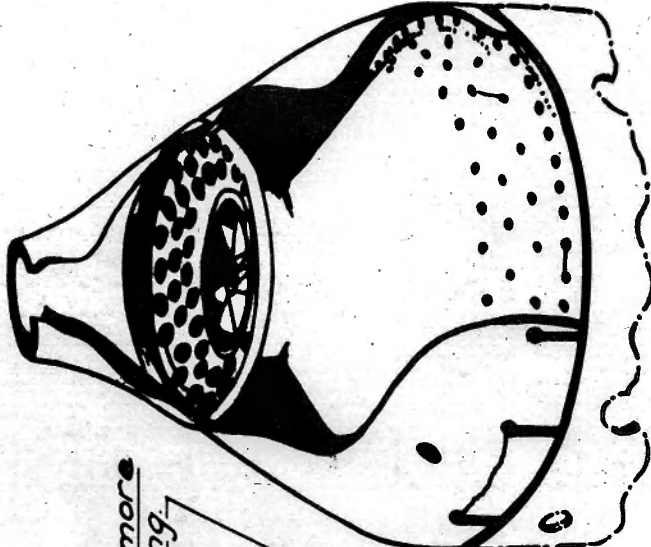
ACCEPT

No cracking permitted in snout or diffuser vanes.

Reject if more than 2" long.

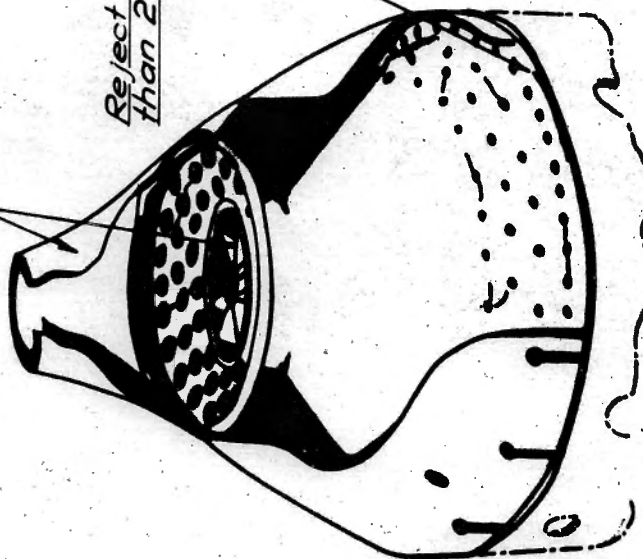
REJECT

CRACKS IN DIFFUSER FLARE, GRID & SCOOP.

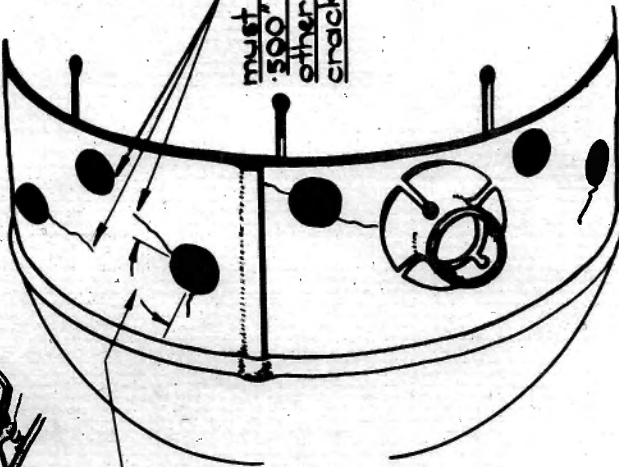
ACCEPT

Only 1 crack permitted in any sleeve

Cracks must not pass beyond weld zone.

Cracks must be more than .500" from any other hole or crack.

More than 90°

Reject if cracks enter keyhole slots

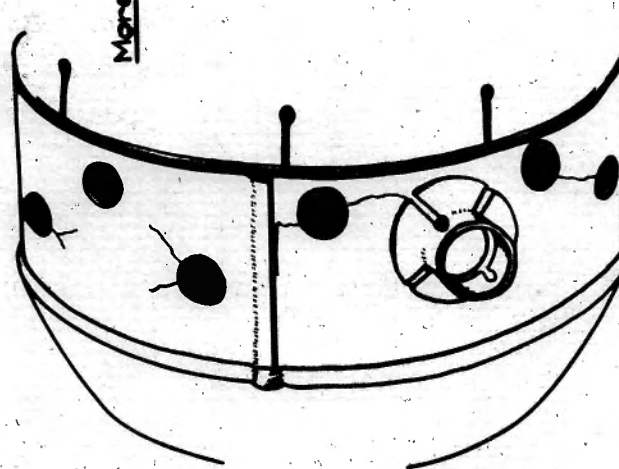
REJECT

CRACKS IN CYLINDRICAL SECTION

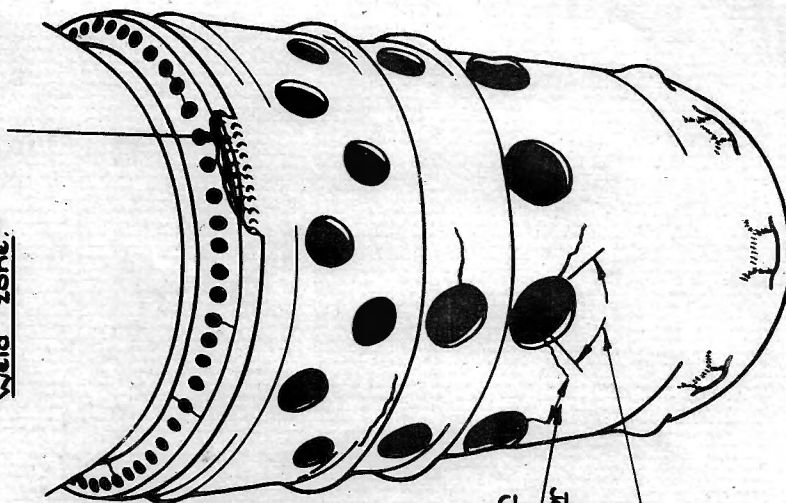
ACCEPT

Cracks from upstream edge must not pass through weld zone.

CRACKS IN WINDOW PIECE + REAR CONICAL

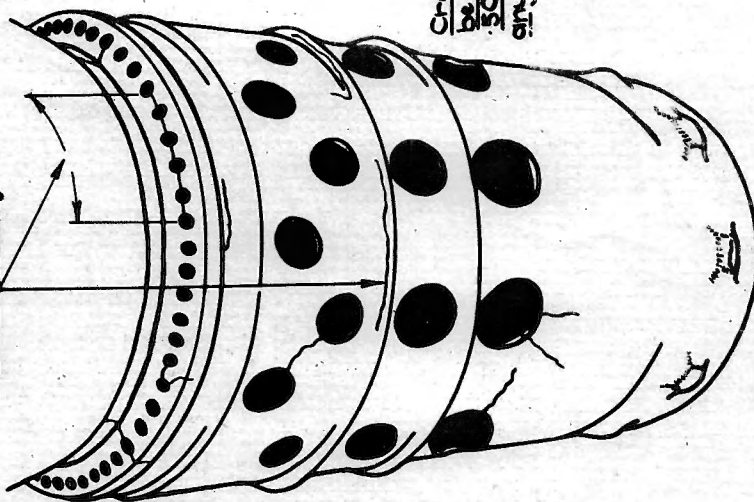
REJECT

Cracks must be more than 500" from any other hole or crack.
More than 90°

Reject if more than 2" long.

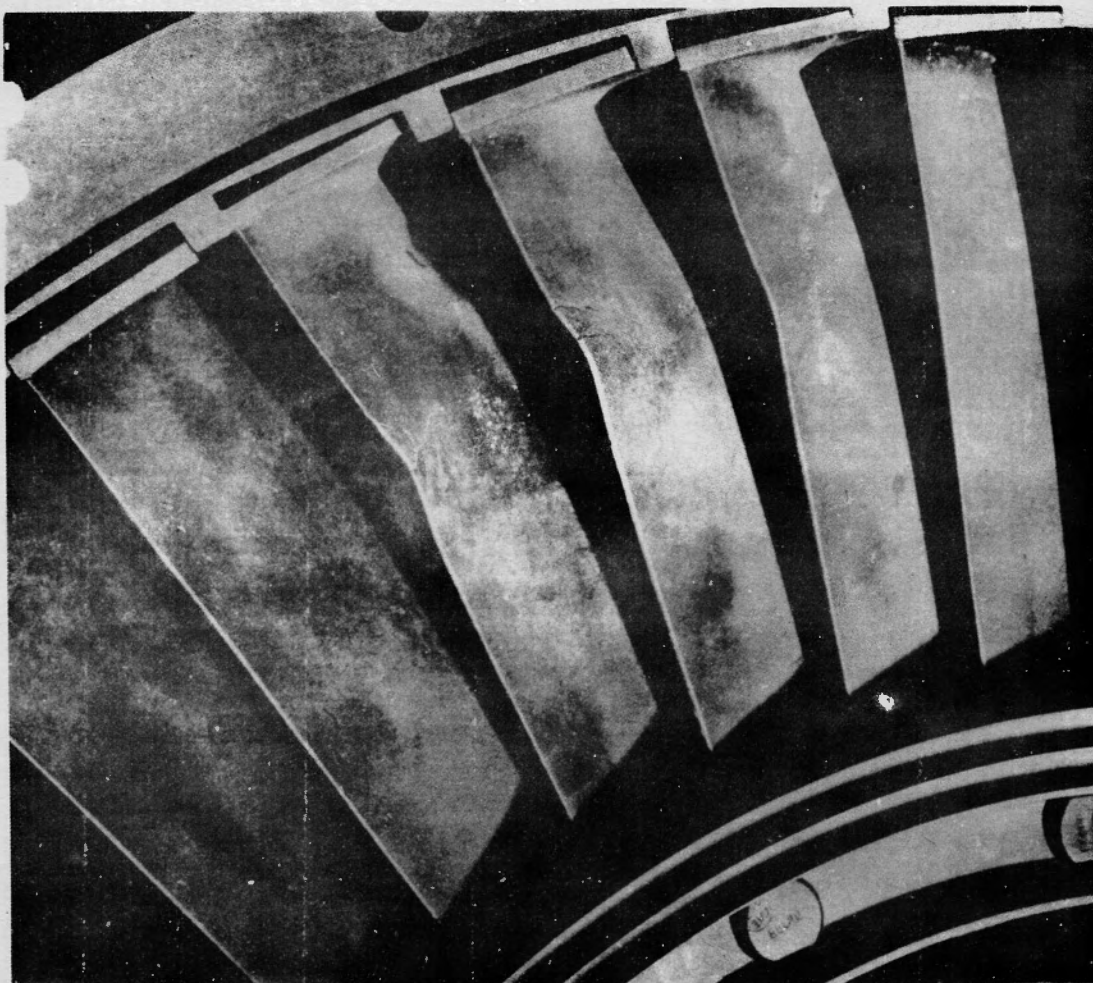
Fig. 1

View of N. G. V. trailing edges showing bowing and cracking at the limiting condition of the visual standard. When vanes are seen in this condition a further examination is necessary as detailed in the standard.

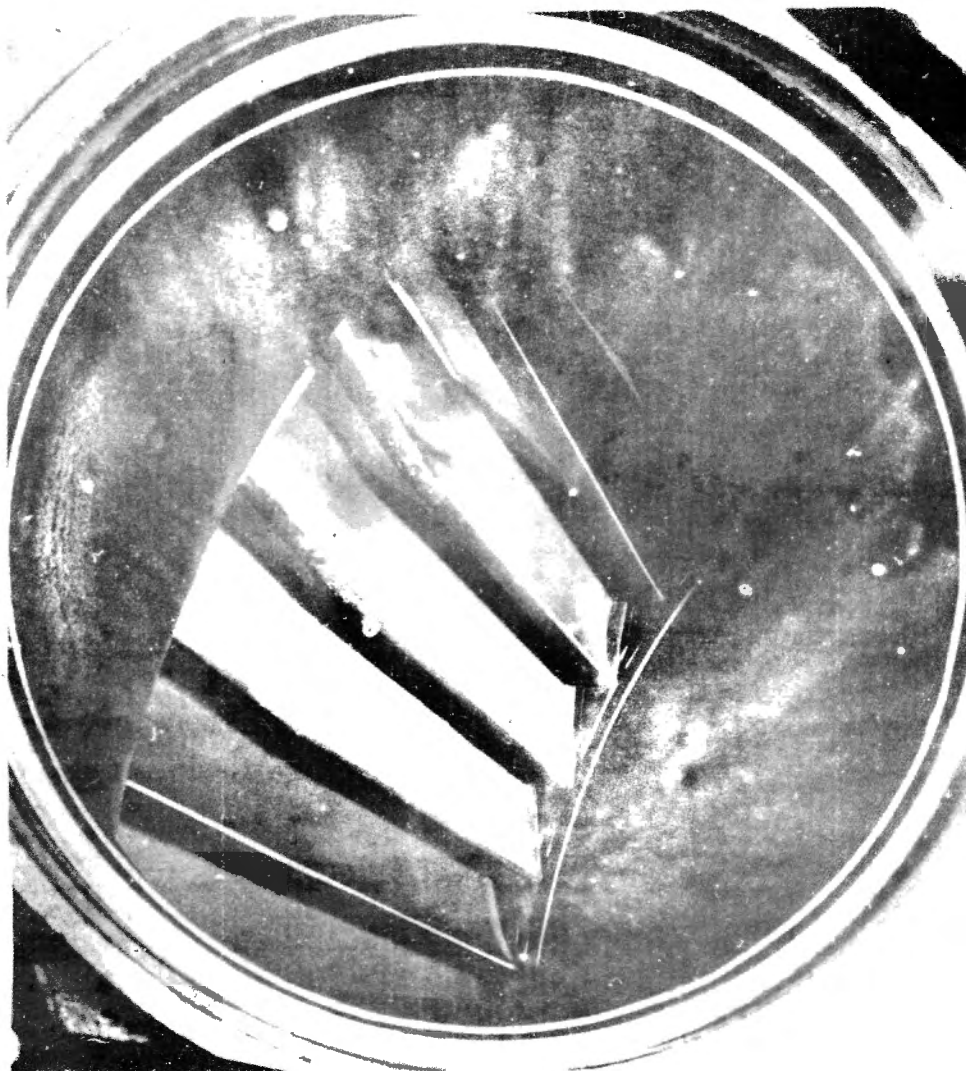
Fig. 2

View of N. G. V's with No. 3 (~~Port Torch Igniter~~) combustion chamber removed. Showing N. G. V's approaching the limit of acceptance for both bowing and cracking.

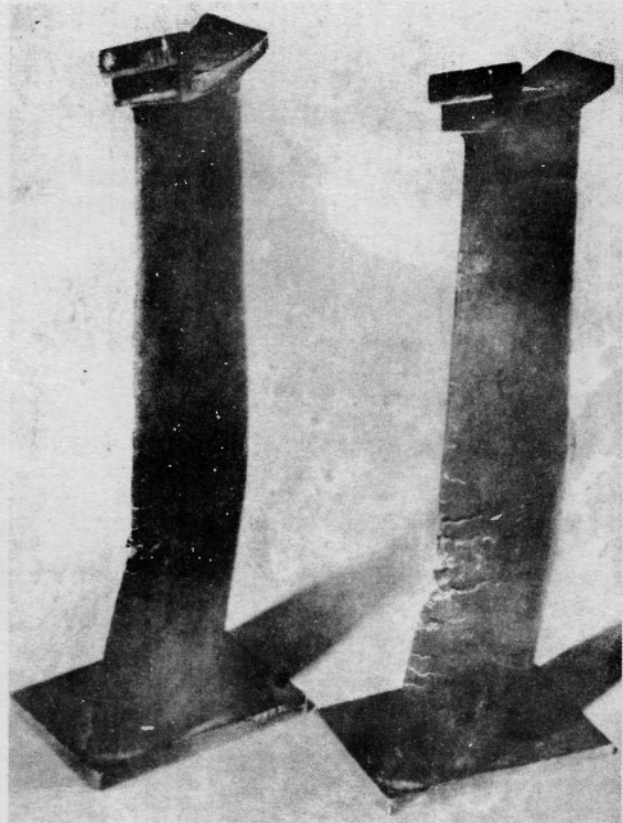
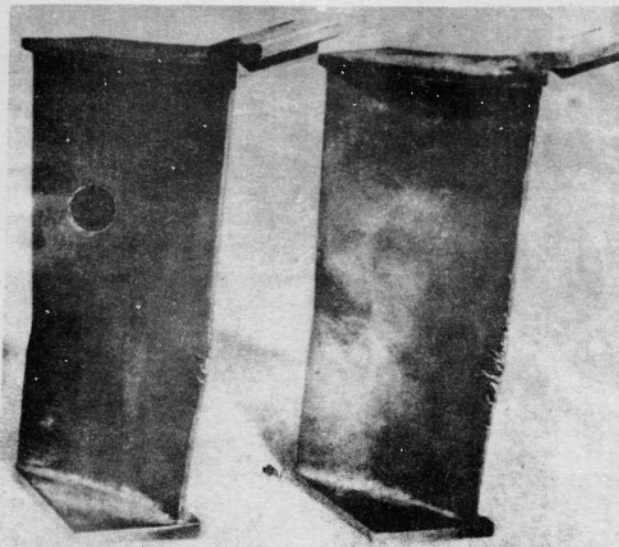
Views of the convex and concave surfaces of 2 N. G. V's, showing cracking and bowing of the leading edge at the limit of acceptance.

N. B. It is normal for cracking to progress further on the convex surface than on the concave as shown in photographs.

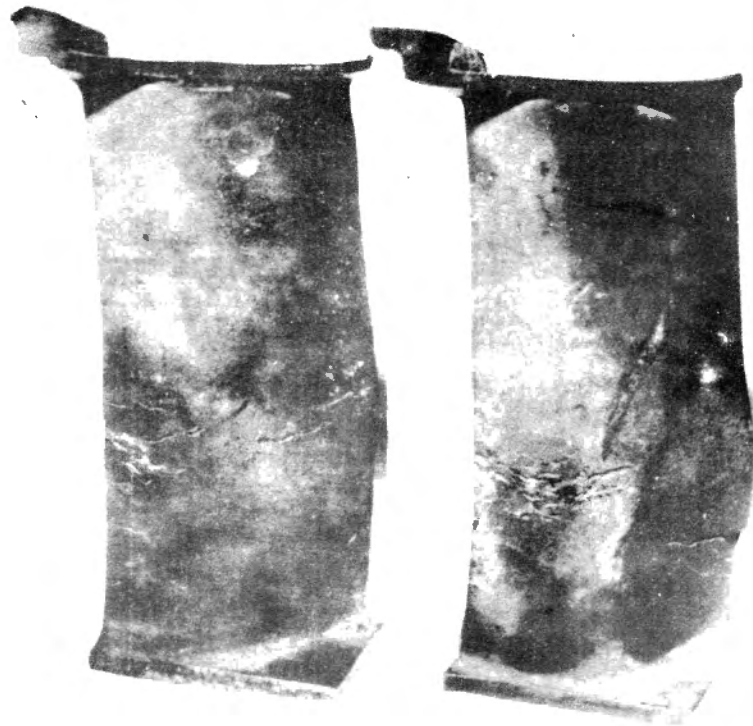
Fig. 4

- (a) leading edge cracks exceed 1.1 inches in length on either side of the vane (see Fig. 2);
- (b) trailing edge cracks exceed 0.75 inches in length (see Fig. 4);
- (c) the sum of the lengths of the longest leading and trailing edge cracks exceed 1.1 inches;
- (d) the bow of the trailing edge is greater than 0.250 inches (see Fig. 6);

View of two typical unacceptable Vanes showing cracking progressing across each vane.

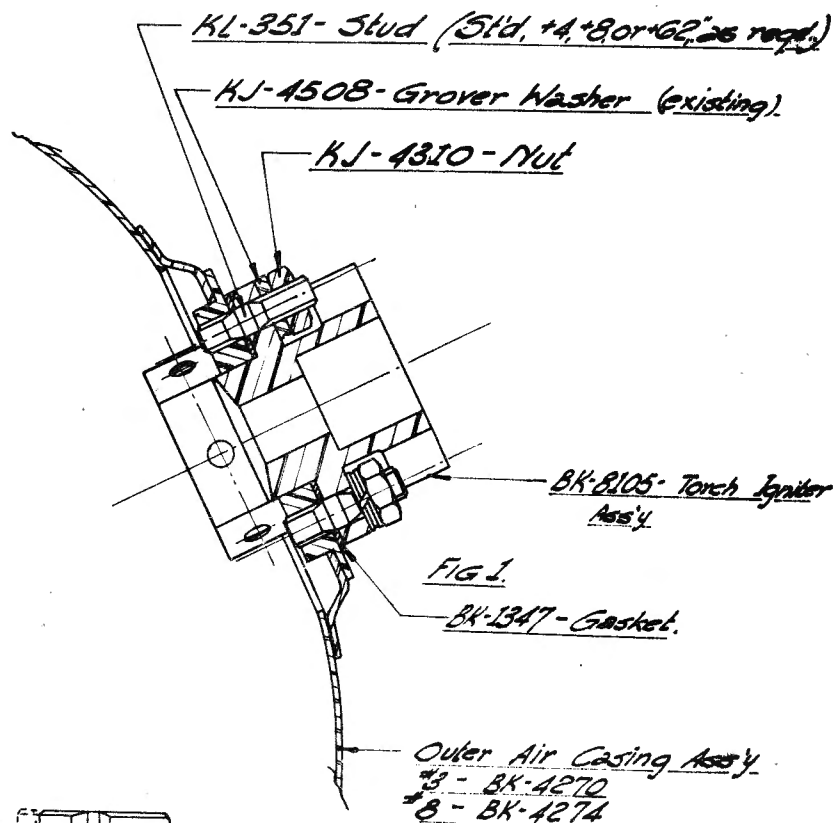
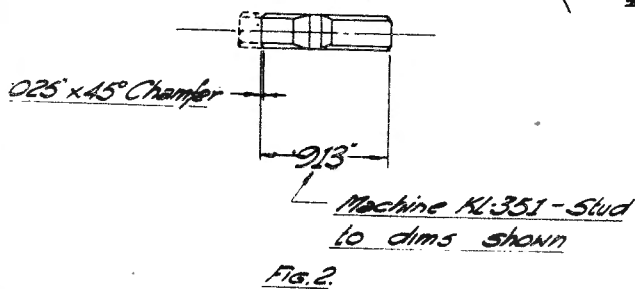
1. This Instruction specifies a method of repair for stripped or damaged setscrew (CA.20137) threads in torch igniter bosses welded into numbers 3 and 8 outer air casing assemblies (BK.4270, BK.4274). If any one of the four setscrew threads in the torch igniter boss is stripped or damaged, all threads are to be repaired as described in paragraphs 2 and 3.

4. On completion of repair assemble gasket (BK.1347) and torch igniter assembly (BK.8105), and secure with existing grover washer (KJ.4508) and new nut (KJ.4310), as shown on Drawing No. B11313 Figure 1 attached.

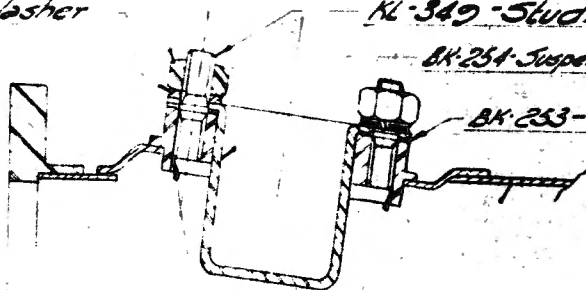
2. This instruction lays down the repair method to be used when outer air casings become unserviceable because of stripped threads.
3. If any one of the setscrew threads in a suspension point boss is stripped, all four threads are to be repaired as described below in sub-paragraphs (a) and (b):-

4. On completion of repair, assemble gasket (BK.253) and suspension tube (BK.254), and secure with existing grover washer (KJ.4507) and new nut (KJ.4007), as shown on Drawing No. B.11322 attached.

Low temperature braze stud
into position, from inside

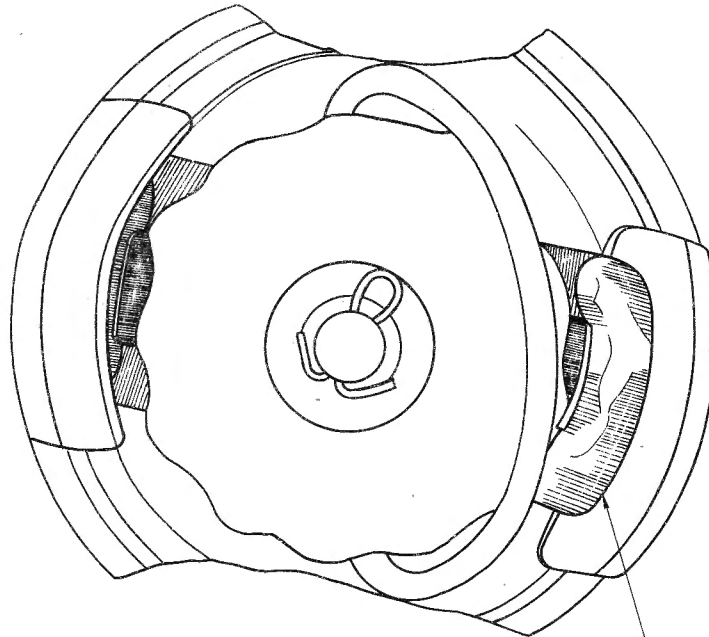
INCORRECT

FAULTY ENGAGEMENT

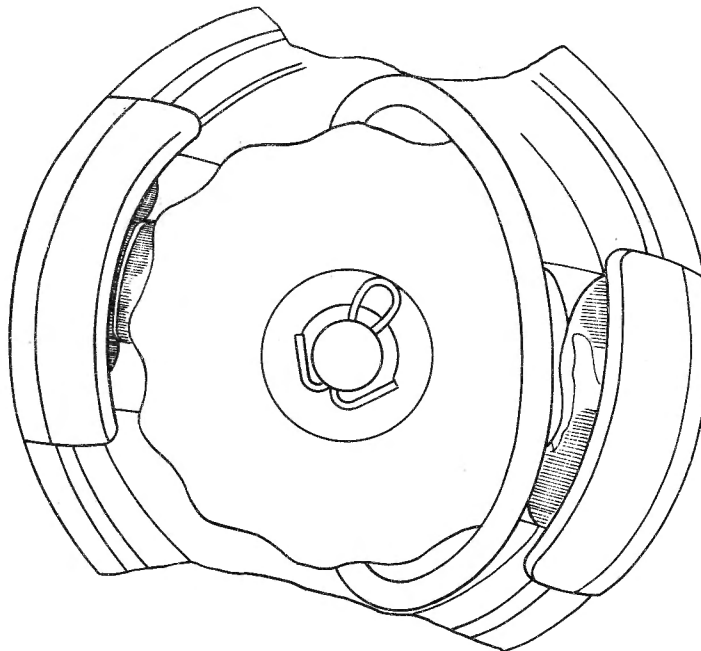
CORRECT ENGAGEMENT
