# AEROPLANES

Vampire F.B. Mk. 9 Aircraft—Two Anchor Nuts on Rib No. 1, Port Wing, replaced by Two Anchor Cap Nuts, Part No. A.G.S.2023/B1, to Support Cables on Engine Side of Bulkhead—Introduction

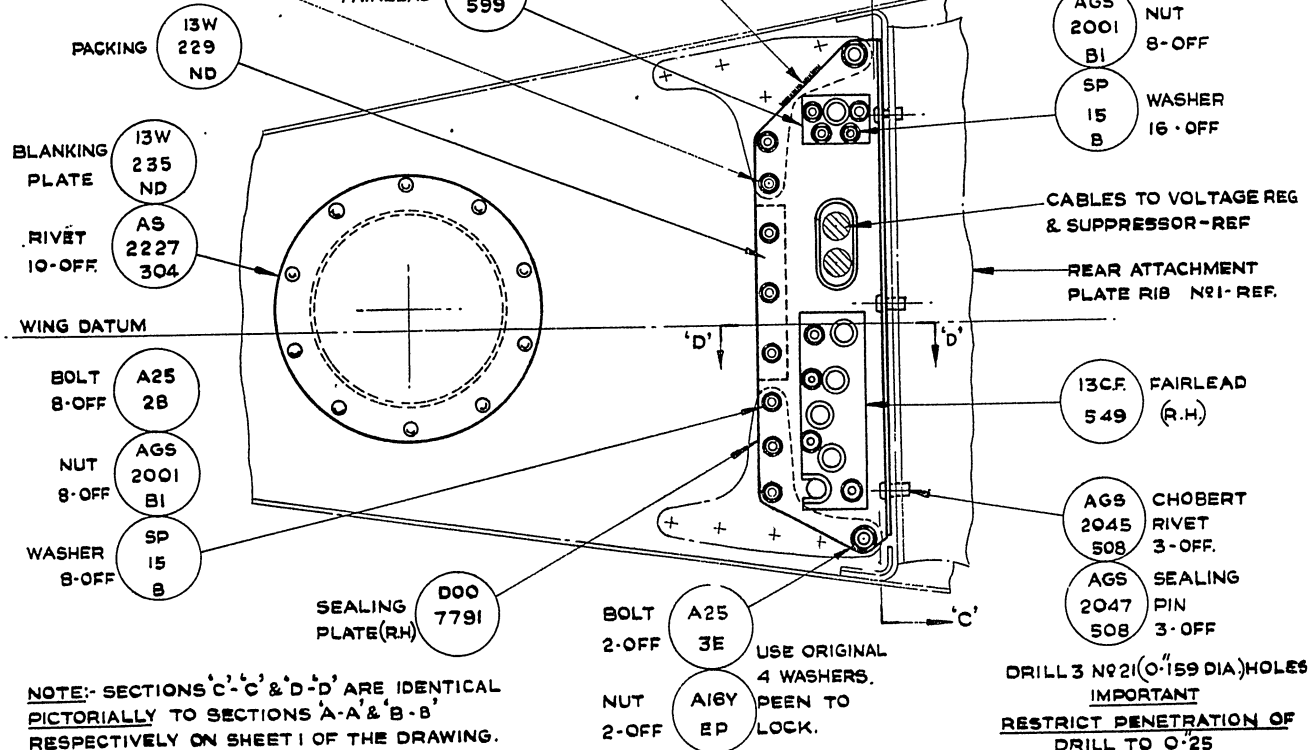
VIEW LOOKING INBOARD ON ROOT RIB NO. 1 (STARBOARD)

1. This modification has been introduced because, in the event of a fire at the rear of root rib No. 1, considerable damage can be caused to various electrical gear in the flap shroud. It seals off the holes in the root ribs to obviate this danger.

REMOVE EXISTING RIVETS FROM ATTACHMENT PLATES & REPLACE WITH FIVE BOLTS AS SHOWN.

CUT BACK VOLTAGE REG. MTG. BRACKET (OMITTED FOR CLARITY) TO CLEAR SEALING PLATE.

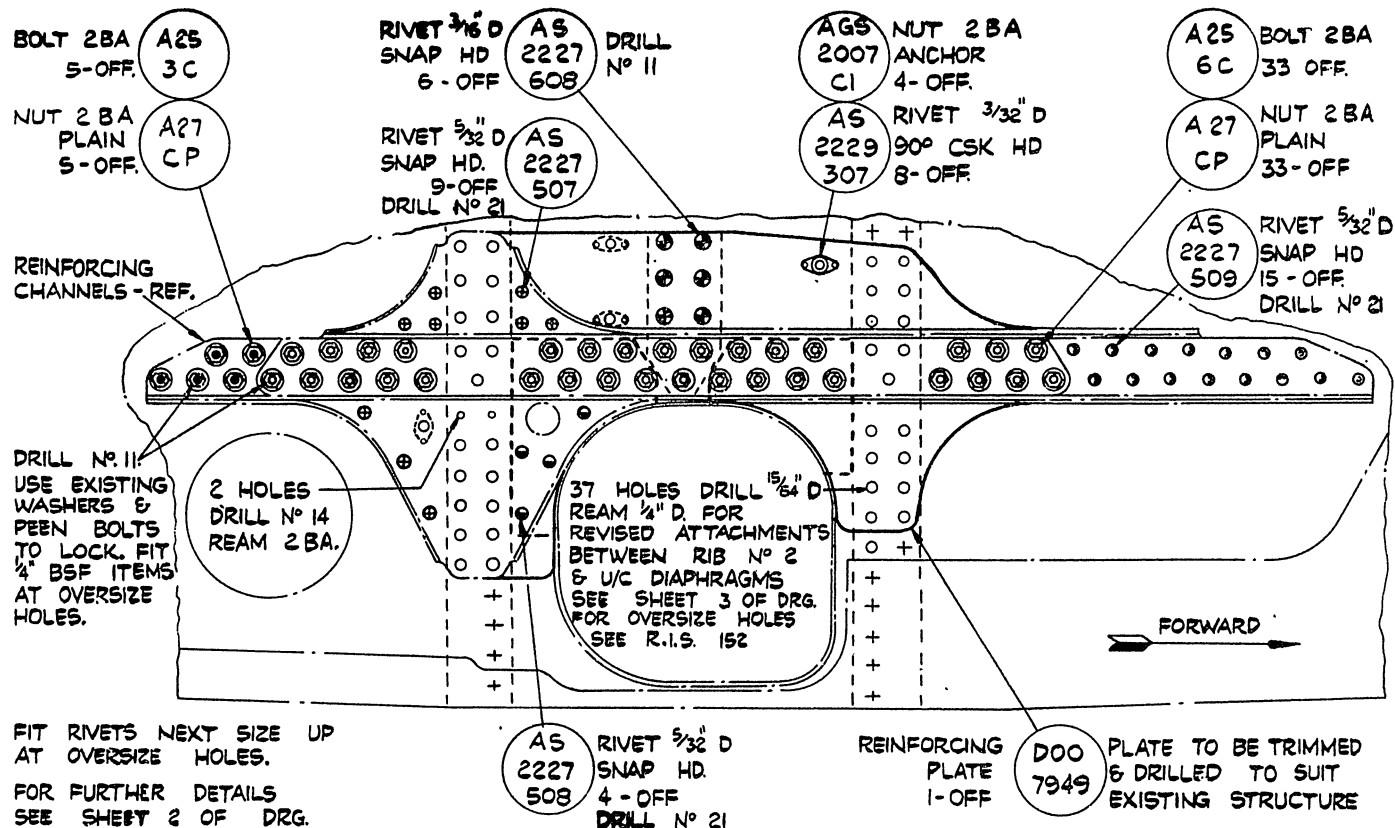
ADDITIONAL REINFORCING PLATE ON INBOARD FACE OF RIB NO 2 (PORT DRAWN)

Reports indicate that Rib No. 2 may crack and buckle in the vicinity of the undercarriage aperture. This modification introduces additional steel reinforcing plates and stiffeners on both sides of Rib No. 2 and on the back face of the rear undercarriage diaphragm and on the forward face of the front undercarriage diaphragm. Fixing holes through Rib 2 and the diaphragms found oversize during the embodiment of this modification are to be dealt with in accordance with Repair Instruction Sheet No. 152, Issue 2.

*Note:*—Repair Instruction Sheet No. 137, Issue 3 introduced a reinforcing plate, Part No. R.OOD.424 (port); R.OOD.425 (starboard) on the inboard side of Rib No. 2 similar to that shown on sheet 1 of the drawing and two reinforcing plates, Part Nos. R.OOD.378 and R.OOD.380 (port); R.OOD.379 and R.OOD.381 (starboard) on the outboard side of Rib No. 2 similar to those shown on sheet 2 of the drawing. Examine the latter two outboard plates and ensure that their flanges do not exceed 0.125 in. Reduce the flanges to this dimension and remove all sharp edges where necessary. The following operations (4) to (12) do not apply to mainplanes with the aforementioned reinforcing plates already installed.

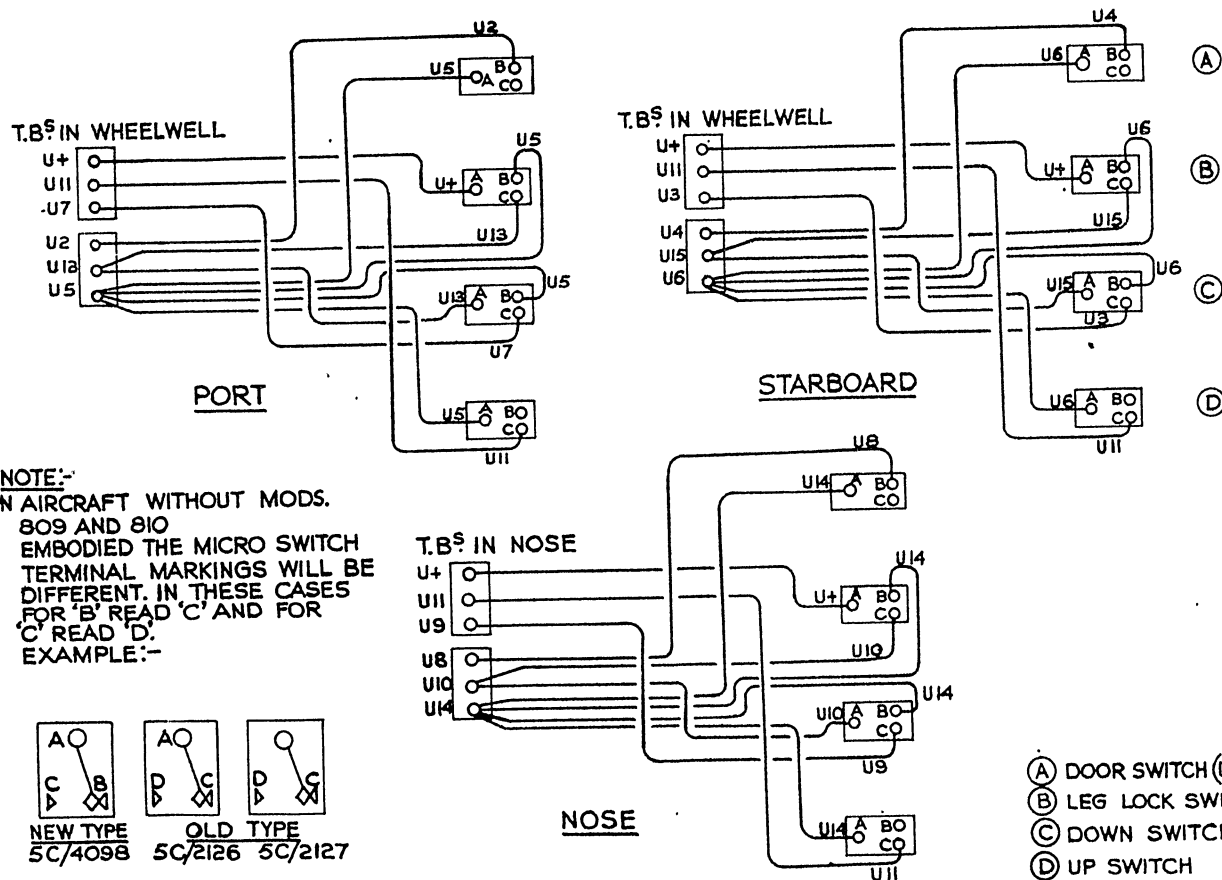
WIRING DIAGRAM OF U/C. BETWEEN T.B.S. AND SWITCHES.

1. This modification introduces an additional down lock micro-switch at each undercarriage leg (port and starboard main legs and nose wheel) and revises the wiring. This is necessary owing to reports that micro-switches have sometimes failed to operate correctly in the existing circuit, so that a green, in place of red indication light, may show before the undercarriage is fully locked down. Concurrent embodiment of Mod. No. Vampire/809 and 810 is advisable.

*Note:*—On aircraft without Mod. No. Vampire/809 embodied, the micro-switch markings will be found to differ from those shown in the wiring diagrams. In these cases, read the markings as given in the example in Sheet 3 of the drawing. At the "UP" switch and "LEG LOCK" switch, it will be found that there is a redundant lead which must be taped back and insulated.
