Introduction and make-up of A.P.4099G, Vol. 2, Part 1

GENERAL INTRODUCTION

1. Air Publication No. 4099G has been allotted to the Vampire F.B. Mk. 9 aircraft. The Vol. 2, Part 1, of the A.P. will contain General Orders and Modification leaflets, and will conform to the "Revised (1948) System for Recording Leaflets".

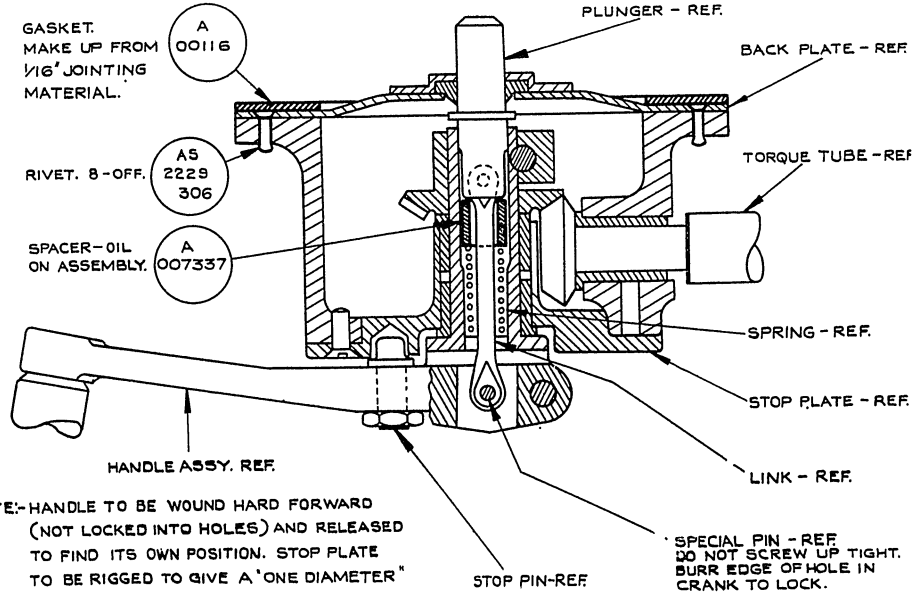
SECTIONAL VIEW OF CANOPY WINDING GEAR BOX ASSEMBLY.

1. This modification results from excessive wear on the stop pin of the canopy winding gear, resulting in disengagement of the locking and subsequent loss of the canopy, and makes provision for the introduction of a hardened pin to obviate this. This modification supersedes and cancels Mod. No. Vampire/970.

SCRAP VIEW SHOWING  
RELEASED POSITION OF  
STOP - PIN.

NOTE:- HANDLE TO BE WOUND HARD FORWARD  
(NOT LOCKED INTO HOLES) AND RELEASED  
TO FIND ITS OWN POSITION. STOP PLATE  
TO BE RIGGED TO GIVE A "ONE DIAMETER"  
POSITION AS SHOWN IN SCRAP VIEW  
USING THE VERNIER ADJUSTMENT.

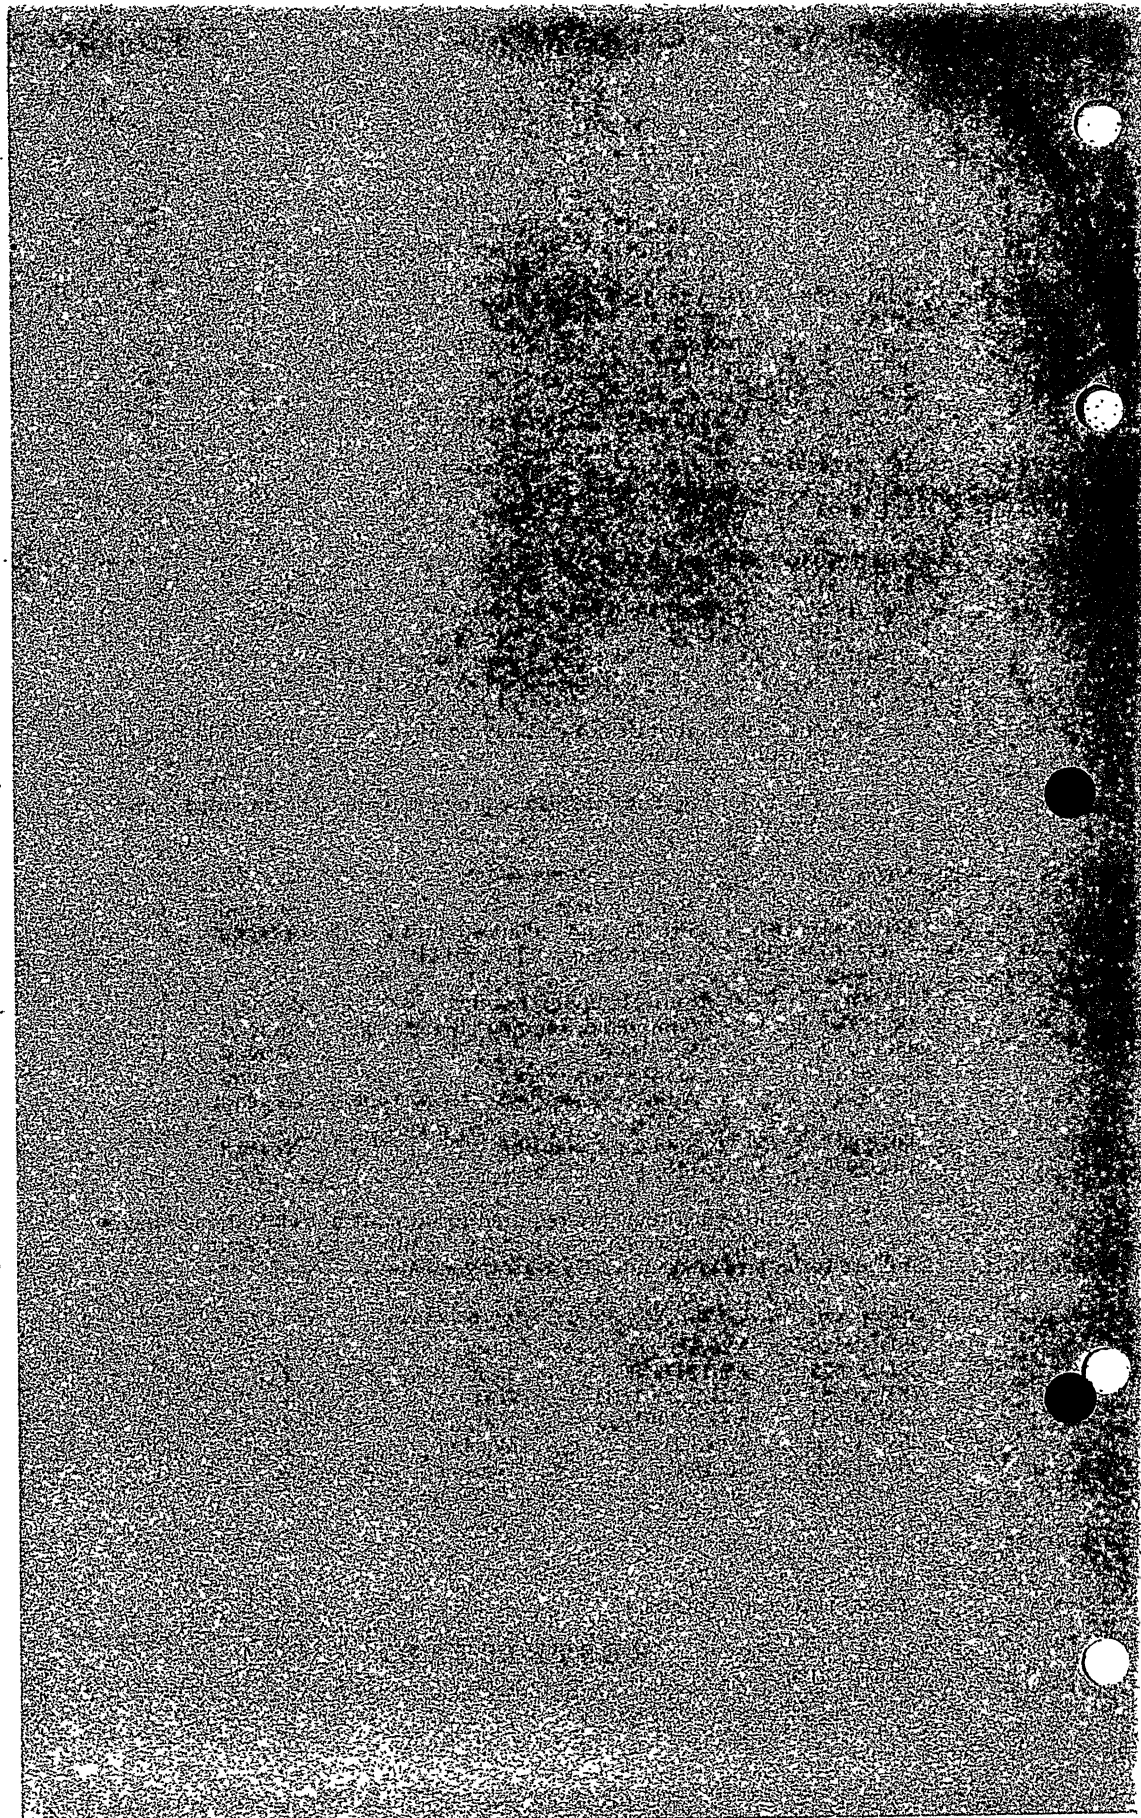
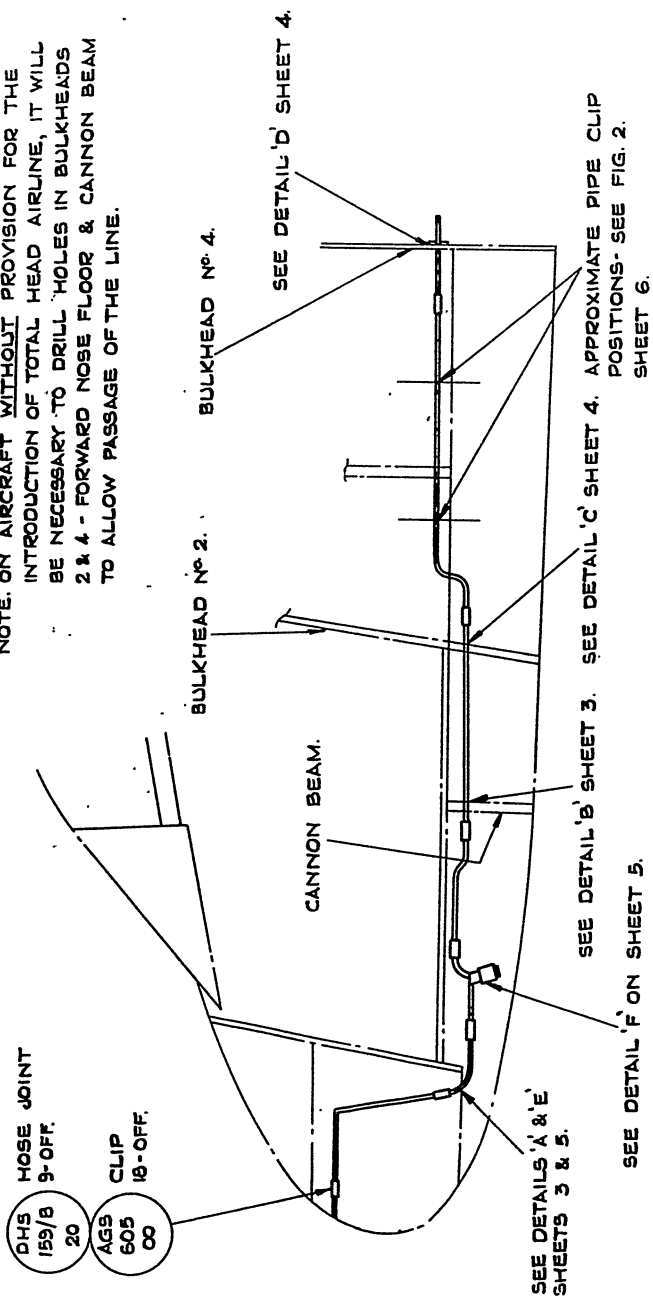
ARRANGEMENT OF TOTAL HEAD AIRLINE TO BAROSTAT.

1. It has been found that, with the existing total head air supply from the generator cooling inlet duct, the air flow is disturbed, resulting in fluctuating barostat pressure. This modification introduces a new pipe run from the nose of the aircraft to obviate this.

NOTE ALL HOSE JOINTS TO BE BONDED WITH  
A TINNED COPPER STRIP  $\frac{1}{4}$ " WIDE X 22 SWG.

NOTE. ON AIRCRAFT WITHOUT PROVISION FOR THE  
INTRODUCTION OF TOTAL HEAD AIRLINE, IT WILL  
BE NECESSARY TO DRILL HOLES IN BULKHEADS  
2 & 4 - FORWARD NOSE FLOOR & CANNON BEAM  
TO ALLOW PASSAGE OF THE LINE.

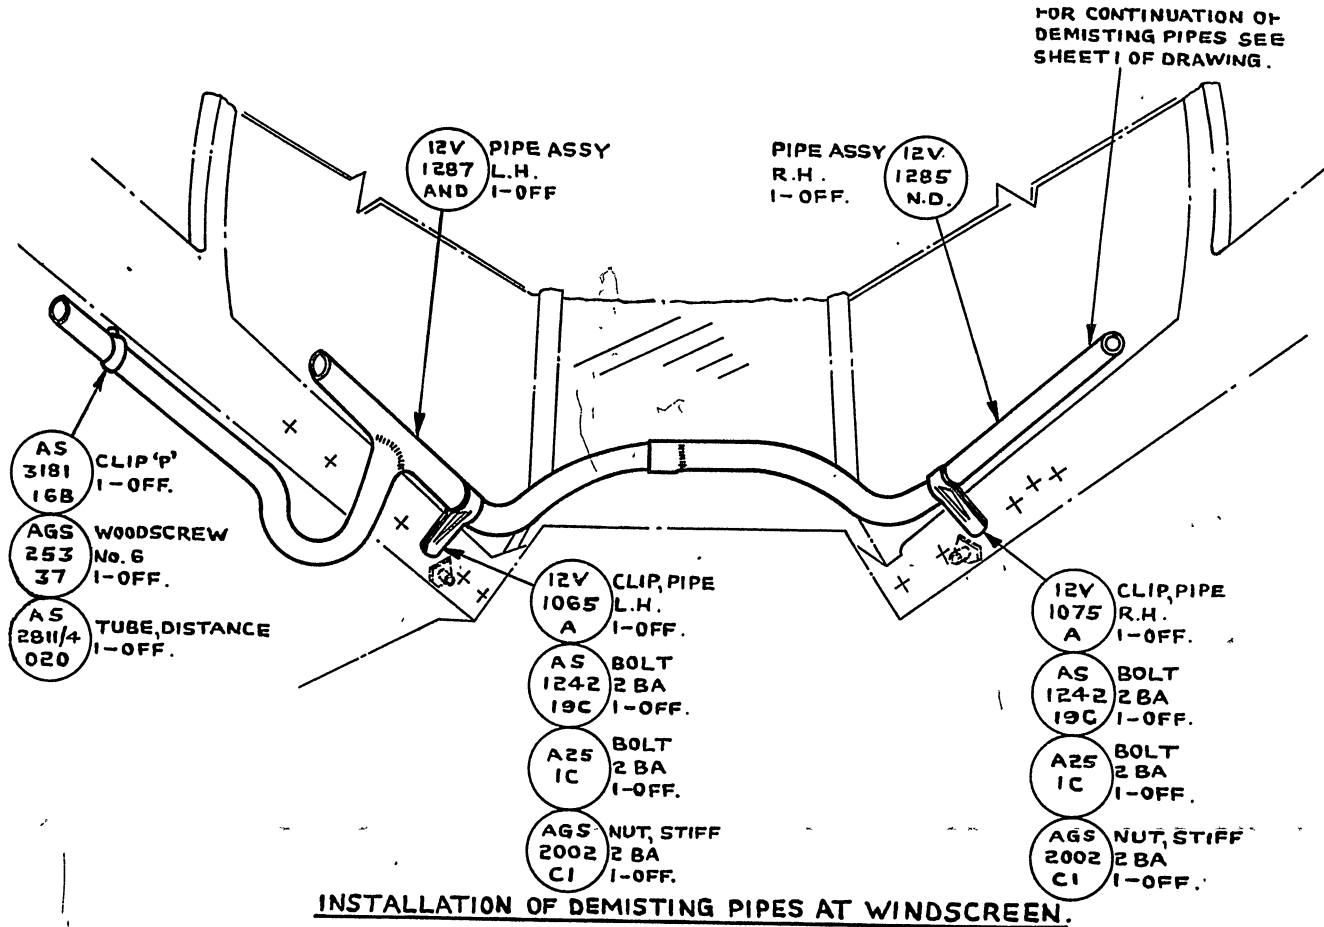
SHEET 3

It has been found that the canopy perspex is fracturing in flight. To prevent this, this modification introduces a new strengthened canopy embodying an aluminium alloy front arch member. At the same time to ensure positive jettisoning of the canopy, redesigned demisting pipes are introduced.

(5) Refer to Sheet 3 of the drawing and offer up the new port and starboard windscreen demisting pipes, Part Nos. 12V.1287A/ND (L.H.), 12V.1285ND (R.H.) and the two new forward attaching pipe clips, Part Nos. 12V.1065A (L.H.), 12V.1075A (R.H.) positioning them so that the pipe clips lower attachment holes line up with the countersunk-head bolts that attach the windscreen frame to the fuselage immediately aft of the control lock sockets. When the positions of these bolts are ascertained, remove them, retaining their stiffnuts and washers, and replace them with two new 2 B.A. countersunk-head bolts, Part No. AS.1242/19C, coating these bolts with Bostik 1751 sealant prior to fitment. Position the new pipe clips on these bolts and secure using the retained washers and stiffnuts. Using two new 2 B.A. hexagon-head bolts and stiffnuts, Part Nos. A.25/1C and AGS.2001/C1, respectively, through the pipe clips upper holes, tighten the pipe clips around the demisting pipes. Couple the port demisting pipe to the demisting feed pipe using the existing pipe joint and hose clip.
