**STRUCTURES REPORT 378**

**FATIGUE TESTING OF VAMPIRE WINGS**

**R. A. BRUTON and C. A. PATCHING**

The fatigue behaviour of a total of 21 port and starboard Vampire wings has been investigated for a 12 load level programmed loading sequence, representative of an average Australian flight loading spectrum. An additional two wings were subjected to a randomised sequence of these loads.

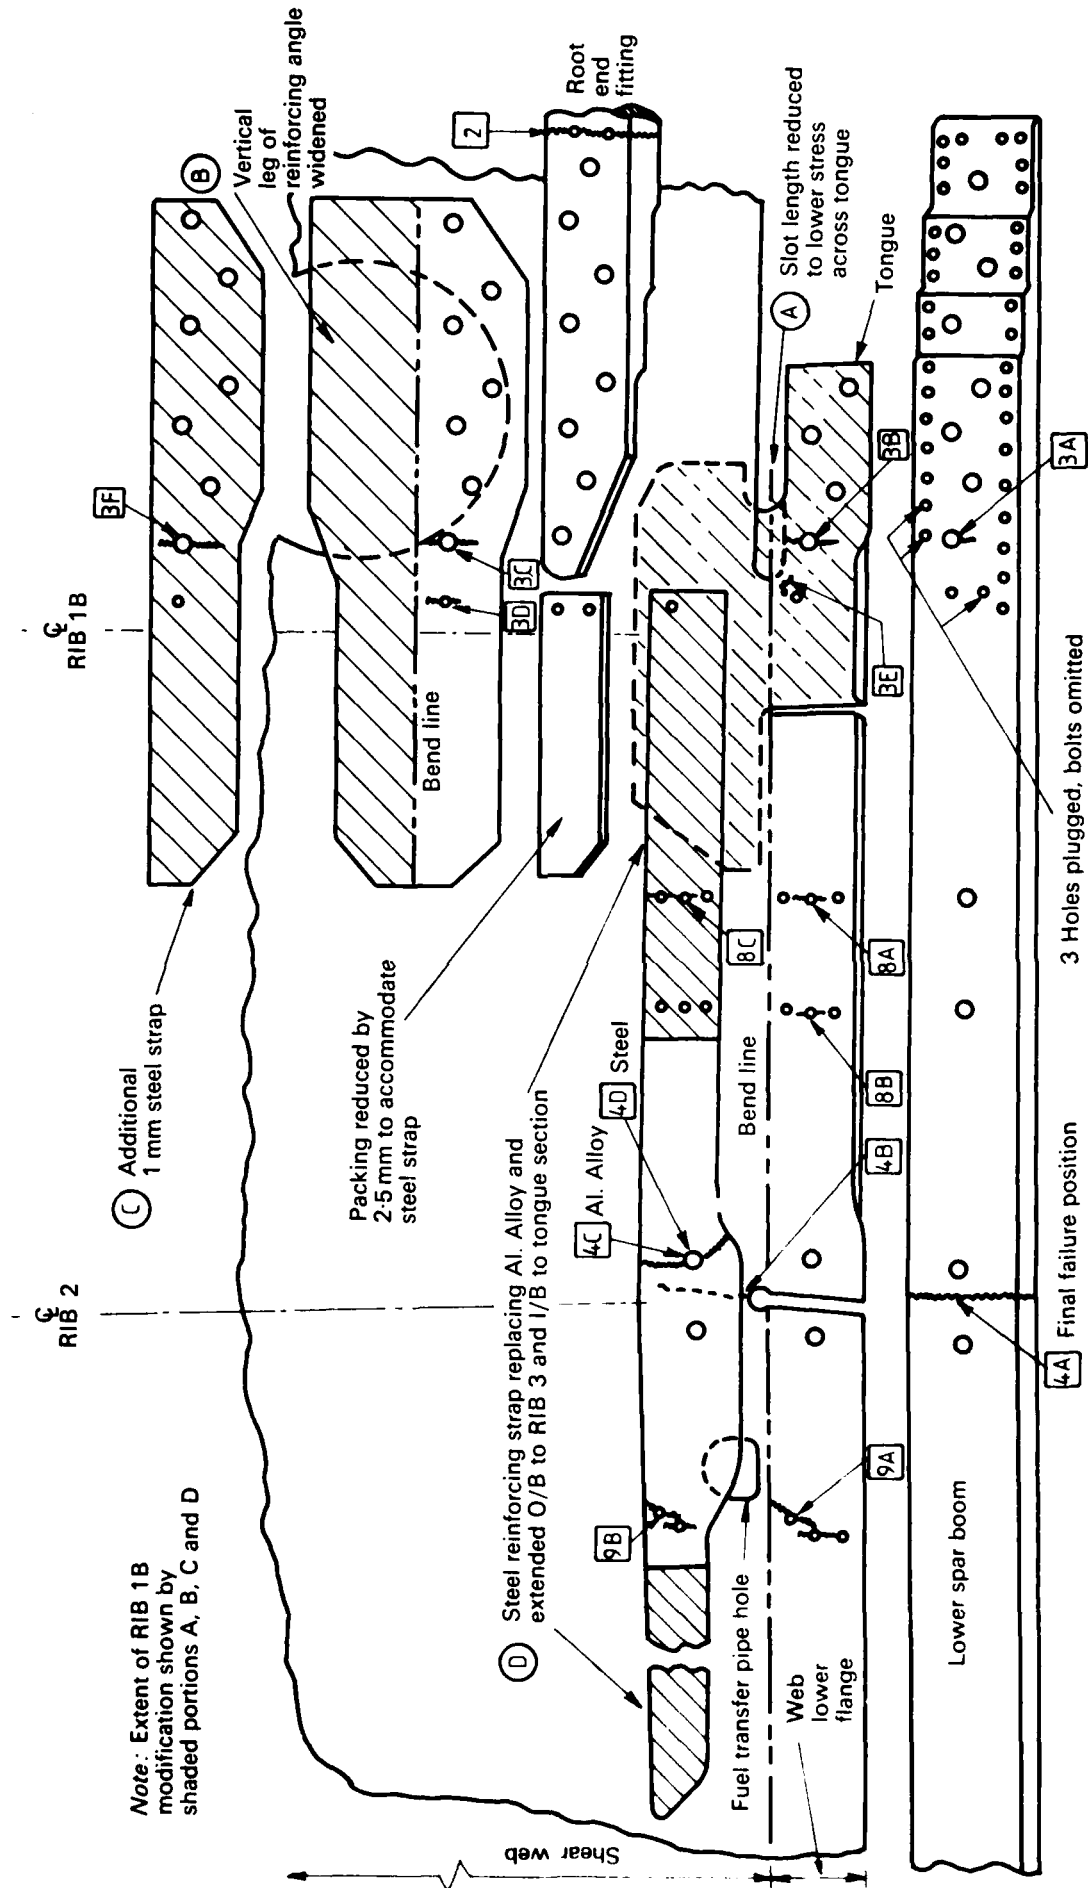
FIG. 1: BOOM REPLACEMENT—MODIFICATIONS AND FAILURES  
EXPLODED VIEW AT REAR FACE OF SPAR WEB PORT WING

- (a) looseness of the inboard five or six corner screws of No. 1 tank door along the main spar and root rib, and a similar number of corner screws of No. 2 tank door along the spar and forward along Rib 2;
- (b) elongation of the screw holes detailed in (a);
- (c) heavy fretting between the mating surfaces of the fuel tank doors and flanges at the area detailed in (a);
- (d) fatigue cracks in the spar web at the end of the flange slot at Rib 2 (failure 4B, Fig. 1) and also in the outboard corner of the fuel transfer hole at Sta. 1524 (failure 9A, Fig. 1).

The opportunity was also taken to increase the fatigue life at Rib 1B by introducing a number of modifications in this region that were agreed to by the parties concerned. The modifications incorporated are shown in Figure 1. Those at B, C, and D were aimed at either inhibiting or delaying the cracking in the shear web flange and reinforcing angle. The change at C was the addition of a chrome-molybdenum steel strap, and at B the reinforcing angle had the vertical flange increased in width. At D the aluminium alloy reinforcing plate at Rib 2 was replaced by a longer steel plate extending from Rib 3 inboard to the root end fitting.

In the region of the root end fitting the changes A, B, and C were designed to reduce the load carried by the spar boom and shear web tongue at the section through the end bolt hole. This necessitated two 4.7 mm (2BA) bolts being omitted, and it was also found possible to remove a third bolt (4.7 mm (2BA)) which further improved the local stress conditions in the tongue. All three bolt holes in the replacement booms for wing specimens 13 and 16 were filled with an epoxy resin to prevent corrosion, as were also the P-K screw holes at Rib 2.

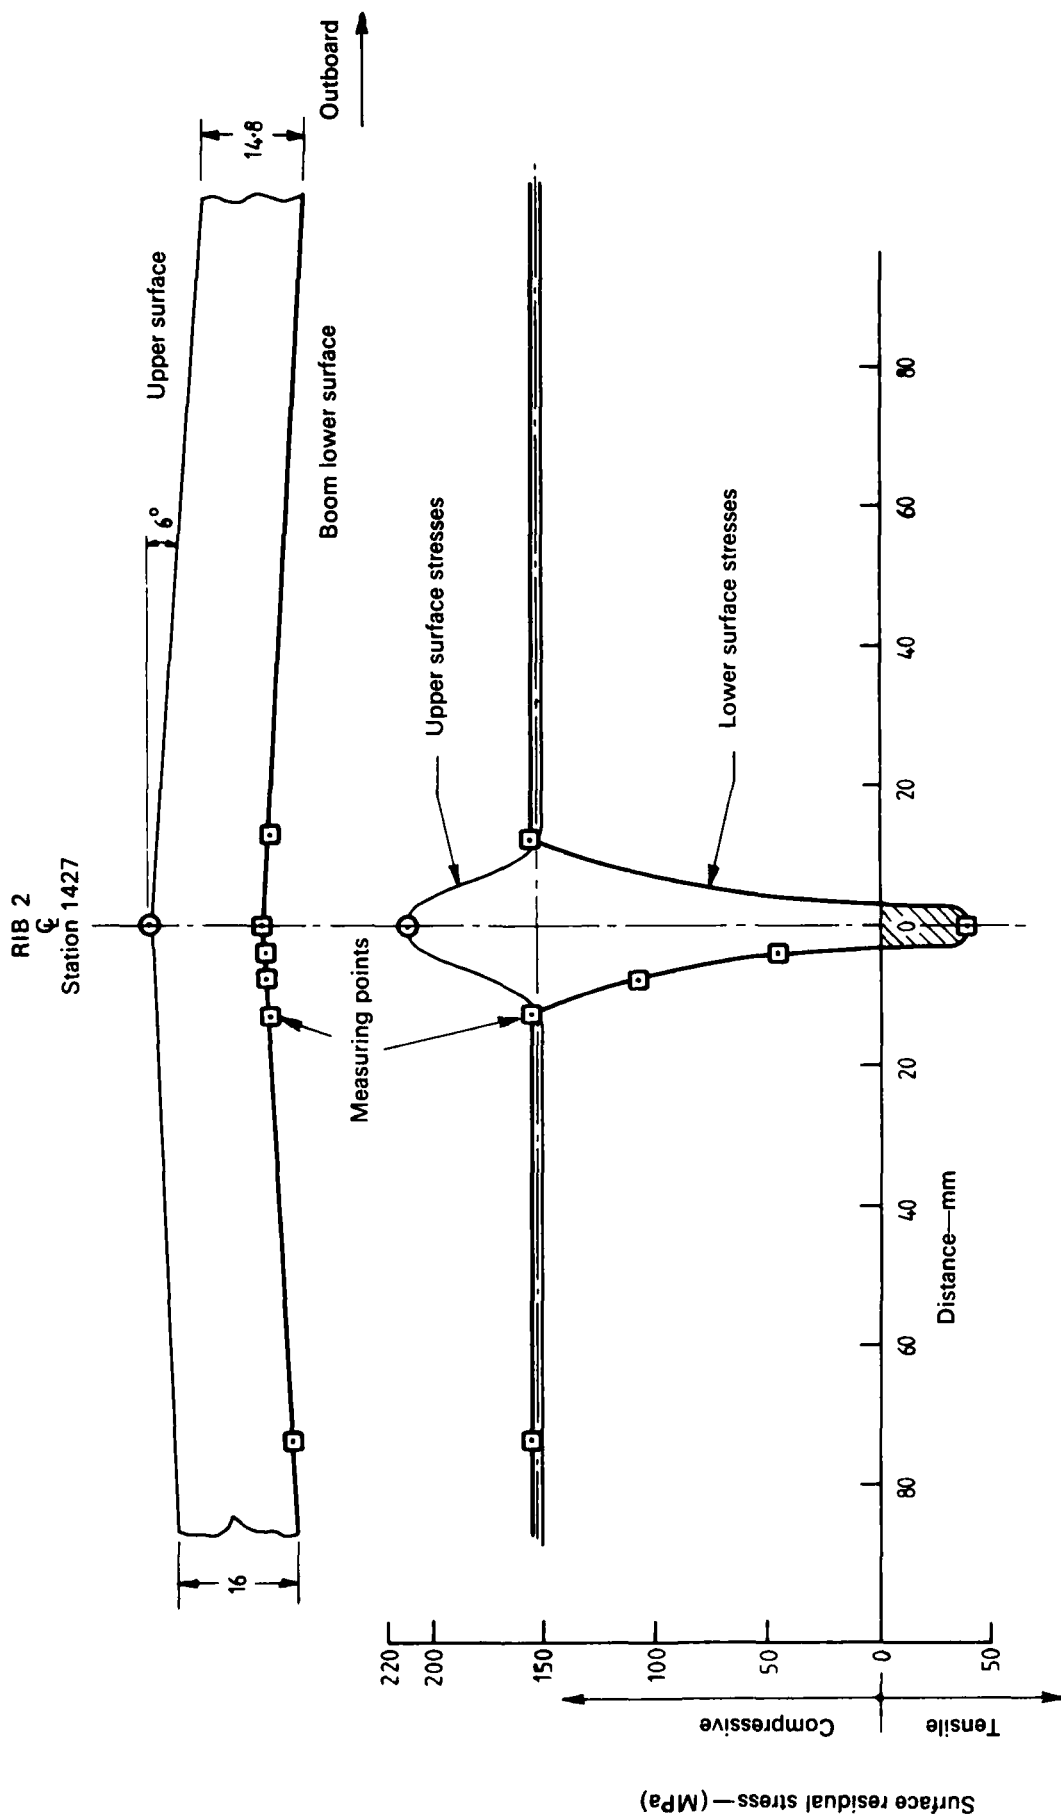
FIG. 2: RESIDUAL SURFACE STRESSES IN VAMPIRE WING  
LOWER SPAR BOOM AT RIB 2

From the fatigue tests conducted in England it was known that the fatigue failure in the lower spar boom at Rib 2 passed through the holes for the P-K screws attaching the skin to the boom. At this point the boom was bent through an angle of six degrees, and the forming process was known to produce residual tensile stresses on the surface, which would add to the stress concentration factor of the screw holes.

Tensile surface stresses of about 40 MPa were found to be present over only a very restricted length of the boom, and the tensile stresses induced by flight loads greatly exceed this value. Hence the contribution of these residual stresses would have little influence on fatigue around the P-K screws.

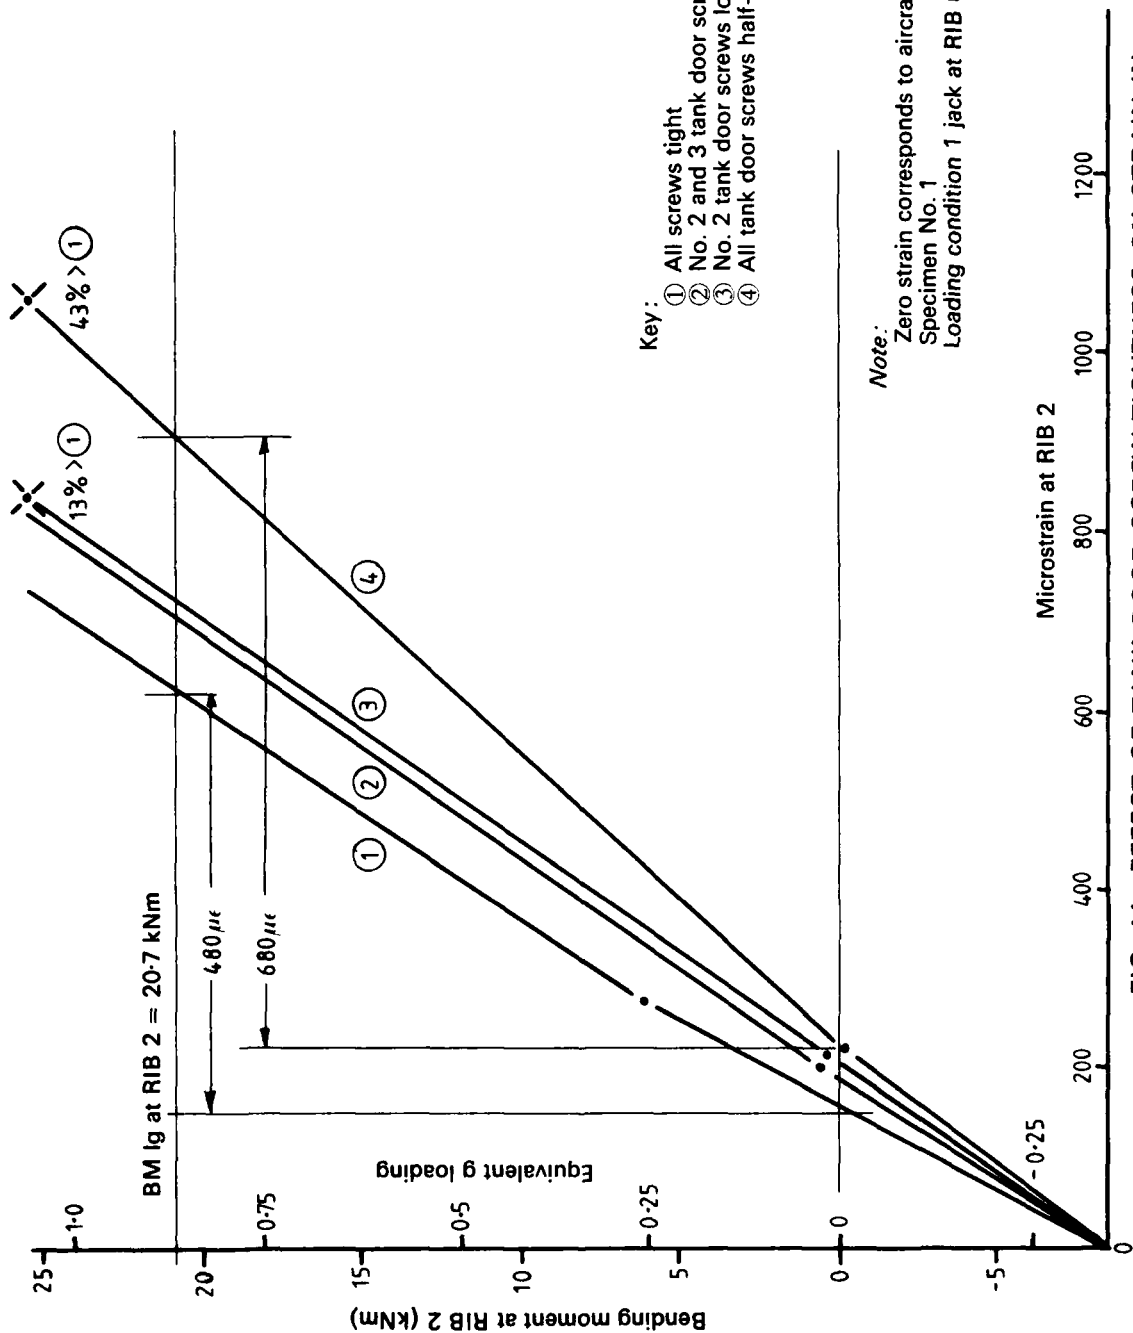
FIG. 11: EFFECT OF TANK DOOR SCREW TIGHTNESS ON STRAIN IN SPAR BOOM AT RIB 2

A series of tests was conducted which showed that the strain in the spar boom was directly controlled by the flexibility of the screwed attachments for the removable tank bay doors. The effect of screw tightness on strain in the spar boom is shown in Figure 11, where it can be seen that the strain variation could amount to 43% if all attachment screws were loose instead of being tight.

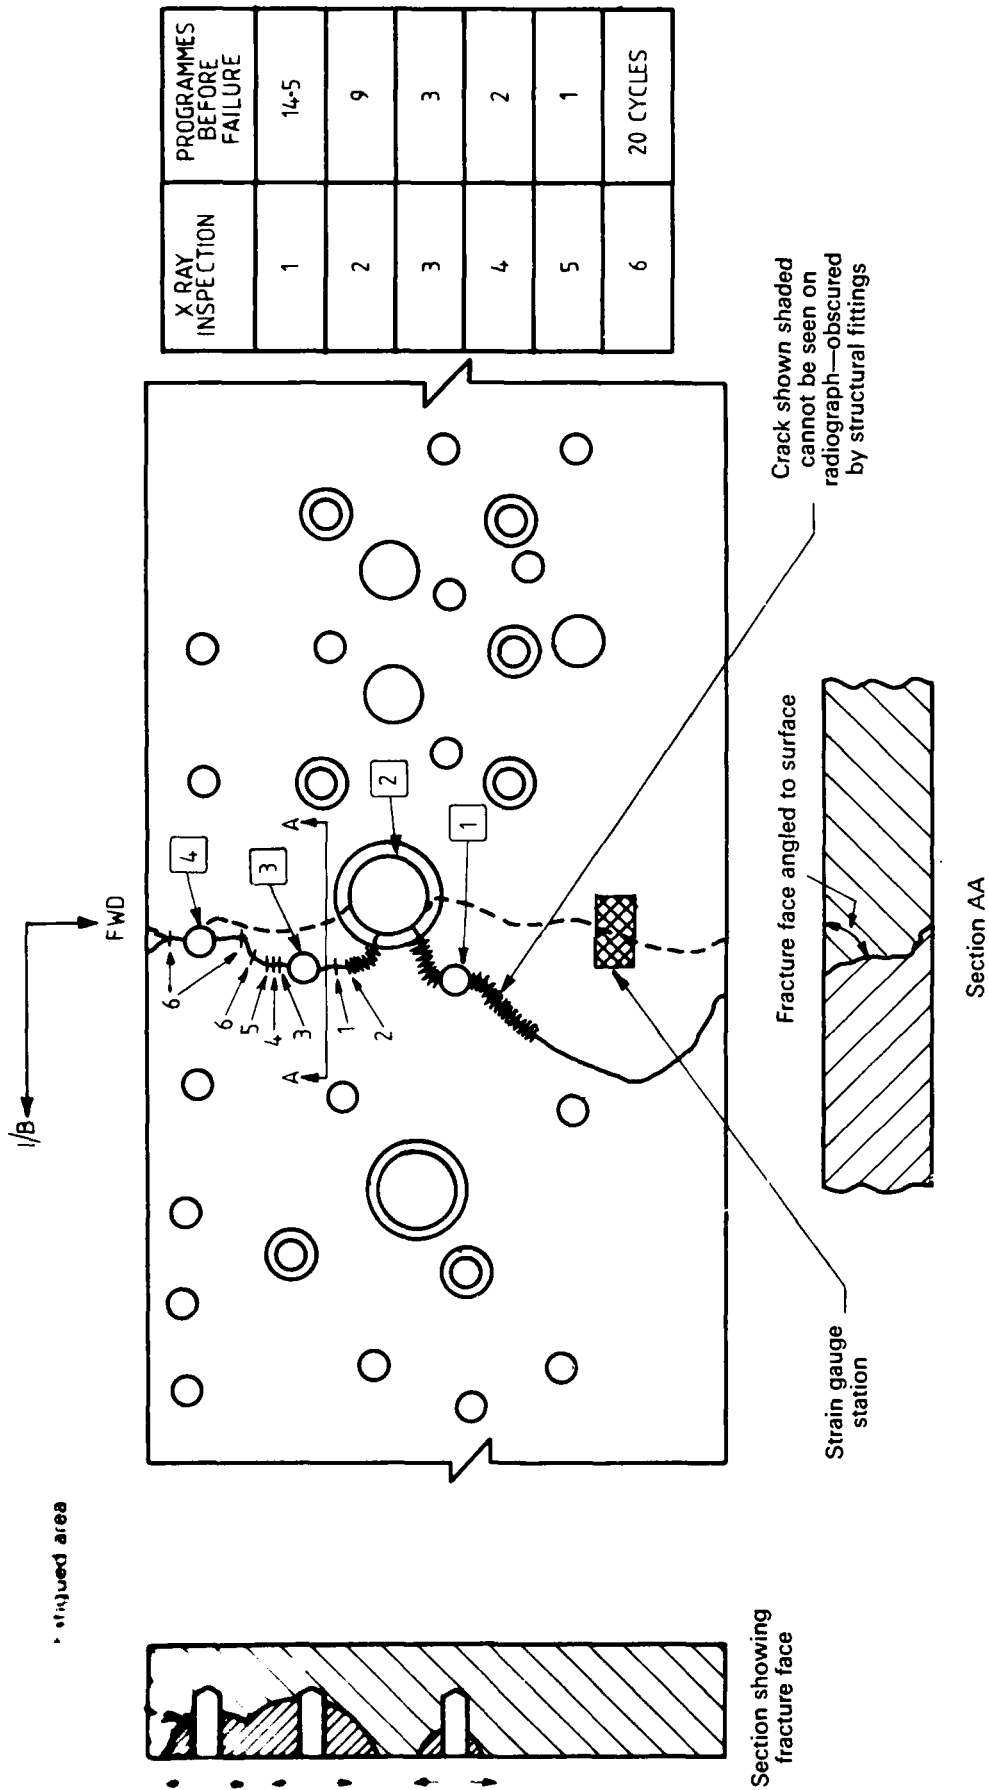
FIG. 12: LOWER SPAR BOOM—RIB 2 FAILURE—SPECIMEN No. 6

An electric resistance strain gauge was mounted on the spar boom at Rib 2 (see Fig. 12) close to the expected path of the fatigue crack. However, the measured strain from this gauge remained virtually unchanged until collapse was imminent. This could be attributed to a number of factors including the following:

- (i) The crack propagated from the aft side of the screw holes in the boom, whereas the gauge could only be attached on the forward side.
- (ii) An alternate load path was provided by bolted reinforcing brackets bridging the fatigue crack.
- (iii) The boom area amounted to 20% of the wing tension surface, and thus the fatigue crack represented a loss of only approximately 4% in area.

A record of the progress of these cracks is shown in Figure 12. The table in this figure gives the number of programmes before failure at which each X-ray exposure was taken. Inspection 1 made 14.5 programmes before failure, showed a crack propagating forward from hole 3. Inspection 2 showed that this crack had progressed into an area beyond the sensitivity of the X-ray beam. Examination after failure showed that this same crack had actually joined another crack progressing aft from hole 2. Inspection 3, only three programmes before final failure, detected a second crack progressing aft from hole 3. Subsequently, inspections 4 and 5 show further progress of this crack. The sixth inspection, only 20 cycles before collapse detected a crack propagating forward and aft from hole 4.

The crack that grew fore and aft from hole 1 could not be detected by radiographic means because of structural fittings obscuring the X-rays. Most of the forward crack length was due to overload failure and the amount propagated by fatigue is shown in the sectional view on the left of Figure 12.

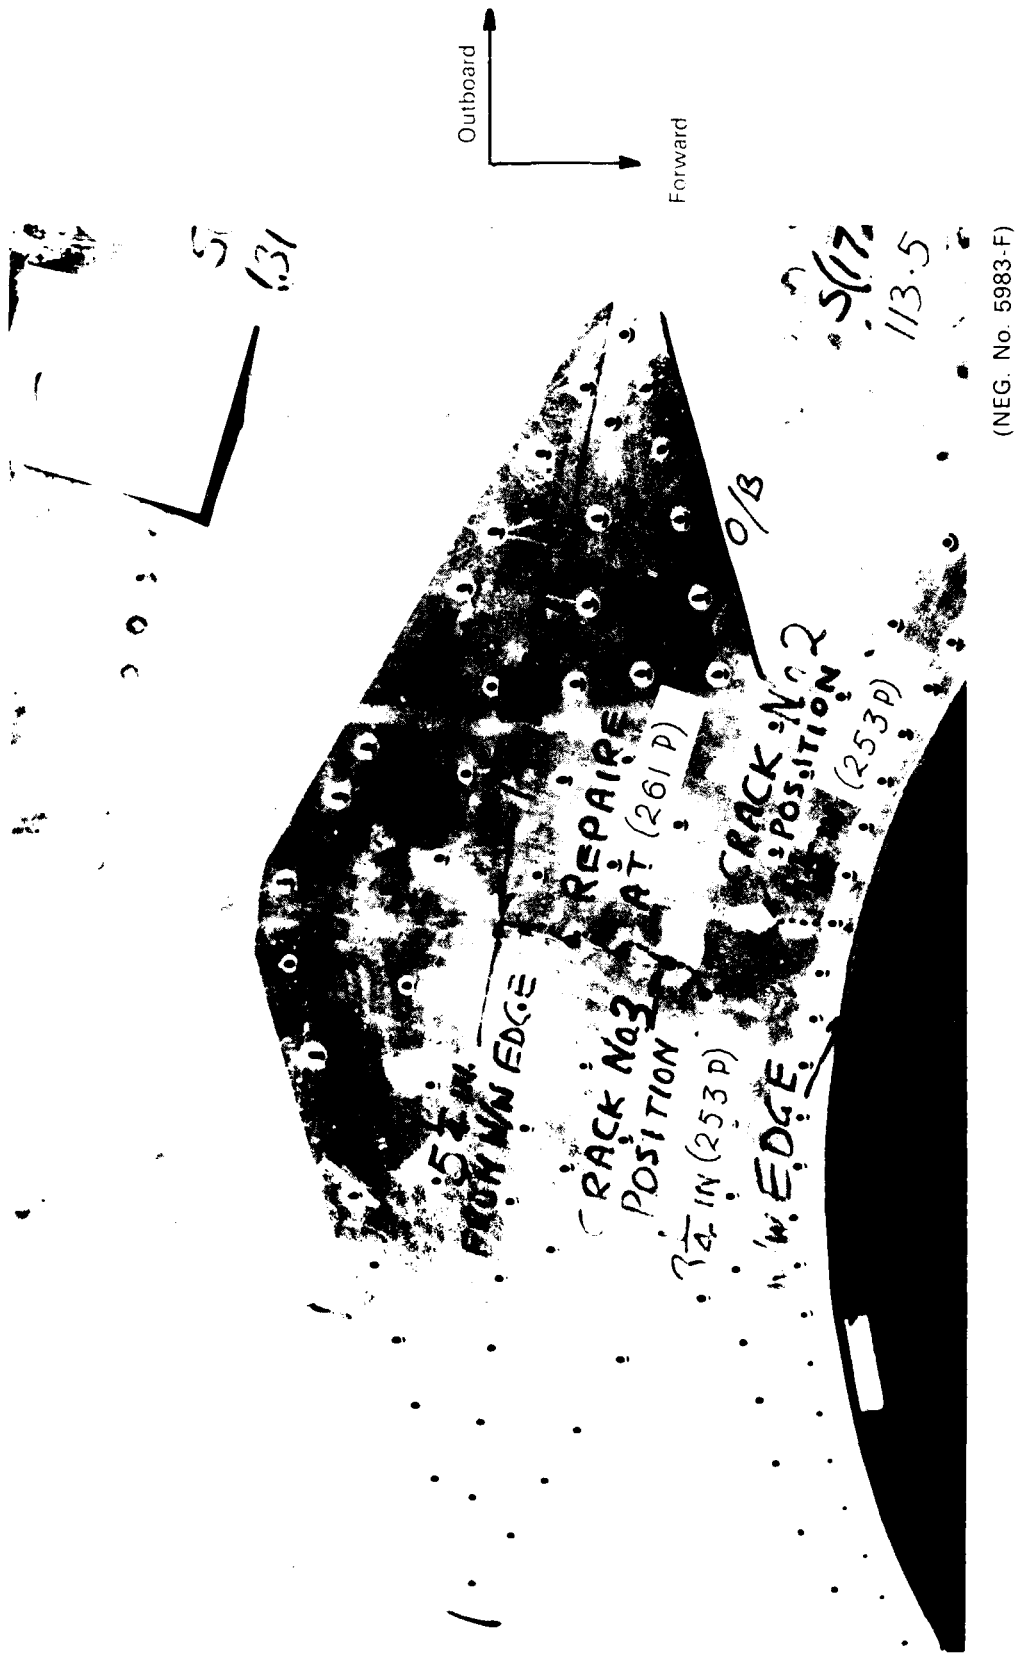
FIG. 24: LOCATION AND REPAIR OF LOWER SKIN FAILURE AFT OF WHEEL WELL AT STA 2248 (TYPE 11)

Fatigue cracks in two locations in the wing were repaired in a standard manner during testing. In the case of failure in the region of the rear spar at Rib 5 an available service repair

scheme was used, and the other at the rear of the wheel well was repaired using conventional repair techniques. The remaining repairs did not necessarily return the structure to the fully factored strength, but sufficient care was taken to allow the fatigue test to proceed without the introduction of undesirable stress concentrations.
