AIRFRAME

VAMPIRE

MODIFICATIONS

TECHNICAL STAFF INSTRUCTIONS
INDEX SHEET.

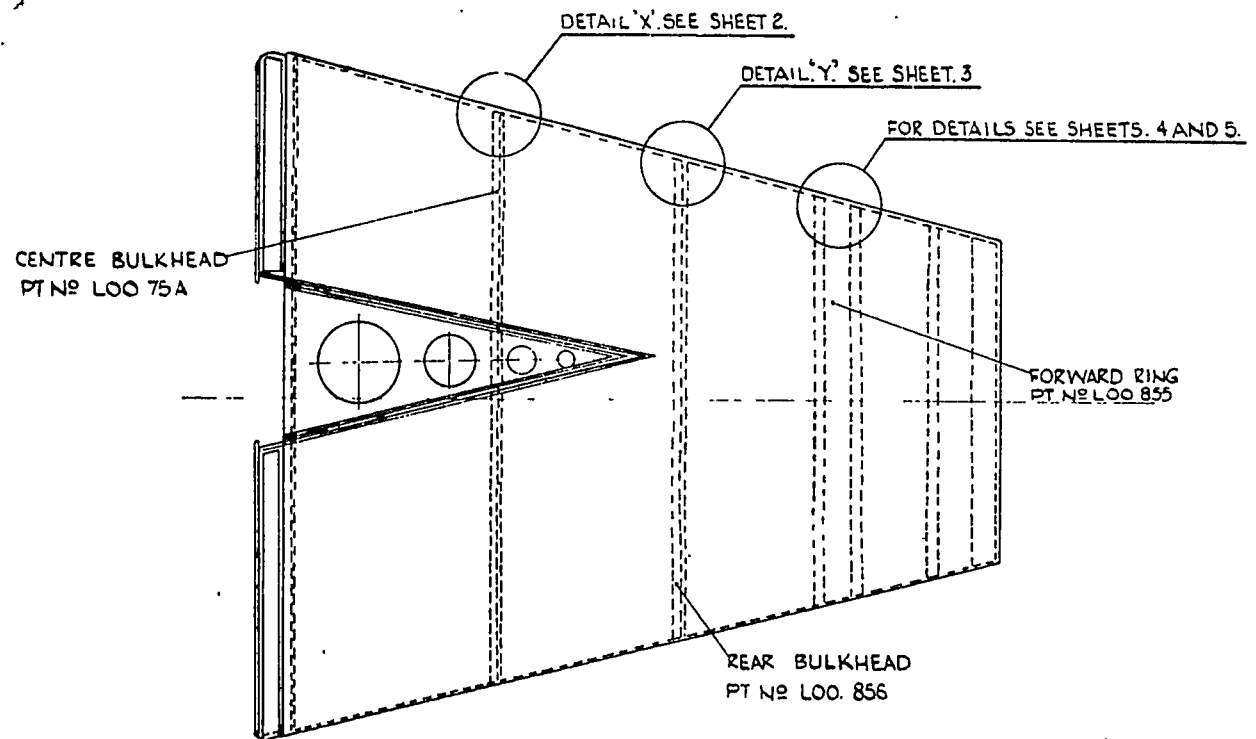
Drg. No. A.P.4099G/P.16:57
Sheet 1

VIEW OF REAR CONE SHOWING THE THREE POINTS TO BE MODIFIED.

- (1) Working inside the rear tail cone, locate the centre former or bulkhead, Part No. LOO.75A, reference to sheet 1 of the drawing will locate the position. At the top, mid-position of this bulkhead, Detail 'X', will be found two fish plates, one each side of the bulkhead, secured by eighteen $\frac{1}{8}$ in. dia. snaphead rivets. Carefully drill out these securing rivets using a No. 30 (0.1285 in. dia.) drill then discard the rear fish plate, Part No. LOO.146, which is rendered redundant. Refer to sheet 2 of the drawing, mark off and cut the cut-out in the bulkhead to the measurements shown, blending in the redundant rivet hole. Remove any sharp edges from the newly cut edge.

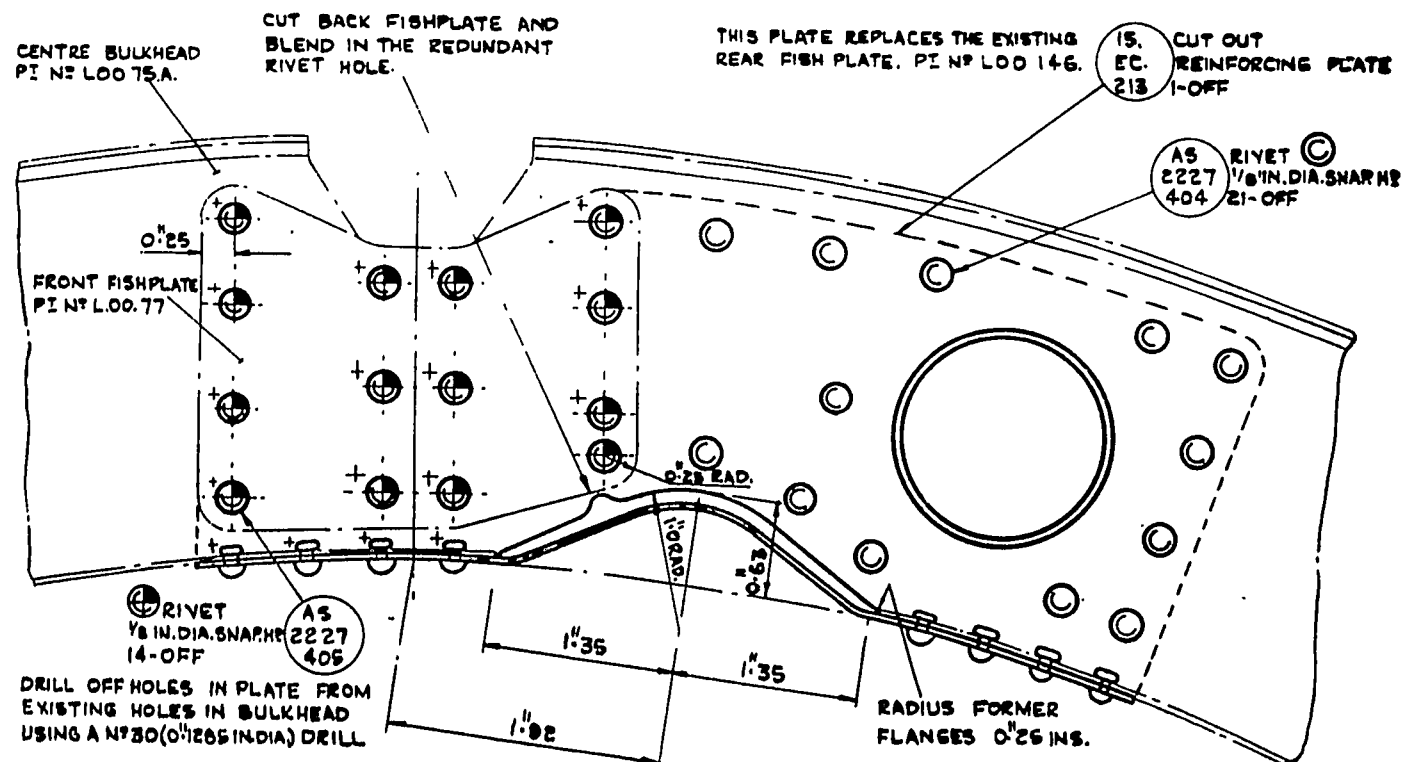
DRG. NO. A.R. 4099 G P 16 57
SHEET 2

DETAIL 'X' FROM SHEET 1. VIEW LOOKING AFT. SHOWING CUT OUT IN CENTRE BULKHEAD OF TAIL CONE AND FITMENT OF REINFORCING PLATE.

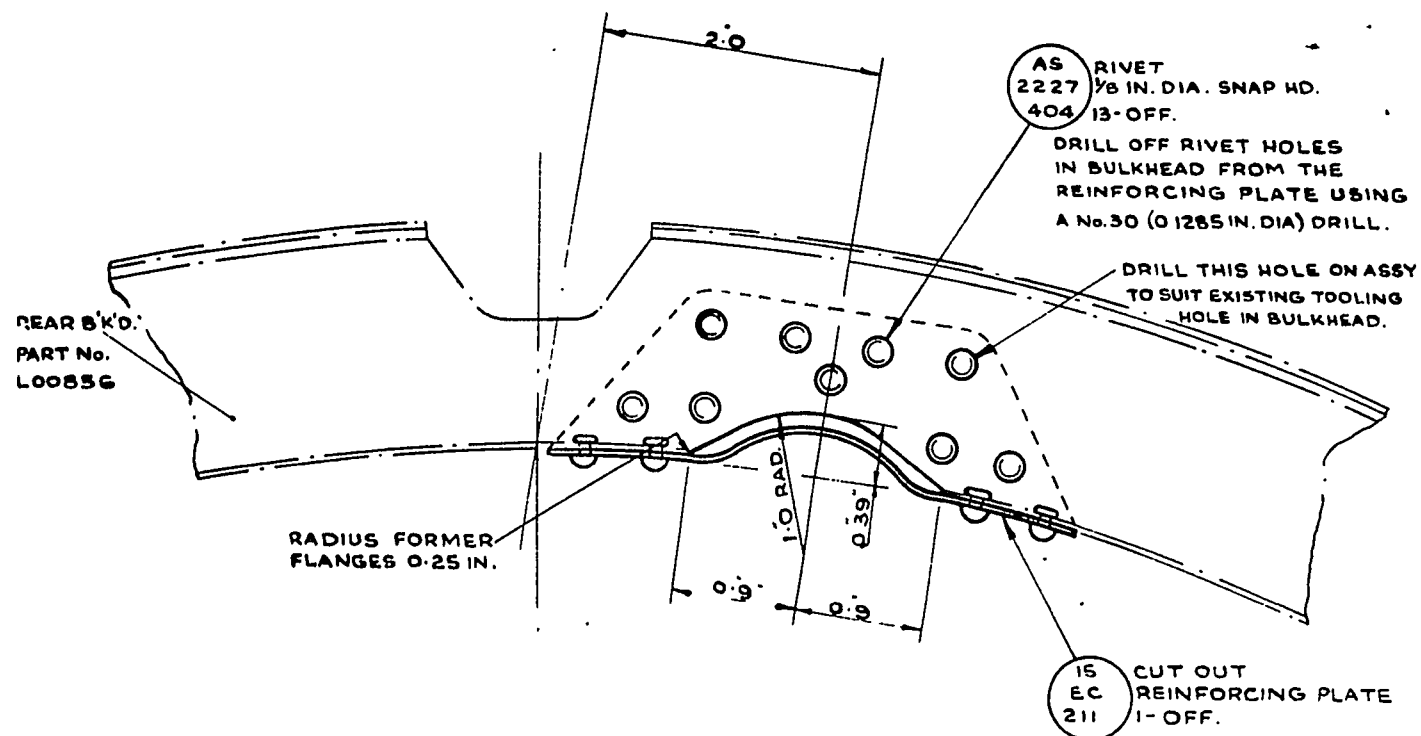
ORG. NE AR 4099 G P 16 57
SHEET 3

DETAIL Y, FROM SHEET 1. VIEW LOOKING AFT SHOWING CUT-OUT IN REAR BULKHEAD OF TAIL CONE AND FITMENT OF REINFORCING PLATE.

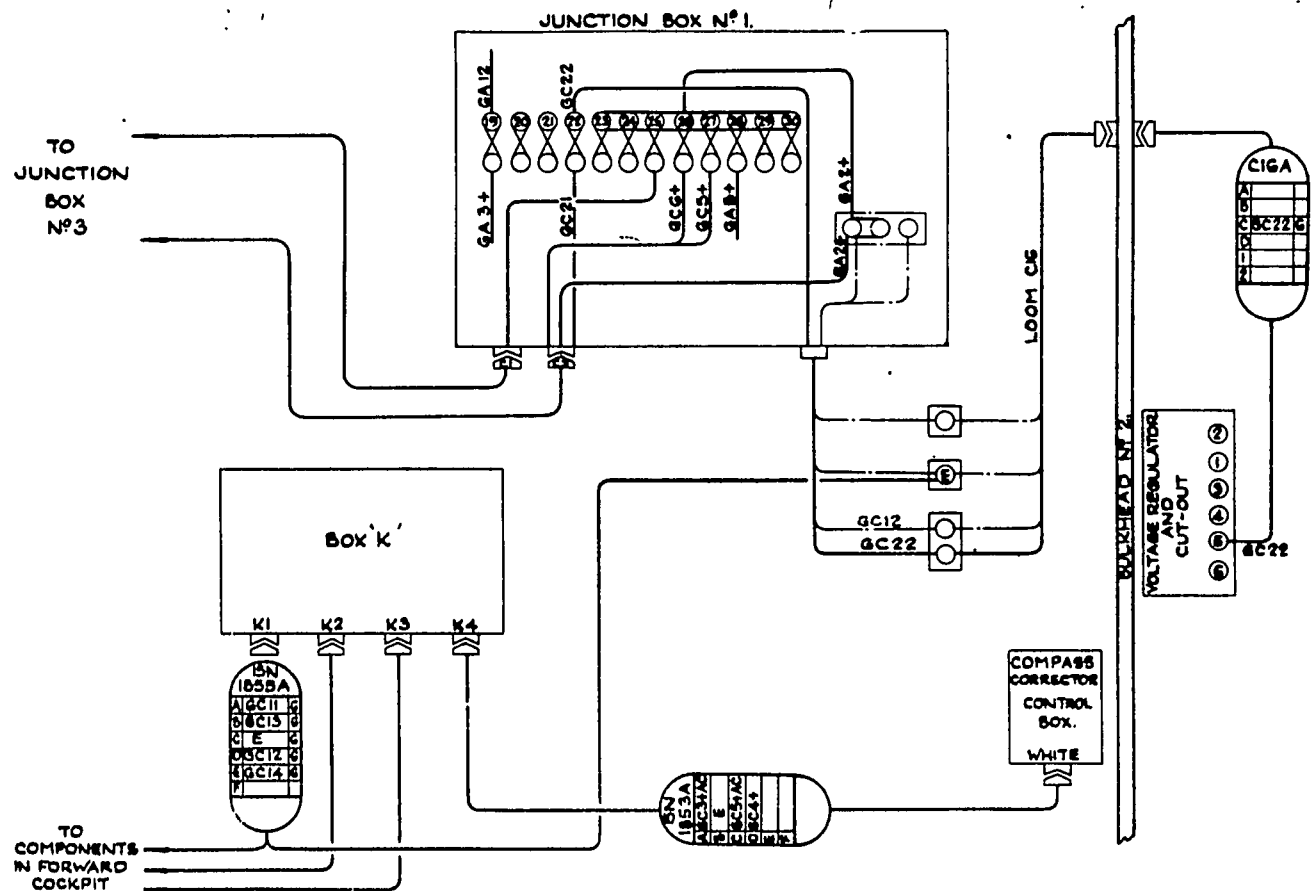
With the present single inverter installation, failure of the inverter renders the artificial horizon and G.M.4 compass unserviceable. To obviate this, this modification introduces twin inverters of an improved type with an electrical automatic changeover circuit.

TWIN INVERTER INSTALLATION WIRING DIAGRAM.

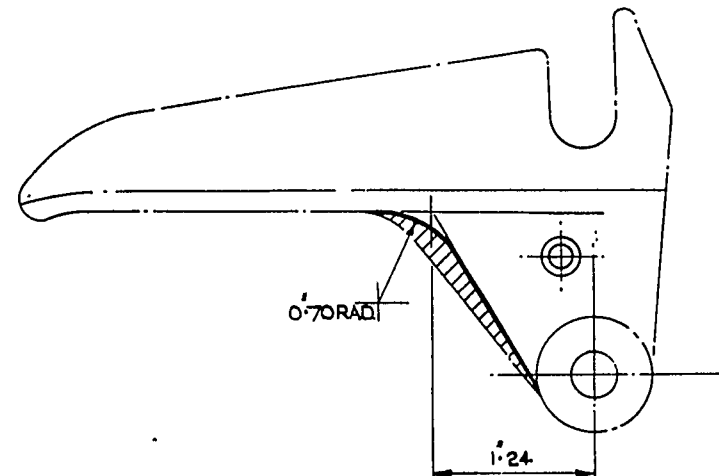
DETAILS OF MODIFICATION TO JETTISON OPERATING LEVER.

TO MODIFY LEVER FILE AWAY THE
SHADED PORTION, REPAIR THE FINISH
USING FINISH, NIGHT SYNTHETIC (STORES
REF. 33B/205) AND RE PART № 15 FC 3411.

IT IS MOST IMPORTANT THAT EXTREME ACCURACY
OF CONTOUR IS MAINTAINED WHEN MODIFYING THIS
CASTING. TO FACILITATE THIS, THE USE OF A
TEMPLATE IS SUGGESTED.

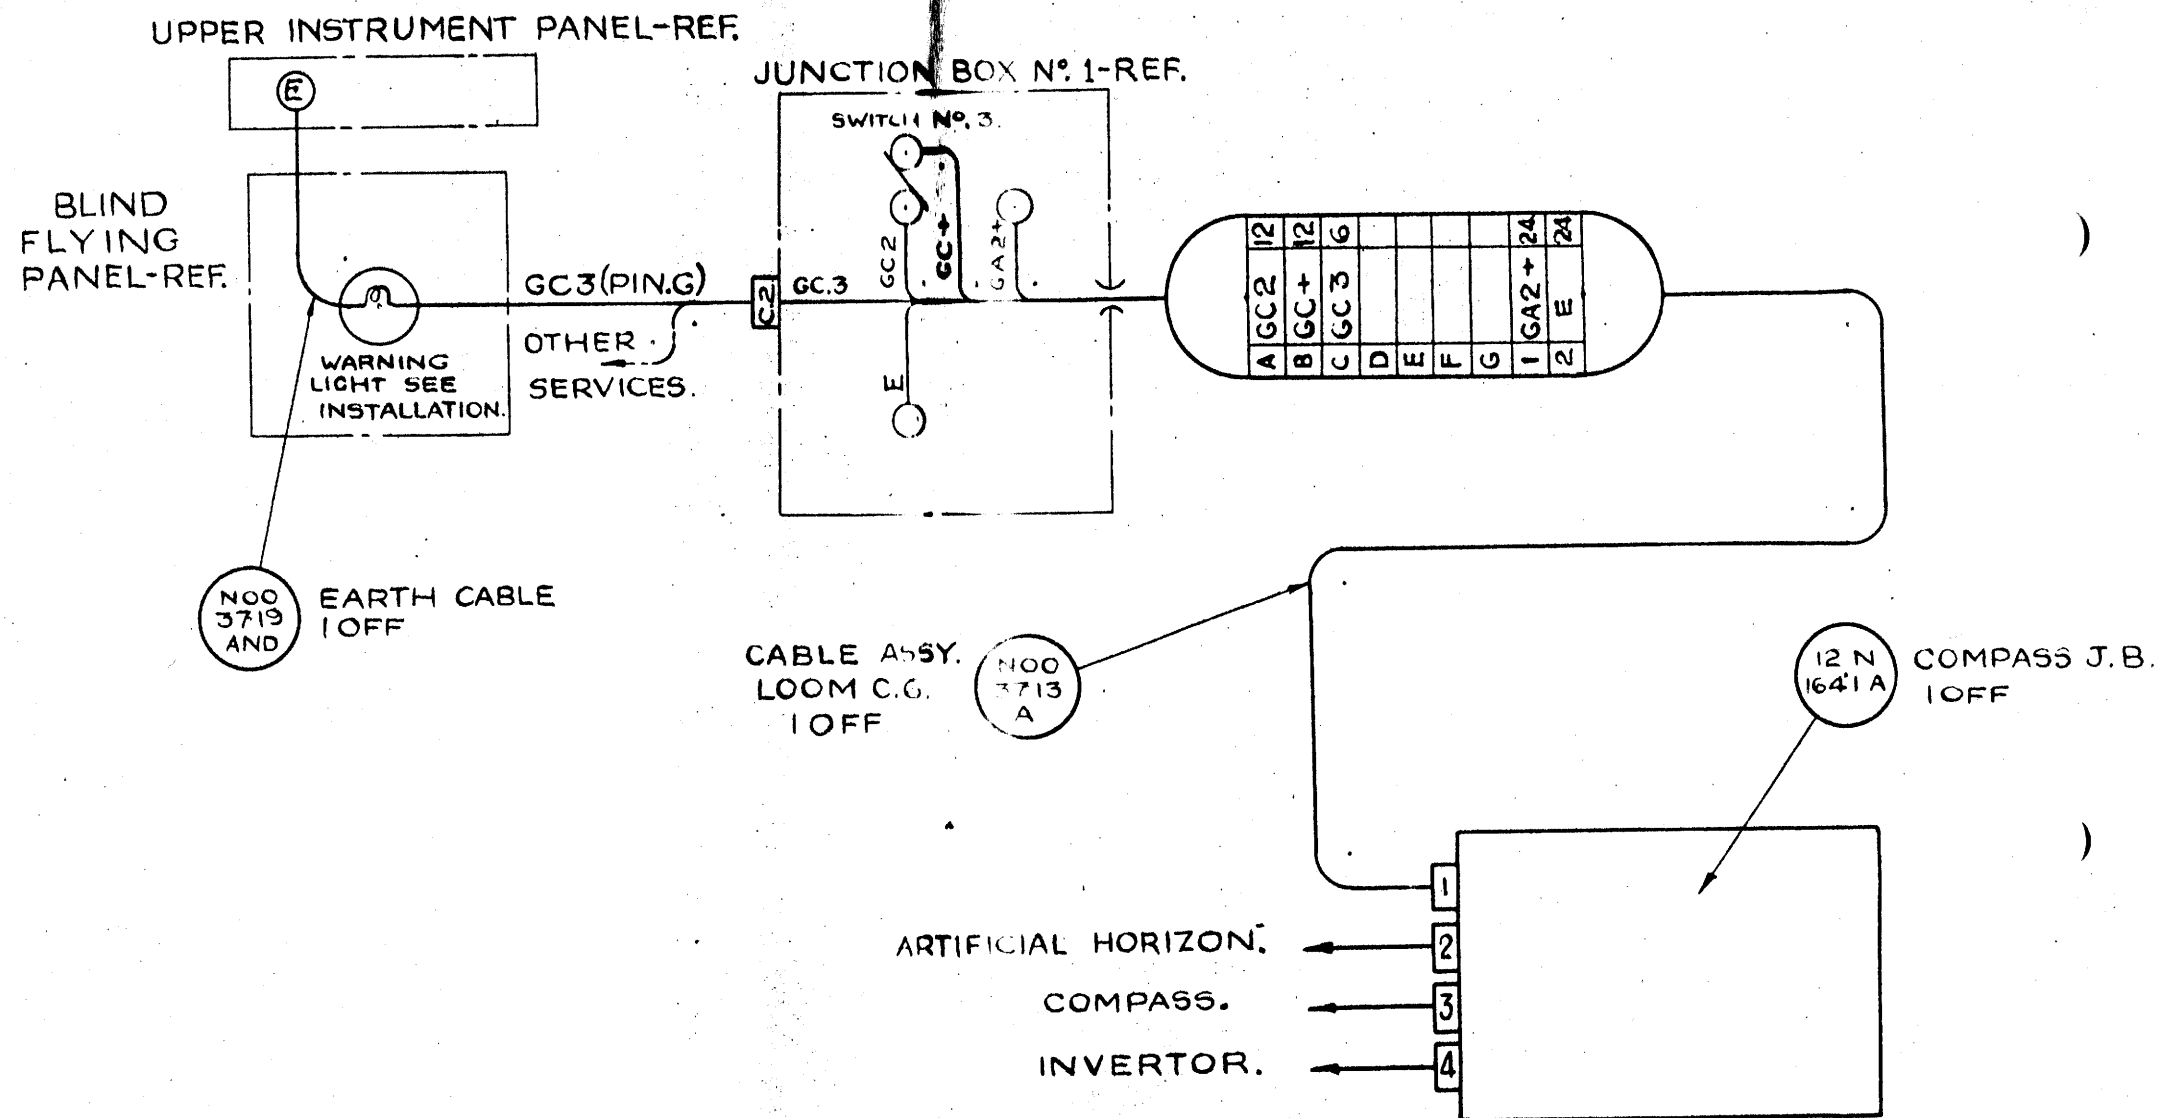
WIRING DIAGRAM FOR POWER FAILURE WARNING LIGHT.

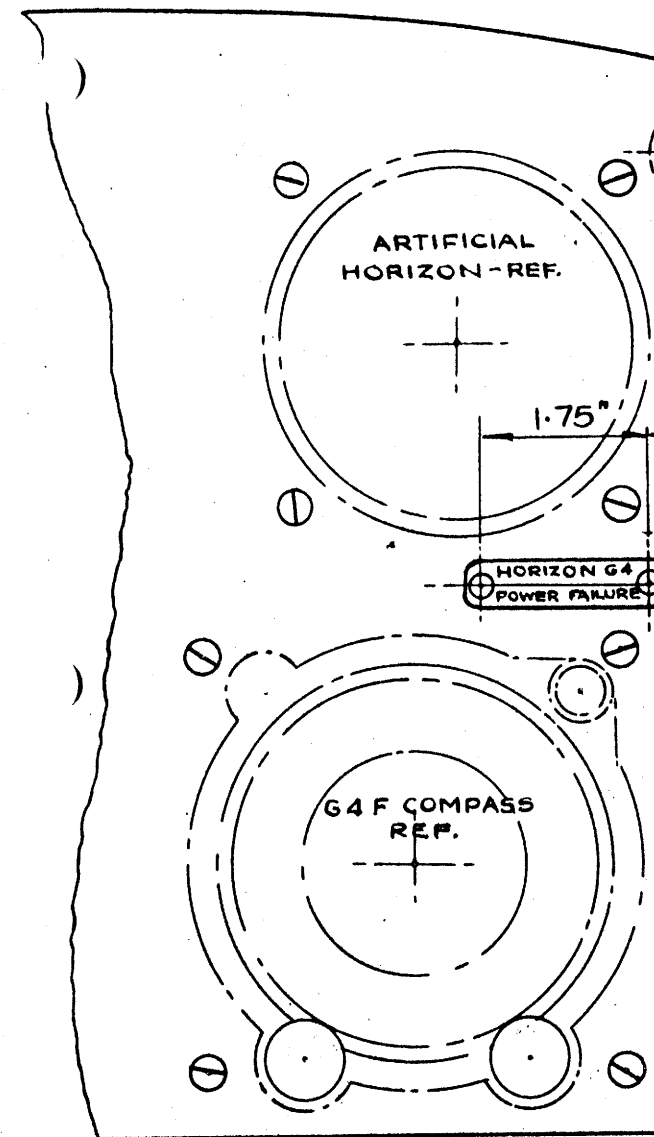
INSTALLATION OF POWER FAILURE WARNING LIGHT ON BLIND FLYING PANEL

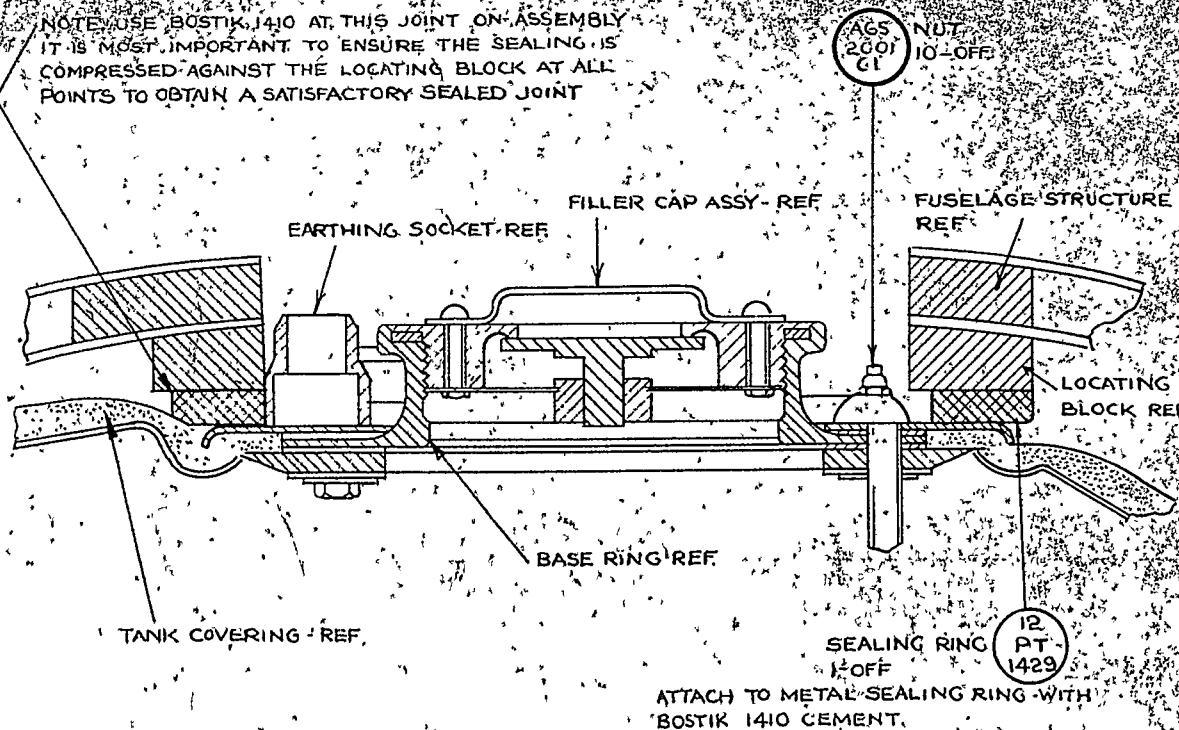
TRACING OF DRG NO. AP 4099 G/H. 22/54

It has been found that the seal at the main fuel tank filler neck has been breaking down, resulting in fuel overflowing into the tank bay during refuelling operations. To overcome this fault, this modification introduces locating spigots and additional sealing at the fuel filler neck.

ARRANGEMENT OF MAIN FUEL TANK FILLER

NOTE: If any of these checks reveal an unsatisfactory state, the fuel system is to be drained, the main fuel tank removed in accordance with A.P. 4099J, Vol. 1, Sect. 4, Chap. 2, and the deficiencies corrected as follows:-

(i) Remove the rubber sealing ring, Part No. 12PT.1429, and fit an annular ring of ply (Ref. No. 31A/-) of the required thickness to make up the discrepancy and so ensure compression of the sealing ring on reassembly. Glue the ply ring to the base of the filler locating block with synthetic resin adhesive and synthetic resin hardener (Ref. Nos. 33C/1188 and 33C/973). Replace the rubber sealing ring and secure it in position with Boscoprene cement 2413, Parts 1 and 2, Spec. D.T.D.900/4130 (Ref. No. 33C/1117), ensuring that it lies central about the filler locating block, but distort it slightly in order to clear the earthing socket.

NOTE: USE BOSTIK 1410 AT THIS JOINT ON ASSEMBLY.
IT IS MOST IMPORTANT TO ENSURE THE SEALING IS
COMPRESSED AGAINST THE LOCATING BLOCK AT ALL
POINTS TO OBTAIN A SATISFACTORY SEALED JOINT

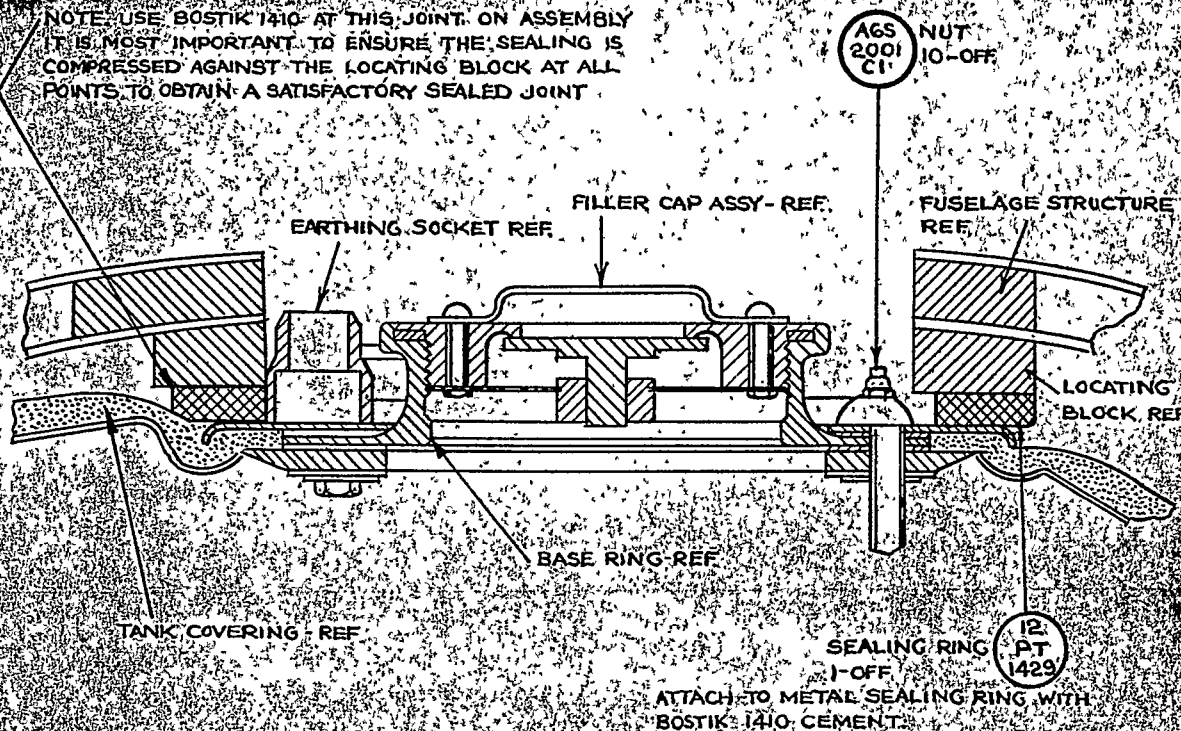
TRACING & DRG NO. AP 4099 G/H 22/54

ARRANGEMENT OF MAIN FUEL TANK FILLER

NOTE: USE BOSTIK 1410 AT THIS JOINT. ON ASSEMBLY IT IS MOST IMPORTANT TO ENSURE THE SEALING IS COMPRESSED AGAINST THE LOCATING BLOCK AT ALL POINTS TO OBTAIN A SATISFACTORY SEALED JOINT.
