TECHNICAL STAFF INSTRUCTIONS  
INDEX SHEET.

VOLUME TITLE AIRFRAME VOLUME NO 1  
SECTION TITLE VAMPIRE SECTION NO 2  
SUB SECT TITLE GENERAL ORDER SUB SECT NO A

VAMPIRE.

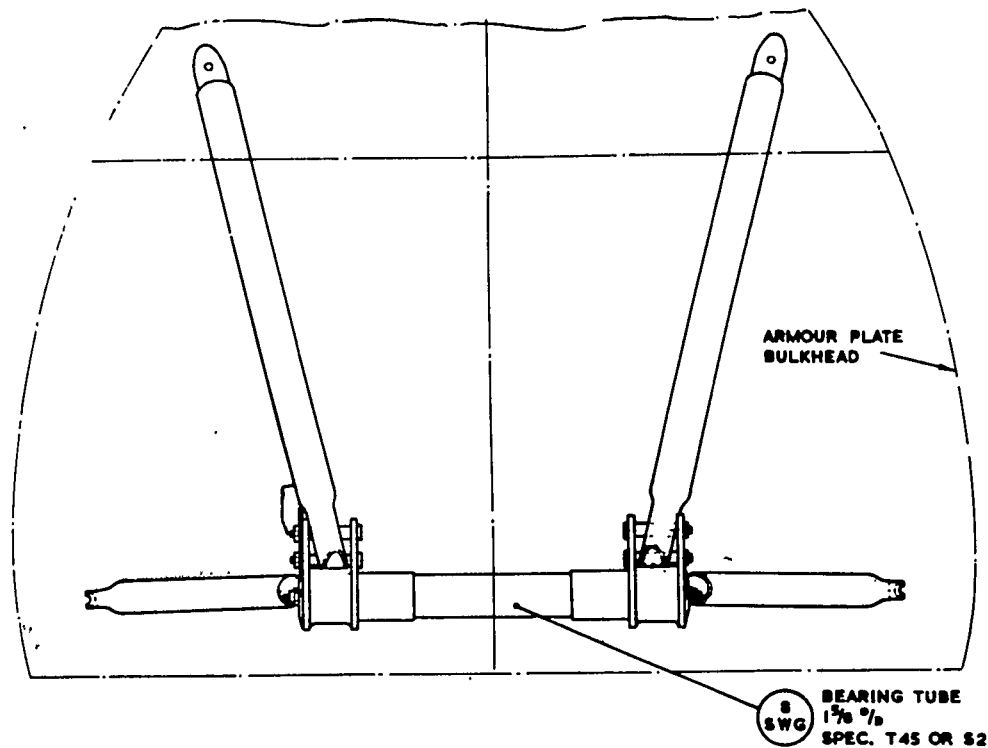
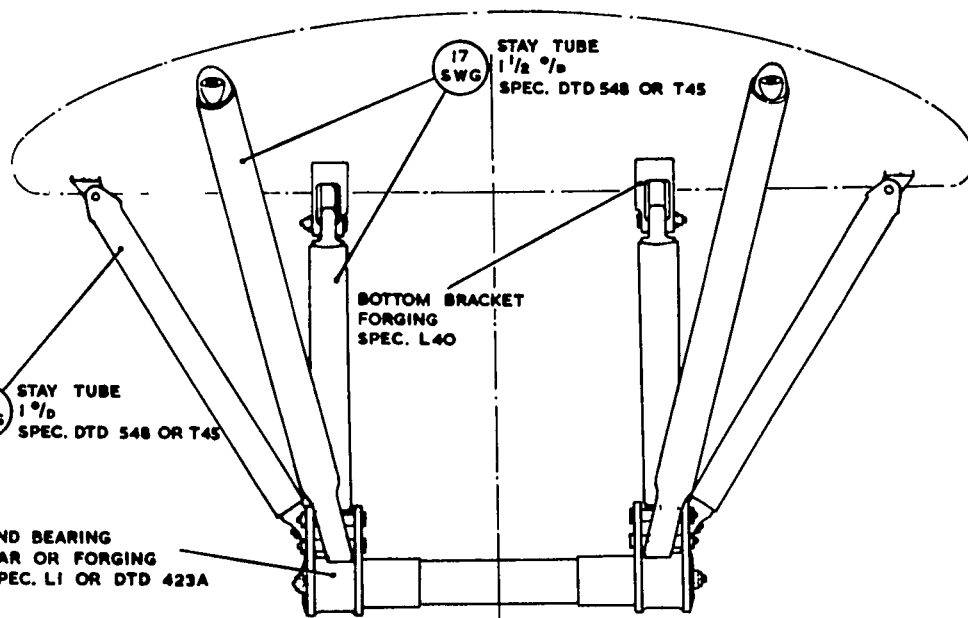
Fig. 5/5. Nosewheel top structure, Mk. 5 and 9

3. Nosewheel top structure, Mk. 9. Any smooth isolated dents which are free from cracks or fractures of the metal, and which do not exceed 1/40th of the tube diameter in depth, may be treated as negligible when situated in the end thirds of a member. The limit of bowing in tubular members which may be treated as negligible is defined in para. 12 of chap. 1.

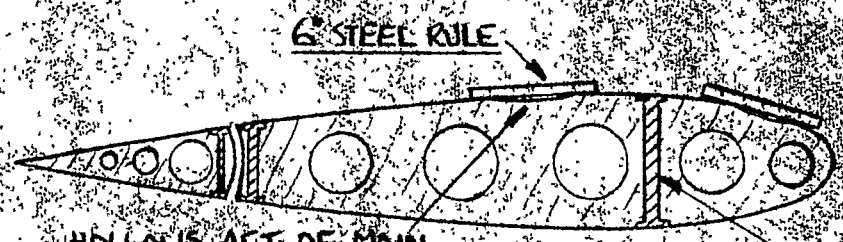
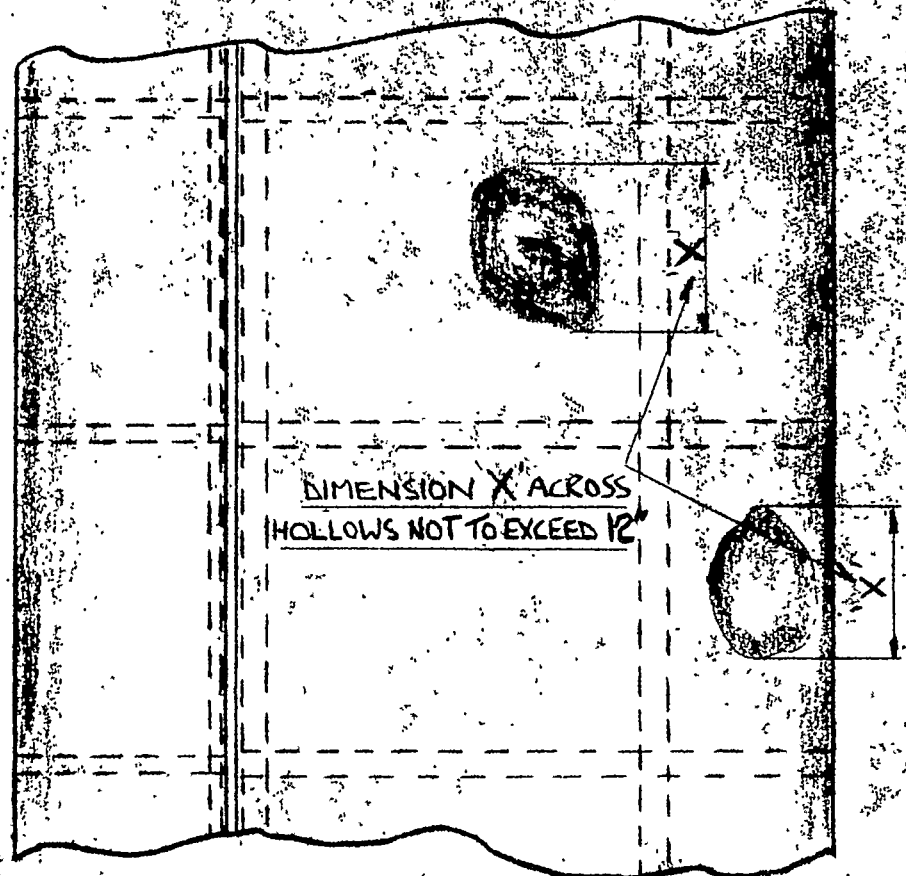
Vol: 3 - 2 - A 65

- (a) An examination of tailplane contours is to be carried out by means of a 6" steel rule and feeler gauges, as shown in the attached drawing. A tailplane is to be rejected if a hollow be found to extend more than 12" spanwise along the tailplane forward of the main spar on top or bottom surface. Any tailplane is also to be rejected if a hollow, deeper than 0.020" and extending more than 12" spanwise along it, be found aft of the main spar on either surface.

HOLLOW ART OF MAIN  
SPAR TO BE NO MORE THAN  
0.020\" DEEP. DEPTH TO BE  
DETERMINED BY FEELER GAUGES

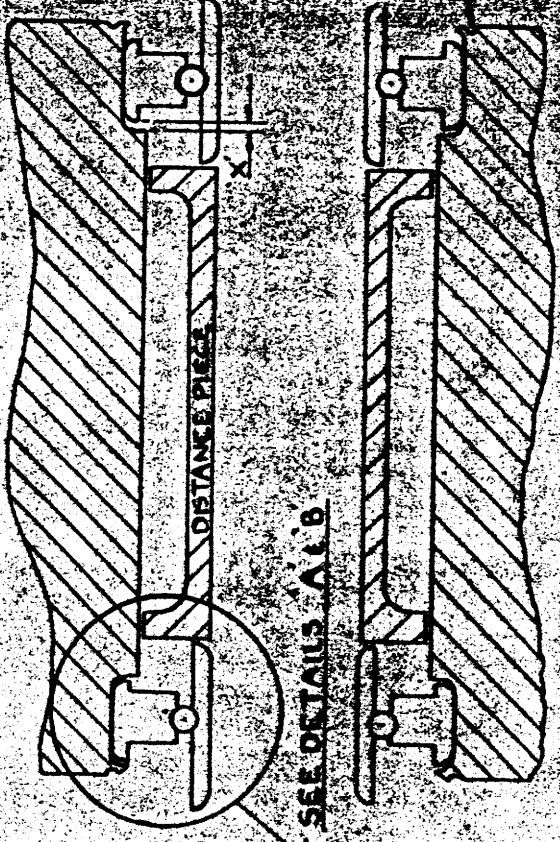
1. Cracked inner tracks due to the shoulder radius on the pivot bolt being greater than the radius on the inner track. This point should always be checked when fitting new races. The race should locate positively on the bolt shoulder.
2. End-loading of the bearings due to overtightening of the pivot bolt. Overtightening will cause the inner race tracks to indent the distance piece with the result that the clearance between the outer track of the floating race and its housing is reduced to nothing.
3. Difficulty in removing the pivot bolt. This is again due to overtightening. The metal of the distance piece is distorted by the indentations until it bears on the pivot bolt.

IF ABUTMENT RADIUS AT BOLT SHOULDER IS LARGER THAN THAT ON BALL RACE INNER TRACK IT WILL FORM AN EXPANSION CONE WHICH WILL CRACK THE BALL RACE ON TIGHTENING.

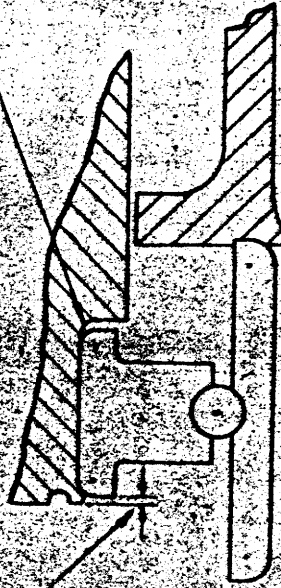
### DETAIL B INCORRECT ASSY

CAULKING ALLOWANCE BELOW MINIMUM PERMISSIBLE DUE TO BAD SEATING OF OUTER TRACK.

HOUSING RADIUS TOO GREAT CAUSING OUTER TRACK TO BE HELD OFF SHOULDER SO IMPAIRING EFFECTIVE SPACING OF BALL RACES.

IF PIVOT BOLT IS OVERTIGHTENED, BALL RACE INNER TRACK INDENTS DISTANCE PIECE CAUSING:-

- 1) BALL RACES TO BECOME END-LOADED WHEN DIM "X" (SEE ASSEMBLY D.W.G.) REDUCES TO NOTHING
- 2) POSSIBLE DIFFICULTY IN DISMANTLING DUE TO DISPLACED METAL BEARING

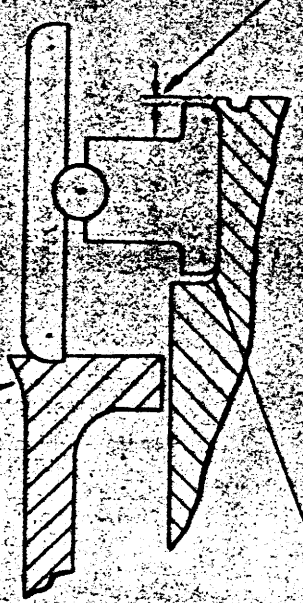
**DETAIL B**

CAULKING ALLOWANCE BELOW MINIMUM PERMISSIBLE DUE TO BAD SEATING OF OUTER TRACK.

**INCORRECT ASSY.**

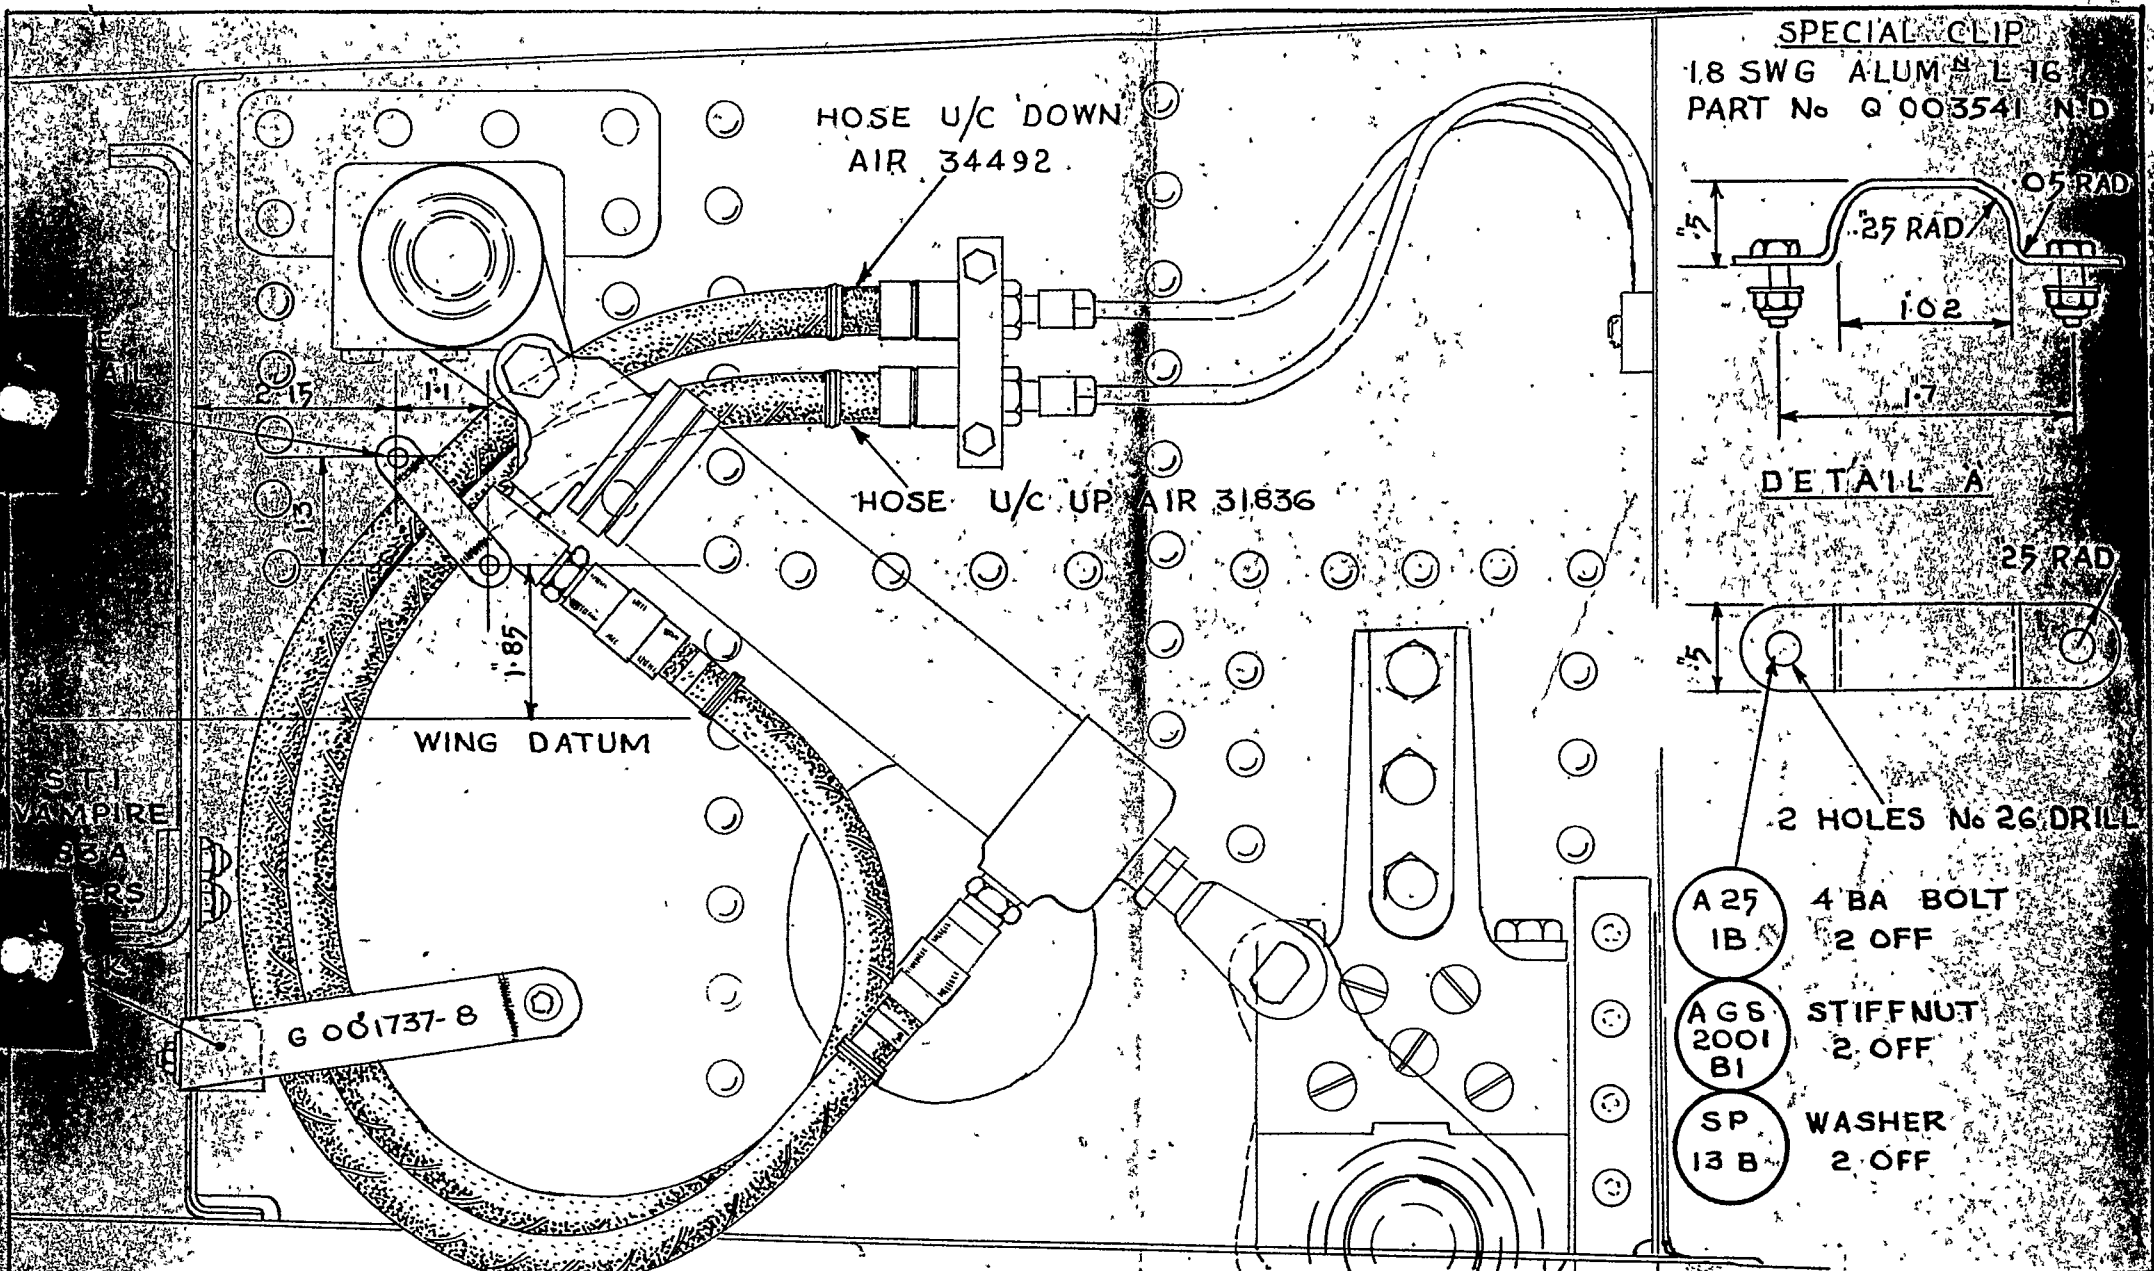
CORRECT CLIPPING OF MAIN  
UNDERCARRIAGE HYDRAULIC HOSES
