AAP 721.79, VOLUME 2, PART 1

VAMPIRE INSTRUCTIONS

CONTENTS TO VAMPIRE INSTRUCTIONS

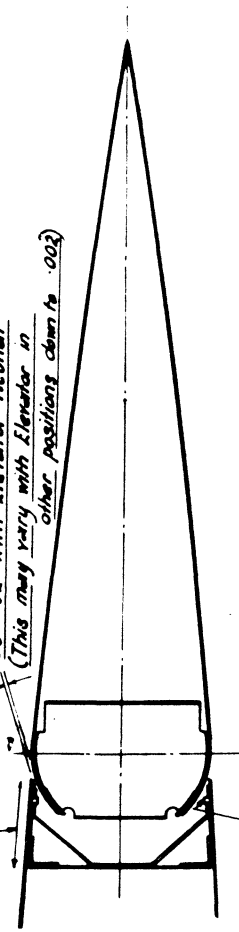
It is important that this section of skin is true to contour - On No Account Must it Have a Concave Outer Surface

Clearances (Top & Bottom) .08" ± .02" with Elevator Neutral (This may vary with Elevator in other positions down to .002)

The clearances indicated are of far greater importance on the Bottom than on the Top.

3. This instruction is to be followed when replacement elevators are being fitted.

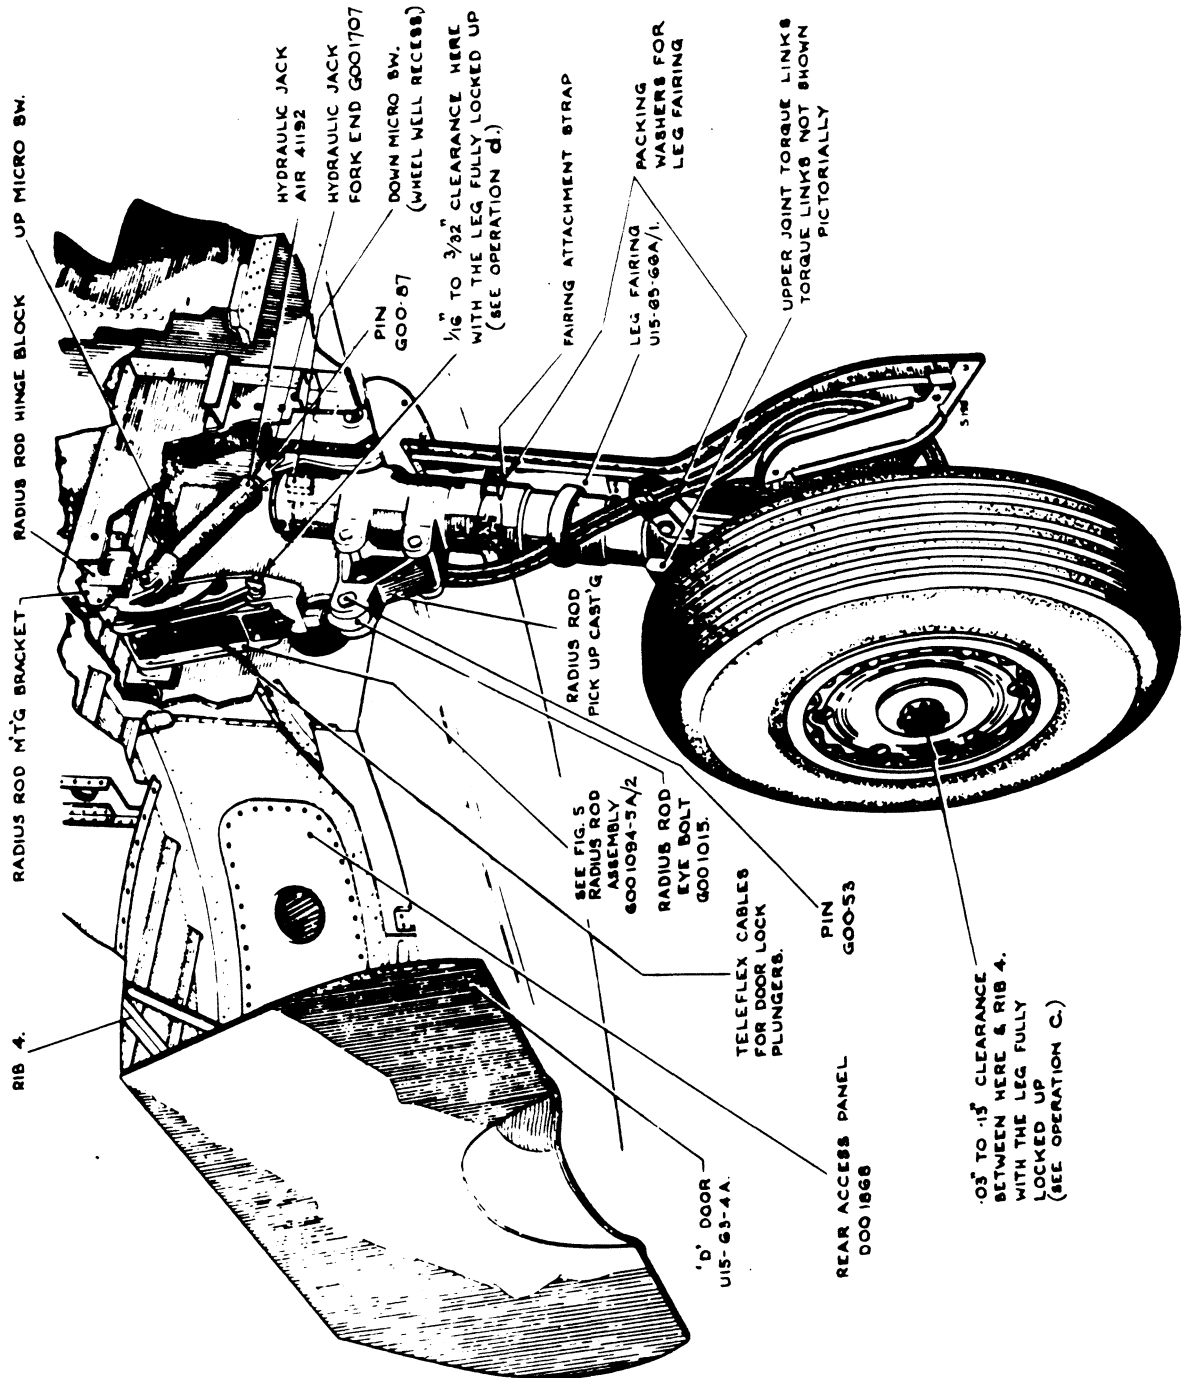
FIG. 1 MAIN UNDERCARRIAGE

1. A number of undercarriage failures have been due to the fracturing of the teleflex controls which operate the main wheel door lock plungers, these are attributed to semi-seizure of the teleflex cables inside the conduit, the lock plungers fouling the door catches, or maladjustment of the lock plungers.
2. This instruction has been raised in issue to clarify the procedures to be adopted in setting the main wheel door lock mechanism and to detail the checks to be made at various periods.
3. The instruction is written in two parts, as follows:-

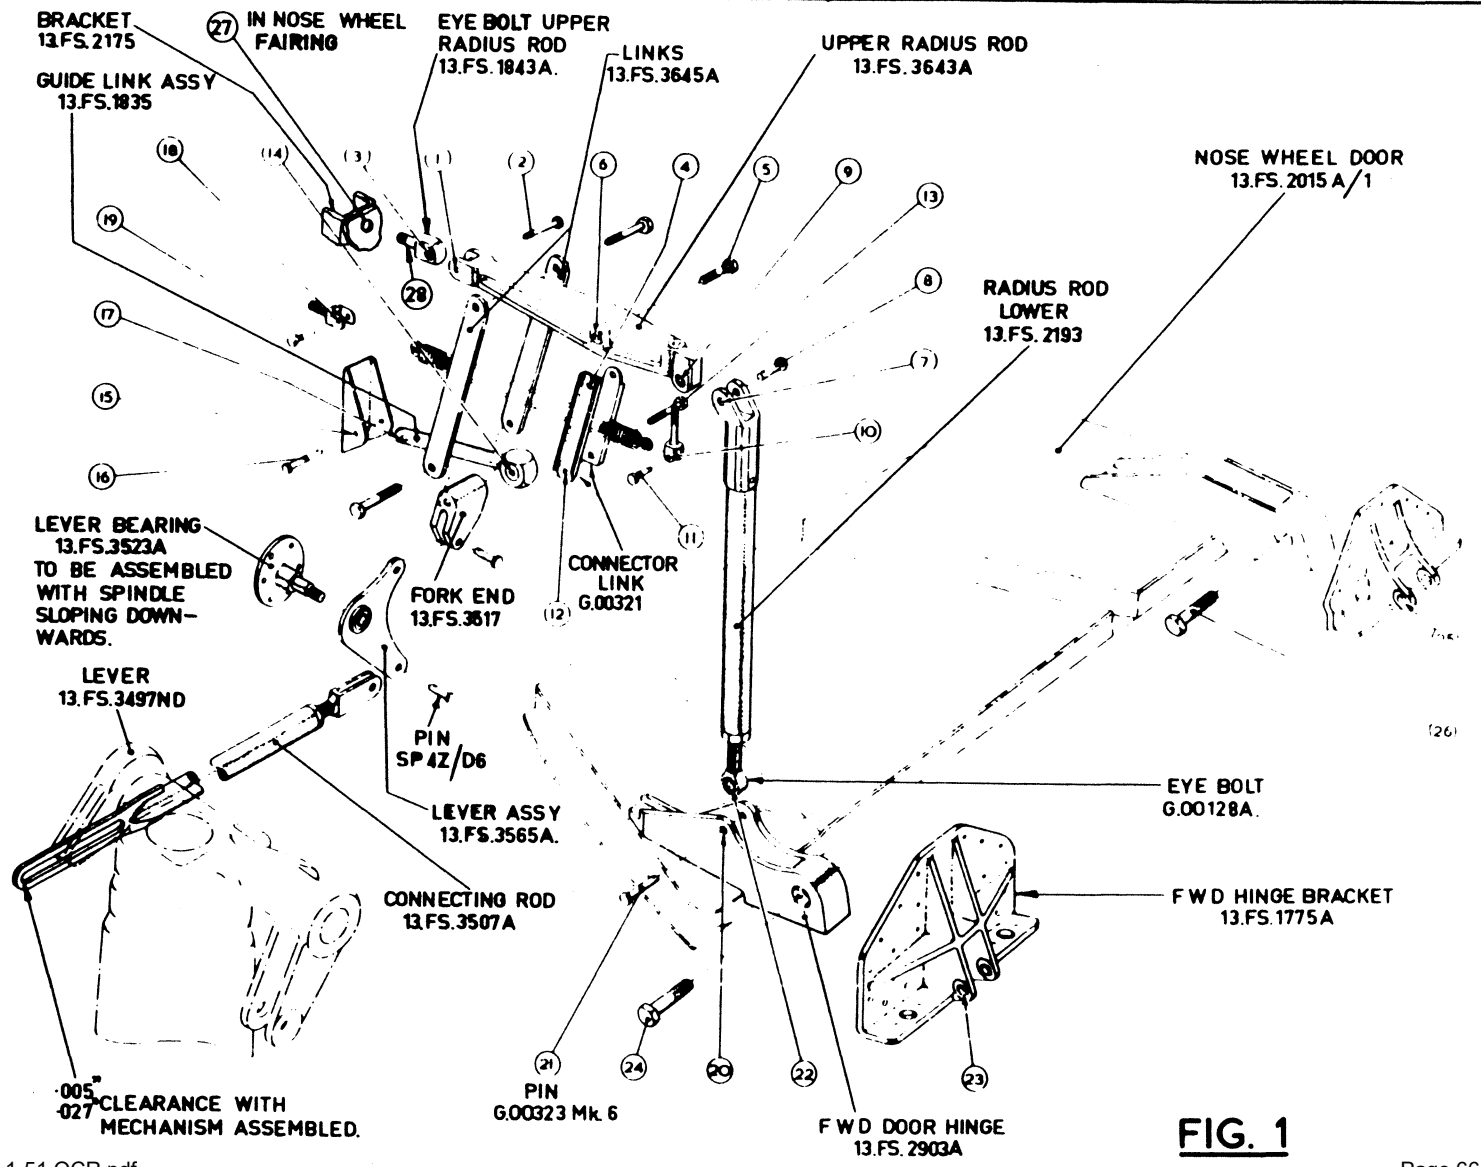
FIG. 1

1. Several cases of failure of the nosewheel door mechanism have been reported and it is considered that excessively worn linkages, incorrect adjustments and insufficient clearances have contributed to these failures.
2. This instruction has been raised in issue to clarify the procedures to be adopted in setting the nose wheel door mechanism and to detail the checks to be made at various periods.
3. The instruction is written in three parts, as follows:-
Part 1 Index of Operations.
Part 2 Operations called up in Part 1.
Part 3 Relevant wear limits.

- (e) Check the eye bolt G00128A and the lower radius rod 13FS2193 (Fig 1) for signs of bending. Bent parts should be replaced.
- (f) Refit all the above components, using Molybond GS10 Grease at all moving joints, except on the pin through the eye bolt G00128A (part of the lower radius rod, Fig 1), which is to be temporarily left disconnected.

- (ii) Particular care must always be taken to ensure that no distortion is present in any part of the nosewheel door mechanism. Repair of parts G00321 and G00128A (Fig 1) is not permitted and if distorted, they must be replaced immediately.

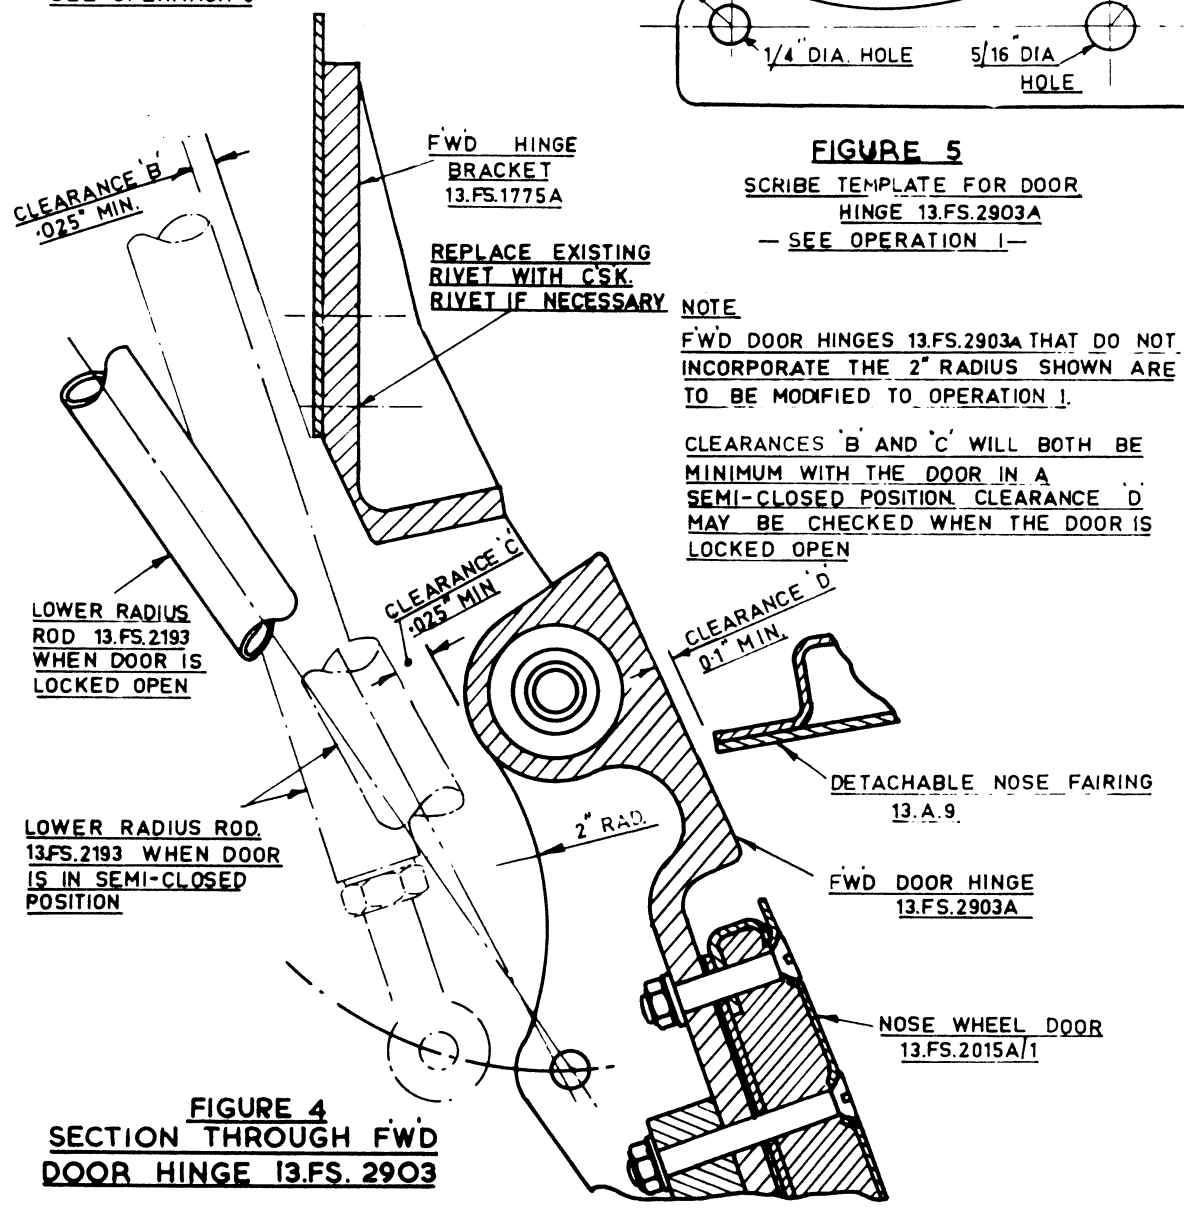
FIGURE 4
SECTION THROUGH FWD
DOOR HINGE 13.FS. 2903

NOTE
FWD DOOR HINGES 13.FS.2903A THAT DO NOT INCORPORATE THE 2" RADIUS SHOWN ARE TO BE MODIFIED TO OPERATION 1.
CLEARANCES B AND C WILL BOTH BE MINIMUM WITH THE DOOR IN A SEMI-CLOSED POSITION. CLEARANCE D MAY BE CHECKED WHEN THE DOOR IS LOCKED OPEN

- (d) Check that the forward door hinge 13FS2903 on the nose wheel door 13FS2015A/1 conforms to Fig 4. Hinges which do not conform are to be modified by cutting away both flanges to suit the scribe template detailed in Fig 5. Treat damaged area with Zinc Chromate and Silver paint.
