## TECHNICAL NEWS SHEET

ISSUED FOR THE GENERAL GUIDANCE OF OPERATORS OF DE HAVILLAND AIRCRAFT AND ENGINES  
OFFICIAL INSTRUCTIONS TAKE PRECEDENCE OVER ANYTHING CONTAINED IN THIS BULLETIN

### INDEX series MAG (Military Airframe, General Circulation)

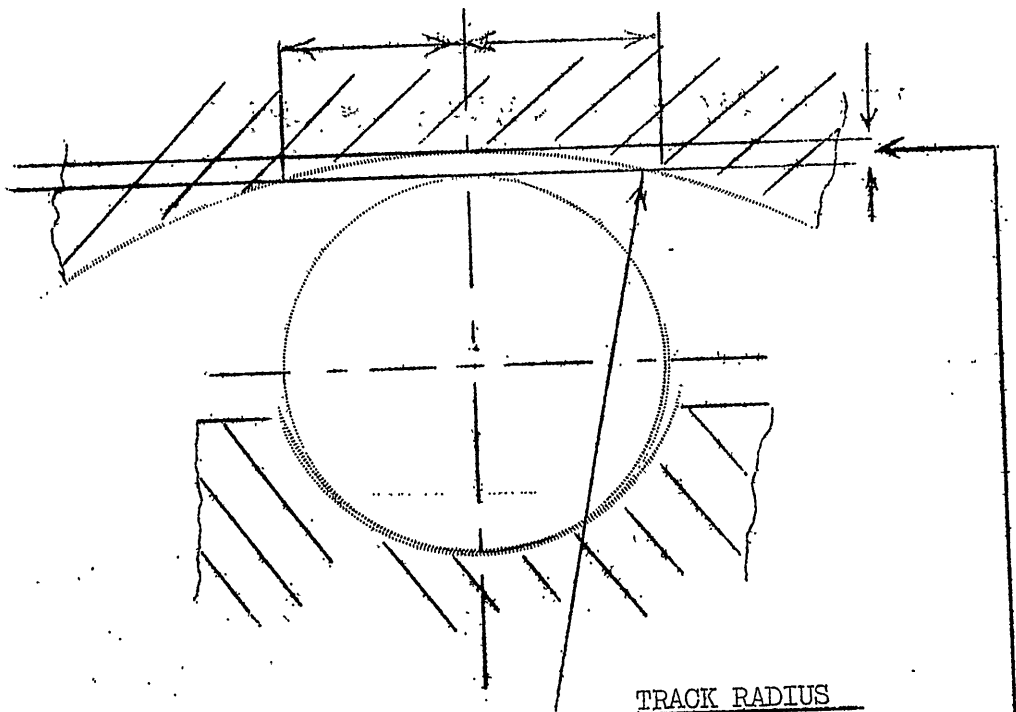
No. 1 Single Row  
SELF ALIGNING BEARING.

DIAMETRICAL CLEARANCE  
NORMAL SIDE PLAY .002 - .004".  
SIDE PLAY.

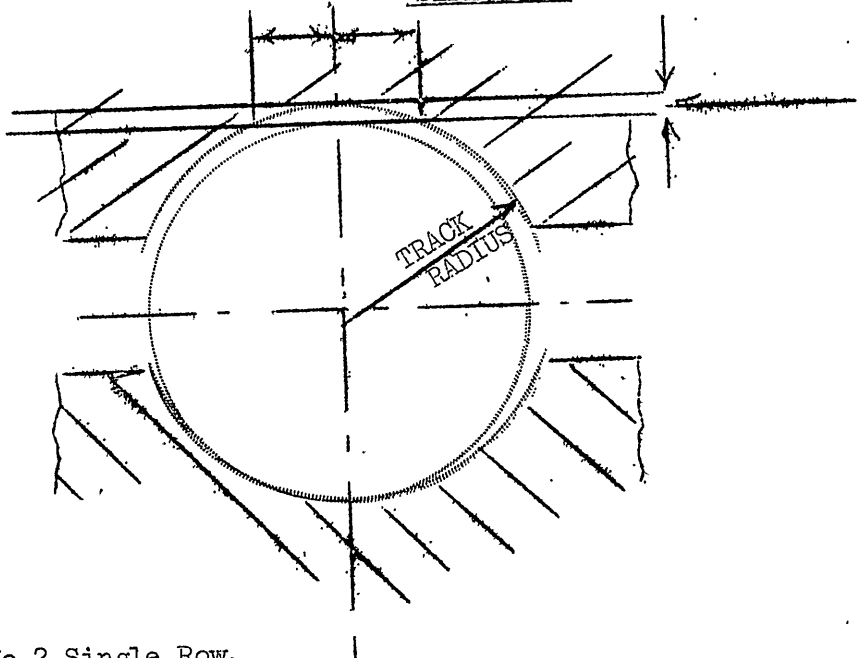
No. 2 Single Row.  
NON SELF ALIGNING BEARING.

As can be seen below for the same diametrical clearance the normal side play of single row self aligning bearings is approximately five times that of the equivalent two row self aligning type.

When checking play on aircraft in service particular care should be taken in assessing the diametrical play. Side play can usually be treated as negligible unless end clearances etc. of the component concerned are seriously affected.
