17 TN 2/2/11 1050/8/2
DE HAVILLAND SERVICE

TECHNICAL NEWS SHEET

INDEX series V (Vampire Airframe, General Circulation)

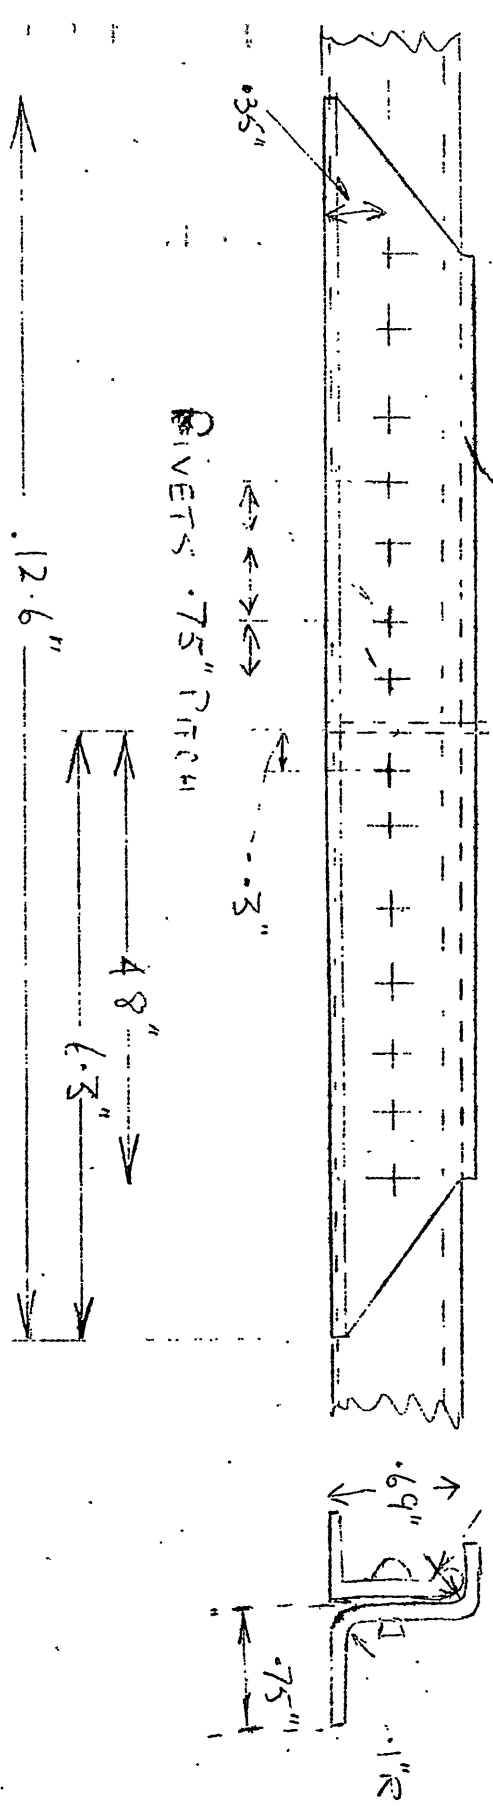
BUTT JOINT IN STRINGER

AMENDED REPAIR SCHEME FOR MAINPLANE
STRINGERS.

A revised Repair is included in this News Sheet, Action is in hand to amend the Air Publication.

14' ALUMINUM D.T.M. 340 JOINT PLATE
 REYNOLDS STRINGER SECTION A.1154.

14 HOLES FULL 1/4" DIA AND RIVETS
 1/8" DIA AS 2227/406.

1/32" HIGH C'SK RIVETS AS 2221/406
 3/32 DIA C'SK CHEFEST STEEL RIVETS
 14 HOLES EQUALLY SPACED

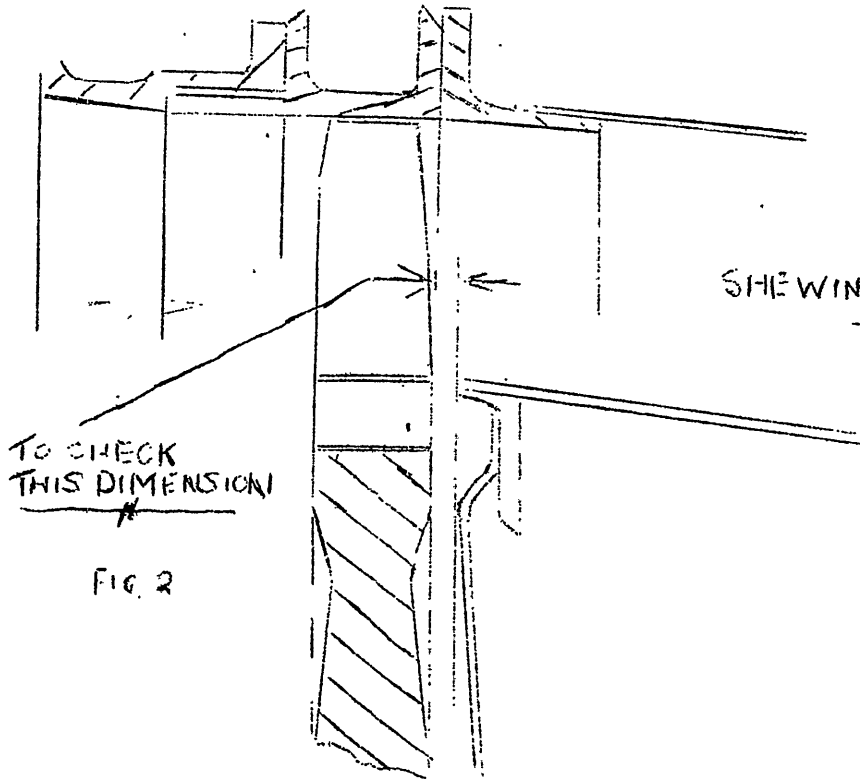
FIG 2

GOBLIN II ENGINES, INNER AND OUTER CONES, AIR TUBES AND AIR FAIRINGS - INSPECTION FOR CRACKS, DENTS AND BUCKLING

In all cases where this minimum clearance does NOT exist, the complete tail assembly is to be rejected and a replacement fitted. In addition to the above inspection, the inner cone is to be checked for security by grasping the apex of the inner cone and shaking".

TO CHECK THIS DIMENSION

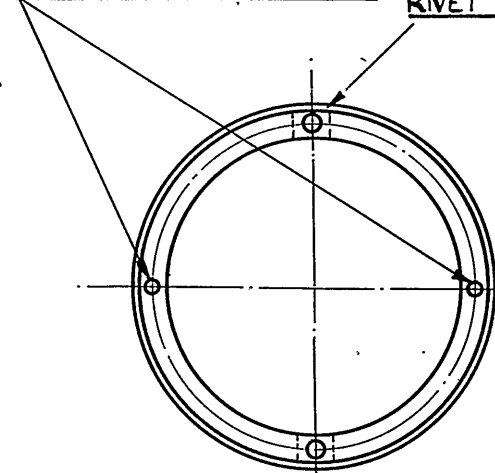
1. This modification provides for the deletion of the shim Part. No. AIR.33132 and the replacement of the Bush Retainer Part No. AIR. 31848 by the bush Retainer Part. No. AIR. 39302, on the main shock absorber struts AIR. 40014 and AIR 40015. Note bush retainer AIR. 39302 can be made from bush retainer AIR. 31848 by modifying to the drawing A.P. _____ This modification has been found necessary, as when the seal and surrounding parts are to the adverse limits the seal has been nipped, thus preventing the seal from moving sideways with the movement of the plunger tube, with subsequent leakage.
The work to replace the bush retainer and removing of the shims will take approximately 4 man hours.

PACKING PIECES TO BE FILED TO SUIT SLOTS.
FIT BENEATH CORE DIA. & FLUSH WITH BORE,
IN BUSH RETAINER AS SHOWN.
RIVET & FILE FLUSH.

IDENTIFICATION MARKS TO BE
STAMPED HERE.

2-№ 42 DRILL HOLES AS SHOWN
ON 3.01" P.C.D. c/s'k .04" X 45°
BOTH SIDES.

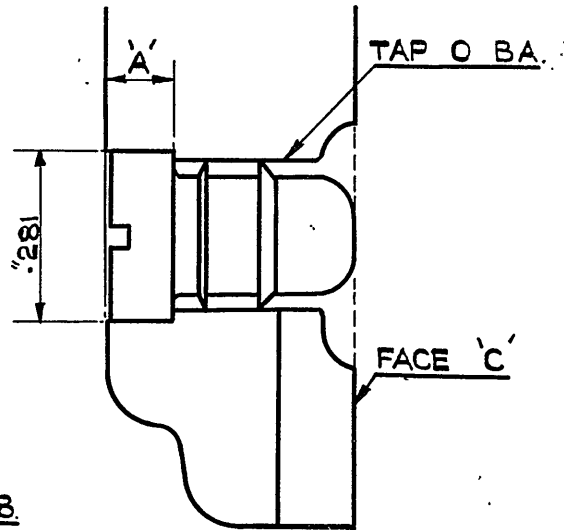
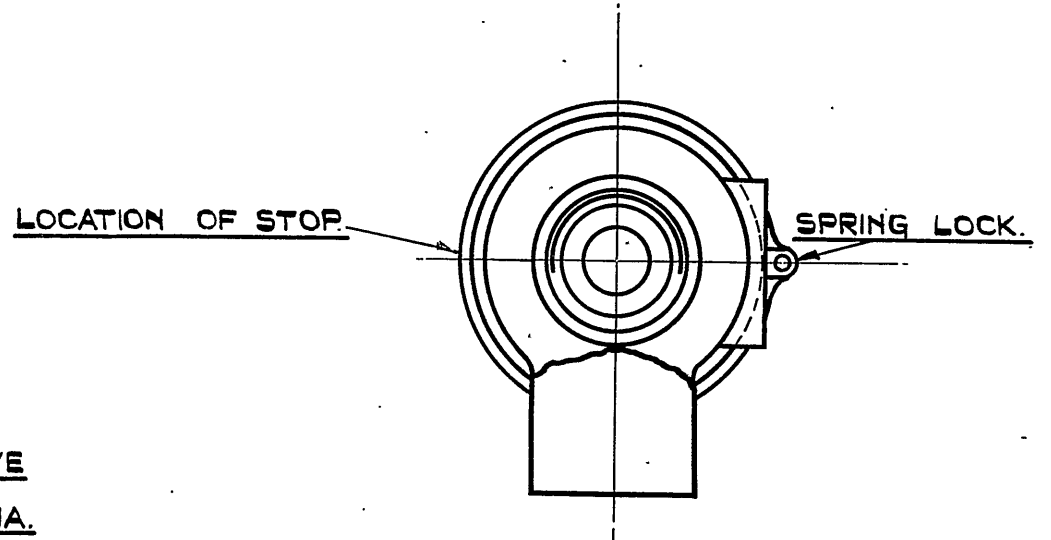
TECALEMIT
SCREW STOP
DRG. NO 150128.

IN CASES WHERE THE FIXED STOP HAS FAILED
& ALLOWED ELEMENT CASE TO ROTATE, THIS
REPAIR IS TO BE CARRIED OUT THE FILTER WILL
THEN BE BROUGHT INTO LINE WITH NEW PRODUCTION.

TAP EXISTING HOLE AS SHOWN ABOVE
THEN COUNTER-BORE 'A' TO 9/32 DIA.
UNTIL THE SCREW STOP END IS LEVEL
WITH FACE 'C'.

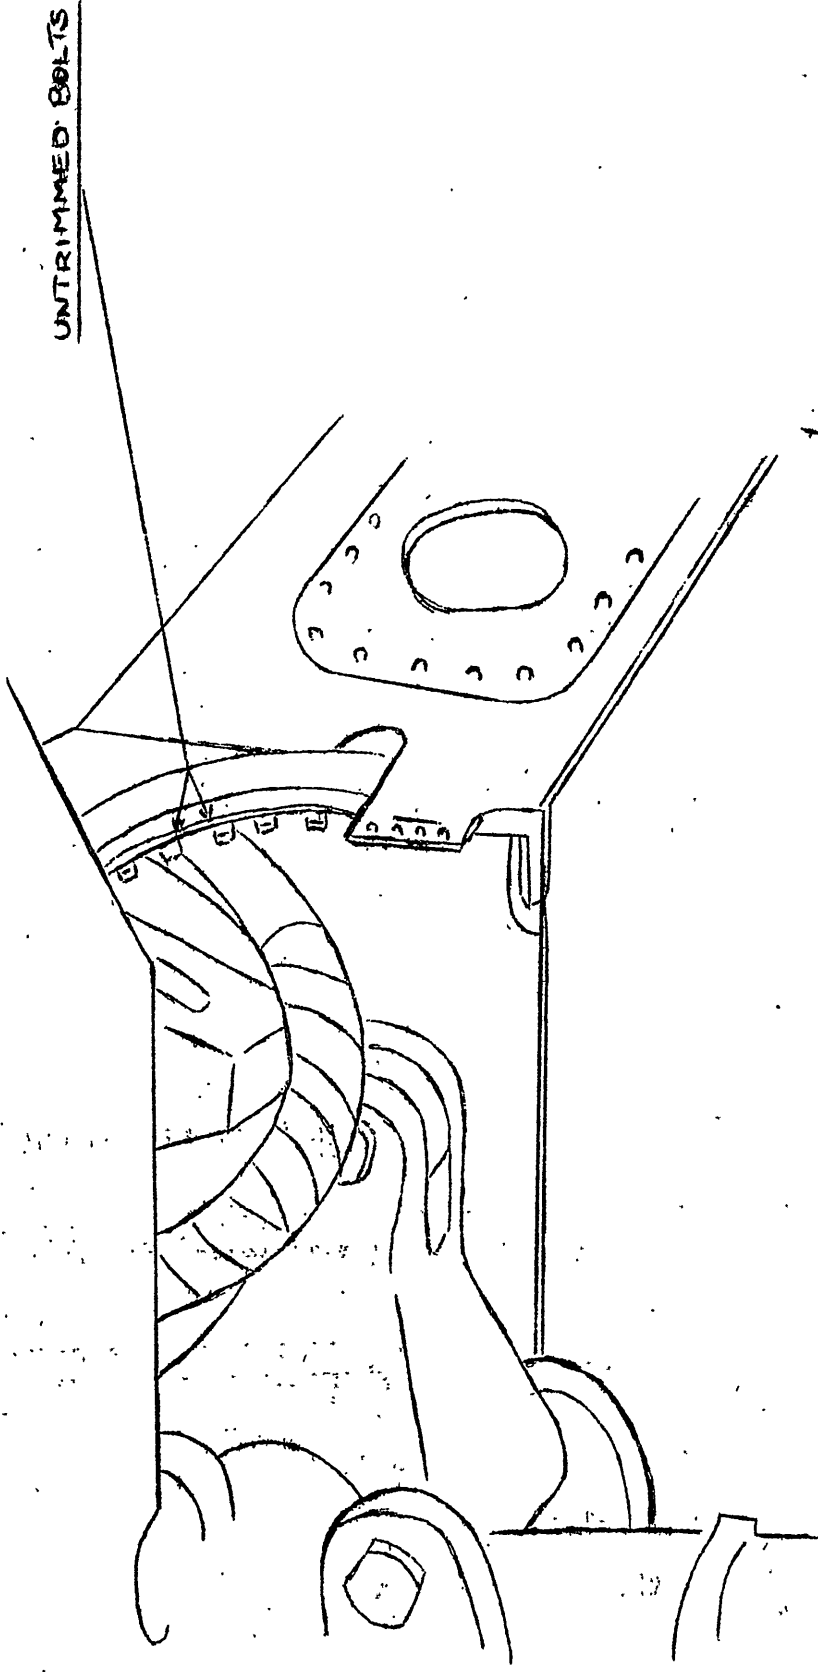
UNDERNEATH VIEW OF J/C BAY

- A. Special Technical Instruction/Vampire/28
Hydraulic hose from undercarriage jack becoming trapped between
Rib No.3 bolts and hinge pick-up radius rod.
- B. Vampire Mk. 1, 3, 5. Sea Vampire Mk. 20, 21.
- C. Cases have occurred of failure fully to lower undercarriage due to the hydraulic hose from undercarriage jack becoming trapped between surplus threads of bolts in Rib. No.3 and hinge pick-up radius rod, thereby restricting the hydraulic pressure resulting in failure of system.
- D. At the daily servicing, bolts on Rib No.3 are to have surplus threads cut off in accordance with repair Drg No. R.00D209.
- E. Record on Form 700 (or 1125 as applicable).
- F. Nil.
- G. Modification Vampire 785, introduces a clip to secure jack hose.

UNTRIMMED BOLTS

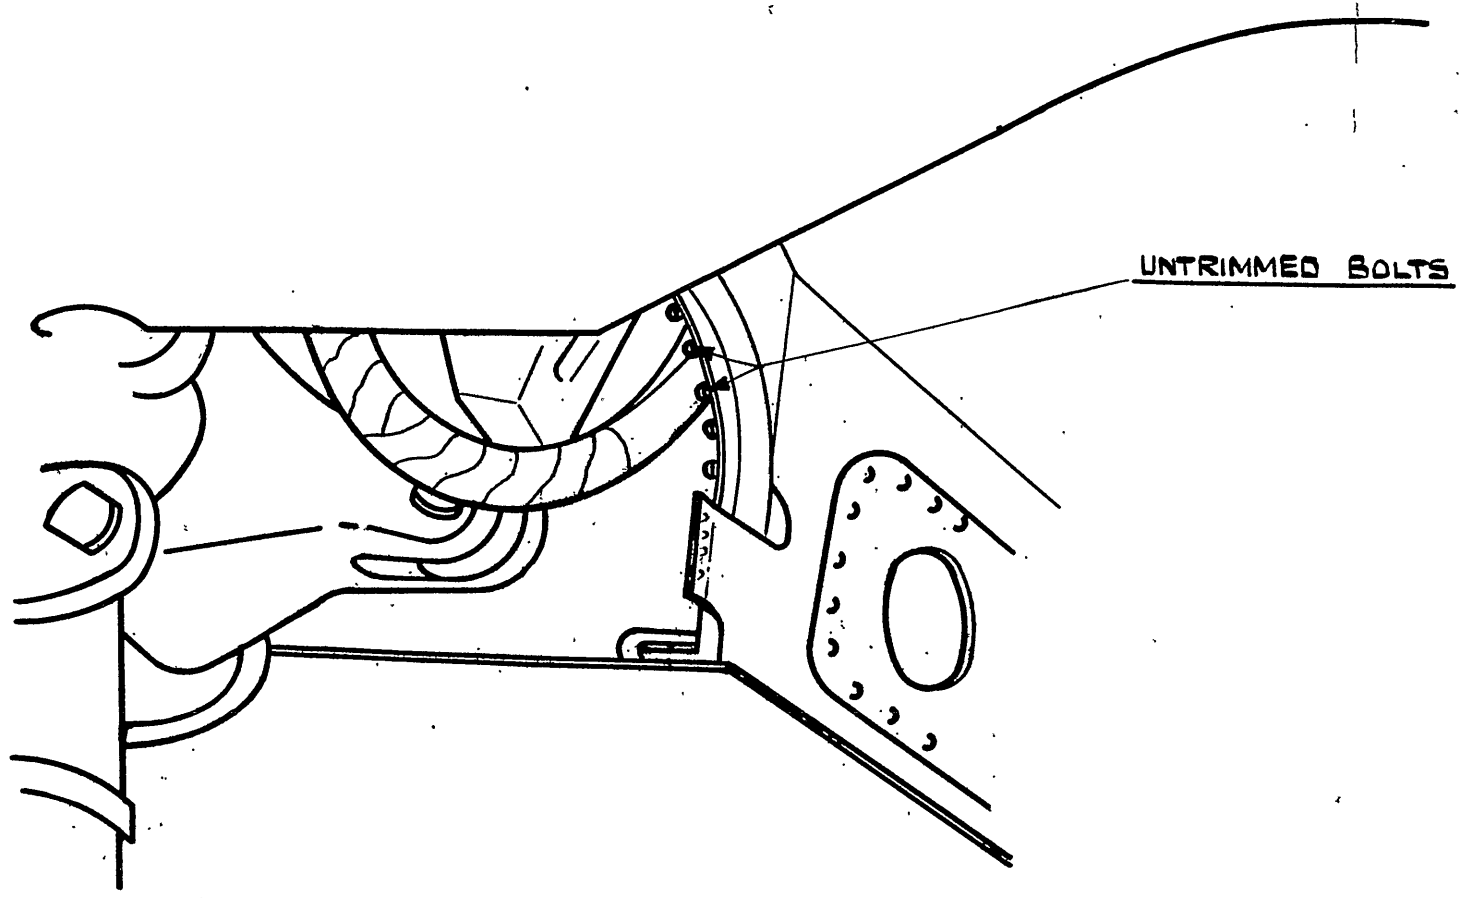
UNDERNEATH VIEW OF 1/2 BAY.

UNTRIMMED BOLTS

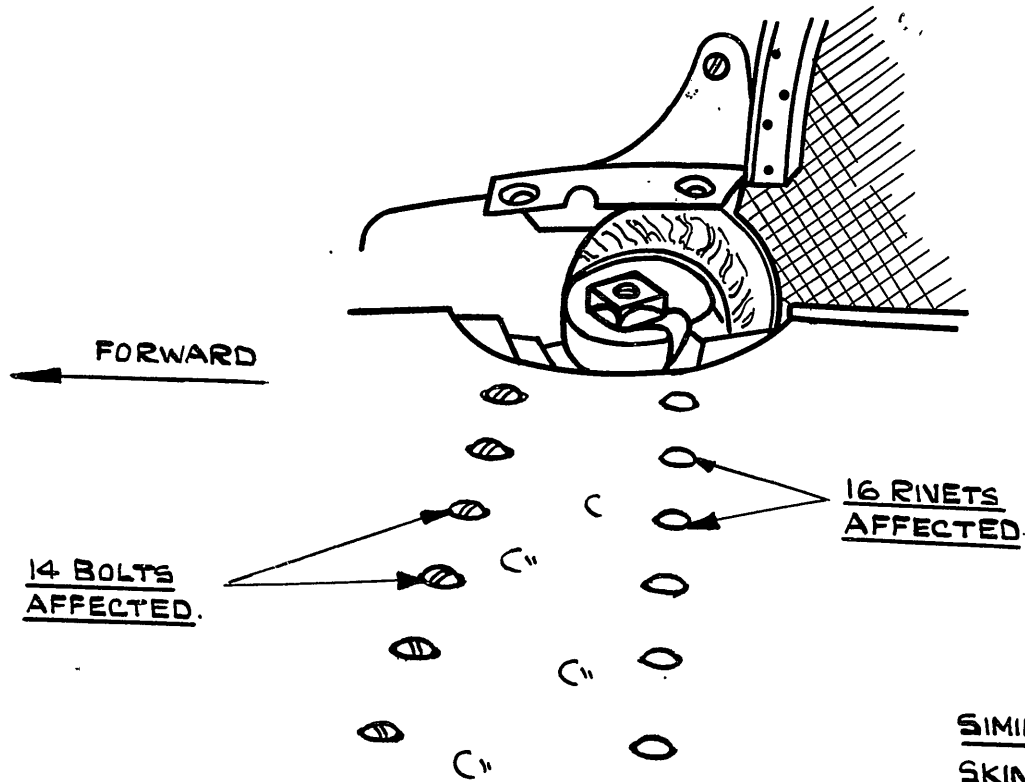
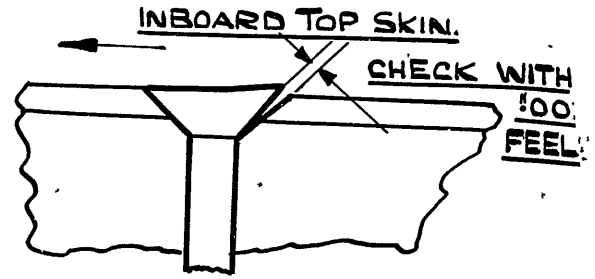
VIEW SHOWING FAILURE OF RIVET.

SIMILAR FAILURE OCCURS ON BOTTOM SKIN THE DIRECTION OF FAILURE BEING REVERSED.

- (d) Turn bolts to bring screwdriver slots running spanwise and hold in this position while tightening nuts from inside wing. On MK. 5 aircraft it will be found that bolts outboard of Rocket Post Support Channel are re-accessible but that only a few of those inboard will be able to be tightened. The number possible to tighten will vary according to the dexterity of the operator, but it should be possible to obtain results to bring the number of tight bolts to the required percentage. Lock nuts by painting with quick drying Bostik Cement 321, Stores Ref. 33C/594.

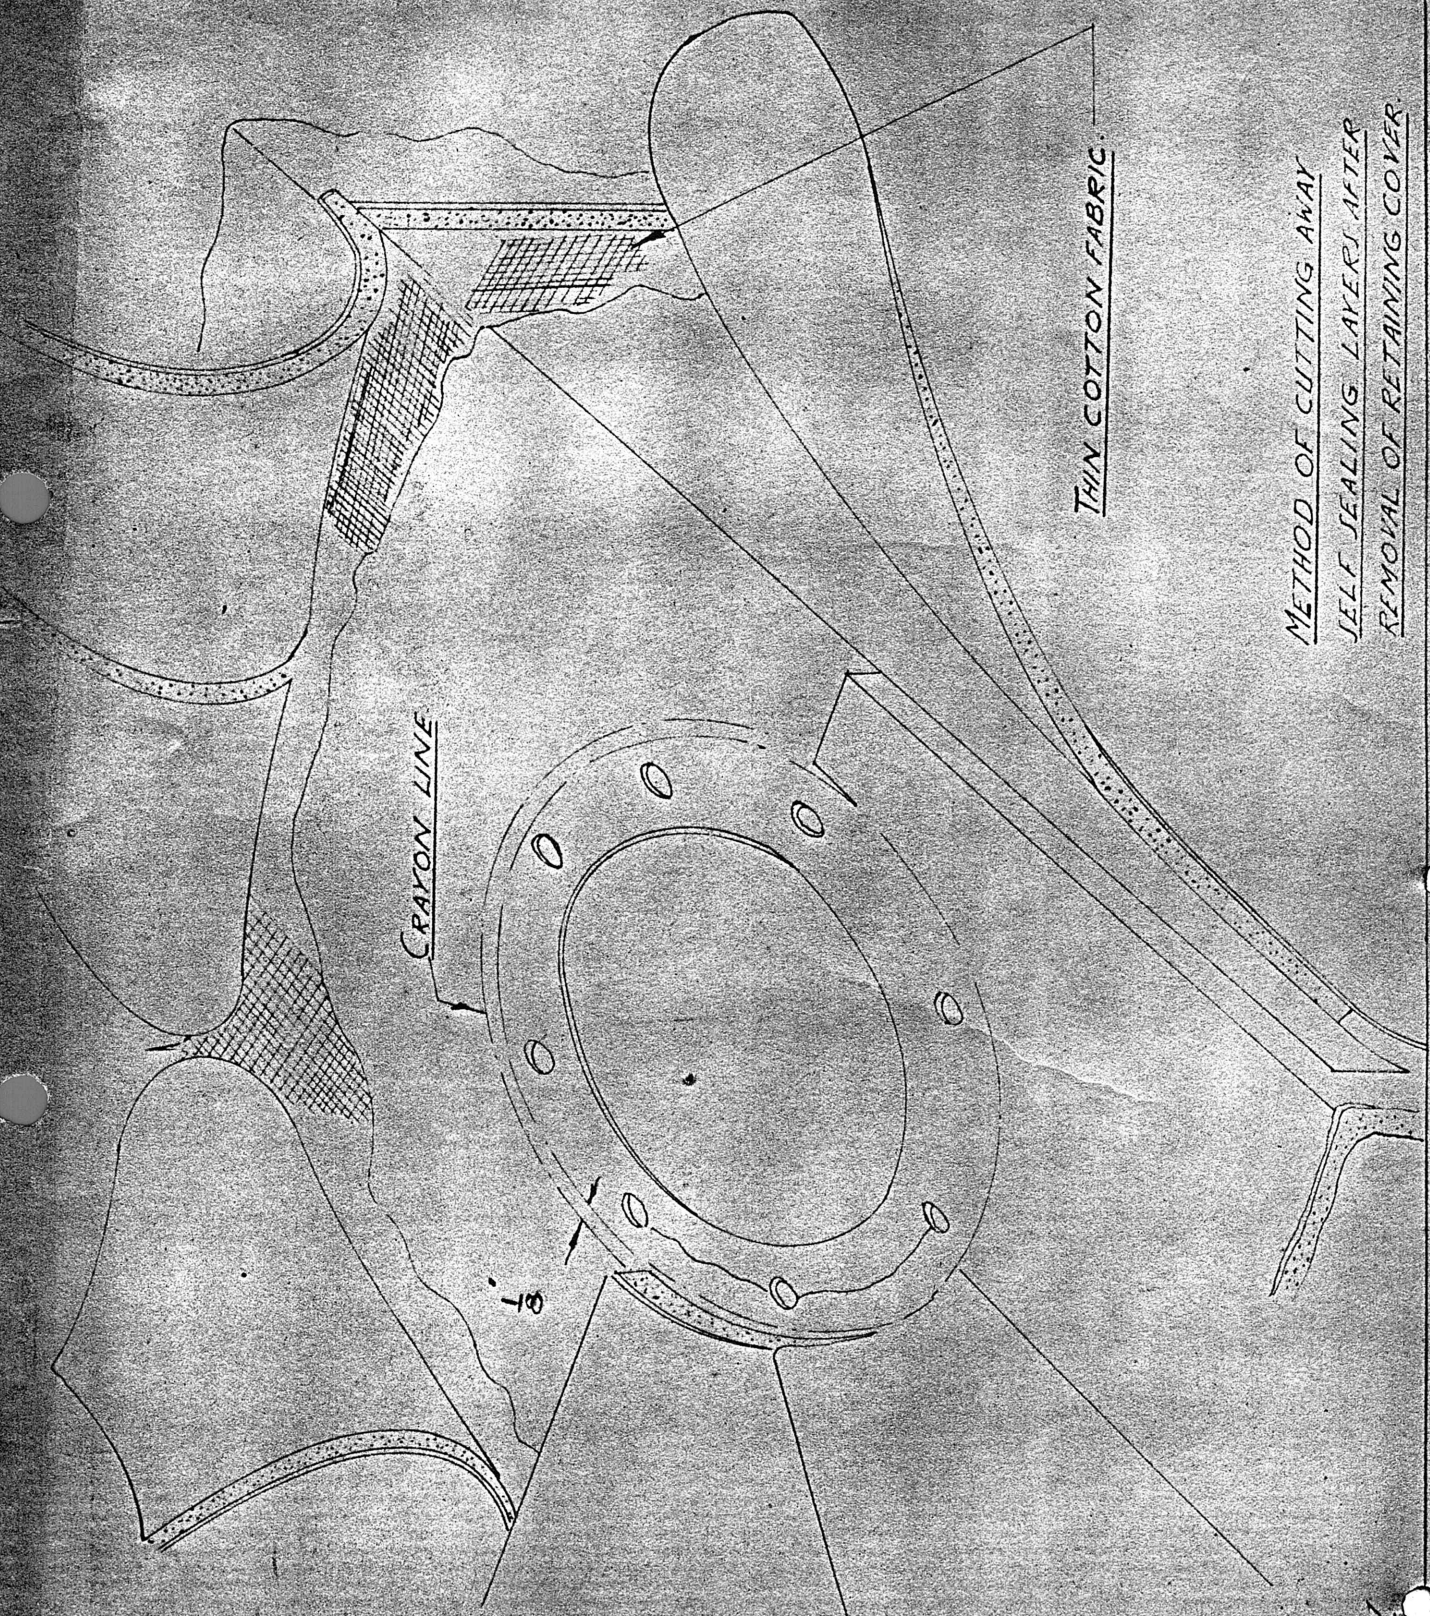
FIGURE J

METHOD OF CUTTING AWAY
SELF SEALING LAYERS AFTER
REMOVAL OF RETAINING COVER

27. In some cases it will be found that the fuel has so attacked the sponge rubber that the operation of peeling the layers away from the tank in the vicinity of the fitting causes disintegration or tearing of the sponge. Where this has occurred it will be necessary to cut the layers away and perform a repair operation as indicated in the repair scheme appropriate to the particular self sealing system.

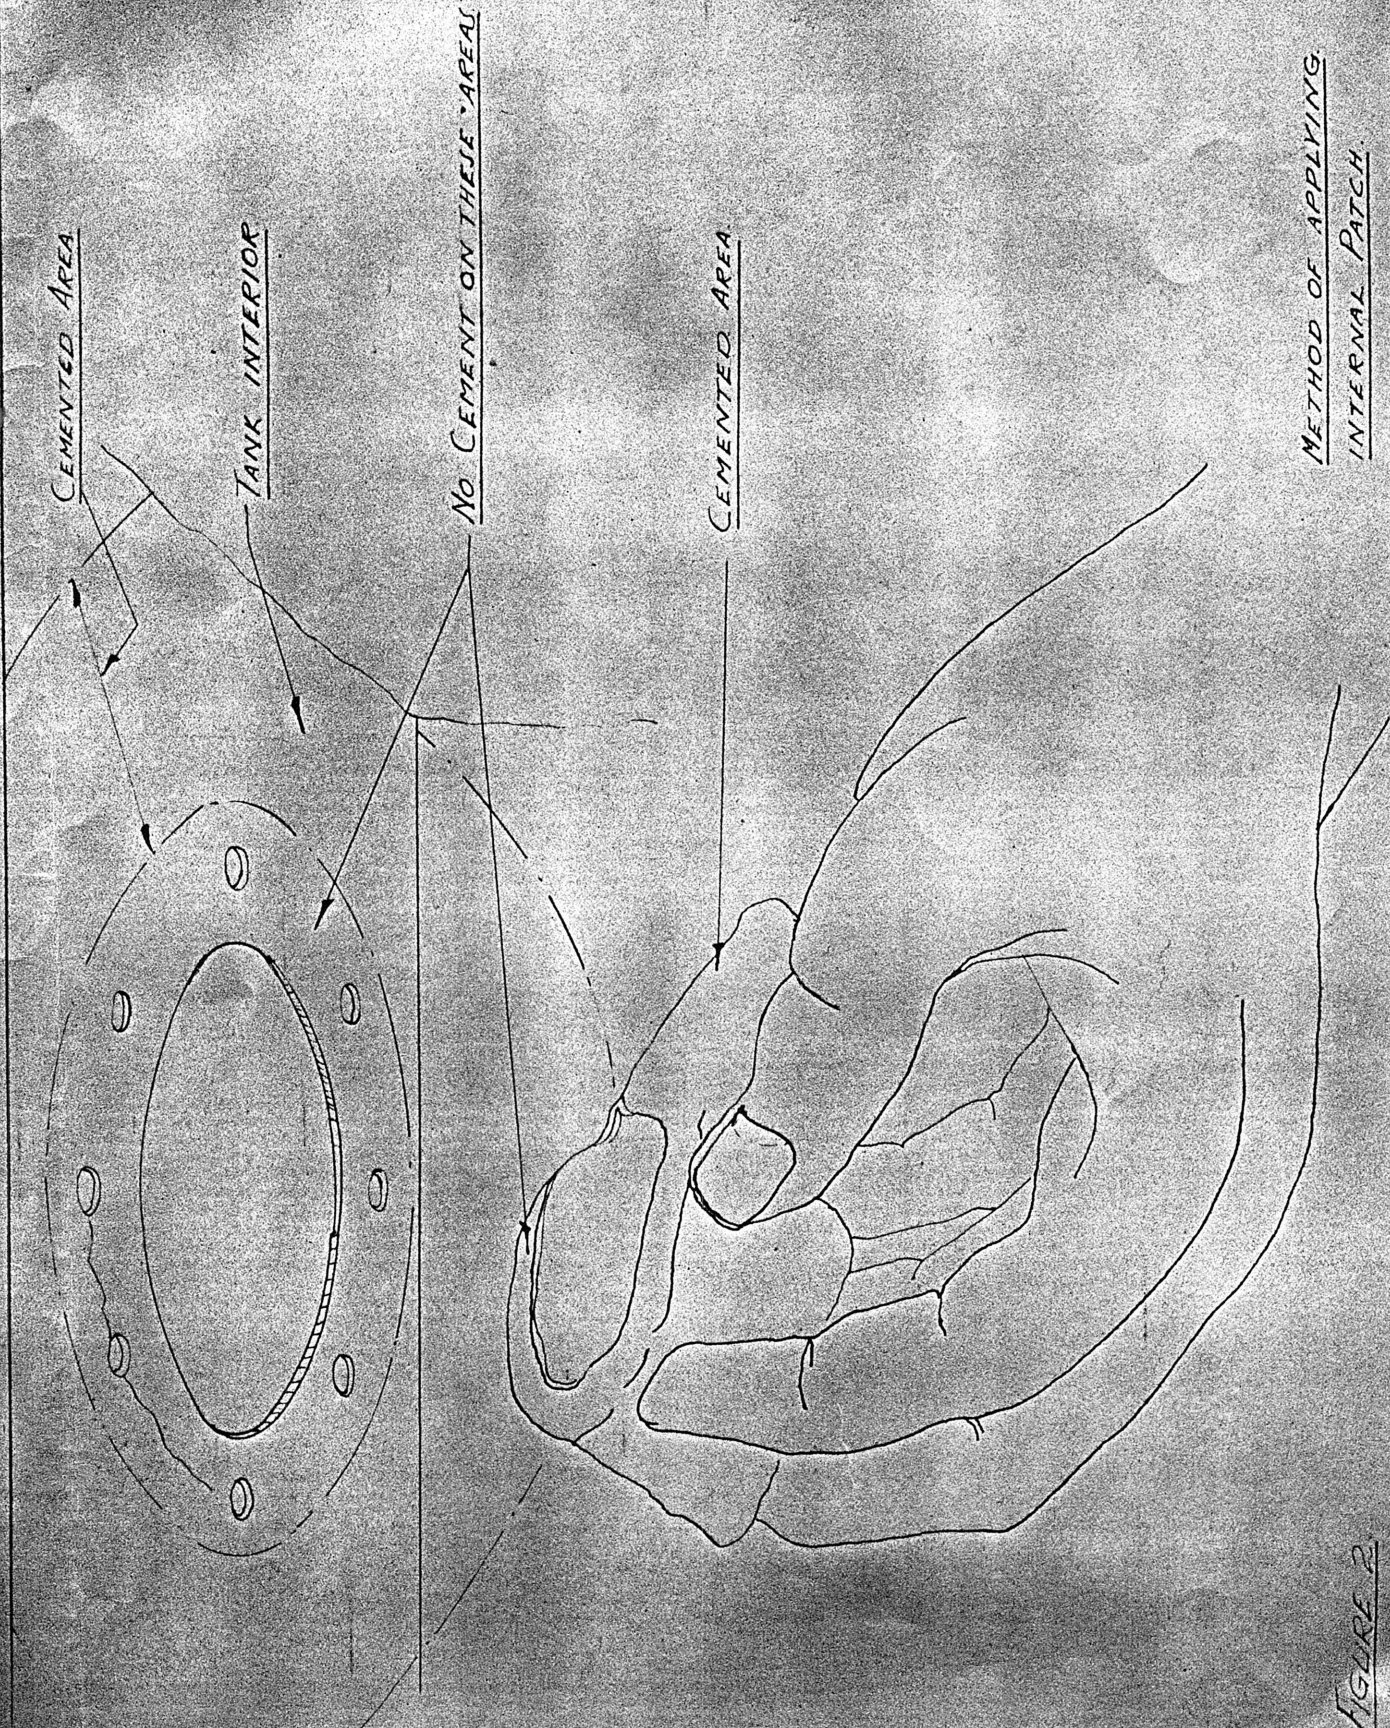
FIGURE 2.

METHOD OF APPLYING
INTERNAL PATCH.

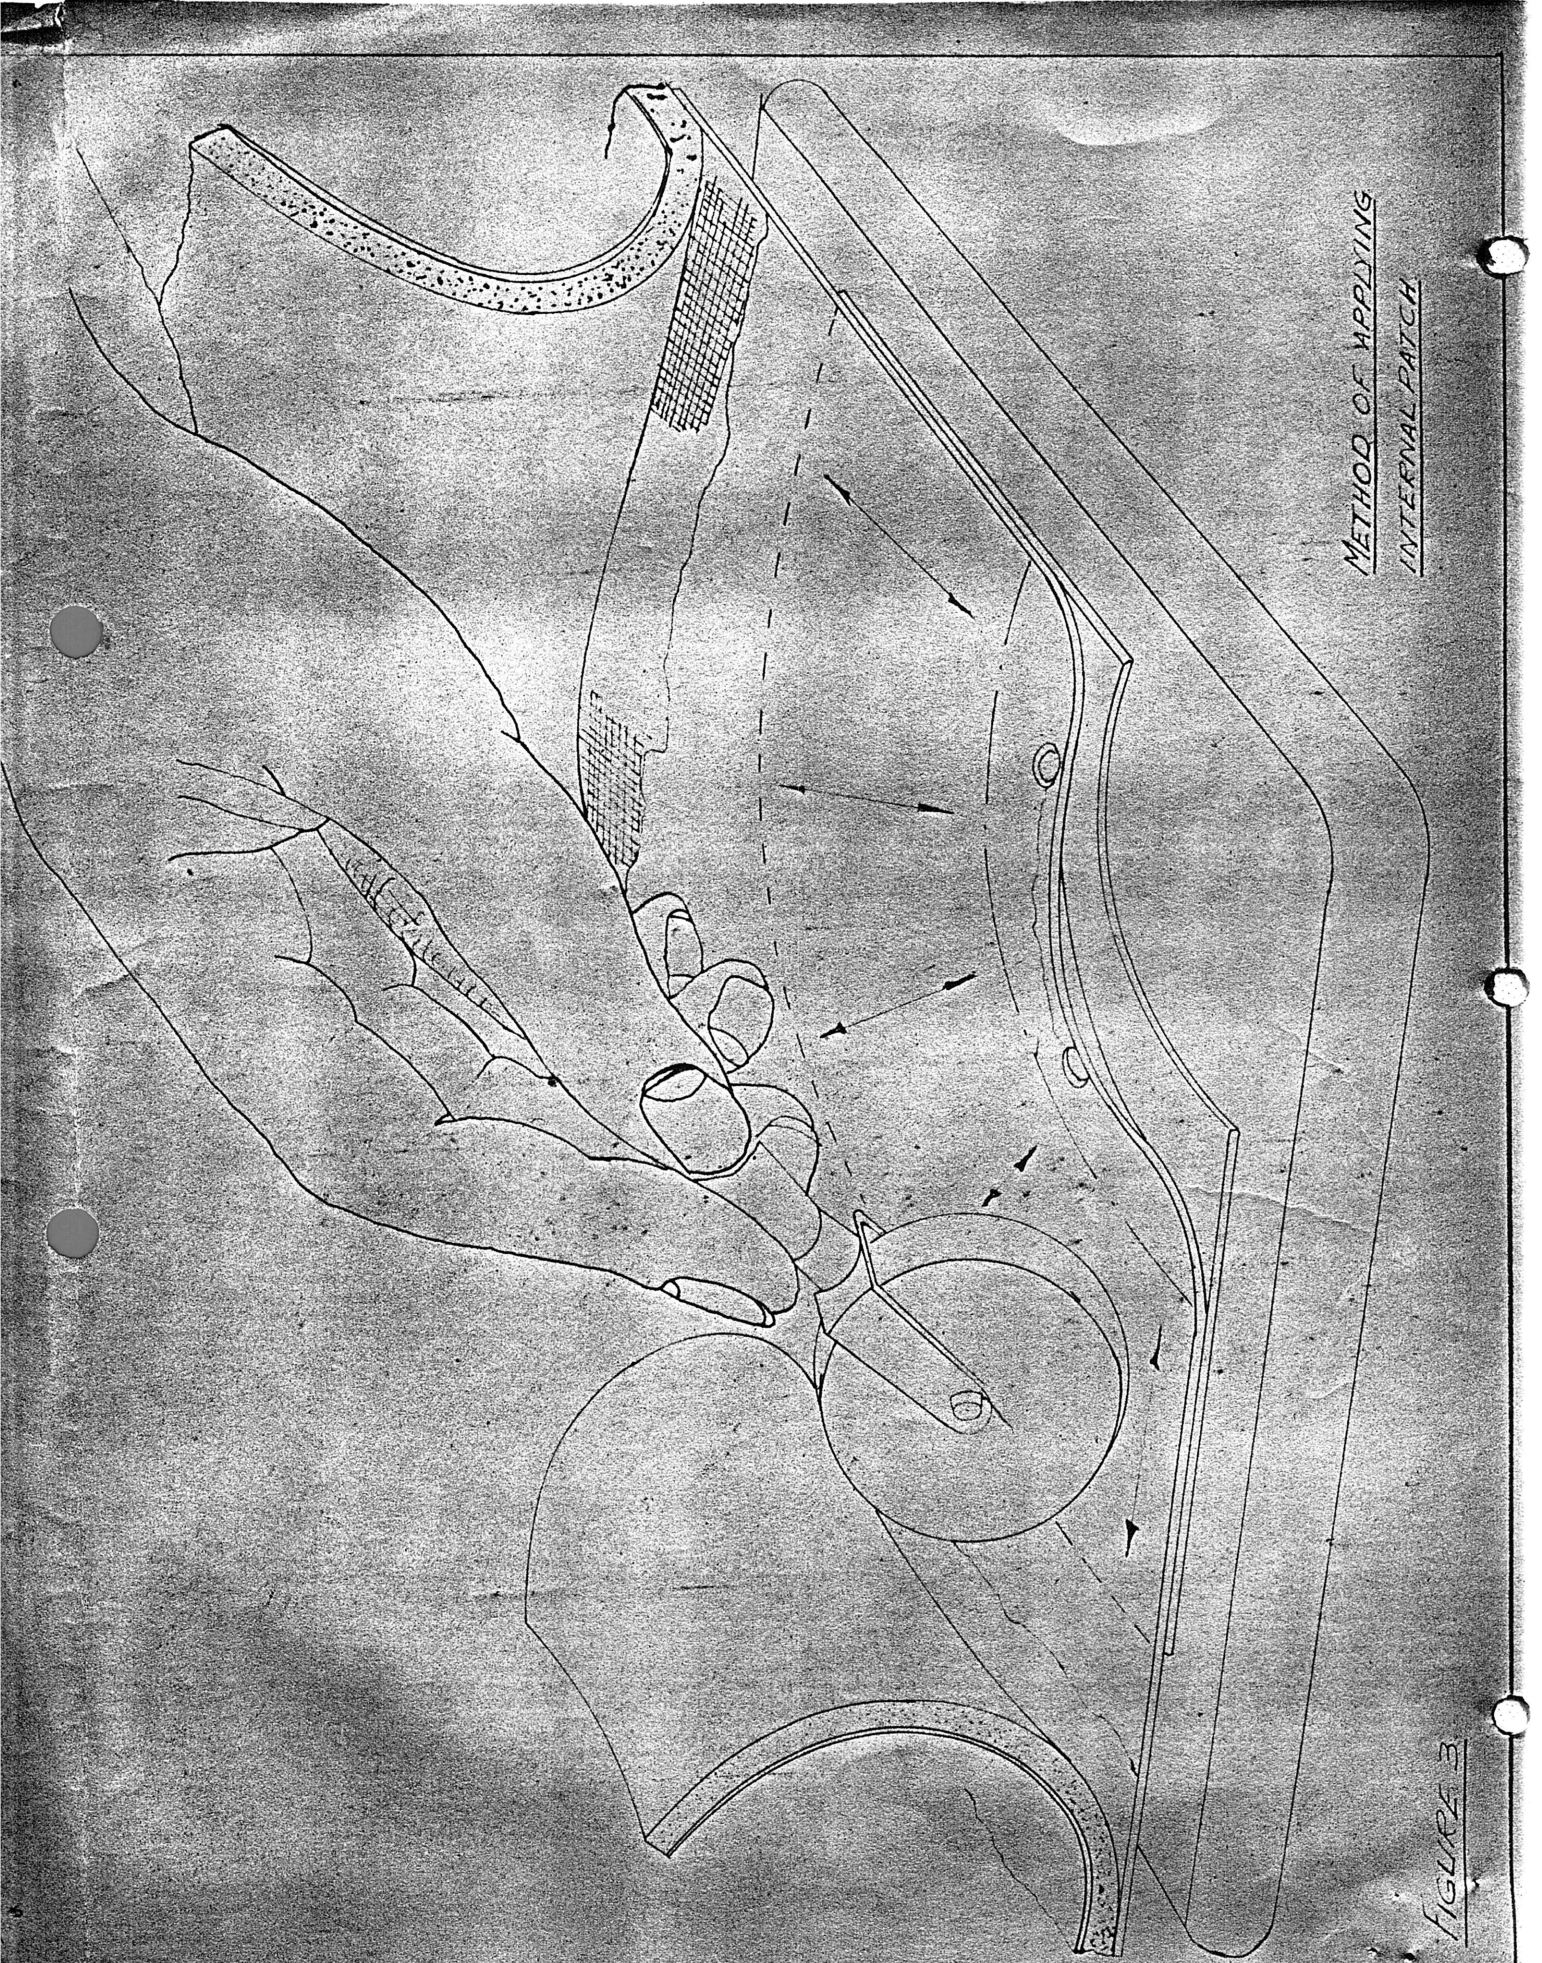
FIGURE 3

METHOD OF APPLYING
INTERNAL PATCH

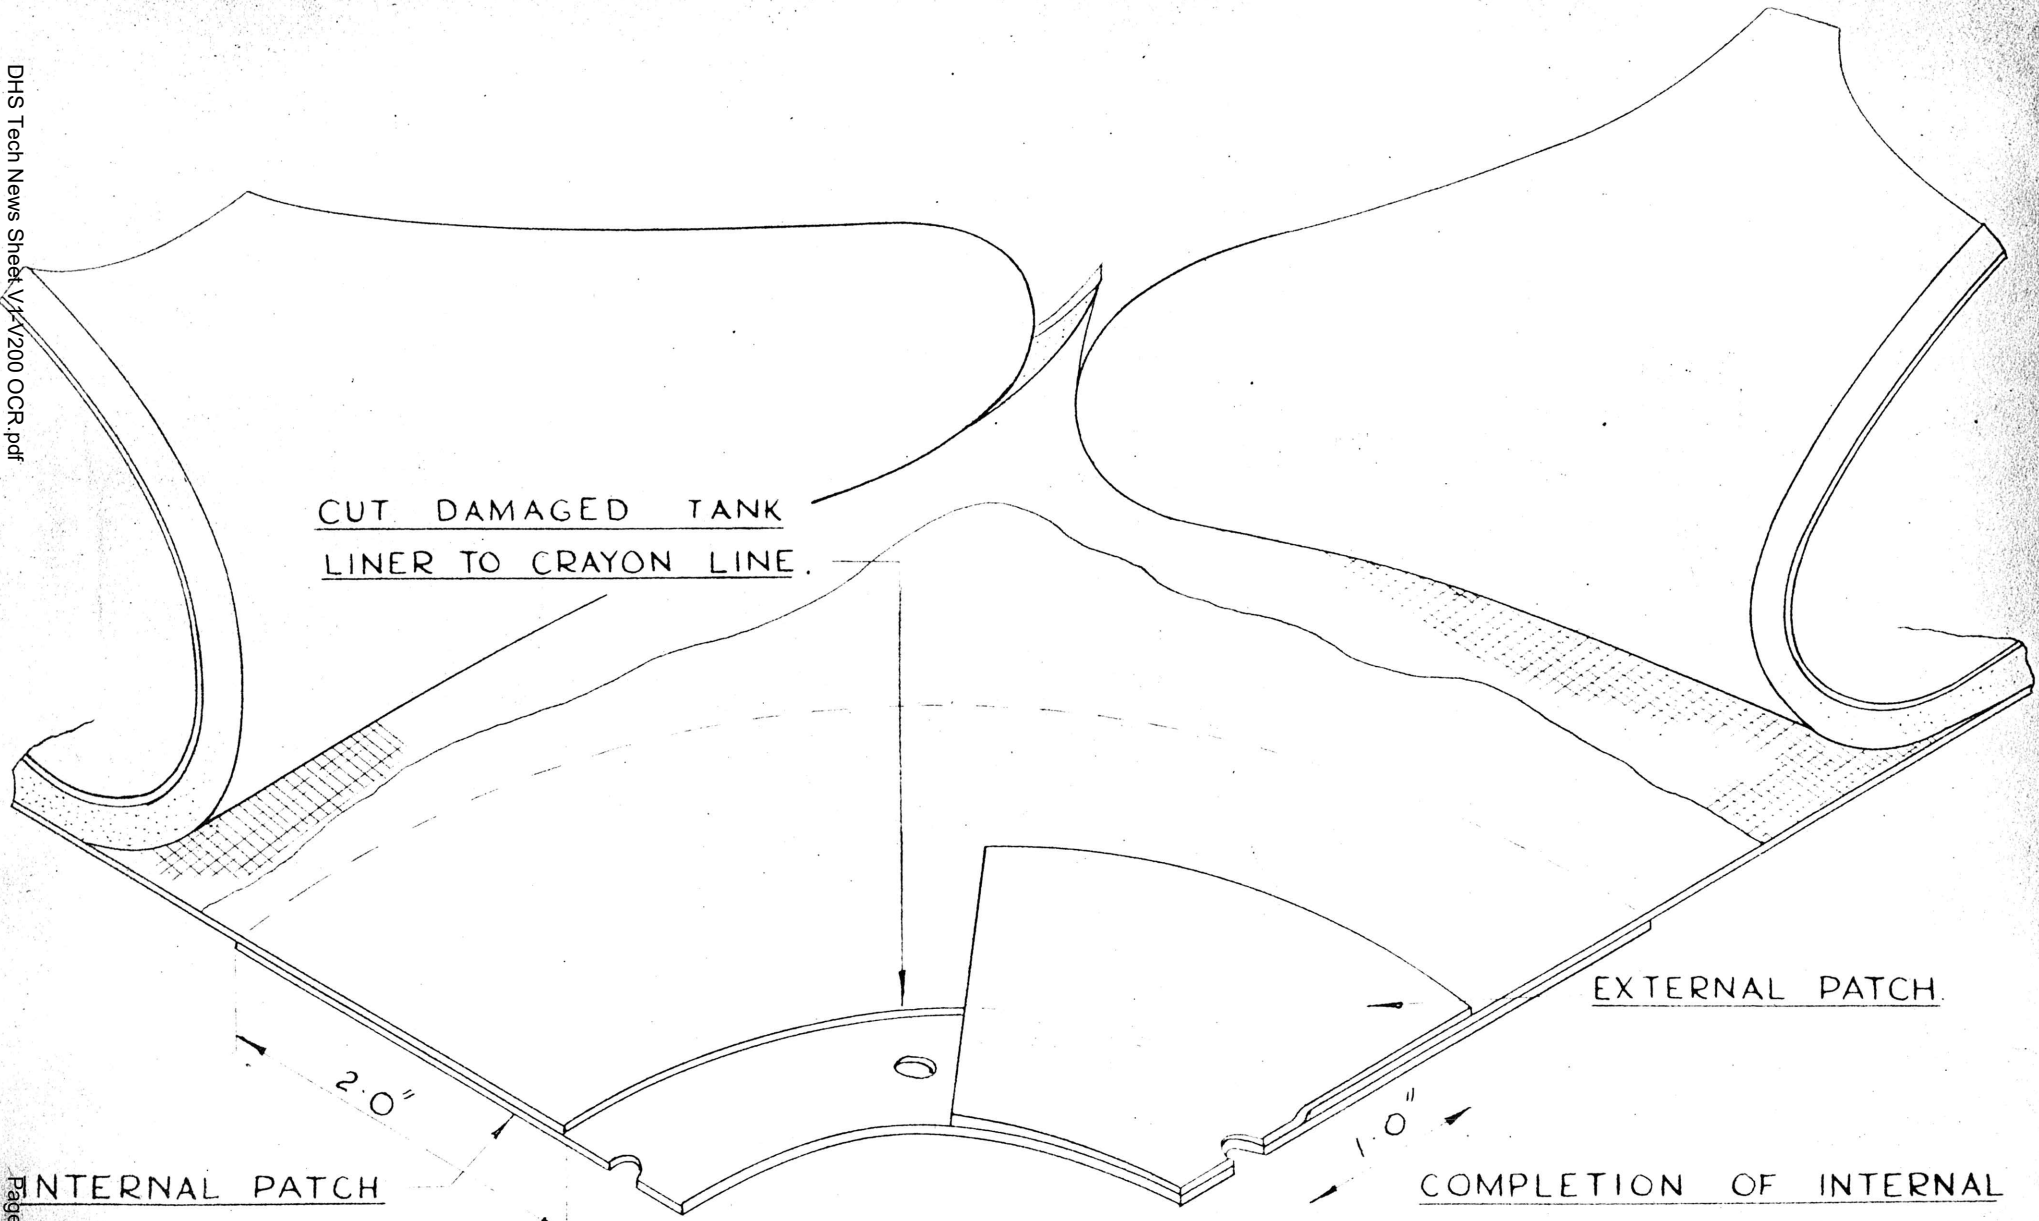
FIGURE 5.

CUT DAMAGED TANK LINER TO CRAYON LINE.

COMPLETION OF INTERNAL PATCH, WITH TANK LINER CUT BACK, AND EXTERNAL PATCH SHOWN IN POSITION.

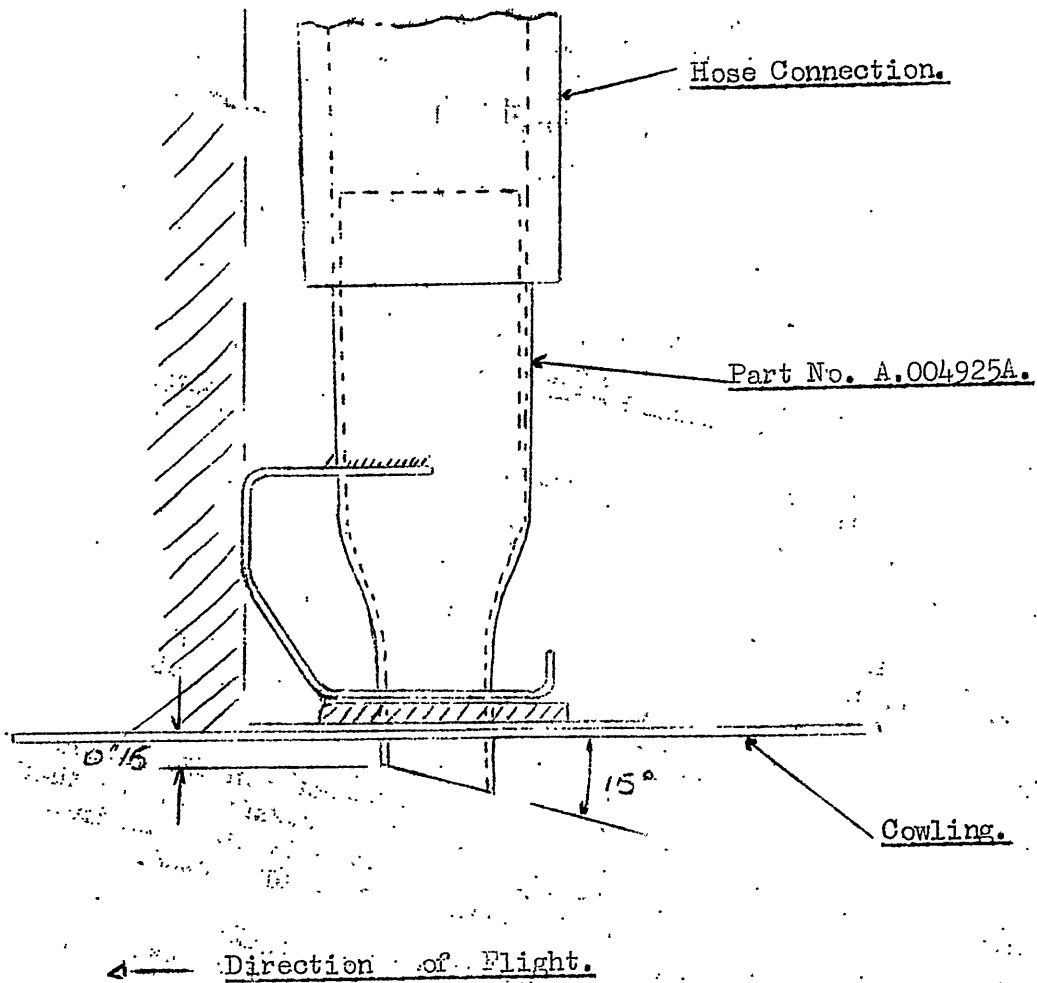
Vampire - Modification to Vent Outlet.

The Normal vent Outlet is Flush with the Outside of the Cowling.

We therefore are introducing this alteration by Vampire Modification 899 and the sketch overleaf indicates how the normal vent outlet is altered by this modification.
