## TECHNICAL NEWS SHEET

SERIES V No 322

DATE 13.5.52.ISSUED FOR THE GENERAL GUIDANCE OF OPERATORS OF DE HAVILLAND AIRCRAFT AND ENGINES  
OFFICIAL INSTRUCTIONS TAKE PRECEDENCE OVER ANYTHING CONTAINED IN THIS BULLETINVAMPIRE AIRFRAME, GENERAL CIRCULATION.  
SUB HEADING 11, ELECTRICAL EQUIPMENT.Circuit Breakers, Type 'A', Stores Ref. 5C/2559,  
60, 61, 62, 63 and 64. Use with Trip Button  
Covers, Stores Ref. 5C/3610.

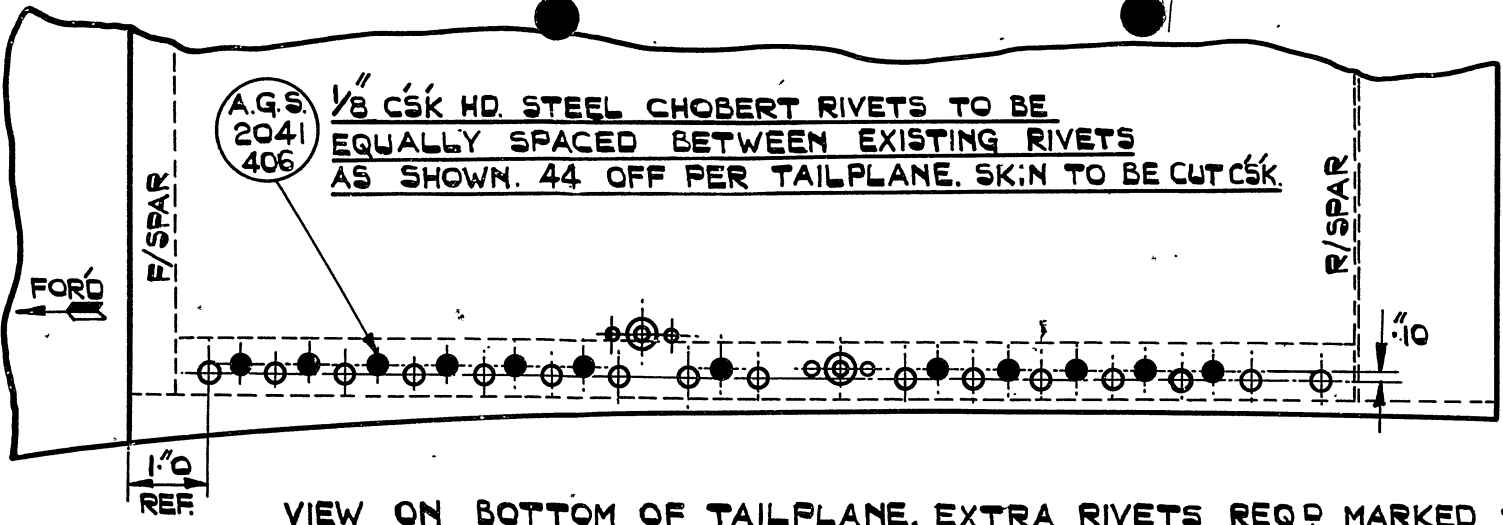
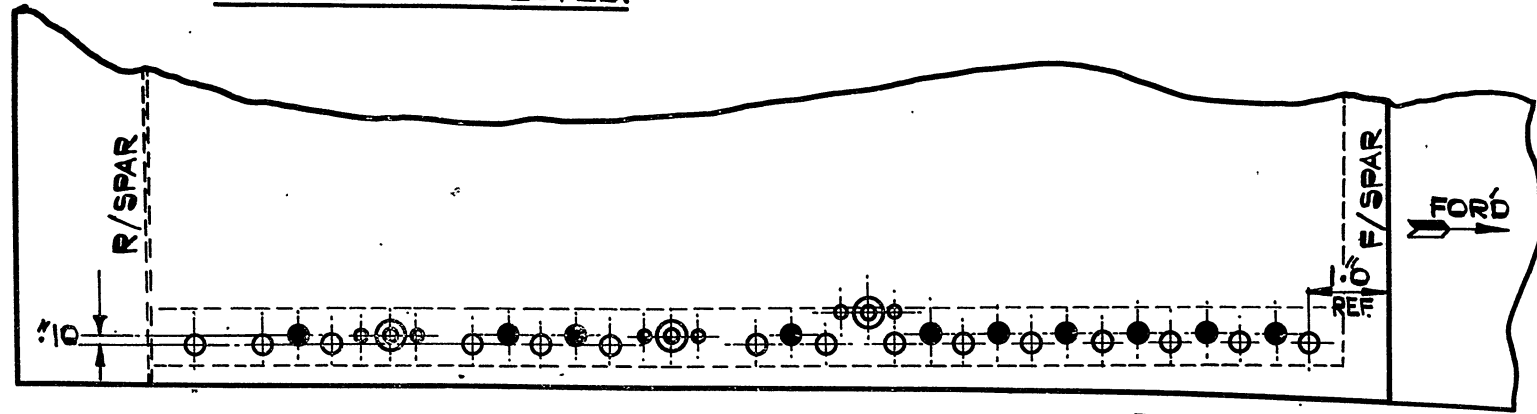
VIEW ON BOTTOM OF TAILPLANE, EXTRA RIVETS REQ'D MARKED THUS:-●  
BOTH ENDS AFFECTED.

VIEW ON TOP OF TAILPLANE, EXTRA RIVETS REQ'D MARKED THUS:-●  
BOTH ENDS AFFECTED.

- Note 2. Add to drawing attached after "Repair to:- Vampire Aircraft".
- D) 2. Examine and rectify all tailplanes 12.TP.1A held as spares or in store, before issue, and stamp STI/Vampire/56, or STI/Venom/2, as appropriate on the modification plate.

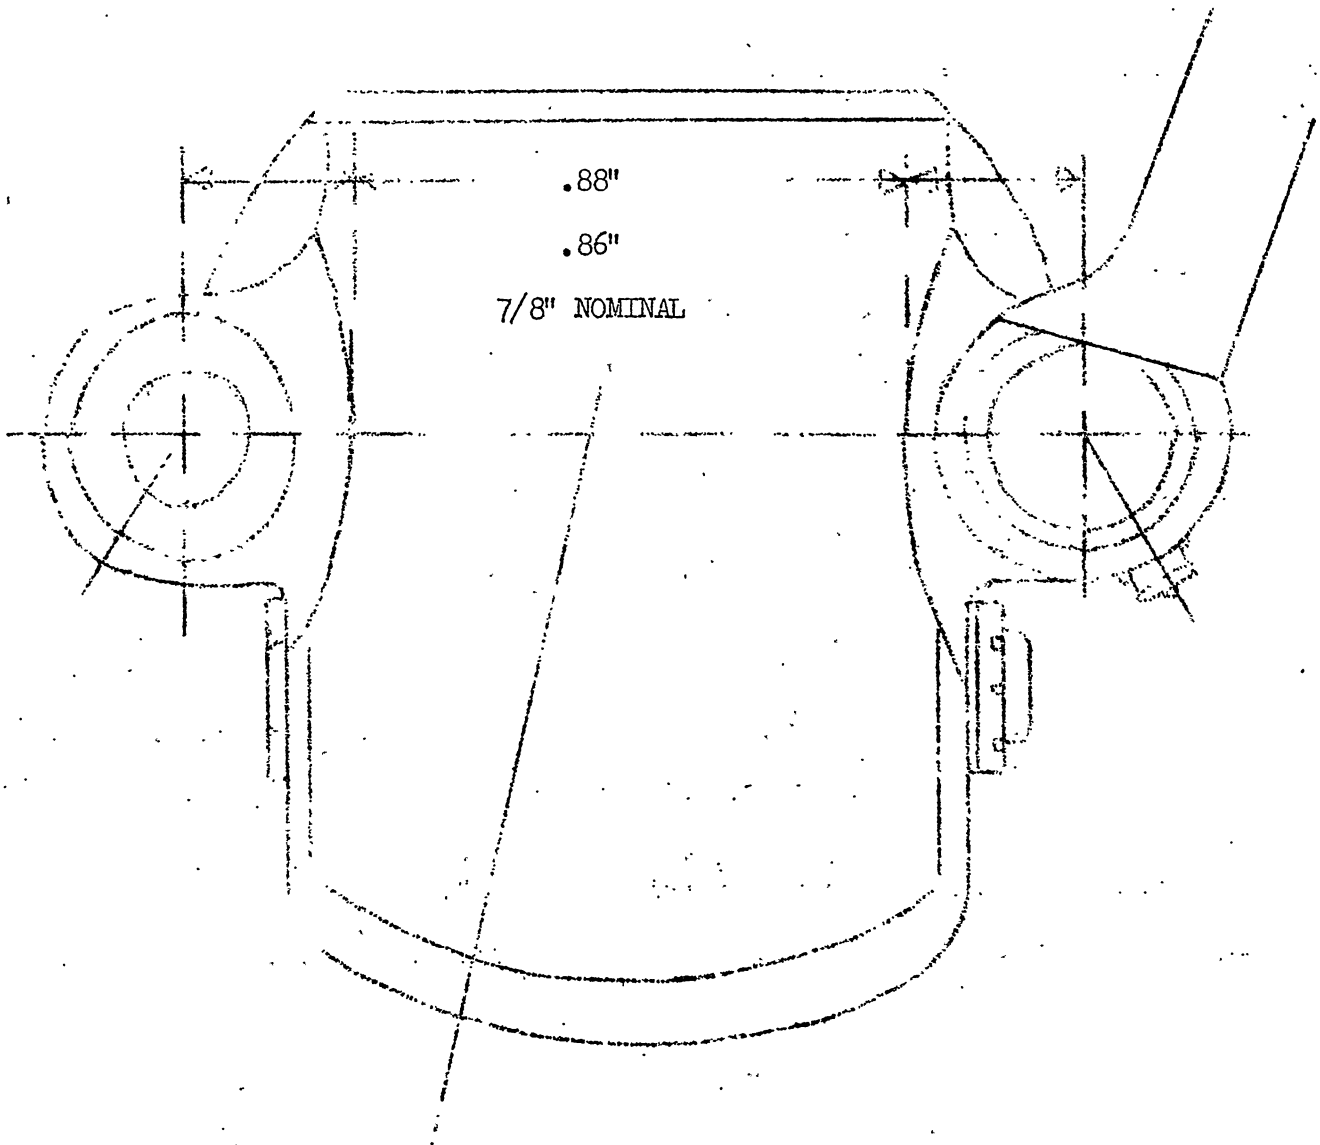
VAMPIRE/VENOM MAIN STRUT

CHECK THESE DIMENSIONS

AXLES WITH THIS DIMENSION IN EXCESS  
OF 5/16\" TO BE RETURNED TO MANUFACTURER -  
LOCKHEED - LEAMINGTON.

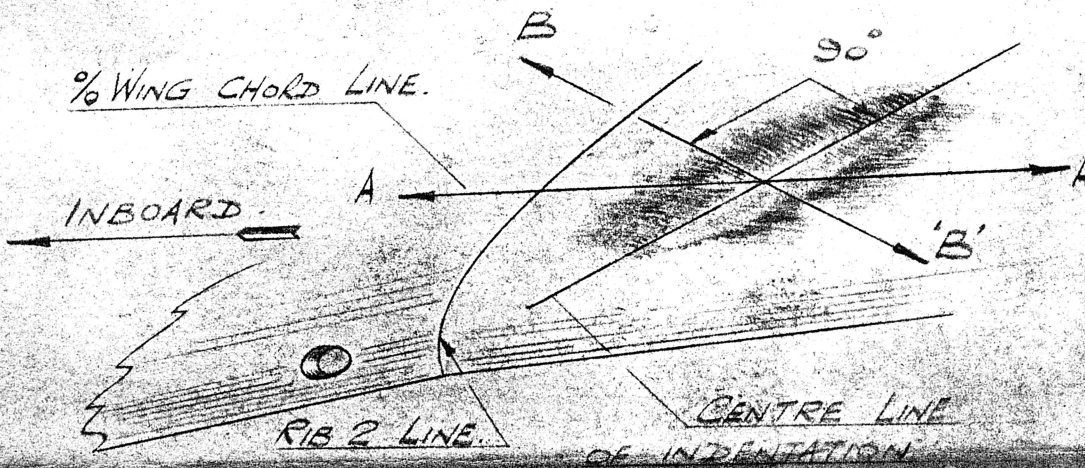
FIG. 4.

VIEW SHOWING MEASURING LINES  
OF DIAGONAL BUCKLE OUTBOARD OF RIB 2.

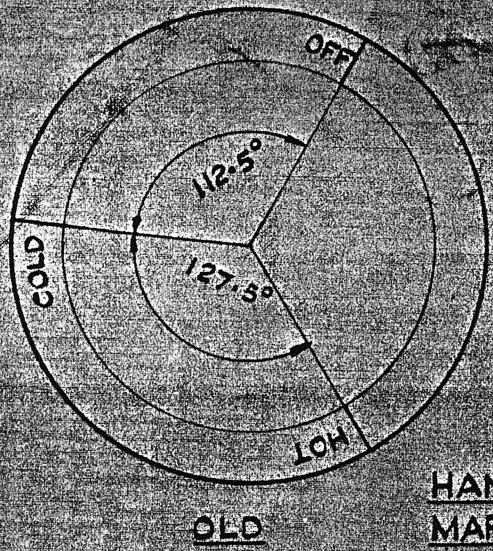
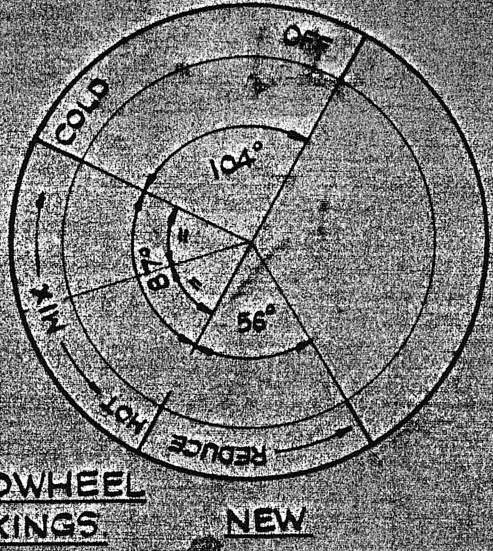
HANDWHEEL MARKINGS

DUE TO INCORRECT MARKING OF THE COCKPIT TEMPERATURE CONTROL HANDWHEEL 15 CE 497A ANGULAR MOVEMENT ON CAMS DOES NOT PRODUCE CORRECT TEMPERATURE CONTROL AS THERE IS NO PERIOD OF MIX (COLD & HOT) OR REDUCE (FROM HOT TO OFF). THE HANDWHEEL SHOULD NOW BE RE-MARKED AND CAMS SHOULD BE RE-SET AS ILLUSTRATED BELOW.
