# DE HAVILLAND SERVICE

## TECHNICAL NEWS SHEET

### INDEX series V (Vampire Airframe, General Circulation)

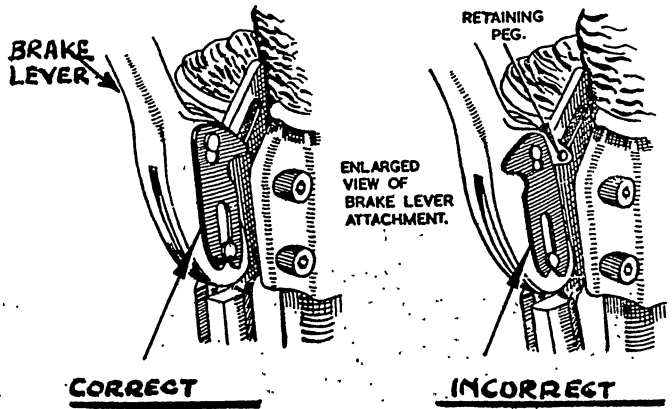
S.T.N/MISC/62.

Cases have been reported where the spring retaining clip was found to be incorrectly assembled to the brake lever of a straight type pilots control handle. Normally the clip in addition to securing the brake lever pivot pins, retains the small retaining peg which pivots in a channel in the guide plate. In the cases reported the clip had been fitted in the reverse way, so that the angular projection was facing forward, leaving the head of the peg exposed and liable to fall out.

The attention of all concerned is to be drawn to the correct method of fitting the retaining clip, as shown in the sketch attached, when brake levers are assembled.

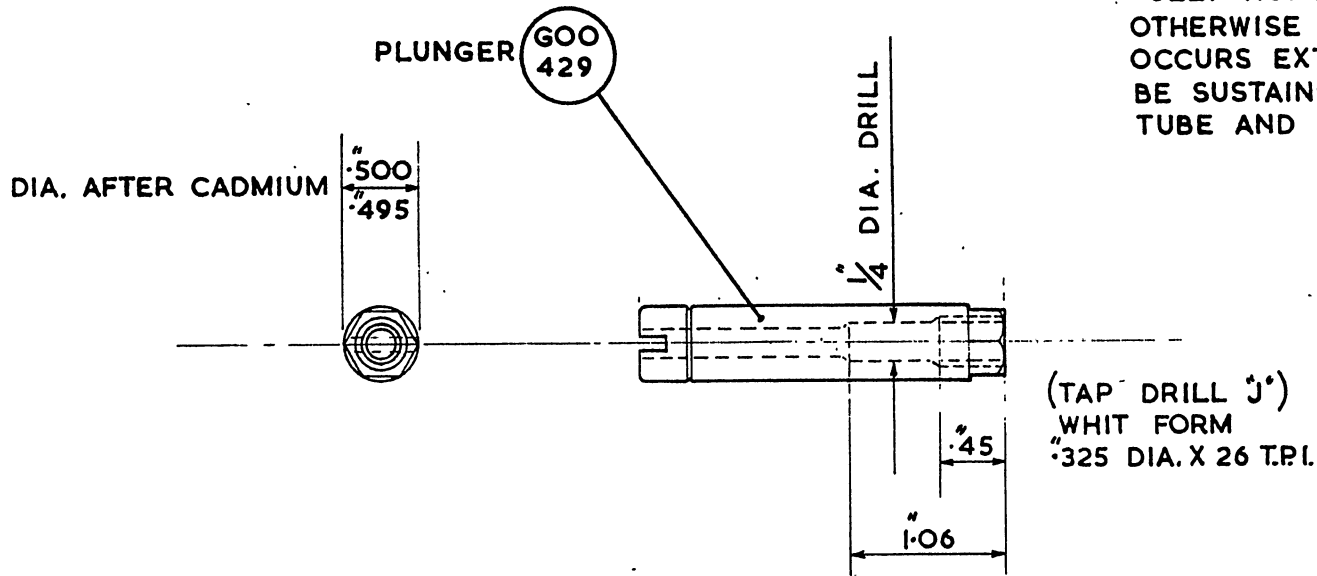
THE PLUNGER MUST BE SCREWED FULLY HOME BUT NOT FORCED OTHERWISE IF OVERTIGHTENING OCCURS EXTENSIVE DAMAGE WILL BE SUSTAINED BY THE SLIDING TUBE AND TELEFLEX CABLE.

S.I. VAM 50 REFERS.  
PRIOR TO COMMENCING PARA. 8 OF THE S.I.  
CHECK THE ABOVE PLUNGER DIMENSIONS,  
THIS IS MOST IMPORTANT TO ENSURE .35 DIM.  
AS SHOWN ON DRG. No. ROOG 47 FIG. 6
