DE HAVILLAND SERVICE

TECHNICAL NEWS SHEET

SERIES V. No 531

VAMPIRE AIRFRAME, GENERAL CIRCULATION.
SUB HEADING 8 GENERAL.

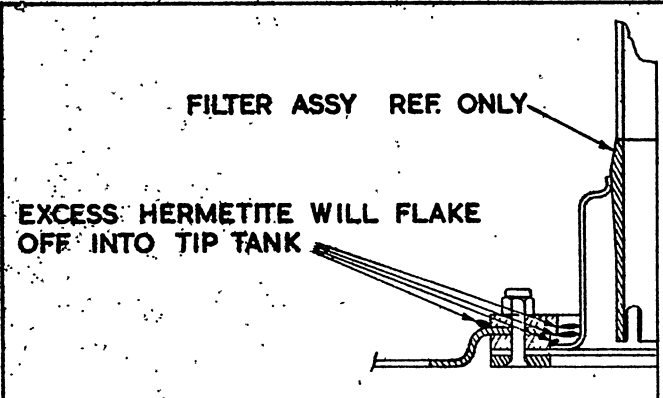
SKETCH No.1 SHOWING EFFECT OF EXCESSIVE APPLICATION OF HERMETITE ON TYPICAL SECTION

Jointing of a thin consistency should be used, preferably Hermatite No. 1326B (Alternative 1310/5069, Stores Ref. 330/1326.)

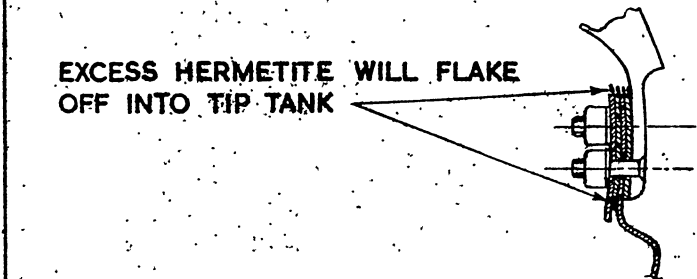
SKETCH No.2 SHOWING EFFECT OF EXCESSIVE APPLICATION OF HERMETITE ON TYPICAL SECTION

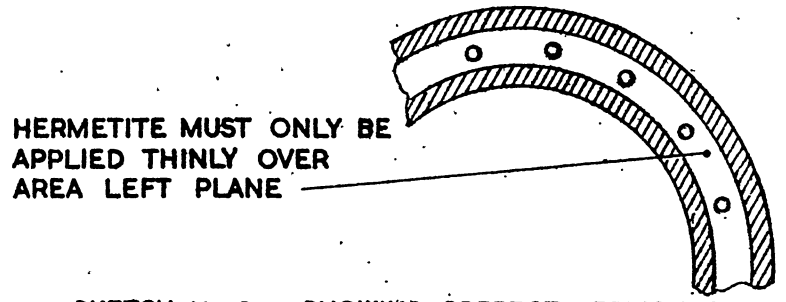
SKETCH No. 3 SHOWING CORRECT APPLICATION OF HERMETITE TO A TYPICAL SURFACE

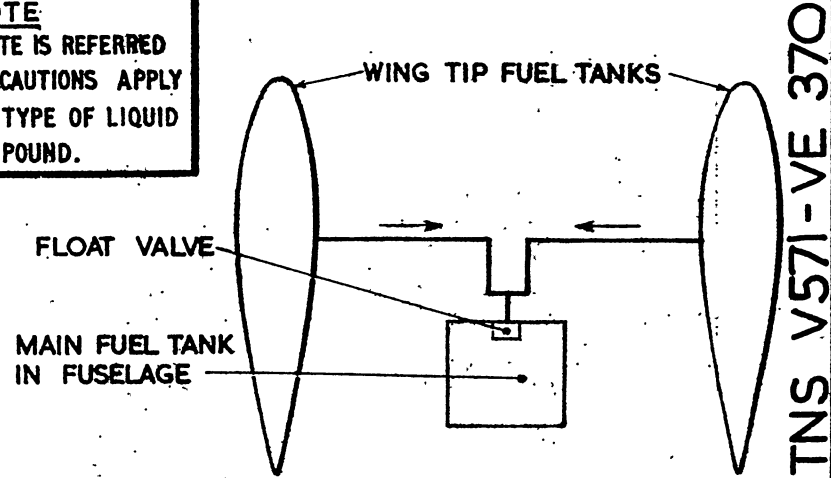
DIAGRAM SHOWING HOW FLAKES OF HERMETITE WHEN APPLIED EXCESSIVELY IN WING TIP TANKS AS SHOWN IN SKETCHES NOS. 1 & 2 MAY BE CARRIED IN FUEL SYSTEM TO OBSTRUCT FLOAT VALVE SITUATED IN MAIN TANK IN FUSELAGE.

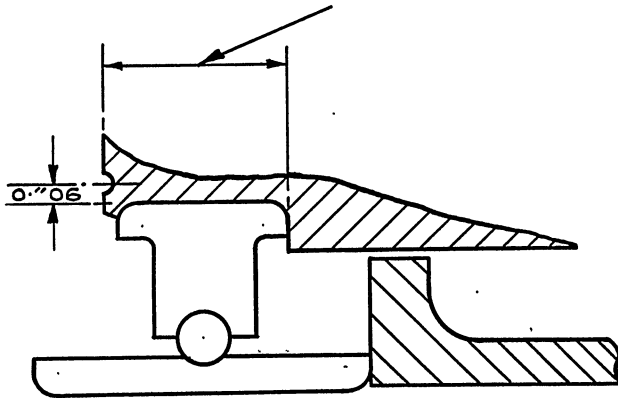
DETAIL 'A'
CORRECT ASSEMBLY.

ALLOWANCE BELOW MINIMUM
 DUE TO BAD SEATING
 TRACK.

HOUSING DEPTH TO BE :-
 WIDTH OF RACE OUTER TRACK PLUS 0.030 + $.010$
 - $.000$

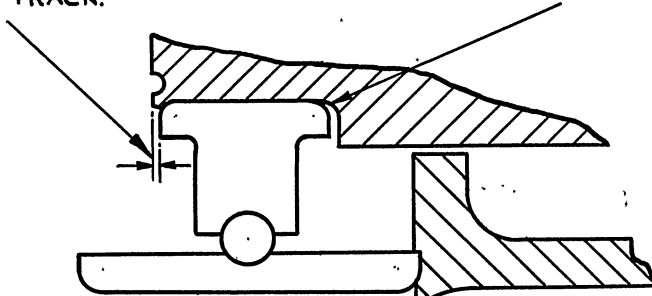
DETAIL 'B'
INCORRECT ASSEMBLY.

HOUSING RADIUS TOO GREAT CAUSING OUTER
 TRACK TO BE HELD OFF SHOULDER SO
 IMPAIRING EFFECTIVE SPACING OF BALLS

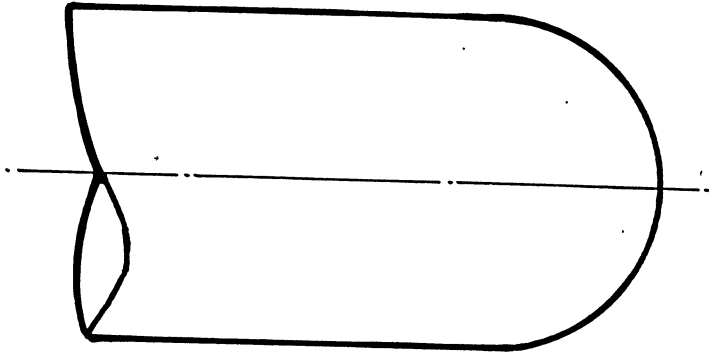
INCORRECT

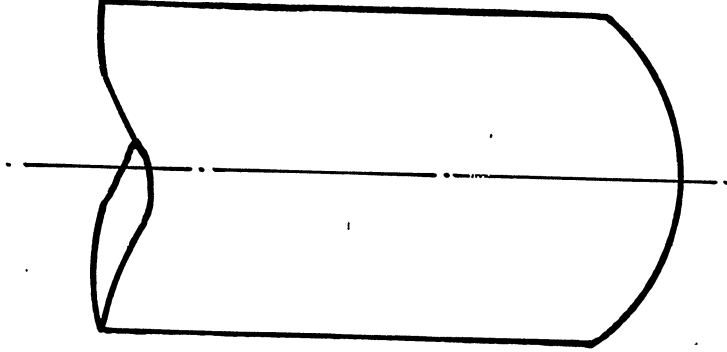
INCORRECT

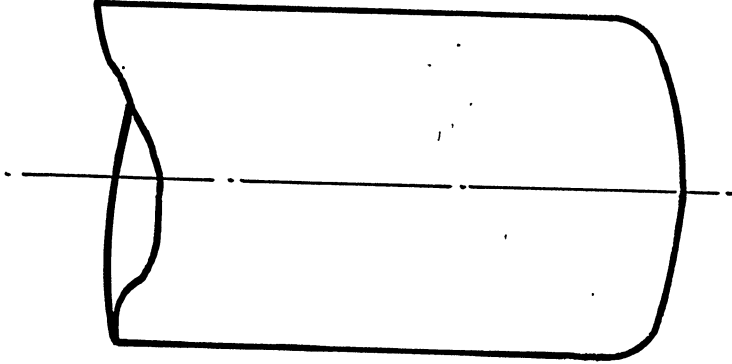
CORRECT.

SKETCH TO SHOW CORRECT AND INCORRECT END FORM OF
