A.P.41218 & C, Vol.2, Part 3

AP 4121B & C V2 P3 Goblin 2 & 3 Servicing 19620901 OCR.pdf

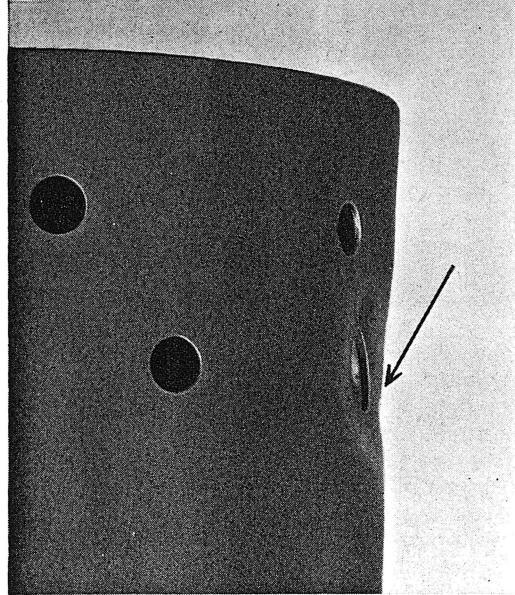
Fig. 13. Distortion of skin at locating pin bossunserviceable but repairable

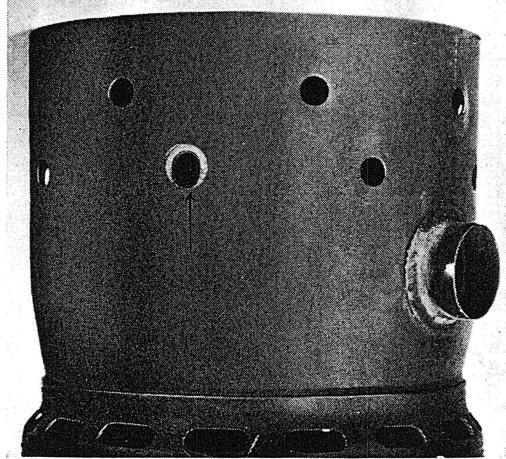
Fig. 16. Locating pin boss elongation—example of unserviceable standard which may be repaired

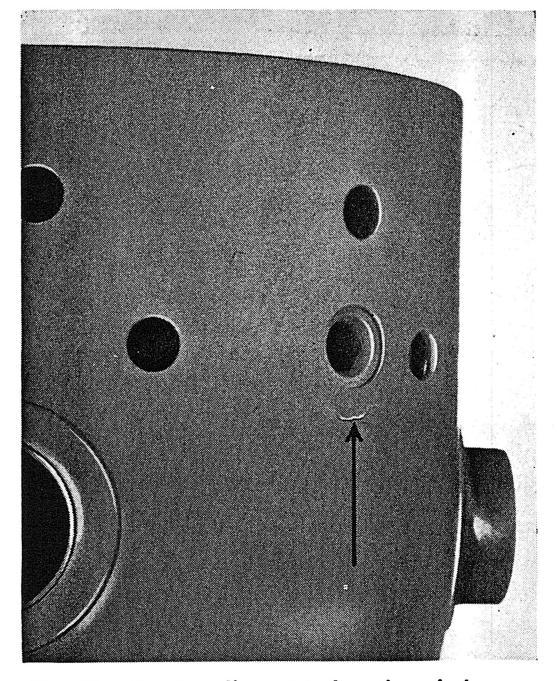
Fig. 17. Cracks adjacent to locating pin bossacceptable standard

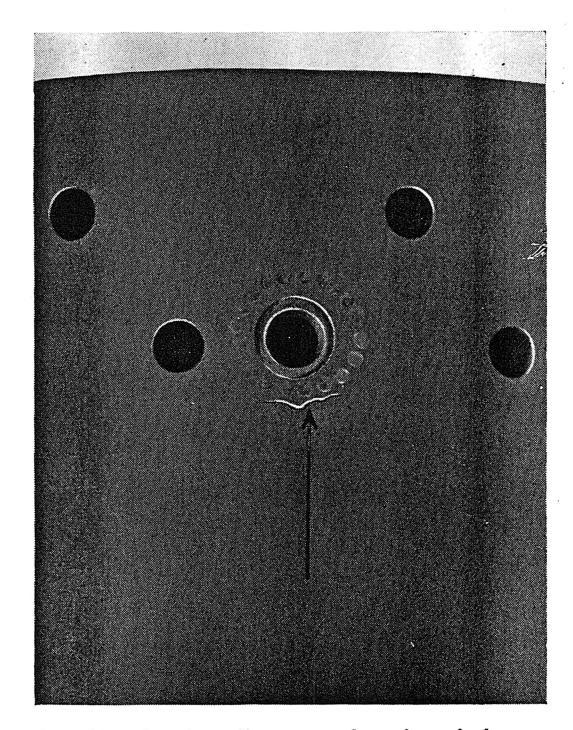
Fig. 18. Cracks adjacent to locating pin bossserviceable for a further servicing period after welding

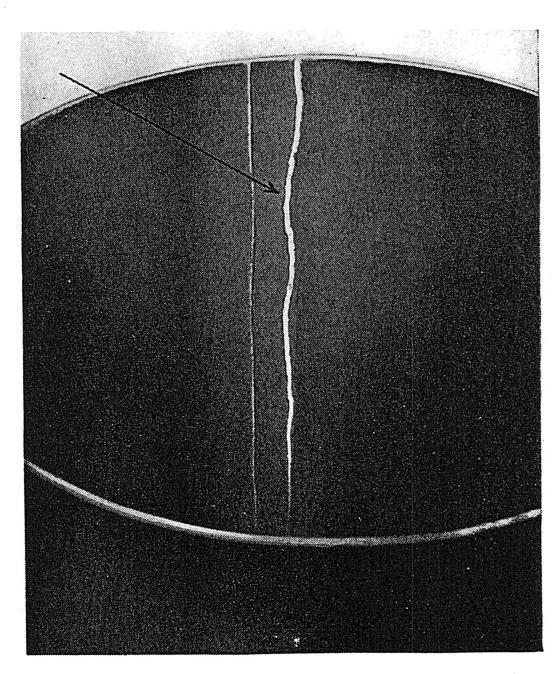
Fig. 19. Splitting at rear end seam—serviceable after repair by welding

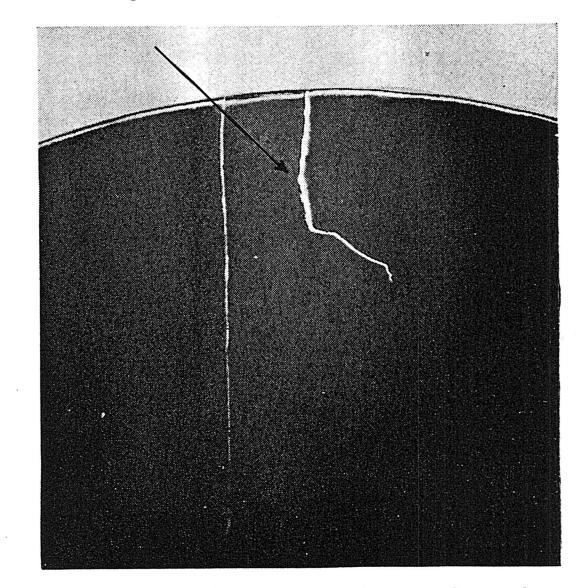
Fig. 20. Splitting at rear end seam—beyond repair

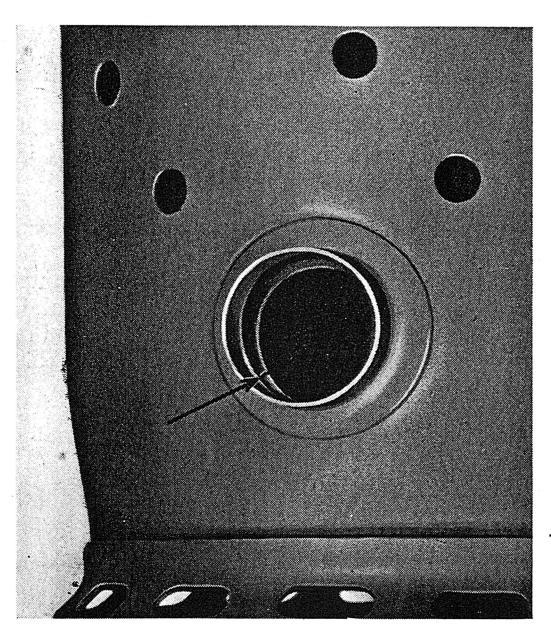
Fig. 21. Cracks in flame tube under the interconnecting stub flange—serviceable for a further servicing period

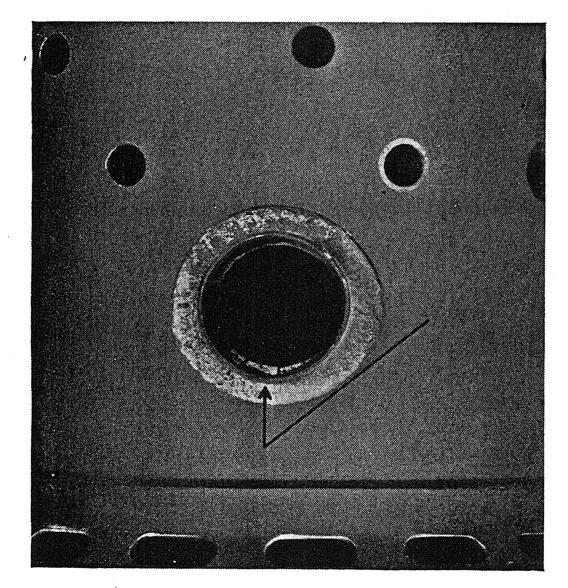
Fig. 22. Cracks in flame tube under the interconnecting stub flange—unserviceable but repairable

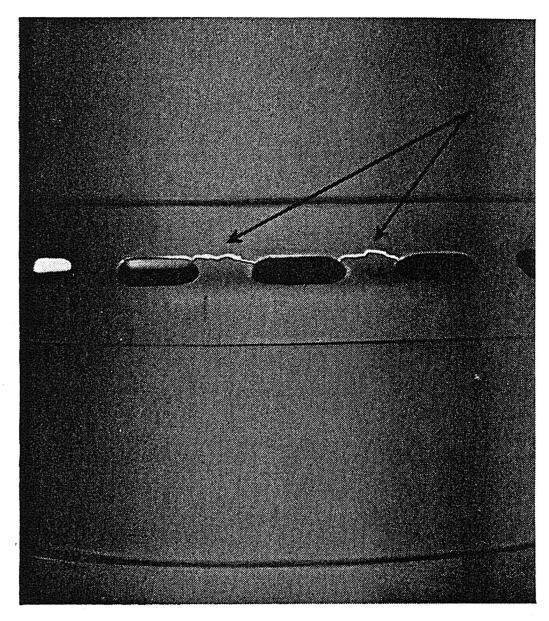
Fig. 23. Cracks at dilution windows repairable

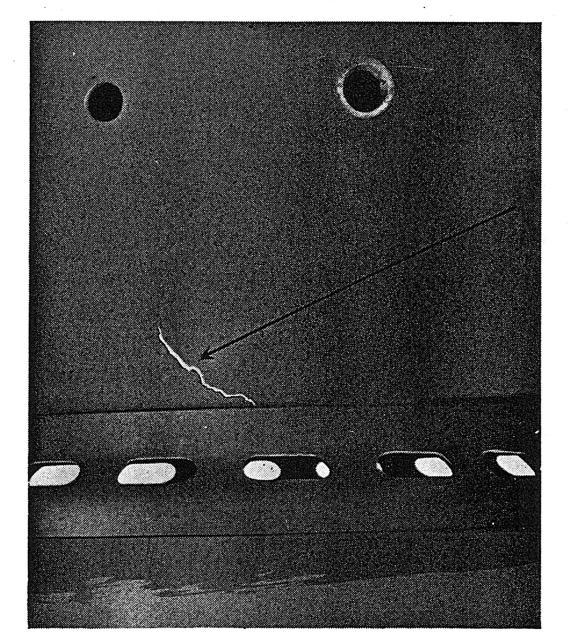
Fig. 25. Cracks from dilution windows repairable

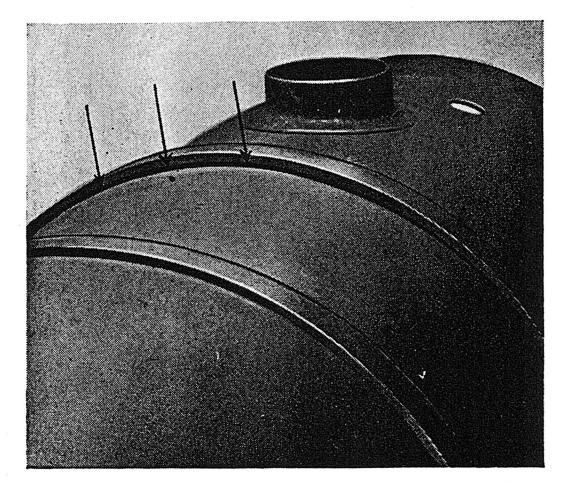
Fig. 26. Weld failure at 1st or 2nd row of dilution windows—beyond repair

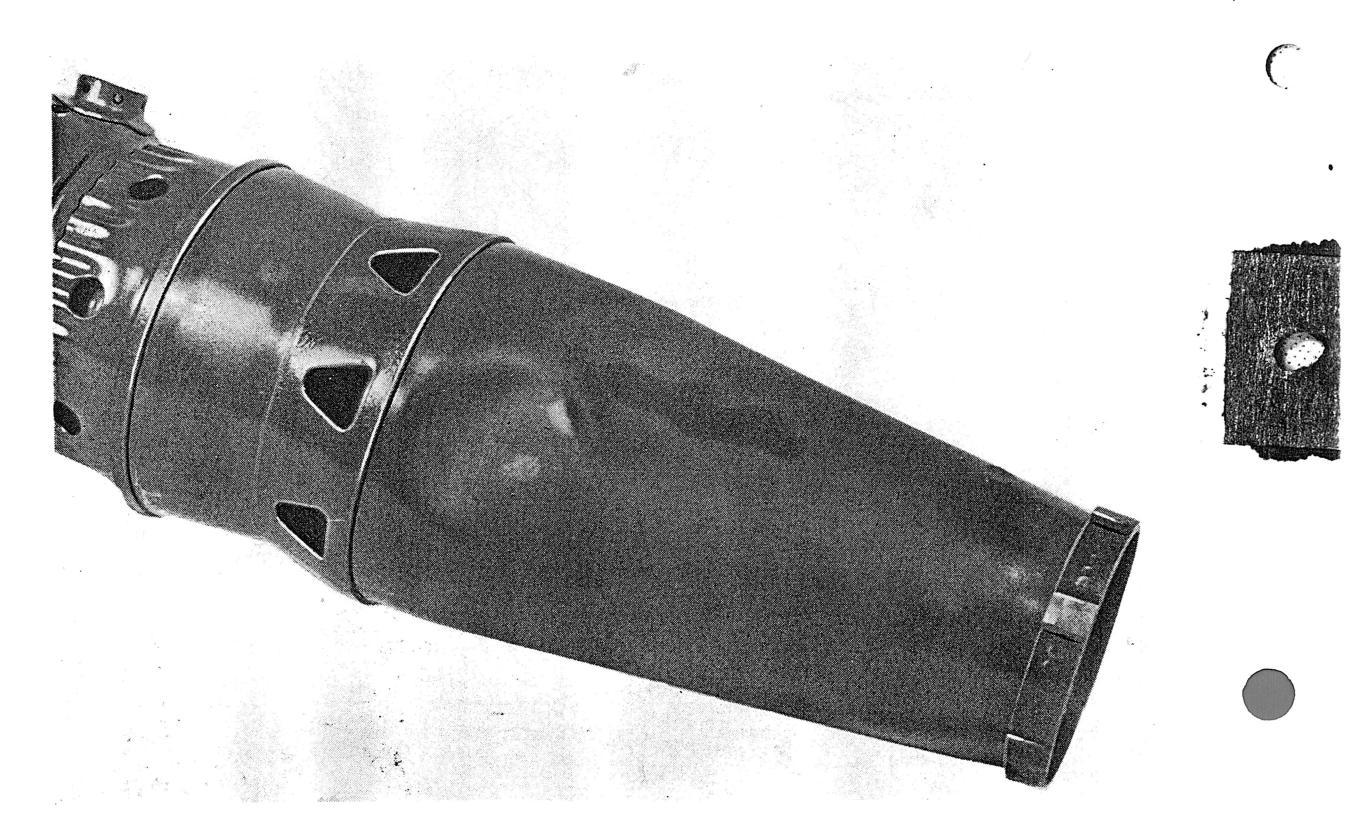
Fig. 27B. Distortion and buckling on flame tube-not acceptable

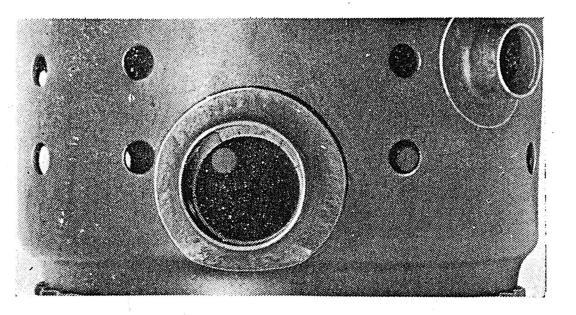
Fig. 27C. Cracking of interconnecting stub flange—acceptable

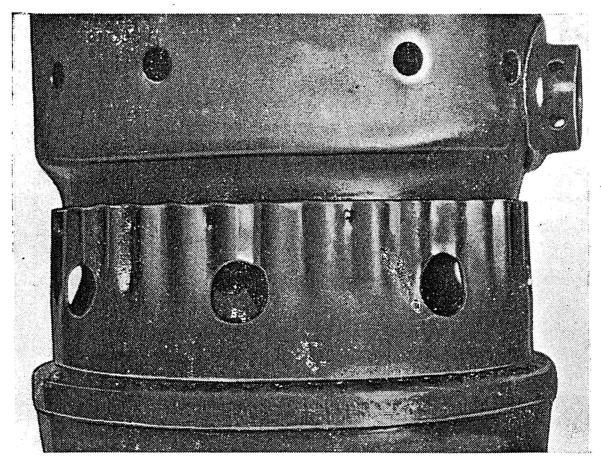
Fig. 27D. Failure of spot welding in flutes-acceptable

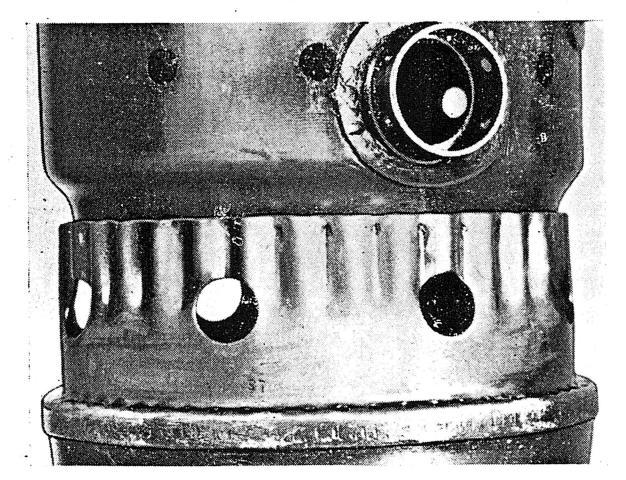
Fig. 27E. Failure of spot welding in flutesnot acceptable

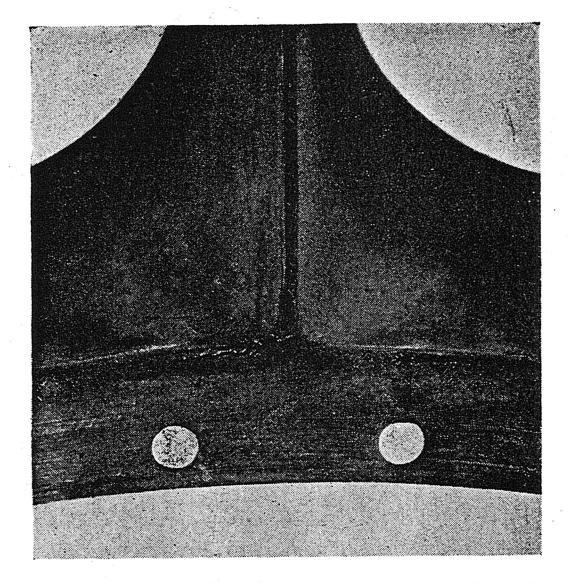
Fig. 32D. Circumferential crack in flange of junction pipe assembly—acceptable standard

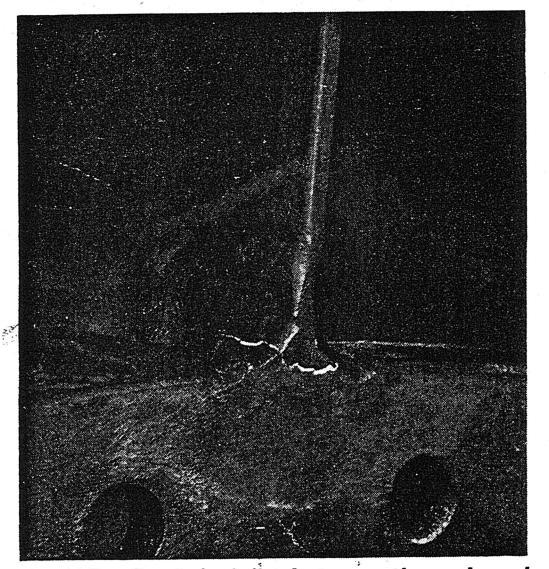
Fig. 32E. Crack in joint between the web and inner flange of junction pipe assembly acceptable standard

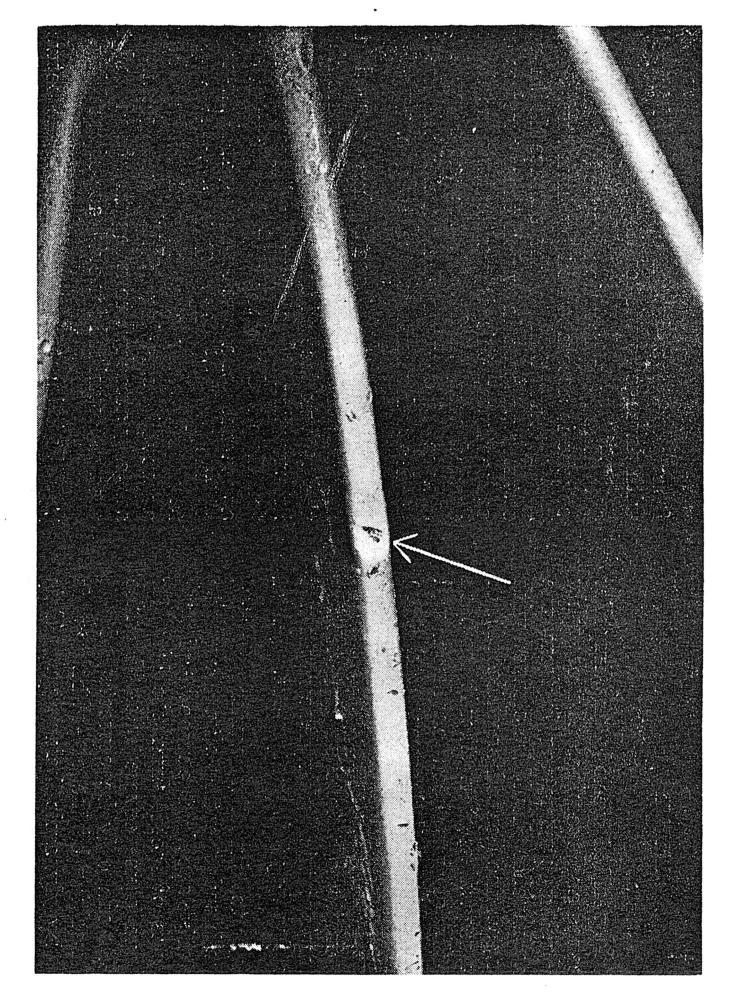
Fig. 34. Little penetration has resulted and there is no interruption on the vane surfaces. The type of damage is in the nature of a bruise and is of an acceptable standard.

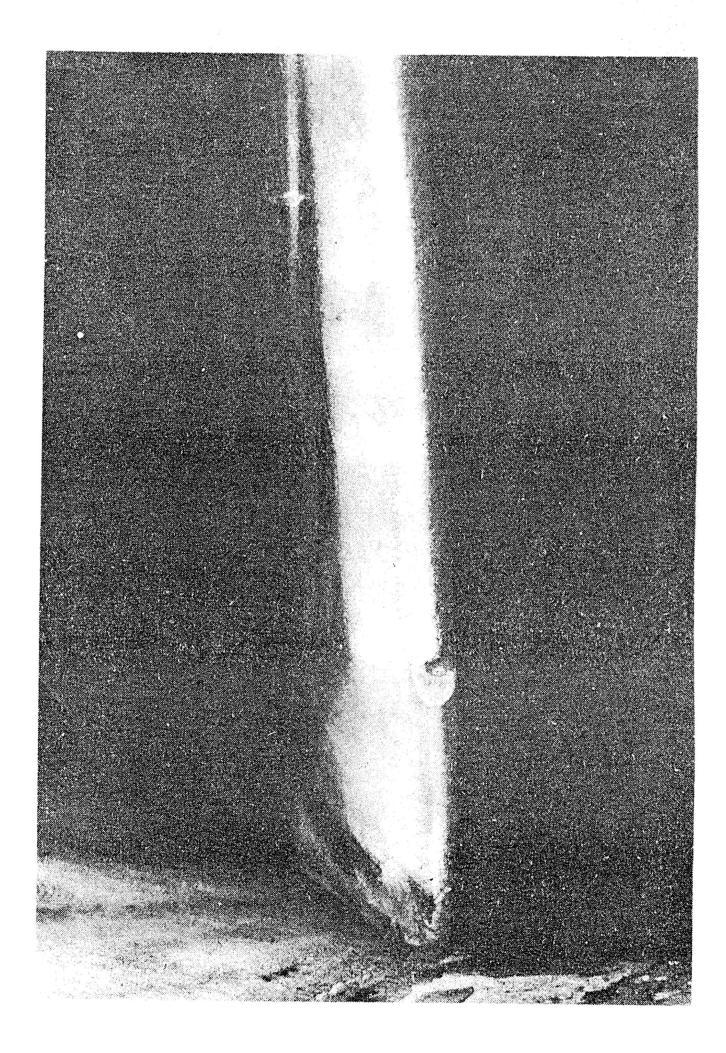
Fig. 36. Damage of an acceptable standard, viewed through port intake

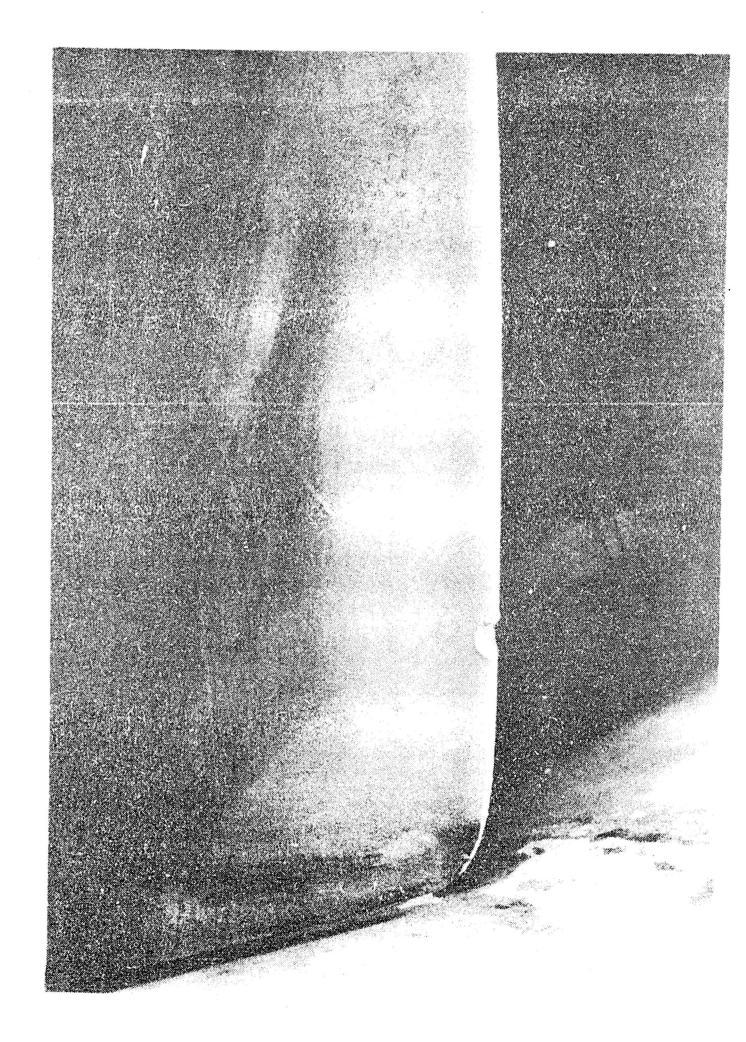
Fig. 37. Damage shown in fig. 36; viewed through starboard intake

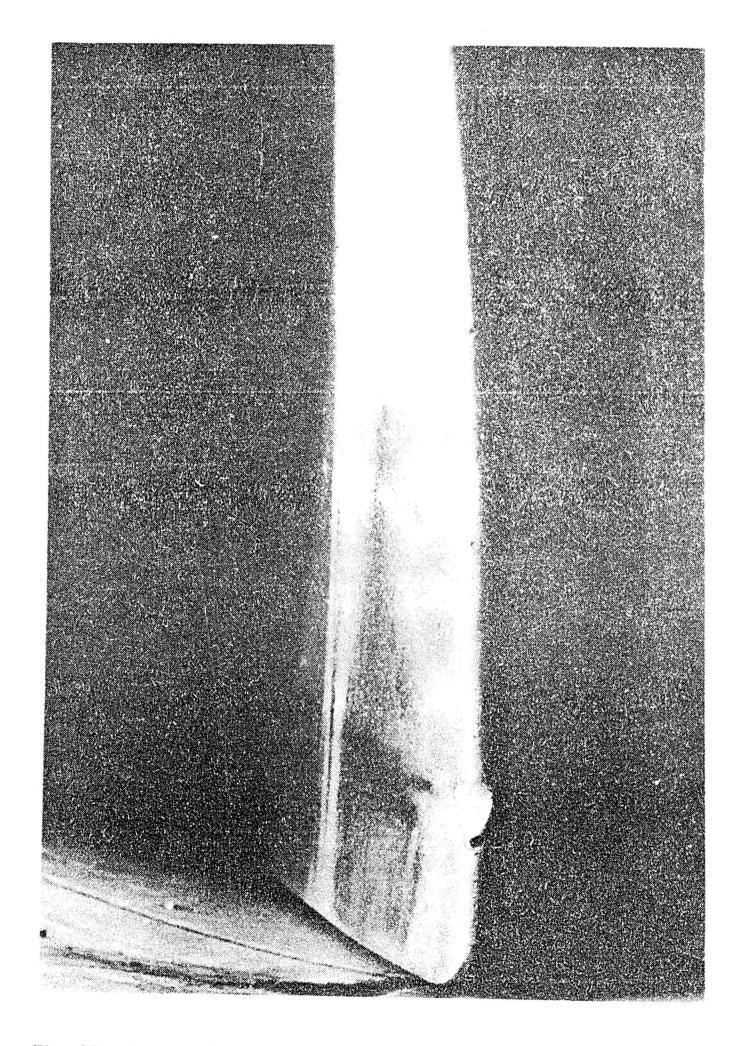
Fig. 38. Impact has resulted in damage of a smoothly flowing contour and represents the maximum extent of damage which is acceptable at any position on the leading edge. View through port intake

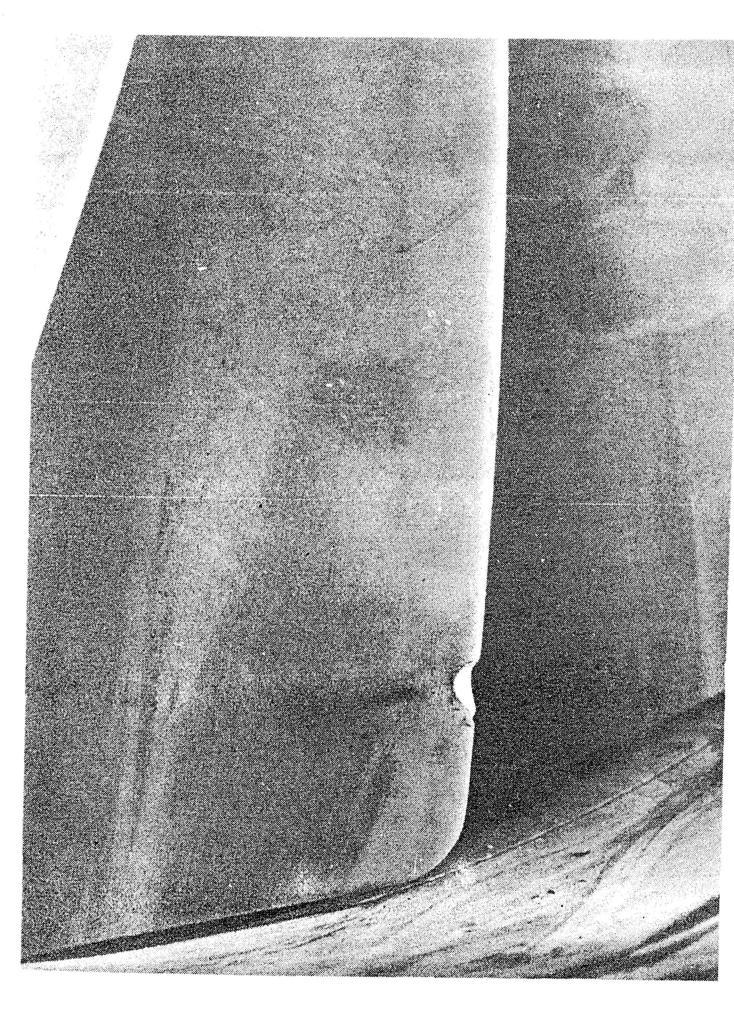
Fig. 39. Damage in fig. 38 as seen through starboard intake, enables the depth of the damage to be established

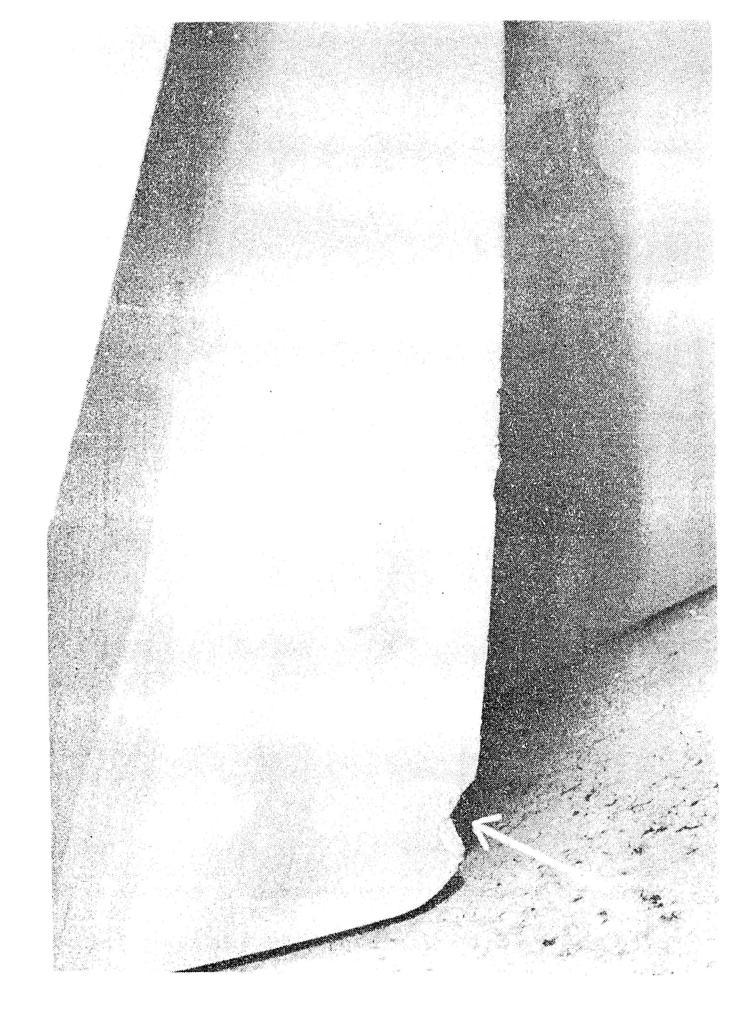
Fig. 41. This example represents the maximum extent of damage which can be accepted within 1.0 in. of the vane tip. Damage of this type is not smooth but must be free from cracks.

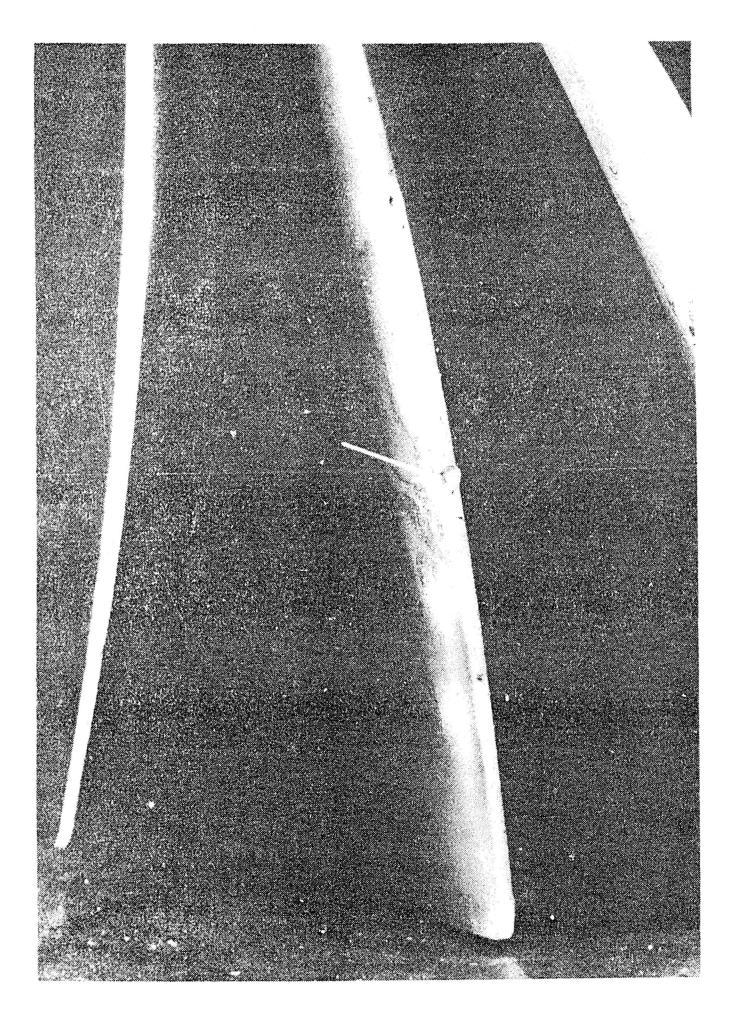
Fig. 45. A further example of damage which has resulted in a notch effect and is not acceptable in any part of the leading edge other than within the last inch at the tip. In this particular case there is little evidence of damage when viewed through the starboard intake.

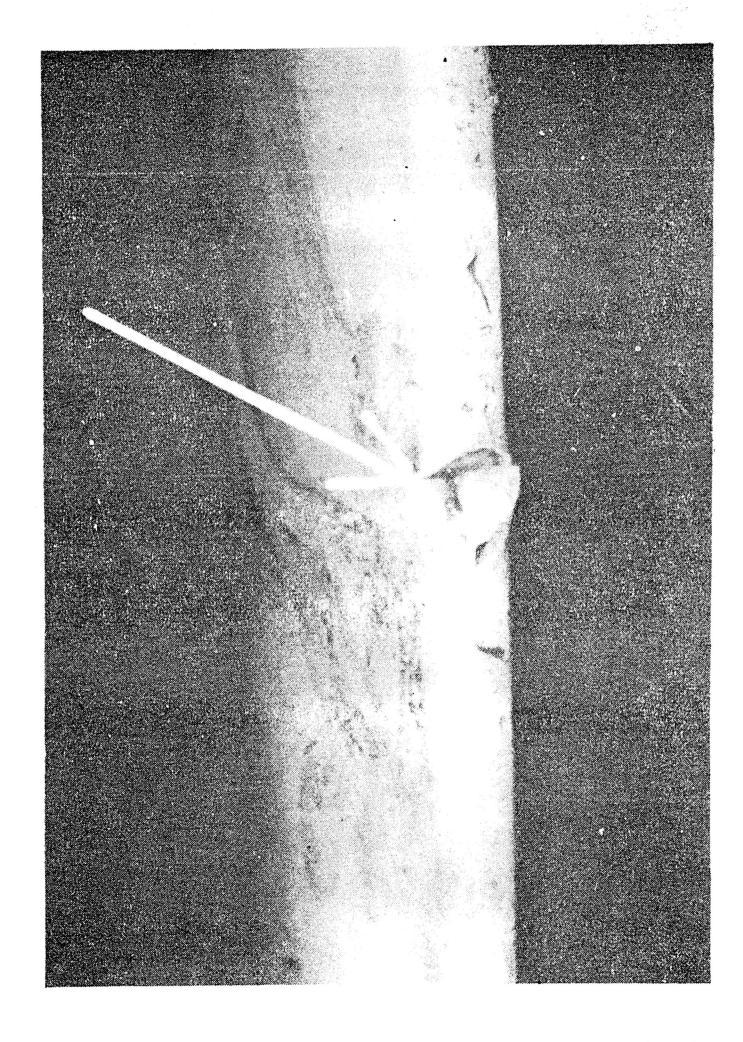
Fig. 46. Enlarged view of damage shown in fig. 45 in which the notch effect is clearly seen. The rapid change in contour caused by impact with a sharp edged object occurs at the point indicated by the arrow. Magnification 5.

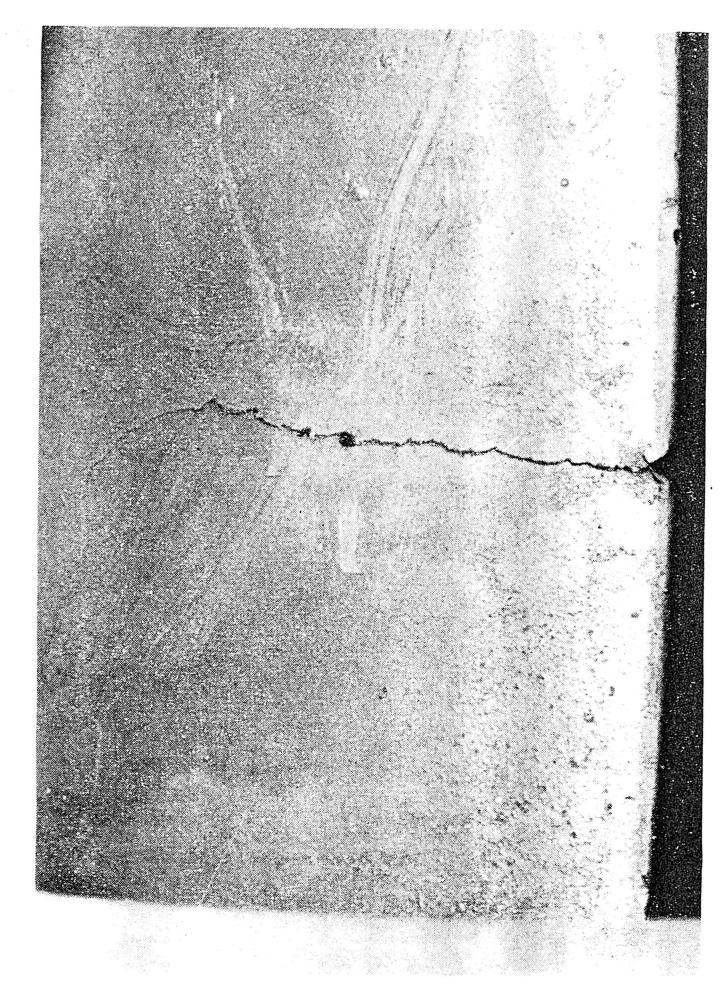
Fig. 47. This is a typical form of notch effect in which the stress concentration has resulted in a crack. Whilst failures of this nature do not normally reach this stage during a single flight it emphasises the need of careful and frequent examination for cracks in the region of all damaged areas.

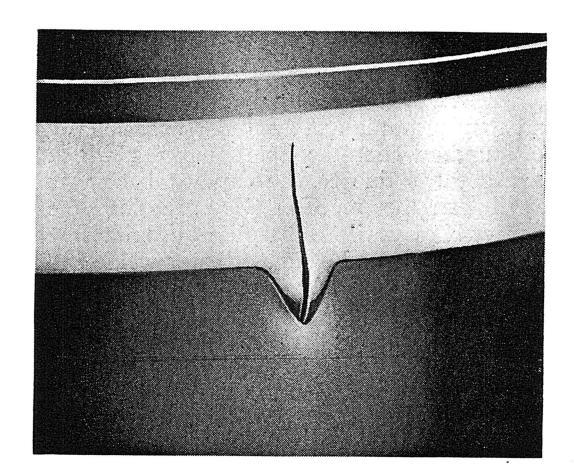
Fig. 52. Dent accompanied by crack in heater muff

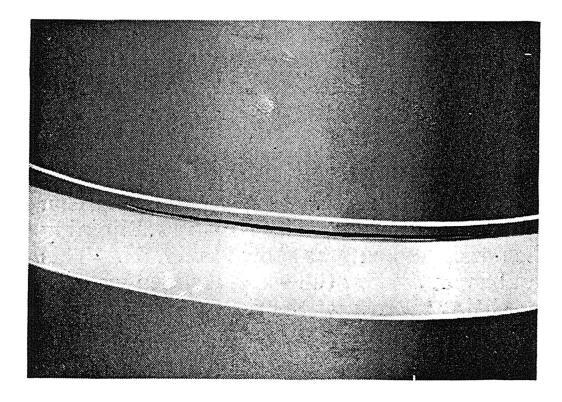
Fig. 53. Repairable split in the stitch weld on heater muff flange

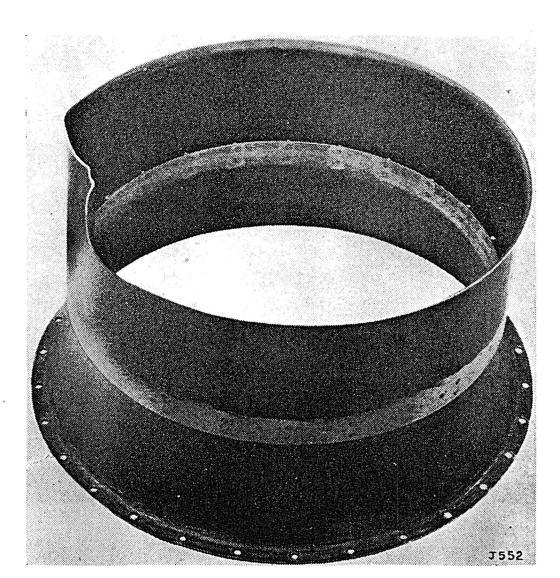
Fig. 54. Venturi cuff and propelling nozzle showing typical damage

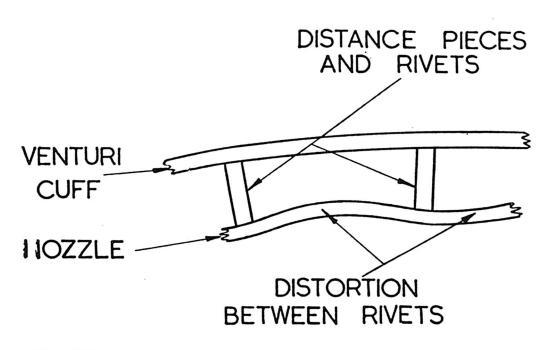
Fig. 55. Distortion between venturi cuff rivets

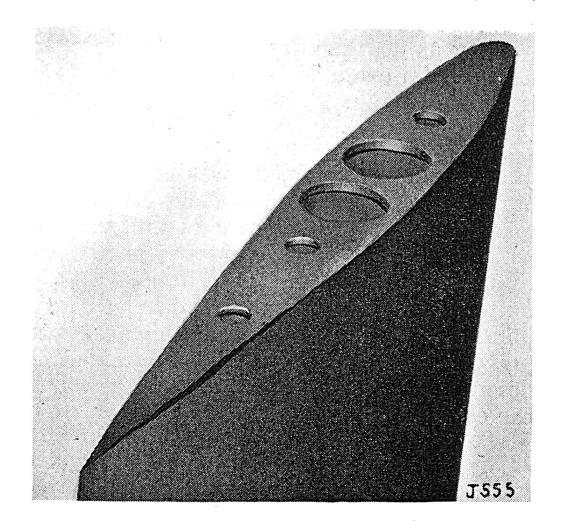
Fig. 65. Repairable damage to fairing where skin is breaking away from outer plate

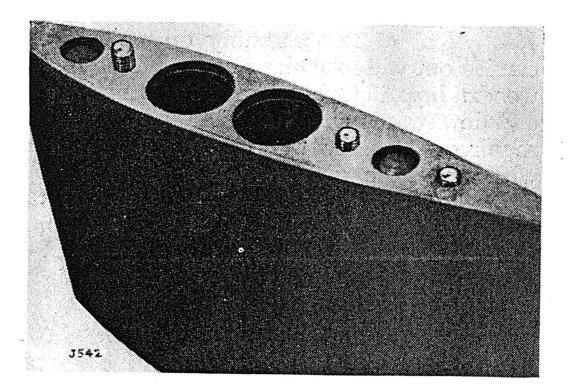
Fig. 66. Broken bolts in fairing

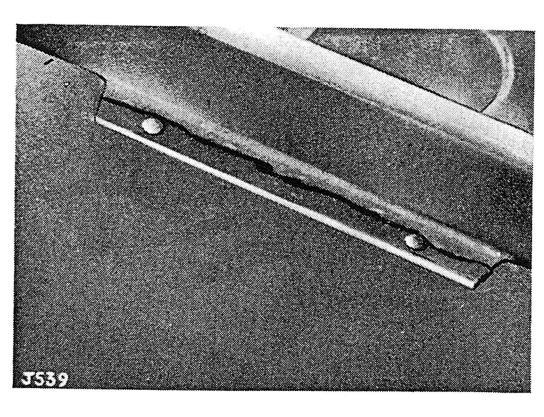
Fig. 62. Non-repairable damage to baffle plate stiffener

125. Baffle plate and stiffeners. Failures on the baffle plate will occur at the stiffeners as shown in fig. 61, and will need a number of small weld repairs. If the fracture occurs right across a stiffener it is no longer service-able and should be replaced. Completely fractured stiffeners are shown in fig. 62. When Mod. No. 444 is embodied in the later

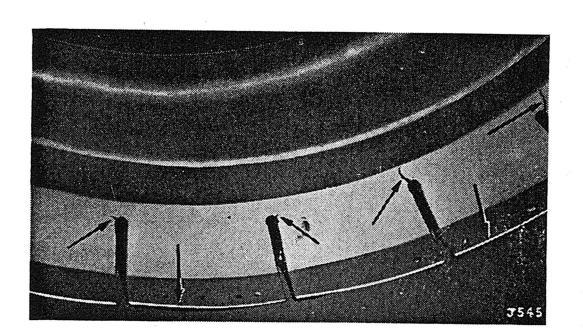
Fig. 60. Typical failures on large diaphragm

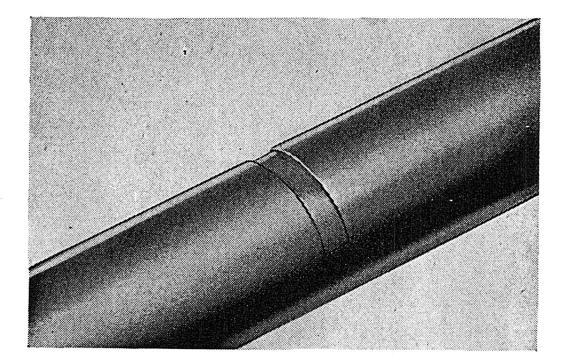
Fig. 63. Support tube indentation and fretting

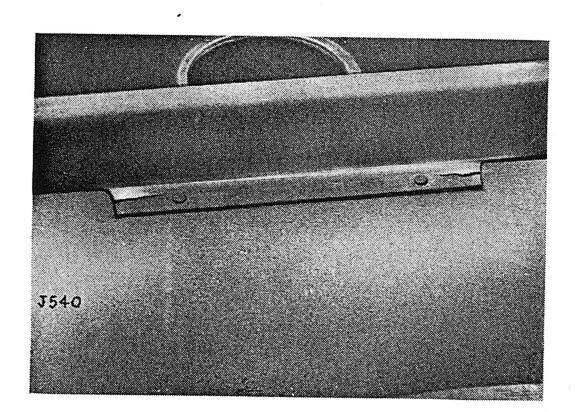
Fig. 61. Repairable damage to baffle plate stiffener

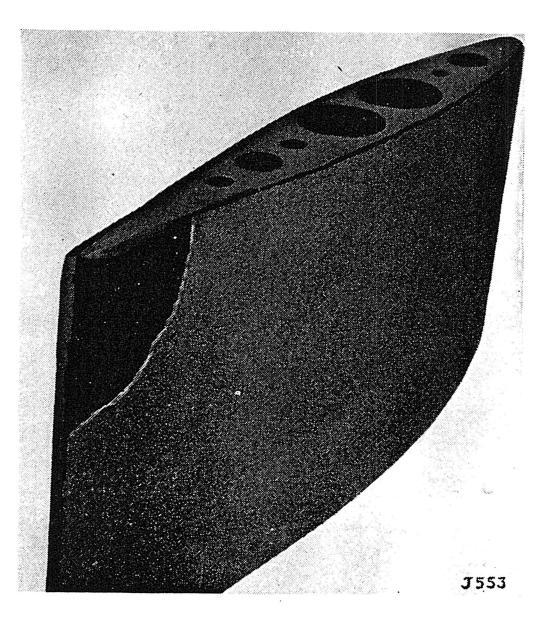
Fig. 64. Fairing rejected for fatigue of the skin and welding failure

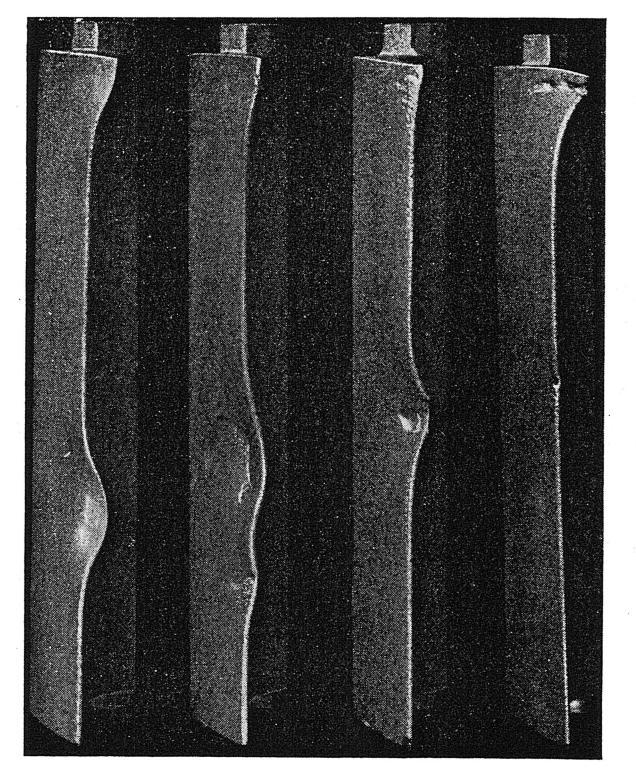
Fig. 72. Maximum extent of acceptable damage to nozzle blades

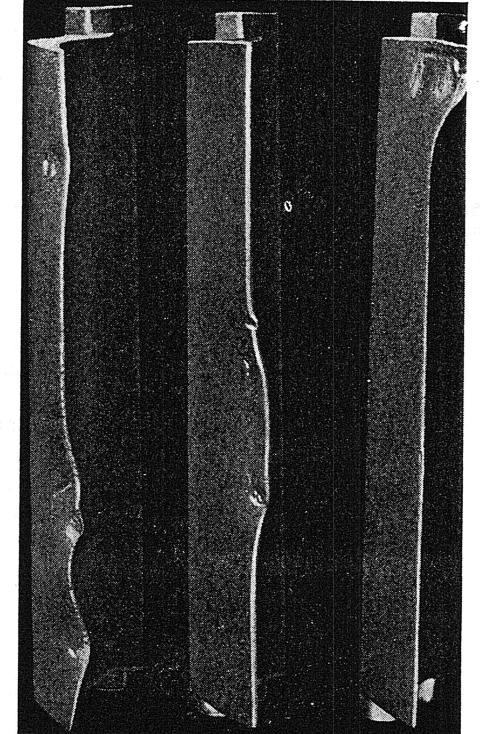
Fig. 73. Damage to nozzle blades—not acceptable

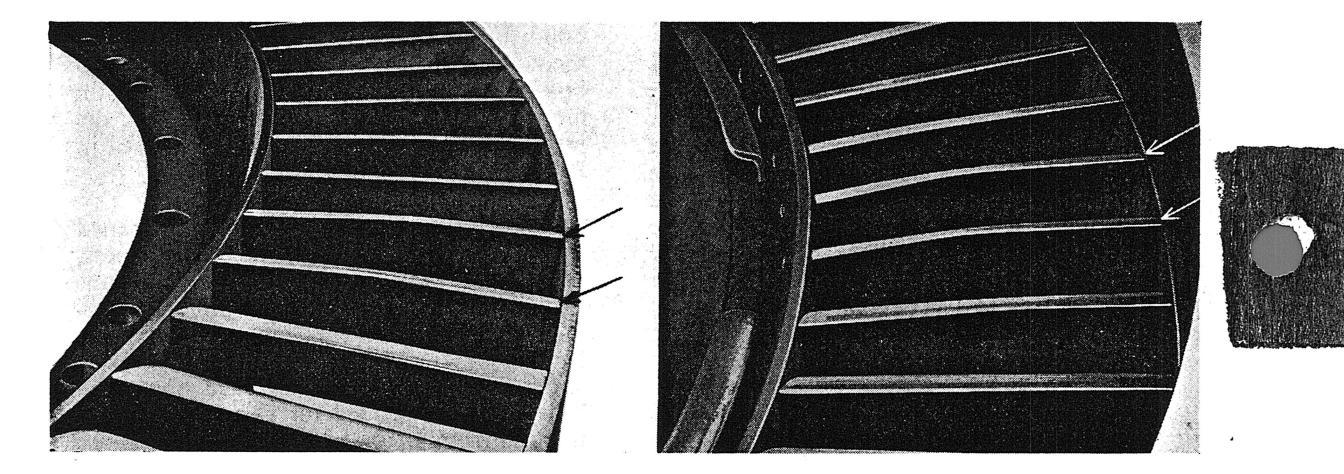
Fig. 73A. Bowed nozzle blades which are acceptable

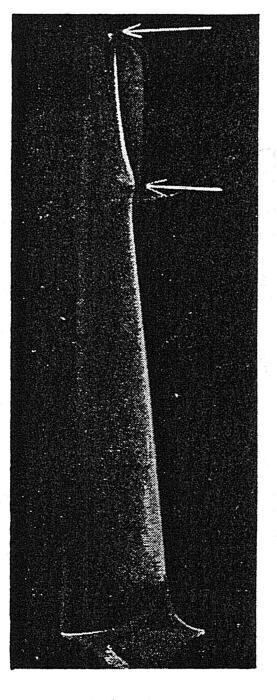
Fig. 78. Acceptable damage to turbine blade

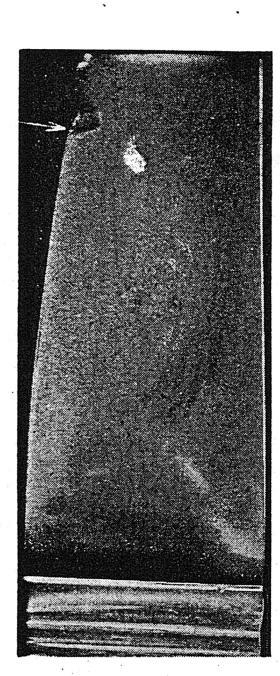
Fig. 79. Acceptable tear at tip of turbine blade

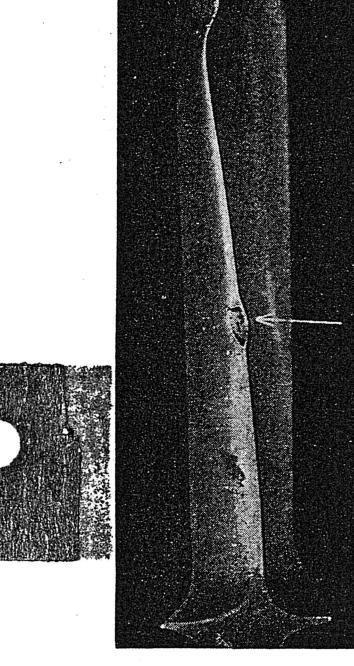
Fig. 84. Acceptable damage to turbine blade

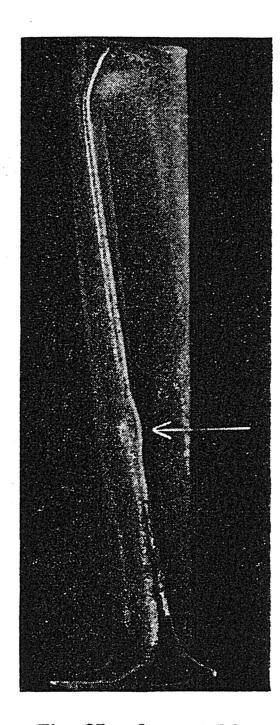
Fig. 85. Acceptable damage to turbine blade

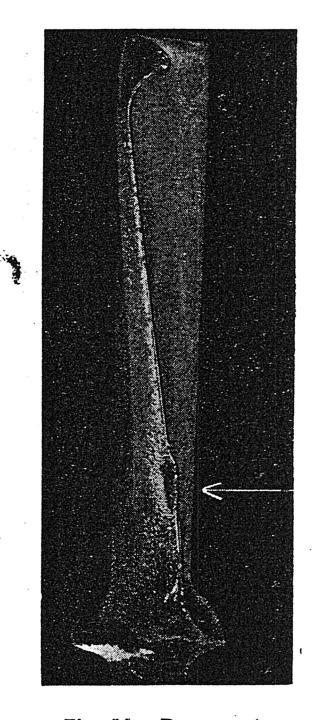
Fig. 86. Damage to turbine blade—not acceptable
