TECHNICAL ORDERS

NENE INSTRUCTIONS

Issued May, 1949

NOZZLE GUIDE VANES - LIMITS OF CRACKING AND DISTORTION

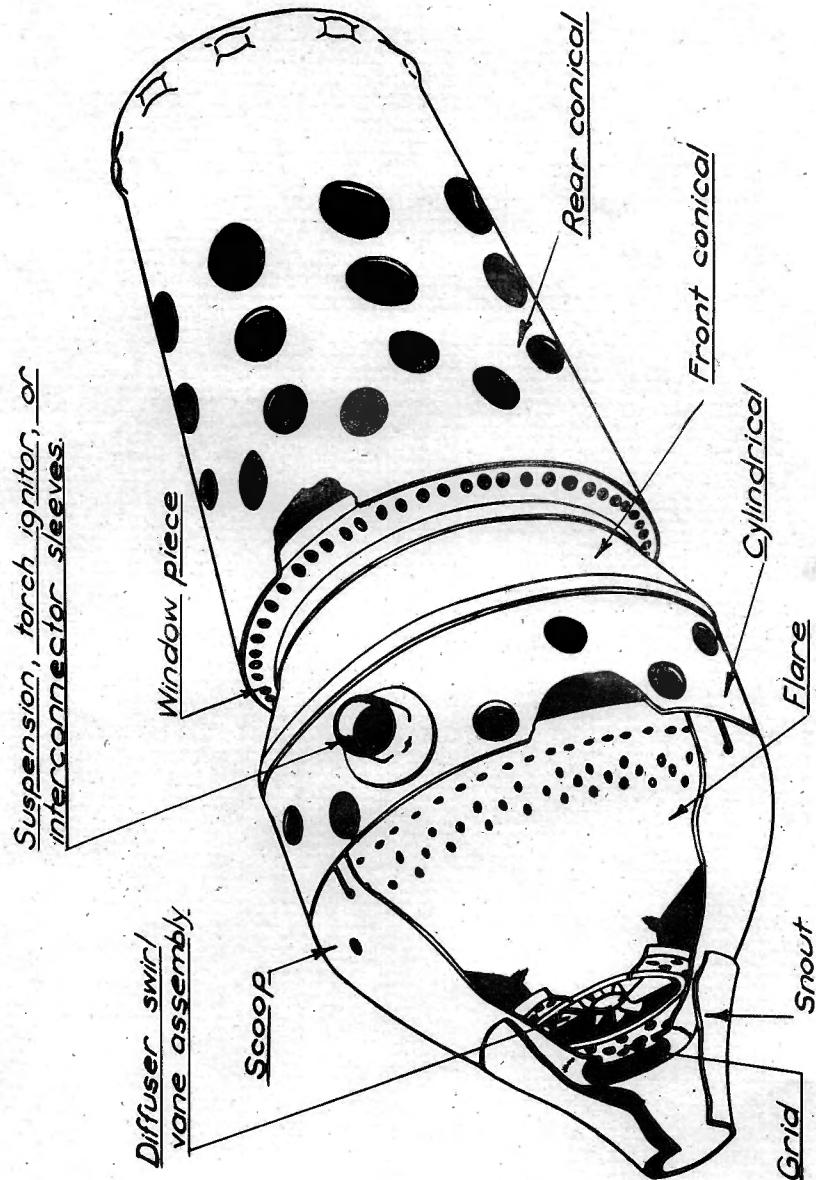
FLAME TUBE - REFERENCE DRAWING

5. Cracking is acceptable in the respective sections of Flame Tubes within the following limits, as illustrated.

7. Radial cracks from the inlet bore are acceptable up to .250 inch in length, provided they are at least 2 inches apart.
8. One crack only is acceptable from or between adjoining key-hole slots in the rim, providing it does not exceed 2 inch in length.

9. Radial or circumferential cracking between air holes is acceptable, provided not more than three (3) holes are inter-connected. More than one such crack is permitted, provided they are at least 3 inches apart.

10. Cracking of the Swirl Vanes or detachment of the vane lugs from the hub or rim is not acceptable. Tubes with this type of defect are to be rejected outright as unsuitable for repair. The most effective means of inspecting these Vanes is to use a light gauge rod or stick as a lever between vanes.

11. Cracking or detachment of the spot welds in the outer rim securing the Vane Assembly to the Flare is permitted, provided not more than three (3) welded areas between Vanes are cracked or detached, and that these be separated by at least alternate sound welded areas of the rim.

13. A combination of radial and circumferential cracking from the same hole, or separate radial or circumferential cracks less than 3 inches apart are not permitted under any circumstances.

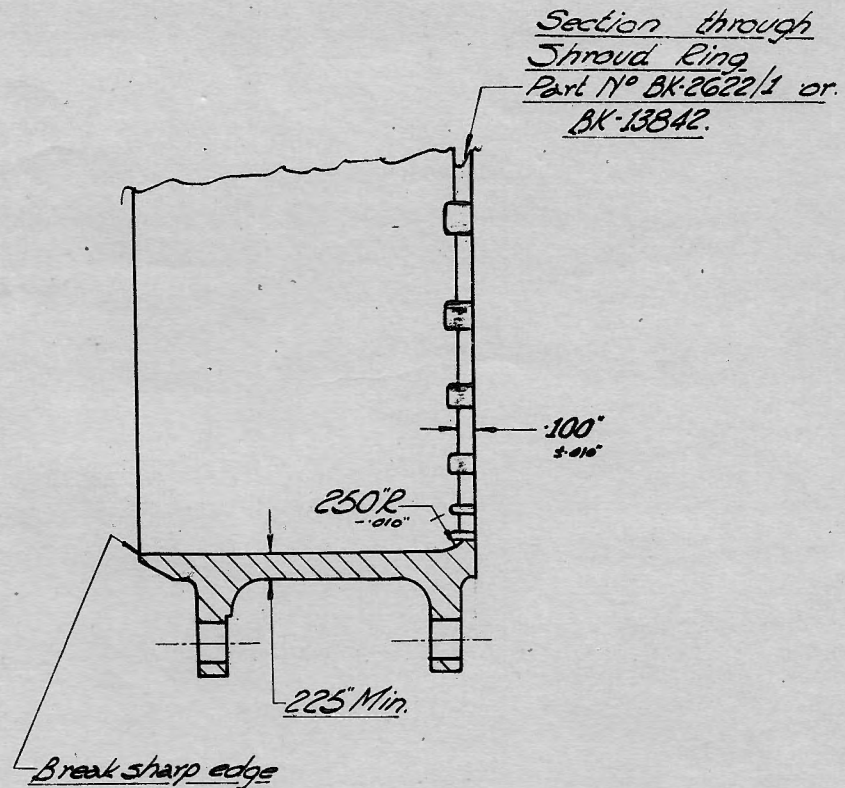
REFERENCE		ISSUED BY			TITLE	
		<i>DIRECTORATE OF TECHNICAL SERVICES R.A.A.F.</i>			<i>SHROUD RING - LIMITS OF RE-WORK</i>	
LIMITS UNLESS STATED		MATERIAL			COMPONENT OF	
DECIMALS	± .010"	SPEC.			MACHINE	
FRACTIONS	± 1/32"	TREATMENT			ENGINE	<i>None</i>
ANGLES	± 1°	FINISH			TECH. ORDER	<i>None INST. N° 4.</i>
SURFACE FINISH		SCALE			DRAWING NO.	<i>B11179</i>
AUSTRALIAN STANDARD		DRAWN	<i>STIRLIN</i>	APPROVED		DRWG. A SIZE
ENC. DRWG. PRACTICE A.S. 621		TRACED		CHECKED

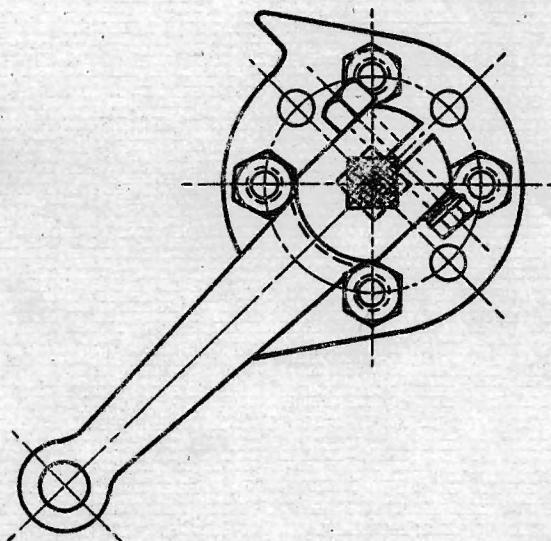
FIG. I.

DESIRED ASSEMBLY
OF LEVER TO SHAFT
