# AEROPLANES

Vampire F.B. Mk. 9 Aircraft—Two Anchor Nuts on Rib No. 1, Port Wing, replaced by Two Anchor Cap Nuts, Part No. A.G.S.2023/B1, to Support Cables on Engine Side of Bulkhead—Introduction

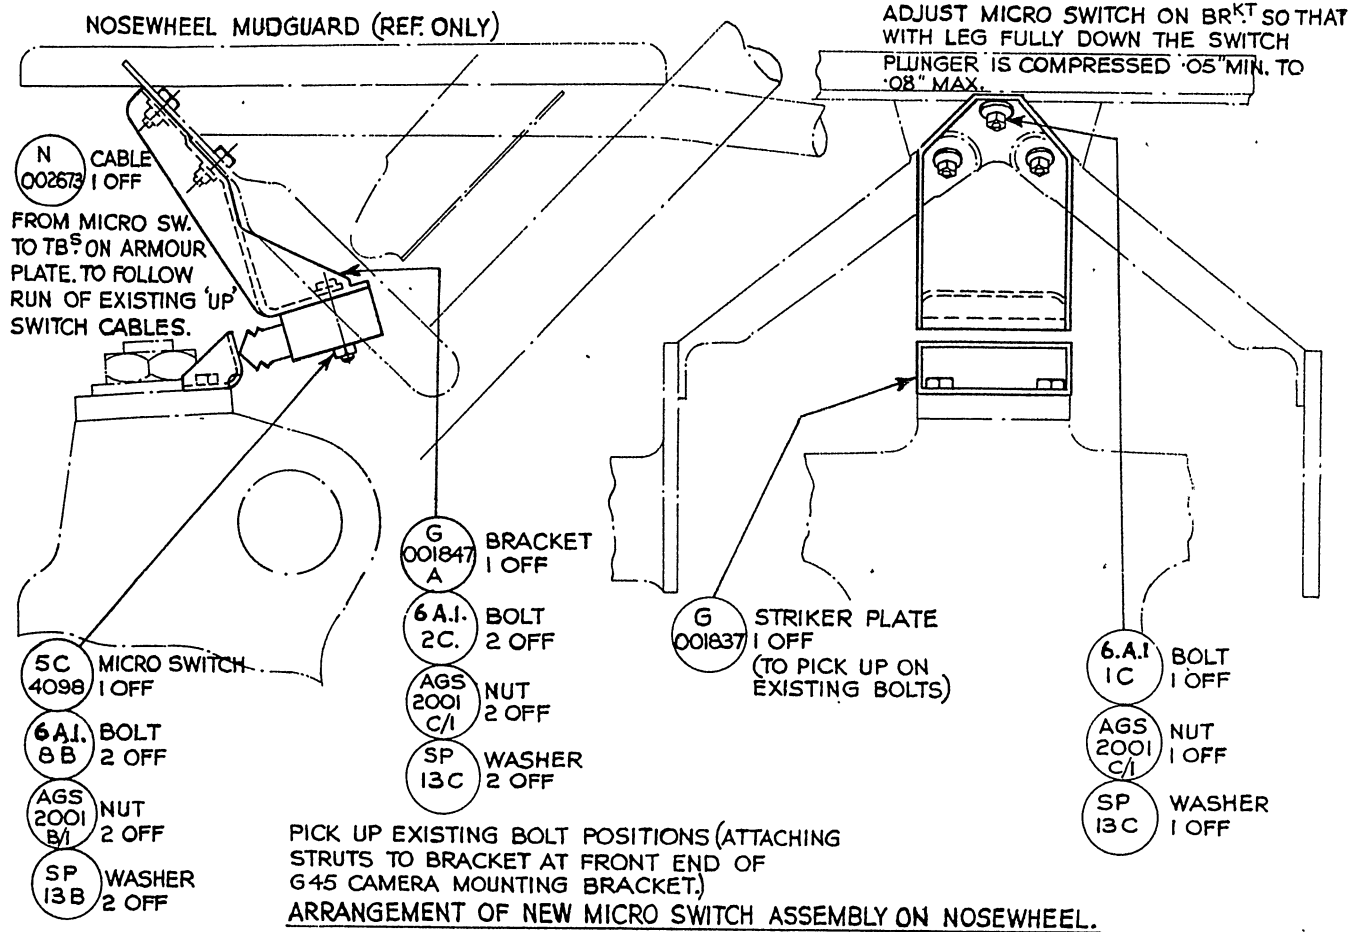
DRG. NO. A.P. 4099 G/B. 11 / 53

1. This modification introduces an additional down lock micro-switch at each undercarriage leg (port and starboard main legs and nose wheel) and revises the wiring. This is necessary owing to reports that micro-switches have sometimes failed to operate correctly in the existing circuit, so that a green, in place of red indication light, may show before the undercarriage is fully locked down. Concurrent embodiment of Mod. No. Vampire/809 and 810 is advisable.

(2) Refer to Sheet 2 of the drawing, and unlock and remove the two  $\frac{1}{4}$  in. B.S.F. bolts indicated. Position the new striker plate, Part No. GOO 1837, replace the bolts and lock with 22 s.w.d. soft iron locking wire.

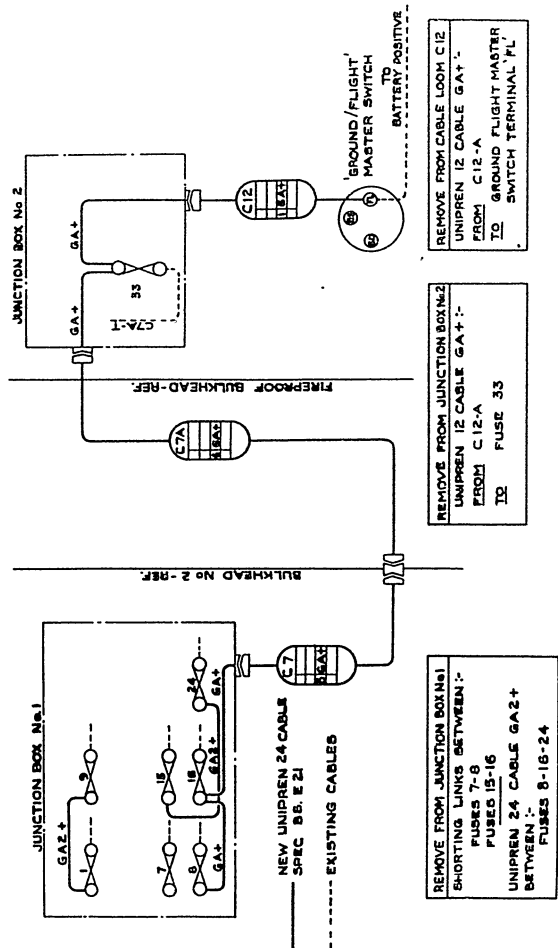
SHEET 1.

WIRING DIAGRAM AND CABLE ALTERATIONS.

- (3) Refer to Sheet 1 of the drawing. Working on the removed junction box No. 1, remove the two fuse block end links (Ref. No. 5CZ/884) linking fuses 7-8 and 15-16 respectively, and the Unipren 24 cable, coded 'GA2+', linking fuses 8-16-24. Refer to fig. 3 on Sheet 2 of the drawing; make up a new link cable as detailed, using a 2 ft. 6 in. length of Unipren 24 cable (Ref. No. 5E/3042). Strip the cable insulation as shown, ensuring that no break occurs in the cable conductor to fuse 16, then cover each section of the unstripped insulation with 5 mm. P.V.C. tubing, Part No. DHS.181/5, which is to fit tightly against the insulated moulding of the plug in one instance and the fuse block terminals in the other. Code the cable ends 'GA+' at each point of termination, using nine 6 mm. marking sleeves, Part No. T3A, which are to be fitted over the P.V.C. tubing. Connect the link cable to its appropriate fuse block terminals 8 and 16 and to pin 6 of plug 'C7', soldering it to the plug pin with electricians' resin-cored solder (Ref. No. 30B/1601). Connect to junction box No. 1 two new link cables, which do not require added insulation, as detailed in the following table:

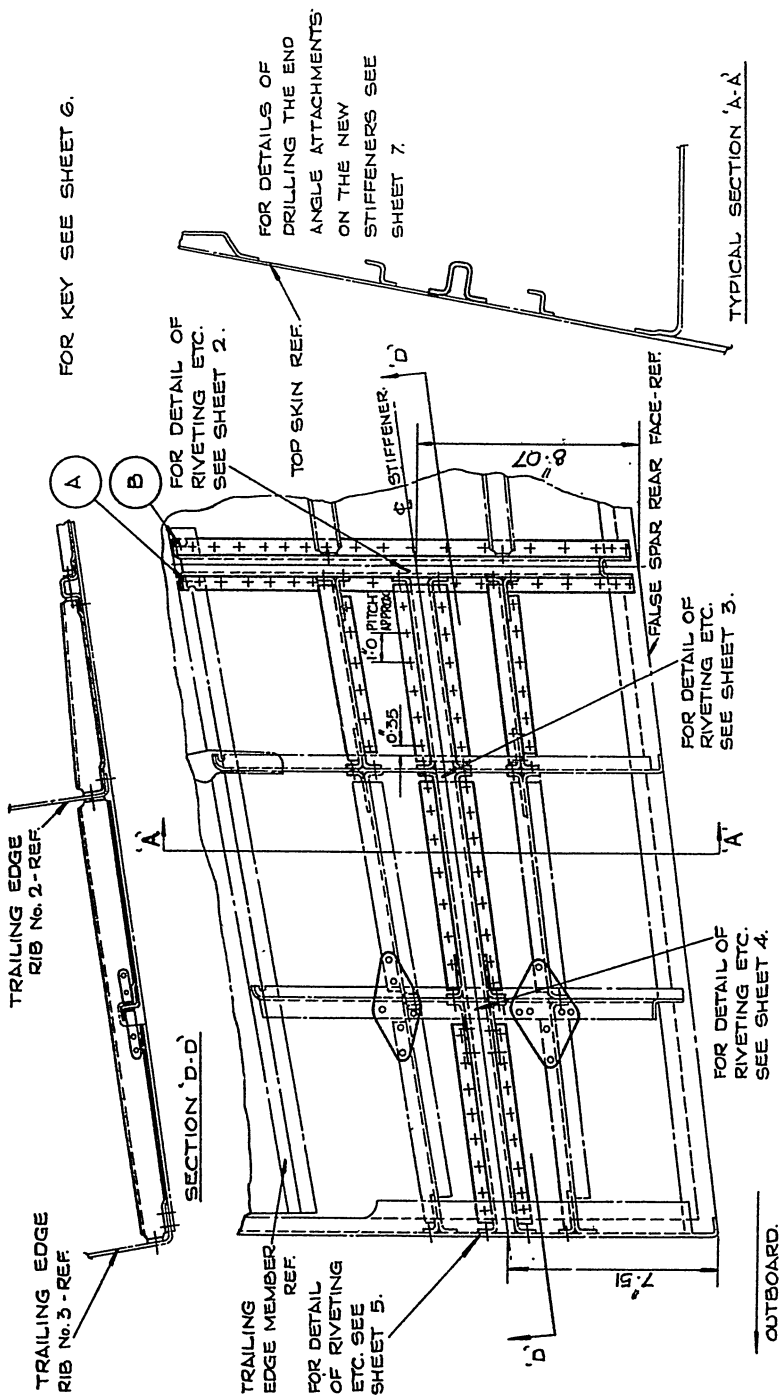
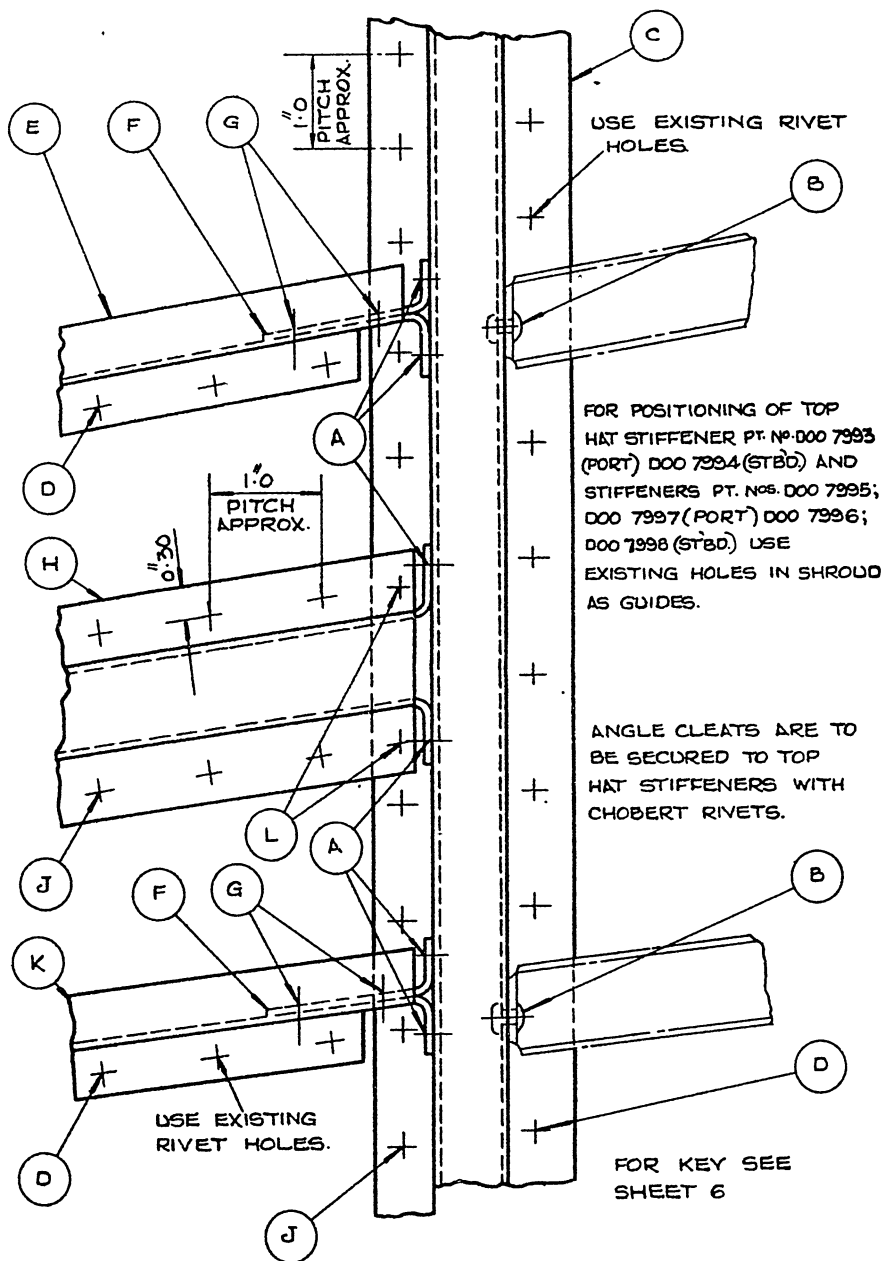
OUTER FLAP SHROUD.

Rivets have become loose on the outer flap shroud and dive brake shroud stiffener-rib attachments and several cracks have occurred in these shroud skins. To obviate this defect this modification introduces reinforcing to strengthen these areas.

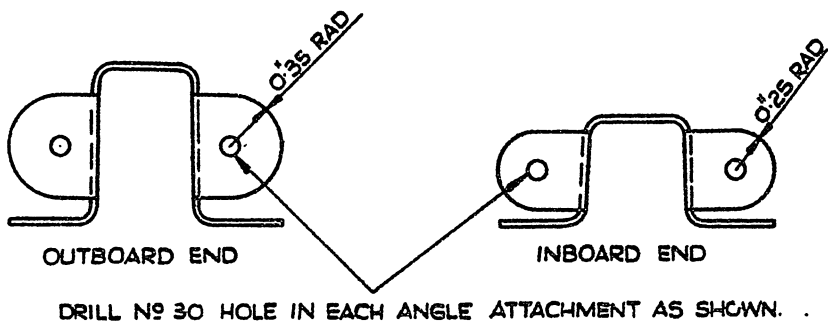
**FIG.2 TYPICAL VIEW OF THE ENDS OF TOP HAT STIFFENERS PART**  
**NOS DOO 7989 AND DOO 7990**

POSITIONS OF RIVET ATTACHMENT HOLES IN THE ANGLE  
ATTACHMENTS ON THE ENDS OF THE NEW STIFFENERS  
ON THE OUTER FLAP SHROUDS.

(7) Mark a centre line for the new top hat stiffener, Part No. DOO.7989 (port), DOO.7990 (starboard) the whole length of the outer flap bay, measuring on its underside 8-07 in. to the rear of the false spar and along the centre line of the new top hat stiffener which was fitted in operation (3) and 7-51 in. to the rear of the false spar along the outboard edge of rib 3, as shown on sheet 1 of the drawing. *Refer* to fig. 2 on sheet 7 of the drawing and drill the angle attachments at each end of the stiffener using the No. 30 drill, as shown. Referring to sheets 2 and 3 of the drawing, mark out and centre punch the rivet pitches on the new top hat stiffener as detailed. Offer up the stiffener to the centre line just marked on the undersurface of the flap shroud, adjacent to the new top hat stiffener fitted in operation (3) and using the No. 35 drill, drill through the stiffener and flap shroud. Dimple countersink these holes on the top surface of the flap shroud 90 deg.  $\times$  0-22 in. dia. and the holes in the stiffener to suit the dimpling in the shroud. Coat the mating surfaces of the stiffener and shroud with pigmented varnish jointing compound and using approximately fourteen  $\frac{1}{2}$  in. dia. 90 deg. countersunk-head rivets, Part Nos. AS.2229/404 (ten off) and AS.2229/405 (four off) using the longer rivets at the ribs and the shorter rivets between the ribs, rivet the stiffener to the flap shroud.

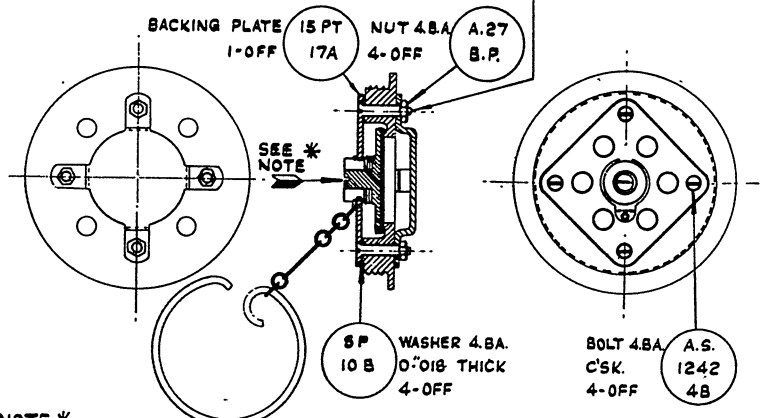
**FIG.2.**

ENSURE THAT AT  $\frac{1}{3}$  P.S.I. OF PARAFFIN APPLIED IN DIRECTION OF ARROW,  
THE LEAK RATE IS NOT MORE THAN 10 DROPS PER MIN.

(5) Refer to Fig. 2 of the drawing, attach the retained swivel plate, with the chain and locking ring complete, to the new backing plate, Part No. 15PT.17A, and assemble to it the remaining fuel tank cap components retained in operation (3), placing the four new 0.018 in. thick washers, Part No. SP.10/B, between the filler cap body and the backing plate. Secure the assembly with the four new 4 B.A. nuts and countersunk bolts, Part Nos. A.27/BP and AS.1242/4B, respectively. The fuel tank cap complete now becomes Part No. 15PT.19A, and is to be numbered as such.

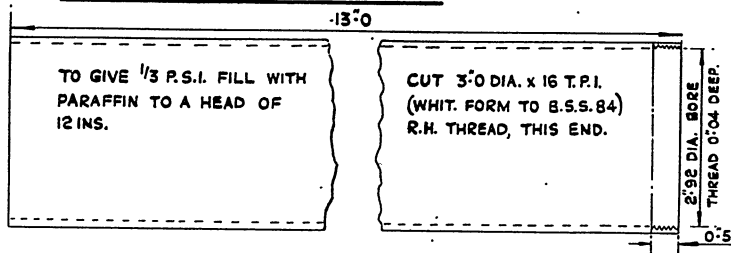
**FIG.3.**

**TUBE FOR PRESSURE TESTING FUEL TANK FILLER CAP ASSEMBLY.**

(1) Refer to Fig. 3 of the drawing and make up a fuel filler cap valve leak testing tube from 2.92 in. dia. bore round tubing as illustrated. Cut an internal thread at one end to suit the filler cap body. To give a testing pressure of  $\frac{1}{2}$  p.s.f., this tube must be long enough to provide a 12 in. head of fuel.

Refer to Fig. 2 and 3 of the drawing, and using a filler cap jointing washer as a seal, screw the fuel tank filler cap into the threaded end of the testing
