Introduction and make-up of A.P.4099G, Vol. 2, Part 1

GENERAL INTRODUCTION

1. Air Publication No. 4099G has been allotted to the Vampire F.B. Mk. 9 aircraft. The Vol. 2, Part 1, of the A.P. will contain General Orders and Modification leaflets, and will conform to the "Revised (1948) System for Recording Leaflets".

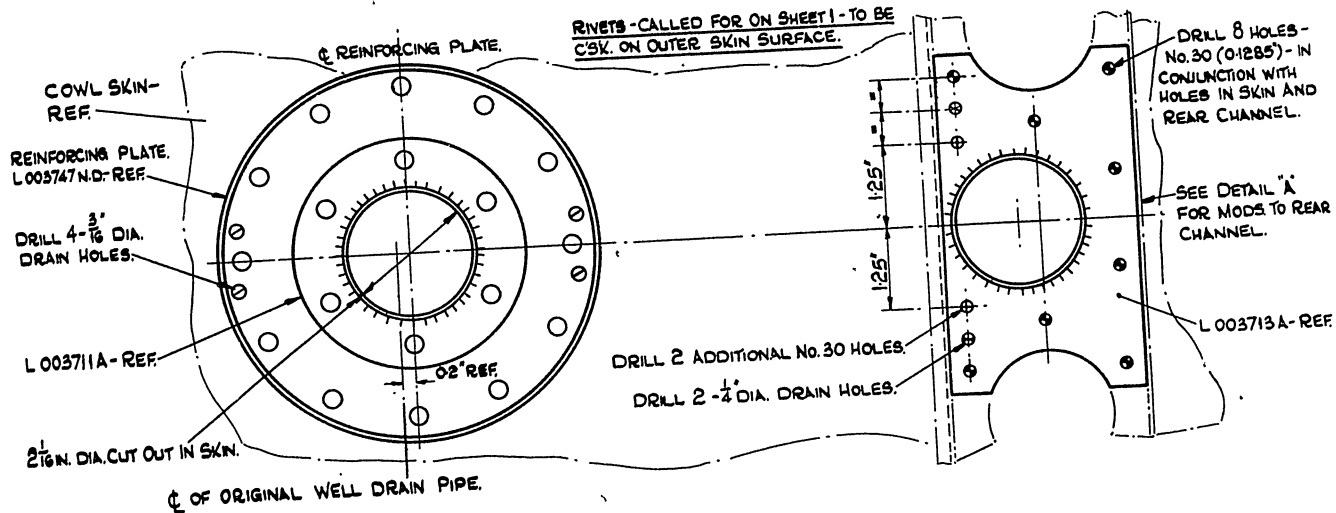
SECTIONAL VIEW - ON CENTRE LINE OF LOWER MIDDLE ENGINE COWL PANEL - SHOWING GENERAL ARRANGEMENT OF THE NEW DRAINS.

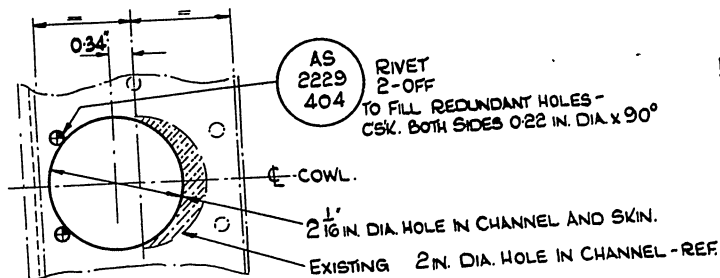
DETAIL "A" - SHOWING MODIFICATIONS TO LOWER MIDDLE COWL REAR CHANNEL.

NOTE:- THE POINT "X" IS THE CENTRE OF THE 5.7 IN. DIA. CIRCLE REFERRED TO IN OPERATION 5 OF THE TEXT.

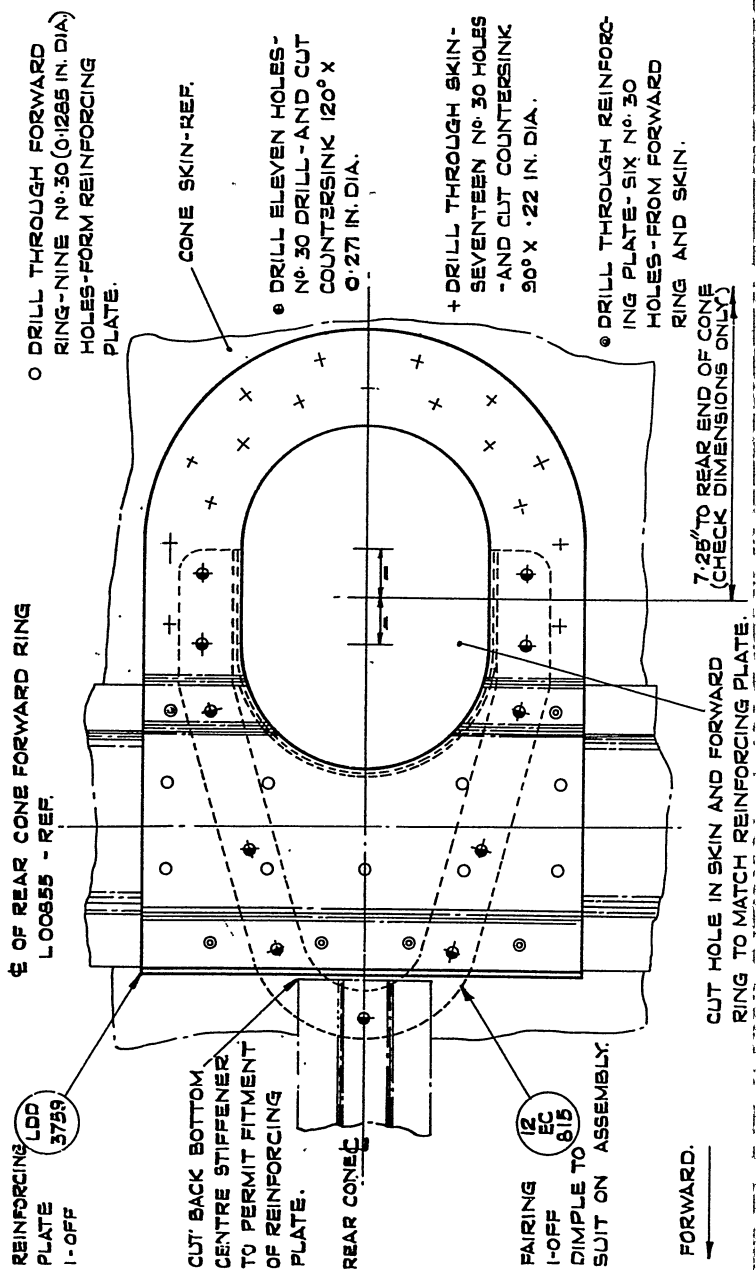
DRG. No A.P.4099 G/P.6 /53  
 SHEET I

PLAN VIEW ON INSIDE OF REAR CONE SHOWING DRILLING DETAILS FOR ATTACHMENT OF REINFORCING PLATE AND FAIRING.  
 -SEE SHEET 2 FOR RIVETING INSTRUCTIONS.-

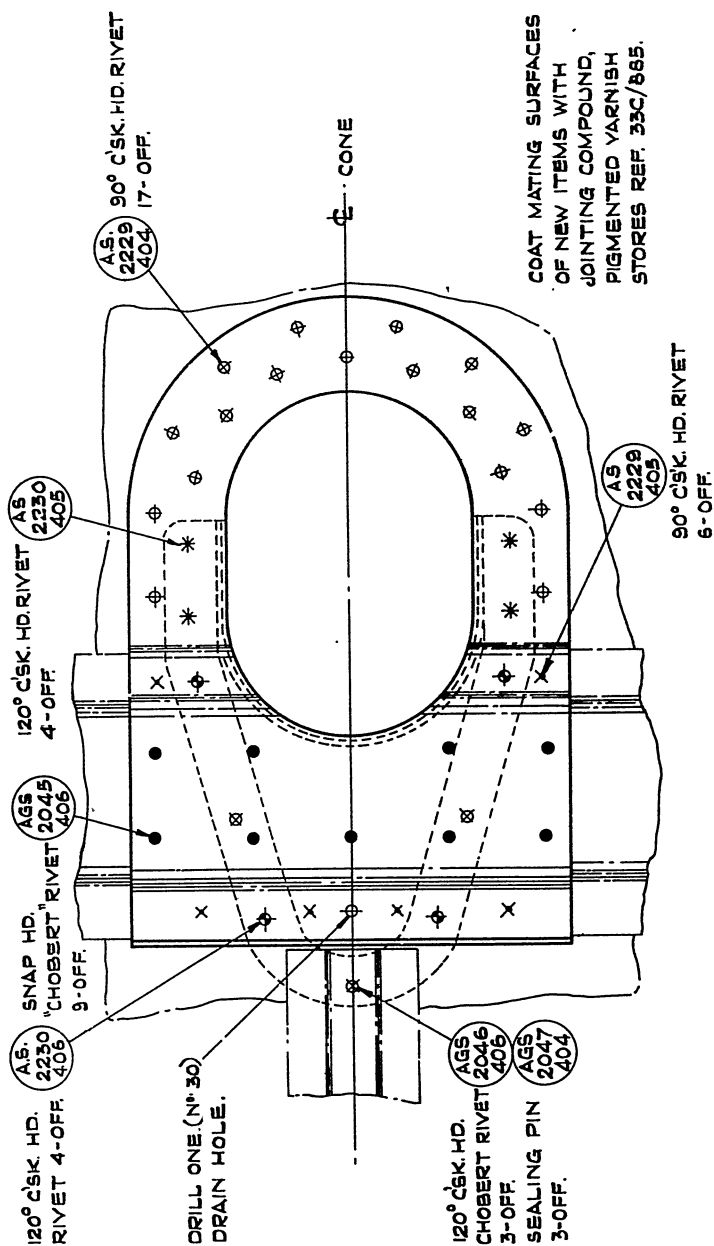
DRG. N° A.P.4099 G / P. 6 / 53  
SHEET 2

RIVETING DETAILS.  
SEE SHEET 1 FOR DRILLING INFORMATION.

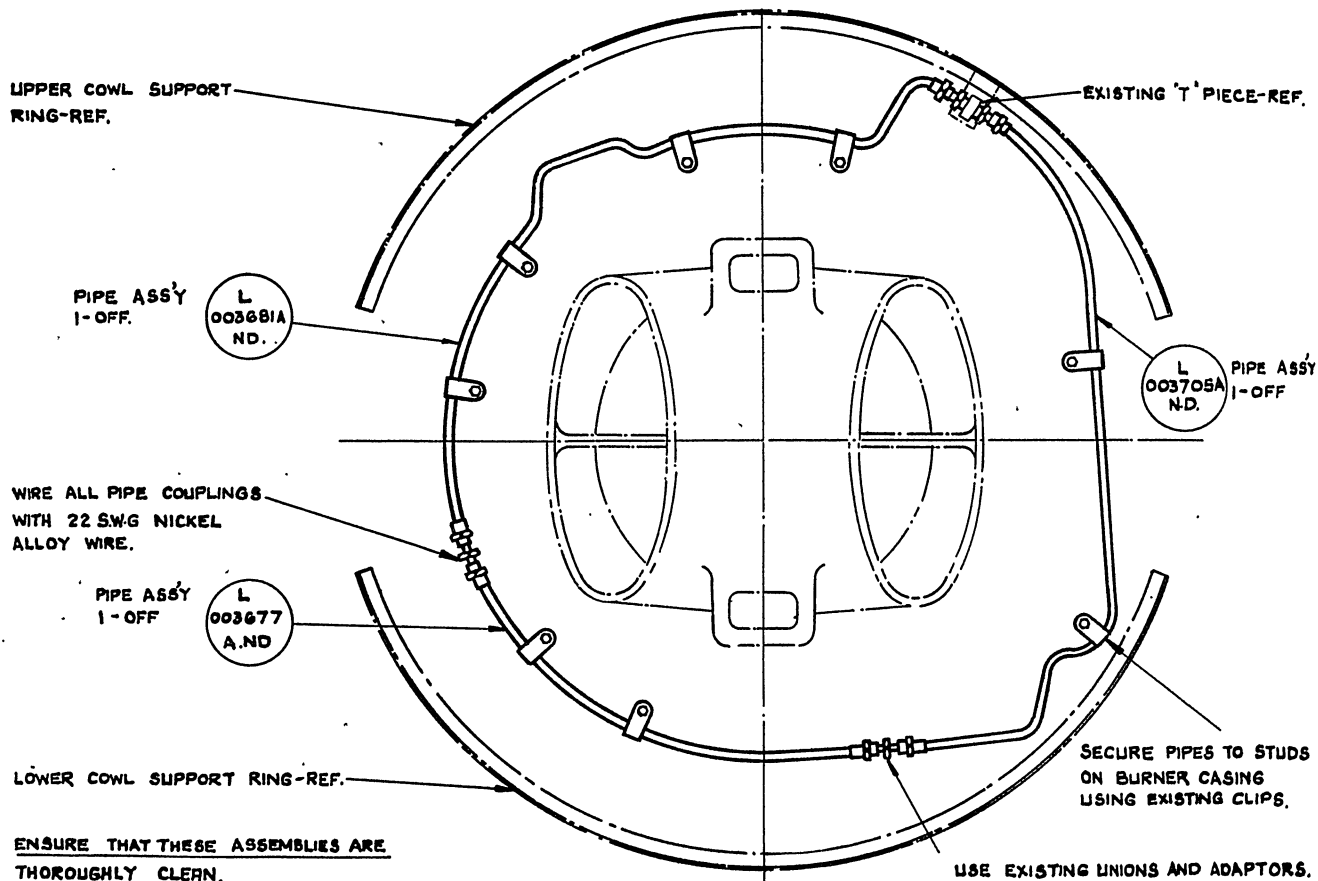
GENERAL ARRANGEMENT OF FIRE EXTINGUISHER SPRAY RING.

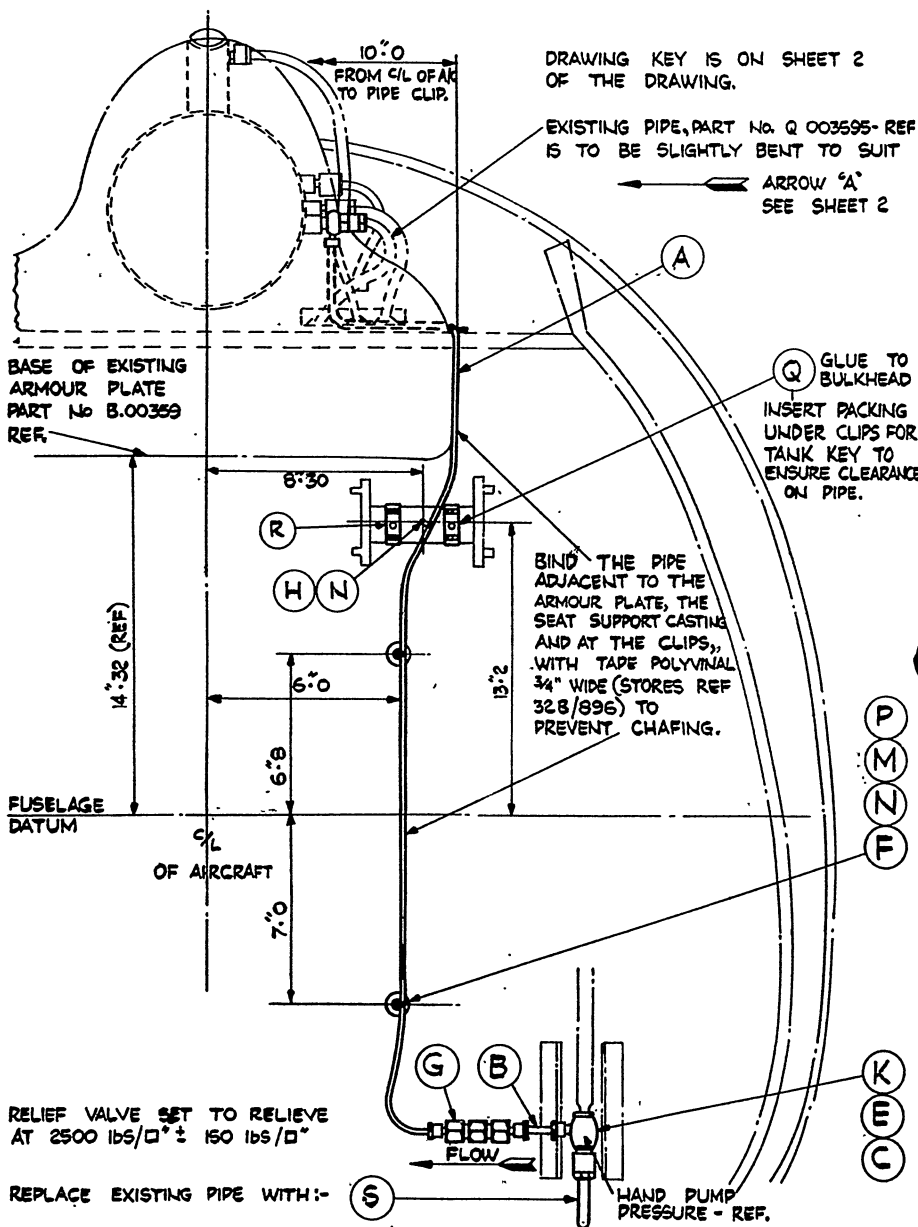
DRG. No. A.P. 4099 G / P. 11 / 56

INSTALLATION OF RELIEF VALVE AND RETURN PIPE LINE FROM HAND PUMP ON FORWARD FACE OF BULKHEAD No. 2.

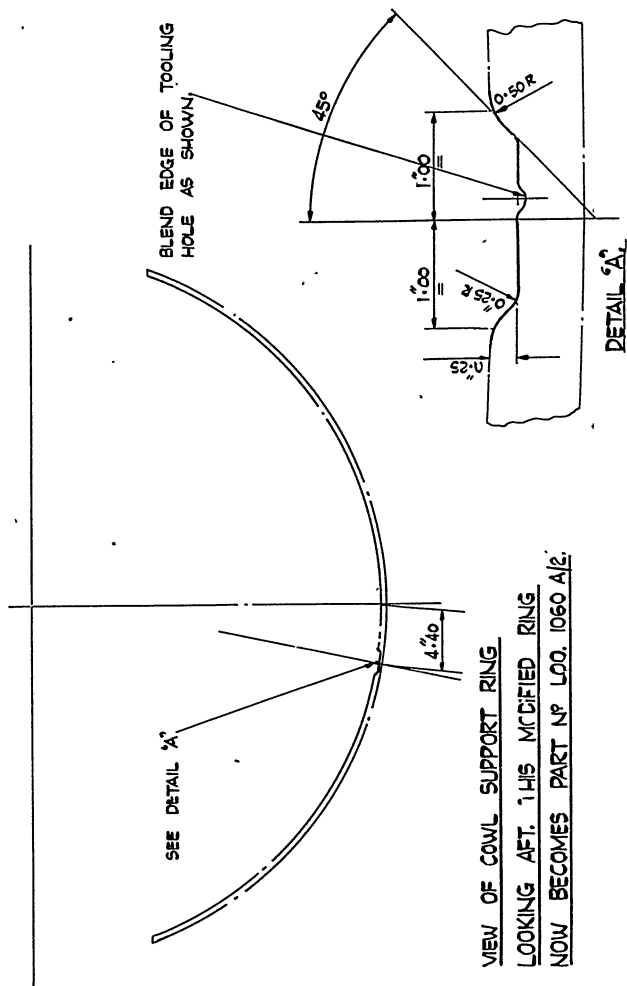
VIEW OF COWL SUPPORT RING  
 LOOKING AFT. THIS MODIFIED RING  
 NOW BECOMES PART N° LOO. 1060 A/2.

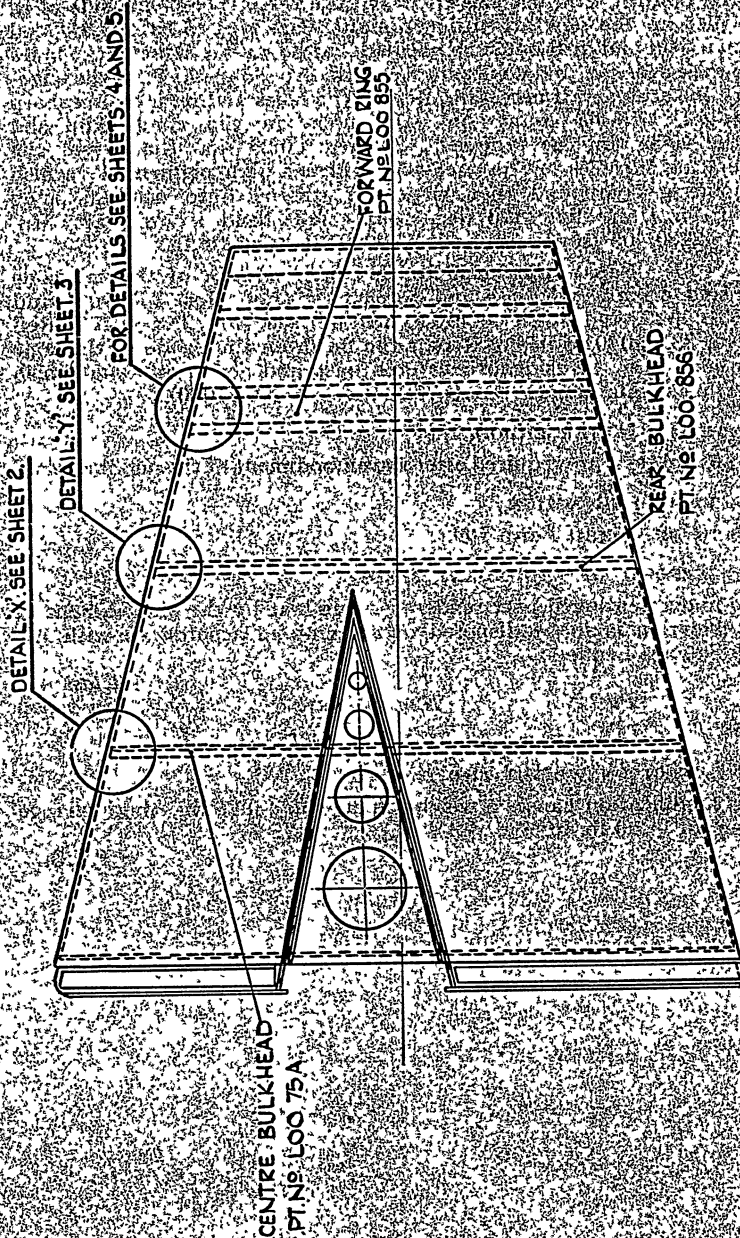
Drg. No. A.P.4099G/P.16/57  
Sheet 1

VIEW OF REAR CONE SHOWING THE THREE POINTS TO BE MODIFIED

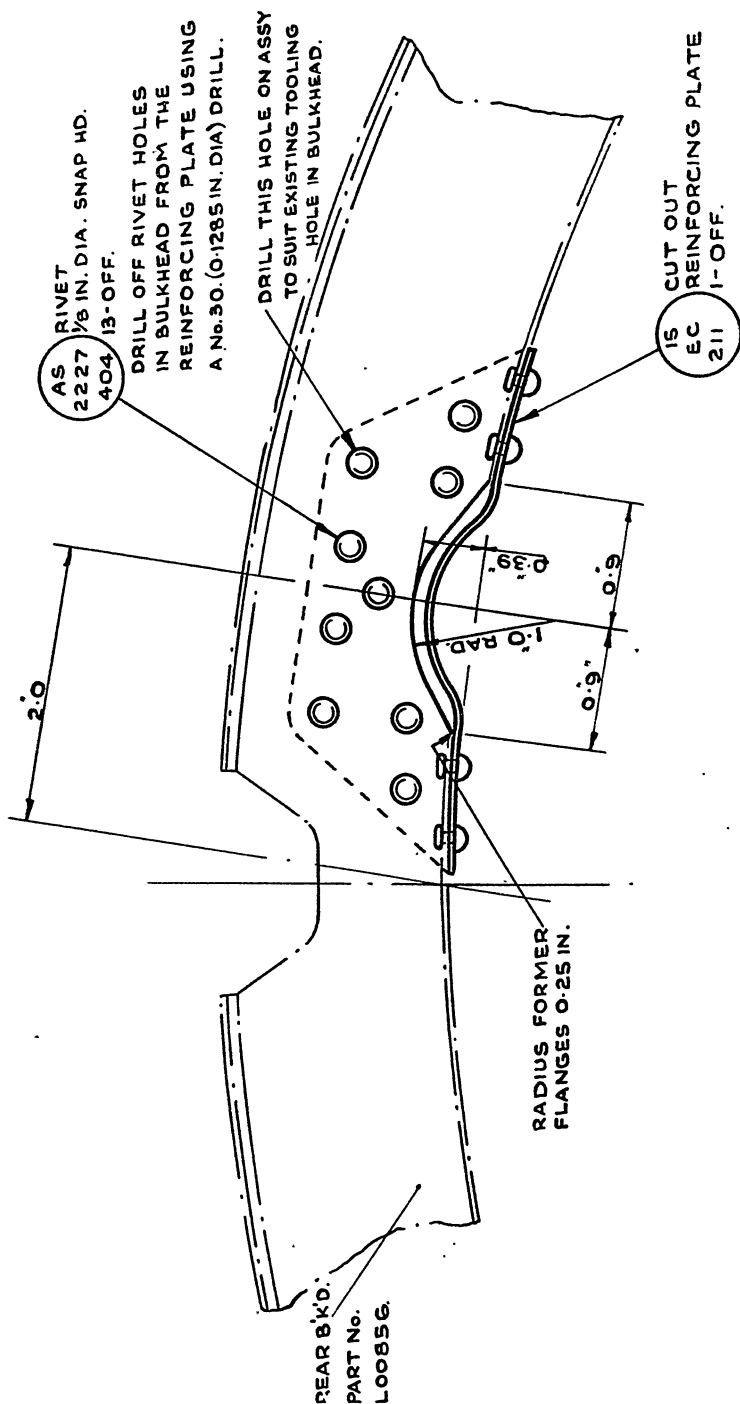
DETAIL Y. FROM SHEET 1. VIEW LOOKING AFT. SHOWING CUT-OUT IN REAR  
BULKHEAD OF TAIL CONE AND FITMENT OF REINFORCING PLATE.

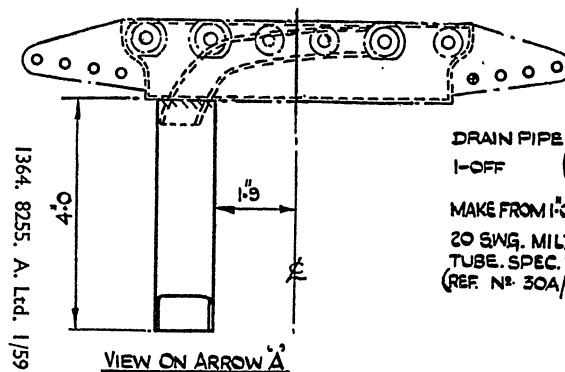
DRAIN PIPE ISEC 93 ND  
 1-OFF  
 MAKE FROM 1'-0" O/DIA.  
 20 SWG. MILD STEEL  
 TUBE. SPEC. T. 45  
 (REF. N° 30A/1828.)

CUT OFF REDUNDANT PIPE, PART N° L00.1050 N.D.,  
 FLUSH WITH DRAIN BOX SIF BRONZE WELD THE NEW  
 PIPE TO BOX OVER AREA MARKED THUS \\\\\\\

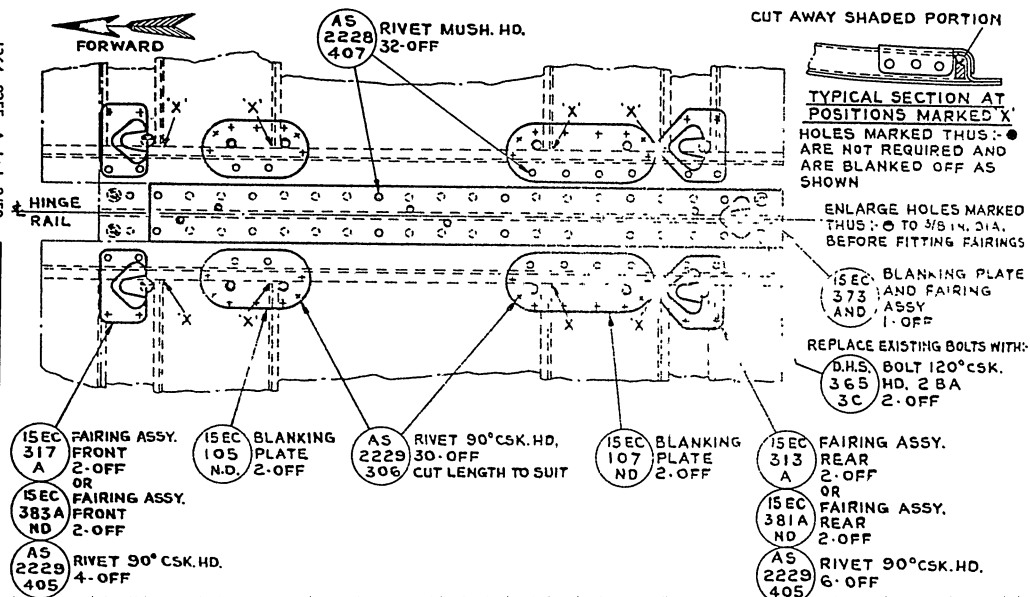
DRG. No. A.P. 4099C/P19/59  
SHEET 1.

VIEW ON THE UNDERSIDE OF THE LOWER ENGINE INSPECTION DOORS SHOWING  
BLANKING OF REDUNDANT DRAIN HOLES AND FITMENT OF FAIRINGS TO THE REMAINING DRAIN HOLES

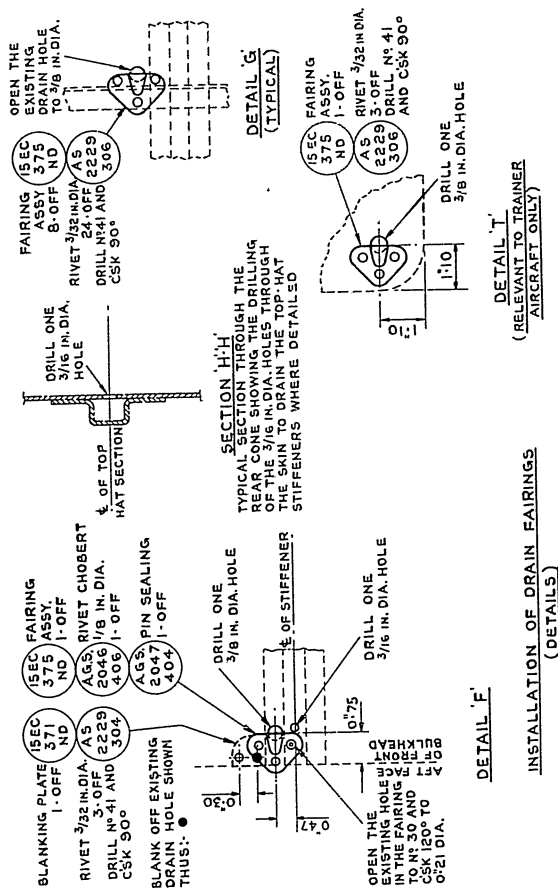
DETAIL 'I'  
(RELEVANT TO TRAINER  
AIRCRAFT ONLY)

INSTALLATION OF DRAIN FAIRINGS  
(DETAILS)

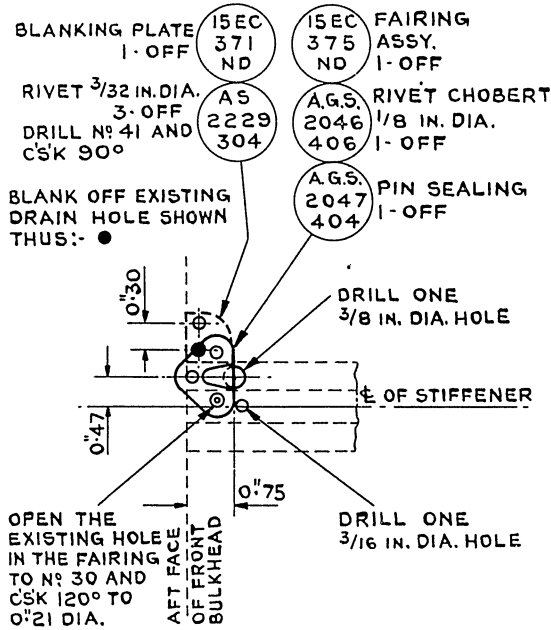
DETAIL 'F'

INSTALLATION OF DRAIN FAIRINGS  
(DETAILS)

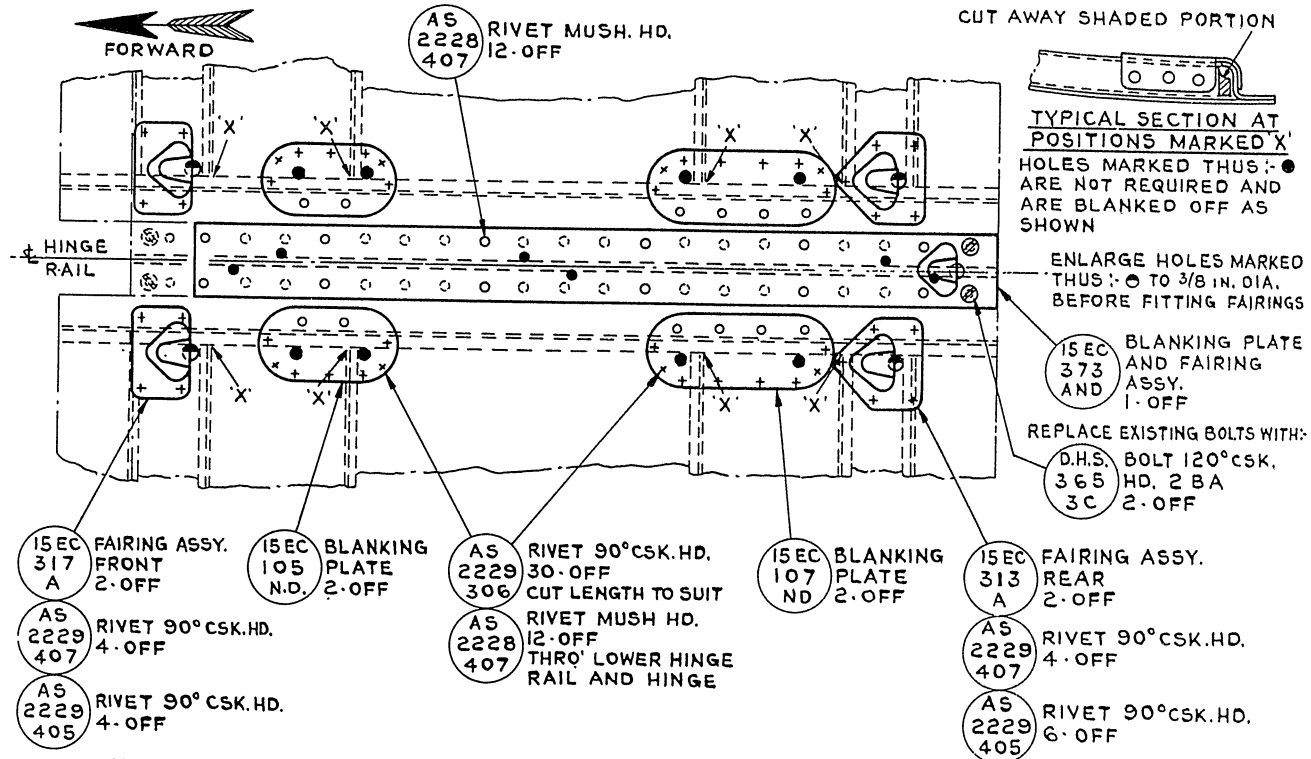
DRG. NO. AR 40946/P.19/58.  
SHEET 1.

VIEW ON THE UNDERSIDE OF THE LOWER ENGINE INSPECTION DOORS SHOWING  
BLANKING OF REDUNDANT DRAIN HOLES AND FITMENT OF FAIRINGS TO THE REMAINING DRAIN HOLES
