**STRUCTURES REPORT 378**

**FATIGUE TESTING OF VAMPIRE WINGS**

**R. A. BRUTON and C. A. PATCHING**

The fatigue behaviour of a total of 21 port and starboard Vampire wings has been investigated for a 12 load level programmed loading sequence, representative of an average Australian flight loading spectrum. An additional two wings were subjected to a randomised sequence of these loads.

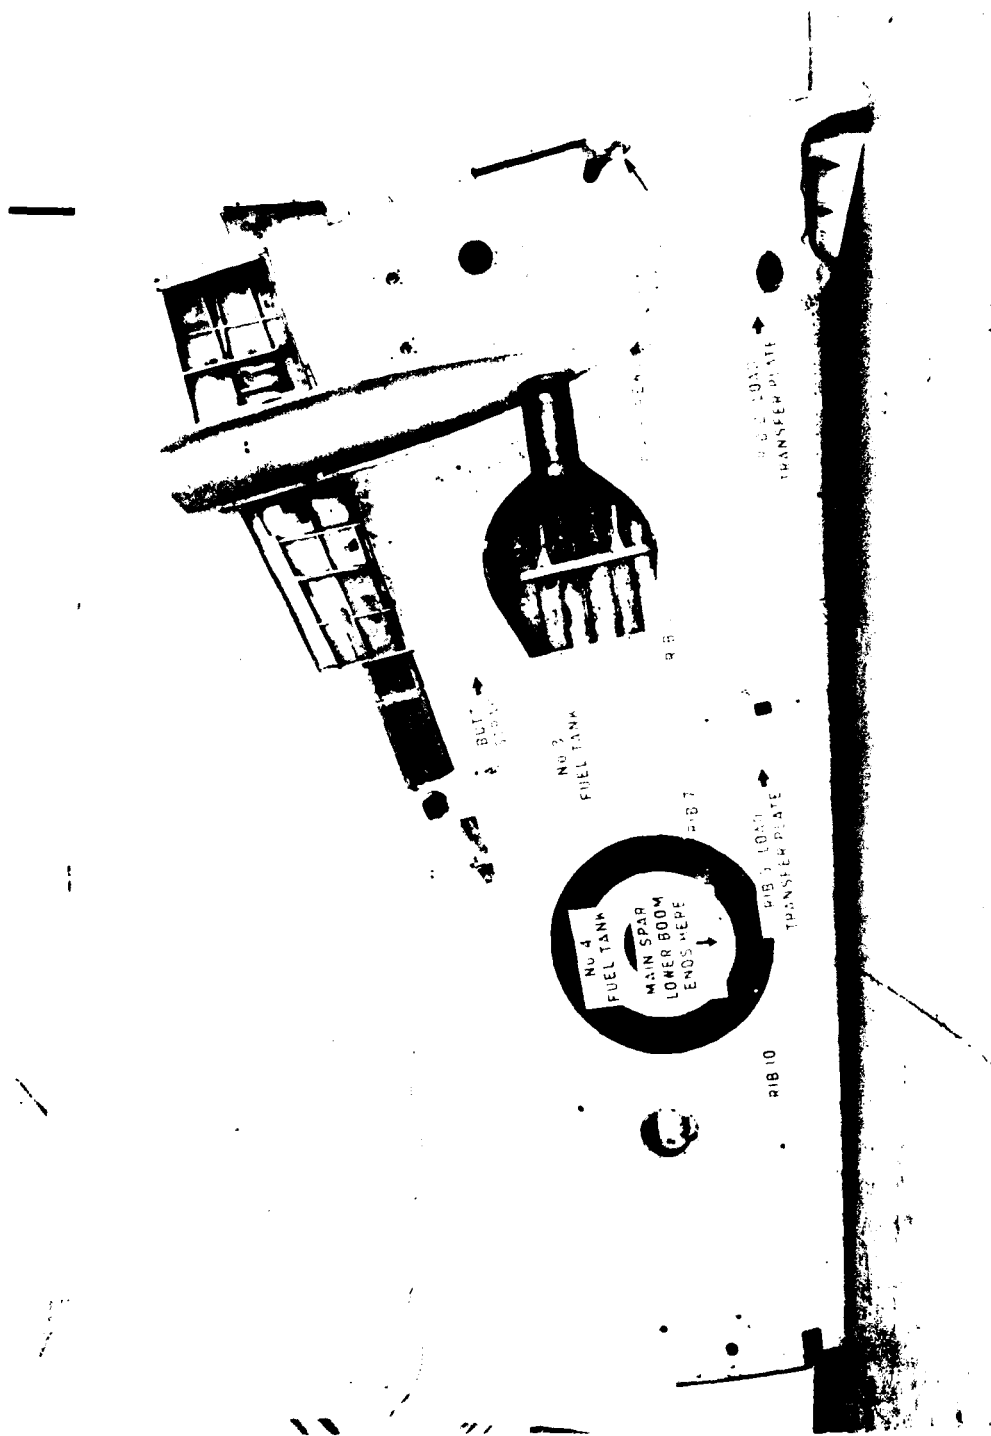
FIG. 7: VAMPIRE PORT WING—LOWER SURFACE

A large proportion of the wing lower surface consisted of fuel tank bay access panels (tank doors), attached along their edges by countersunk screws (see Figs. 7 and 8). During calibration runs it became apparent that the distribution of load between the panels and surrounding structure was dependent upon the tightness of the screws, i.e. the stiffness of the attachment joints.

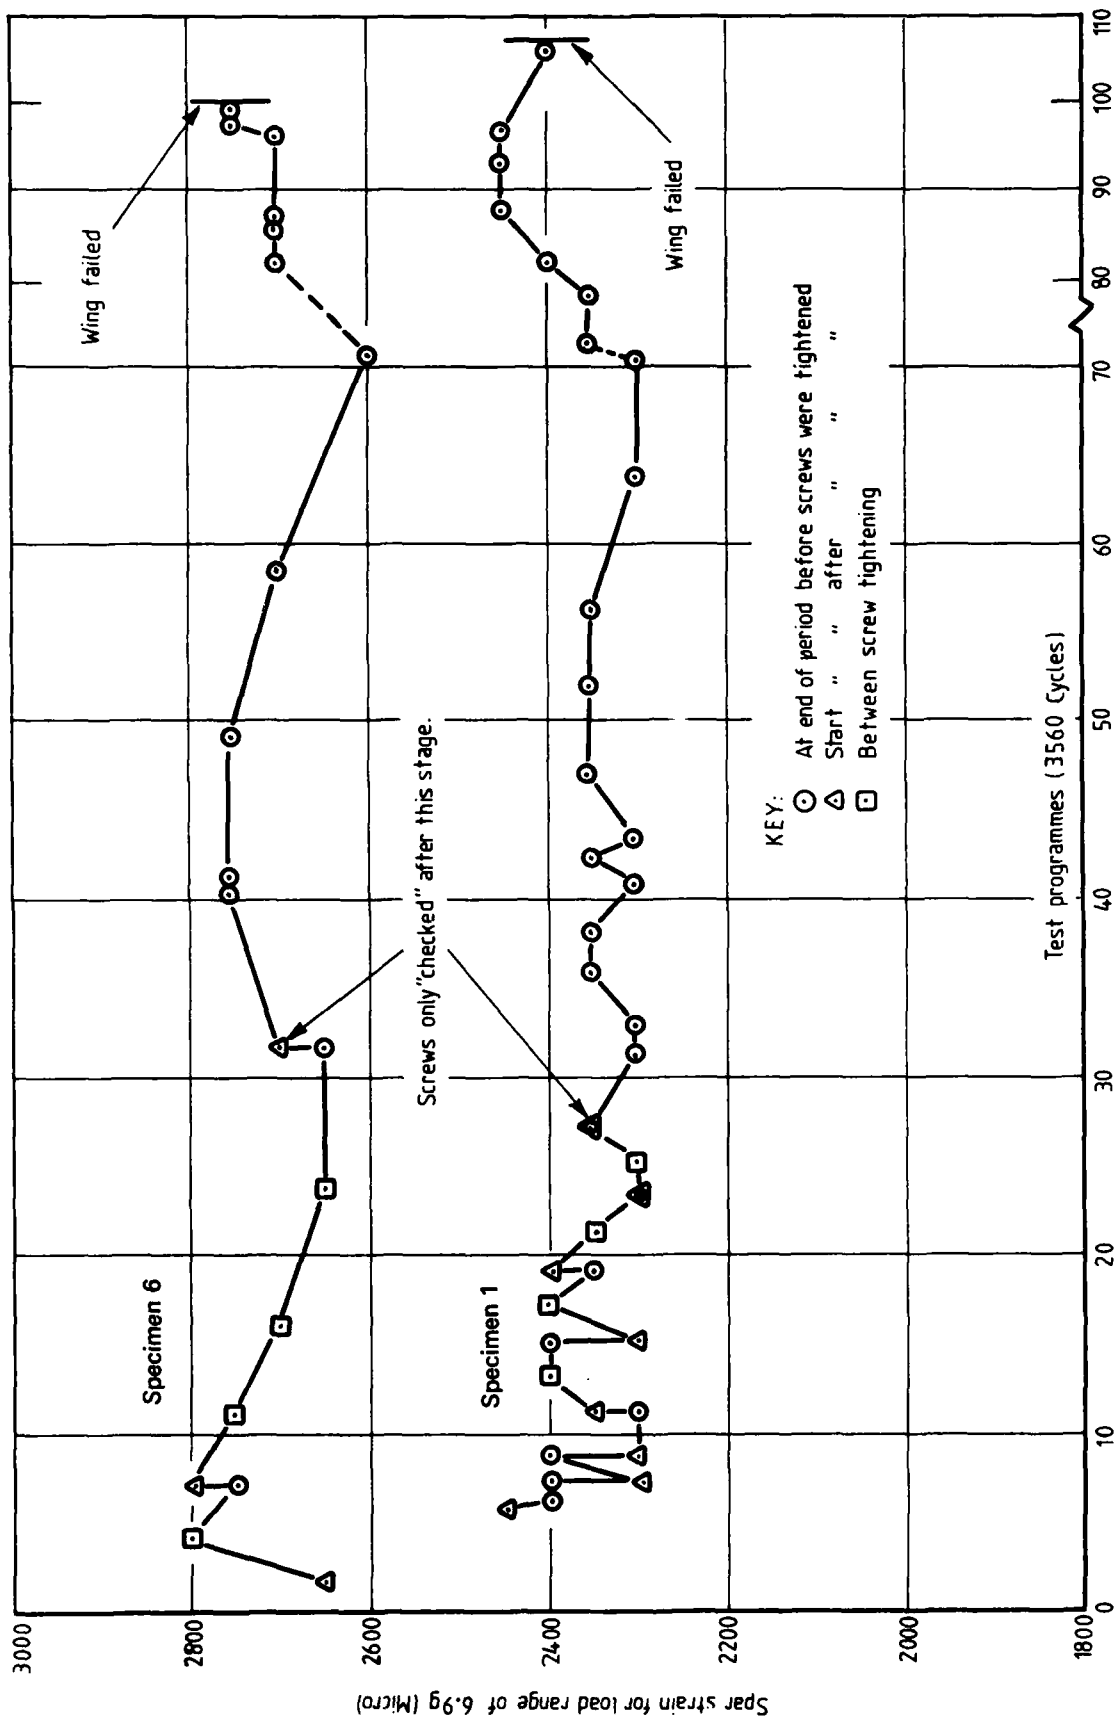
FIG. 26: PROGRESSIVE EFFECT OF SCREW TIGHTNESS ON STRAIN IN SPAR AT RIB 2

By contrast, the value of strain measured in the lower spar boom at Rib 2 varied by a significant amount. For each specimen the strain varied slightly during the fatigue life, and this was related to variations in the tightness of the screwed connections as illustrated in Figure 26. However, between each specimen there was a considerable difference in the average stress value as shown in Tables 6, 7, and 8 for unmodified, modified, and Fighter type wings respectively.

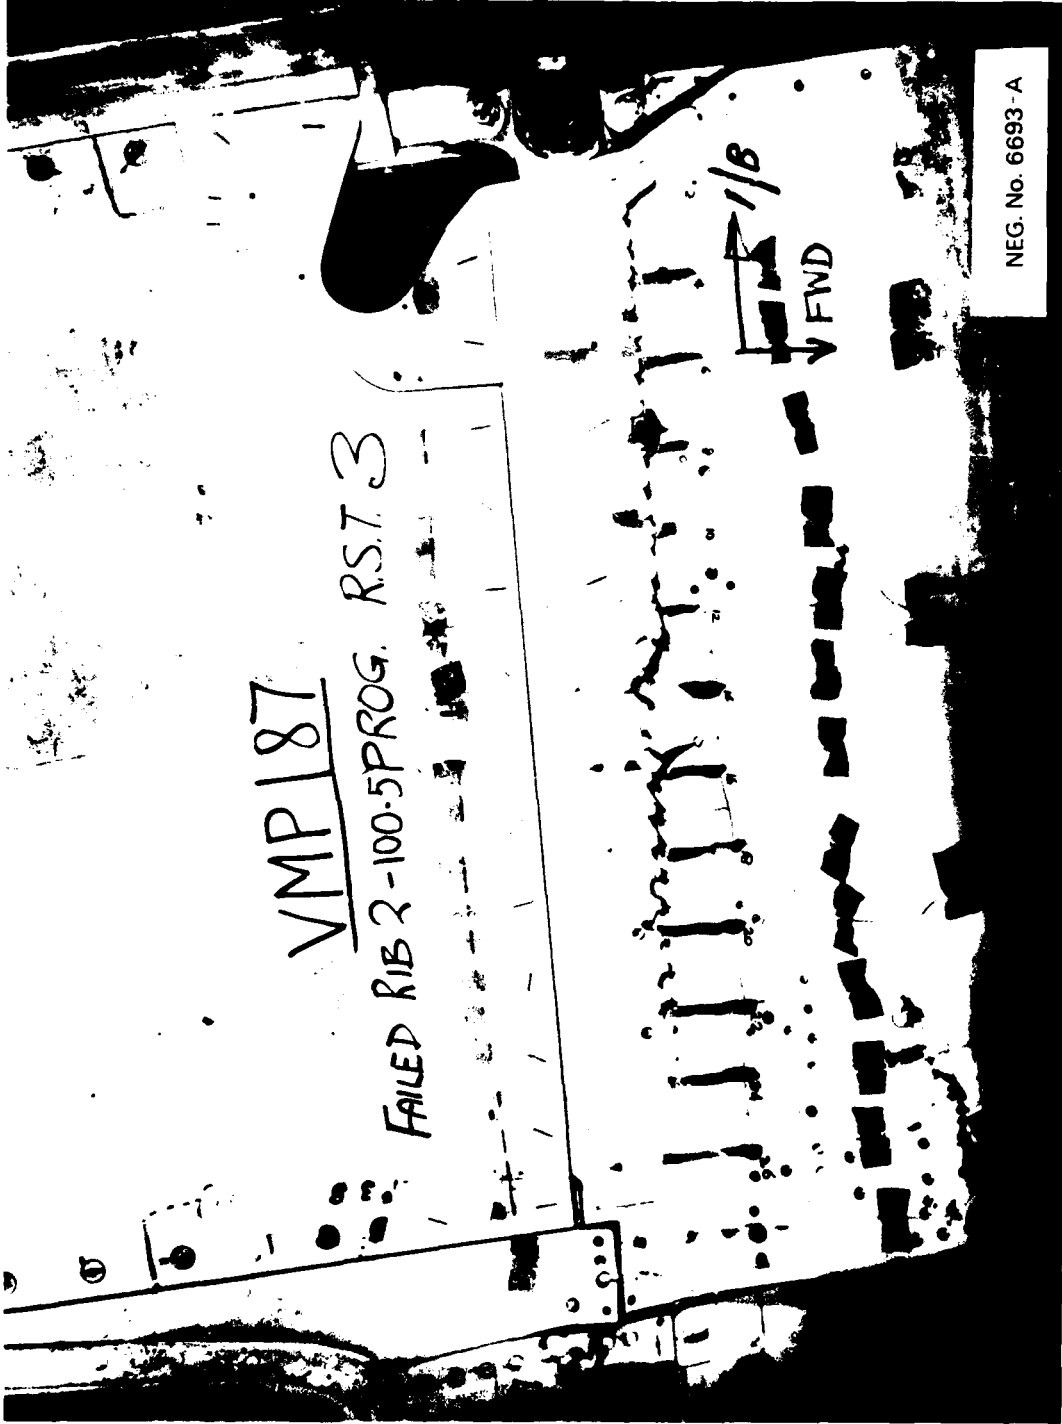
FIG. 30: CRACK PROPAGATION WIRE DETECTOR ON RESIDUAL STRENGTH TEST OF SPECIMEN No. 11

From failures during the fatigue tests it was known where the fractures could occur and hence two specimens were instrumented to record the load at collapse, to photograph the failure path using a high speed camera, and to register crack propagation with a series of "jumper" wires, shown in Figure 30, that triggered lights in the field of view of the camera.

The failing load for each specimen is given in Table 21 and varied little between the four specimens. However, the mode of failure did vary between specimens in that specimen 25 which recorded the highest load failed at right angles to the spar across the tension surface at Rib 2, while the other three specimens all failed by spanwise tearing along a row of countersunk screws attaching skin to the forward edge of the spar boom, outboard of Rib 1B as shown in Figure 30.

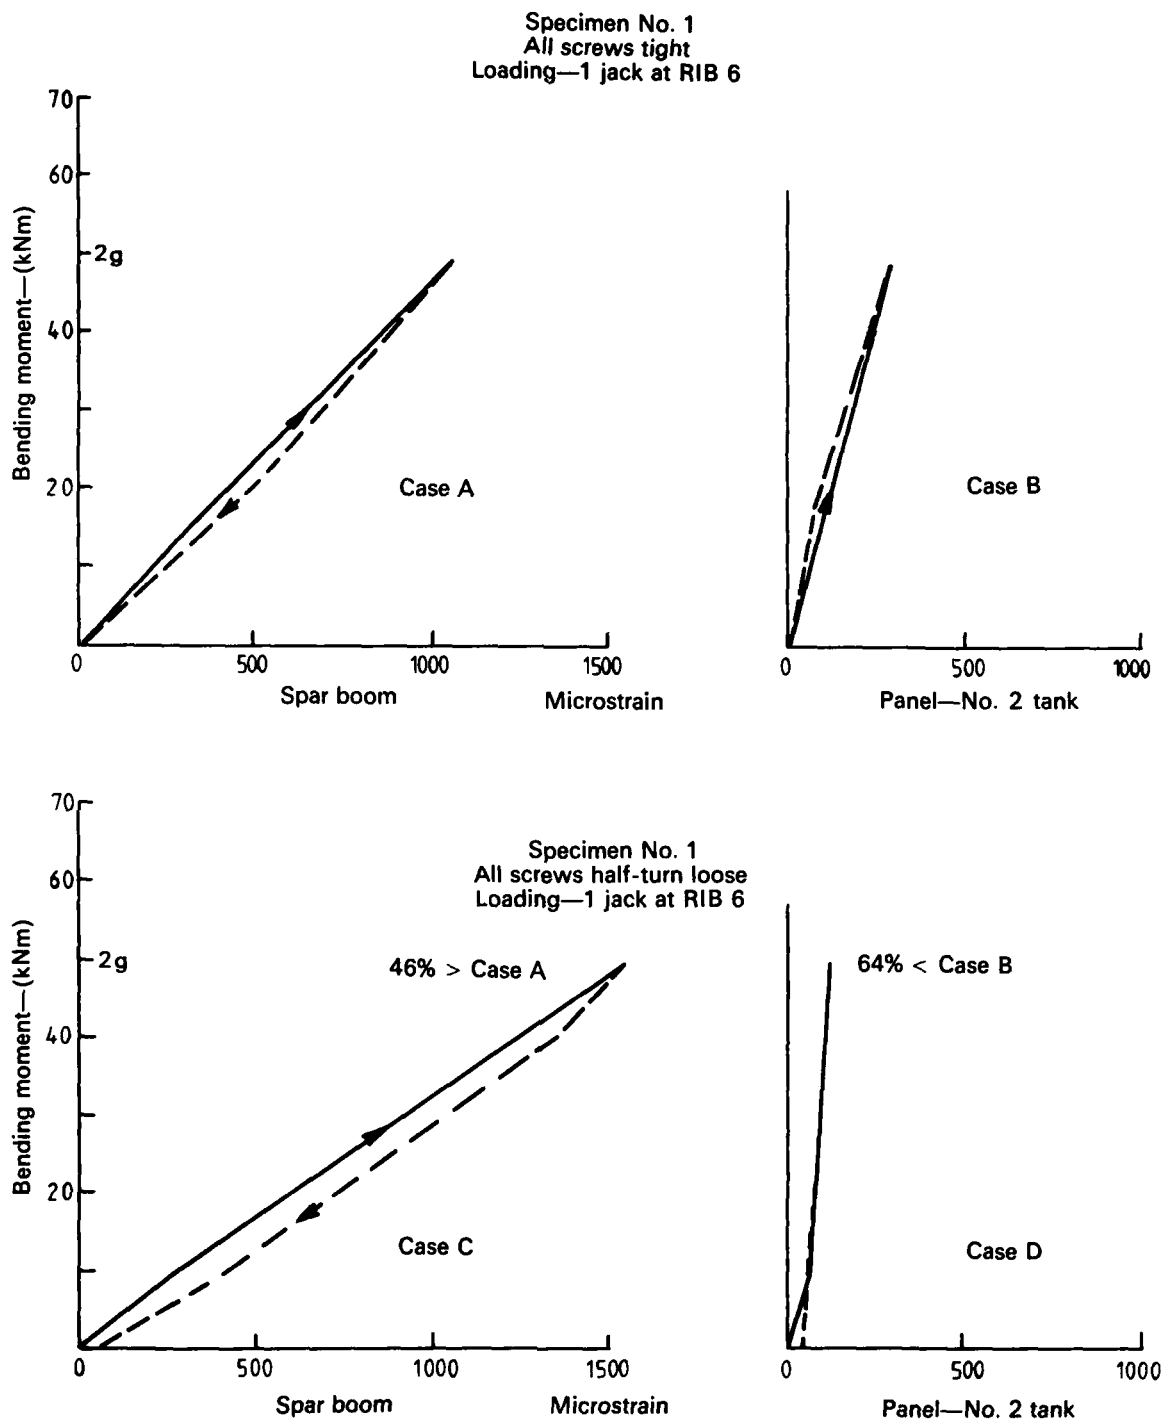
FIG. 37: EFFECT OF SCREW TIGHTNESS ON SPAR BOOM AND PANEL STRAIN AT RIB 2—LOW LOADS

The distribution of strain between the spar boom at Rib 2 and the panel for No. 2 tank for panel screws tight and half turn loose is illustrated in Figure 37. Case C shows that with all panel screws one half turn loose, the strain in the spar boom increased by 46%, compared to Case A when all screws were tight, while strain in the panel decreased 64%, cases D and B (Fig. 37).

The effect of slippage produced a departure from a straight line by individual strain gauge readings, and a non-return to zero for both gauges. Both of these features being more pronounced in cases C and D when the screws were loose (see Fig. 37).

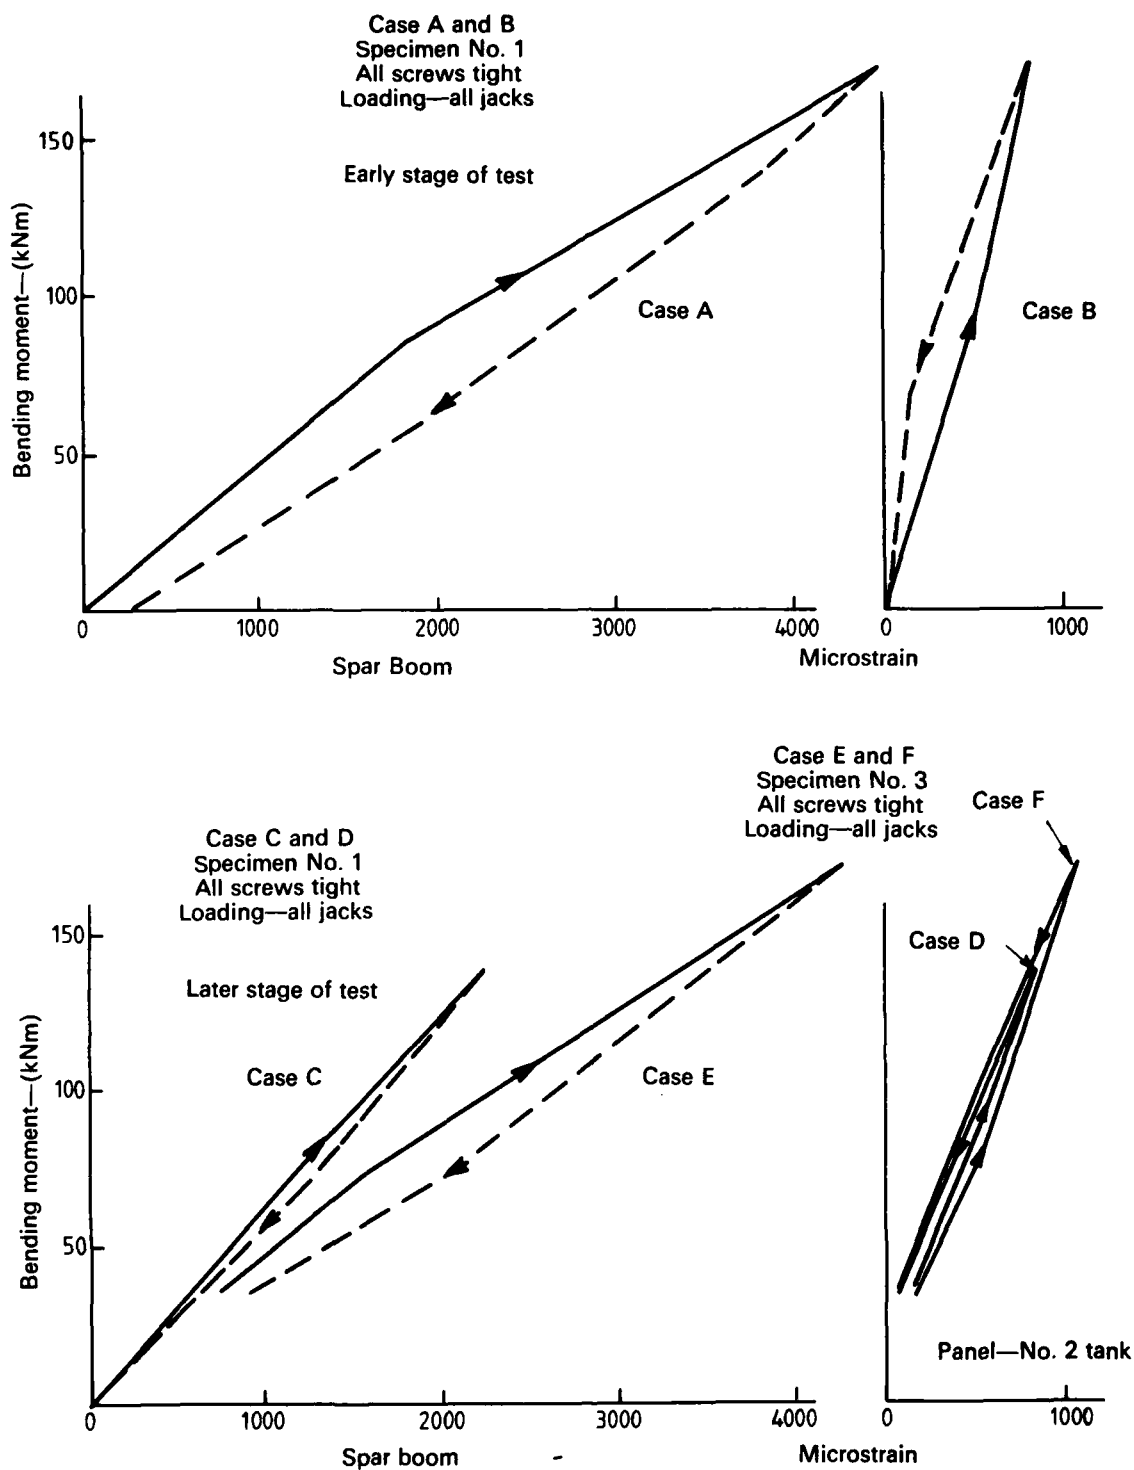
**FIG. 38: EFFECT OF SCREW TIGHTNESS ON SPAR BOOM AND  
PANEL STRAIN AT RIB 2—HIGH LOADS**

The strains measured are shown in Figure 38 and agree closely up to the corresponding bending moment applied in Figure 37. However, at the higher loads there was an increase in the proportion of load carried by the boom, case A (Fig. 38), with a corresponding decrease in panel load, case B (Fig. 38).

A repeat of the strain measurements at a later stage showed a remarkable difference, see cases C and D (Fig. 38). The load-strain relationship for both spar boom and panel were almost linear, which indicated that the attachment joints were functioning more efficiently. This is further supported by the narrowness of the hysteresis loop.
