AIRFRAME

VAMPIRE

MODIFICATIONS

TECHNICAL STAFF INSTRUCTIONS
INDEX SHEET.

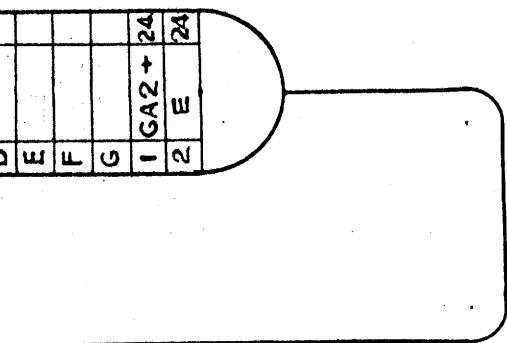
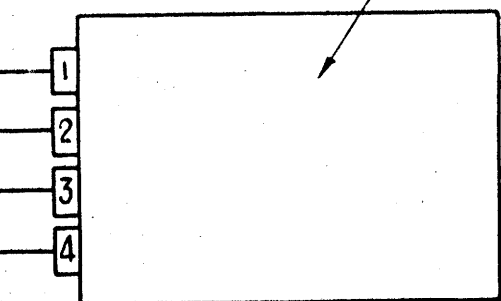
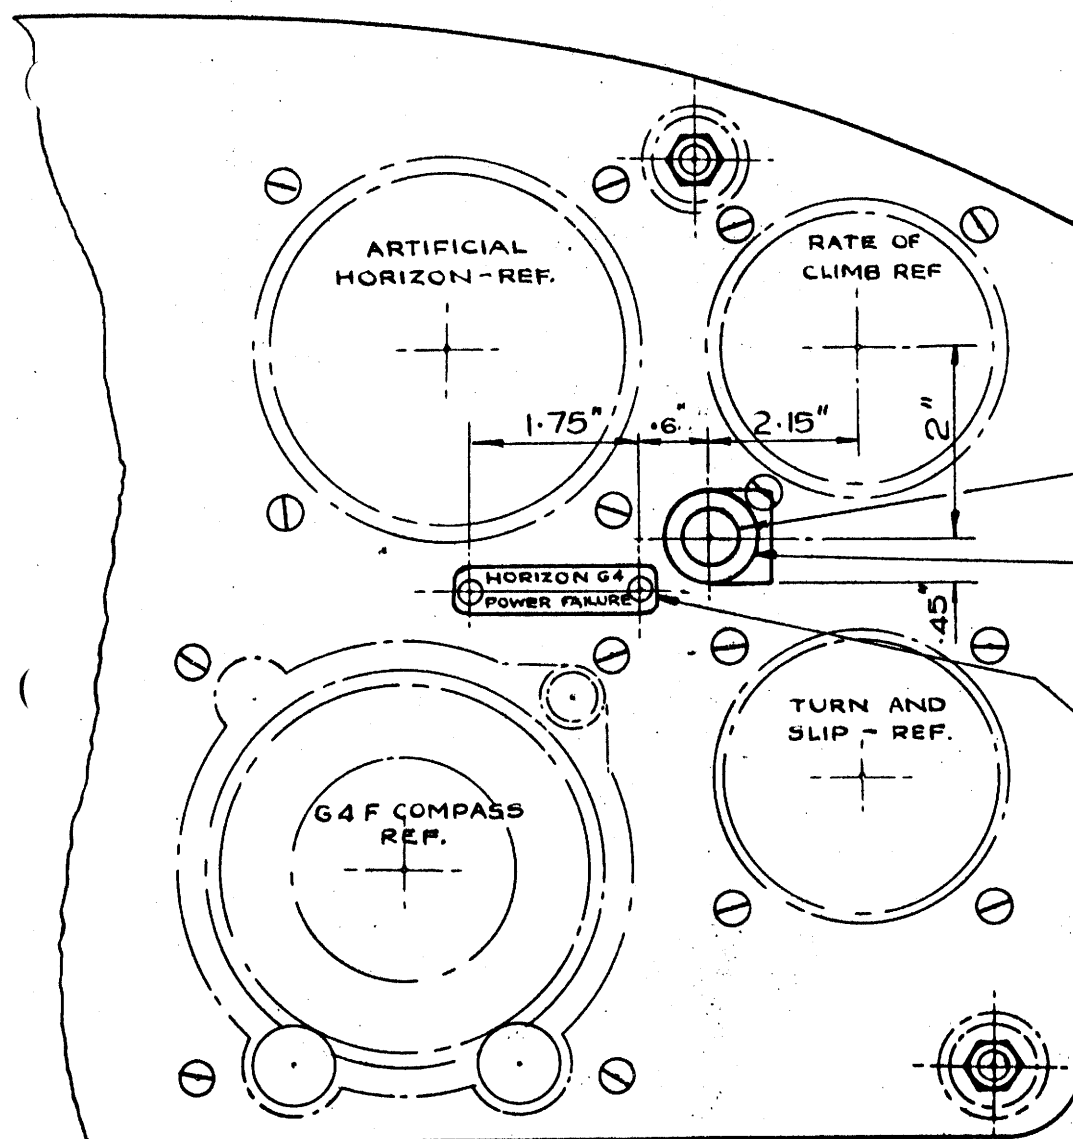
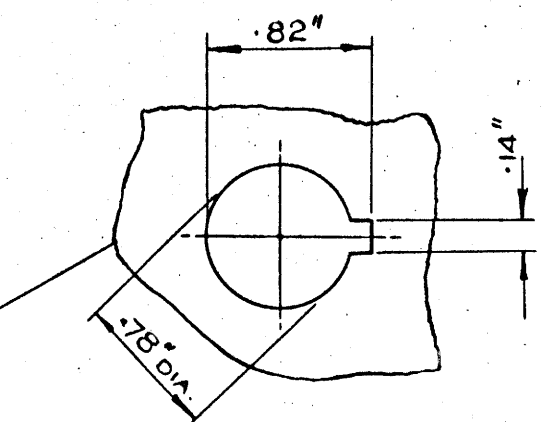
With the present system no warning is given should the G4F Compass indicator and artificial horizon cease functioning due to a power supply failure. To warn of such a failure this modification introduces a power failure warning light mounted on the blind flying panel, together with a new compass junction box, which incorporates the necessary torque switch, circuit breaker and relays, and revised wiring to operate it. The torque switch is also wired to cut out the inverter and so minimise damage.

INSTALLATION OF POWER FAILURE WARNING LAMP
ON BLIND FLYING PANEL.

- (4) Mark out and cut the hole in the blind flying panel for the red warning lamp, as shown on the drawing. Now position the "Horizon - G4 Power Failure" label, Part No. 12-2F 331, as shown and using the holes in the label as guides, drill two holes in the panel to suit, using a No. 41 (0.0960 in. dia.) drill. Remove the label, deburr the holes and clear the panel of swarf.
