TECHNICAL STAFF INSTRUCTIONS  
INDEX SHEET.

VOLUME TITLE AIRFRAME VOLUME NO 1  
SECTION TITLE VAMPIRE SECTION NO 2  
SUB SECT TITLE GENERAL ORDER SUB SECT NO A

VAMPIRE.

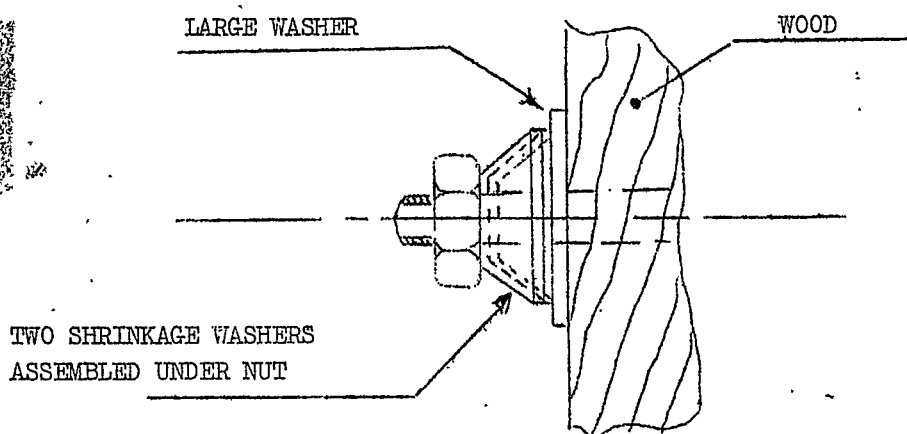
1. Some uncertainty appears to exist with regard to the correct method of fitting shrinkage washers to bolts passing through wooden members.
2. The sketch below shows that a large plain washer should be fitted against the wood, then two shrinkage washers one over the other, and finally the nut.

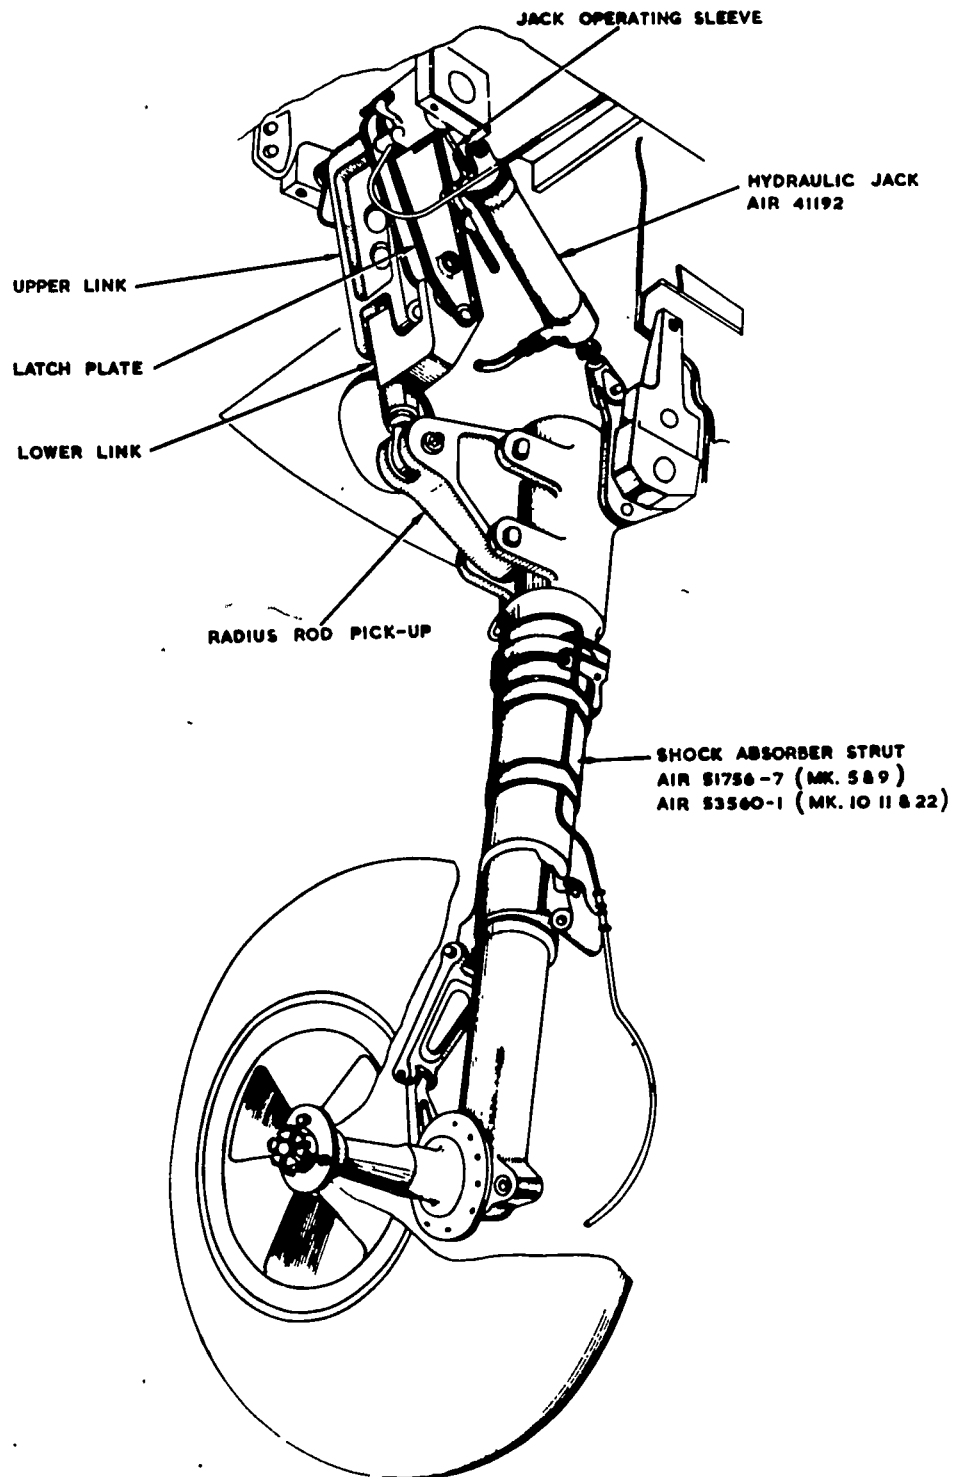
Fig. 5/1. Main undercarriage

2. Main and Nose undercarriage. No damage which affects these structures can be defined as negligible, and in the event of damage the affected members must be renewed.

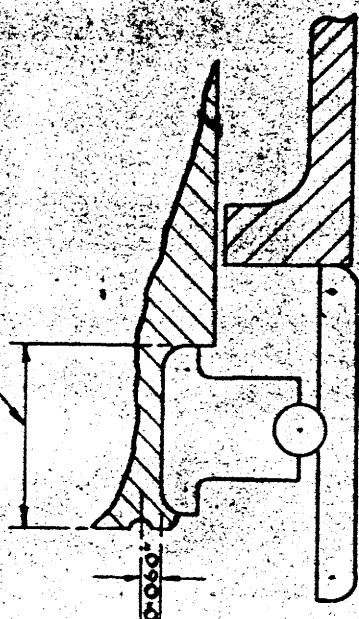
### DETAIL A CORRECT ASSY

CAULKING ALLOWANCE BELOW MINIMUM PERMISSIBLE DUE TO BAD SEATING OF OUTER TRACK.

- 1) A 1/32 RADIUS SPHERICAL ENDED PUNCH SHOULD BE USED.
- 2) DEPTH OF CAULKING TO BE APPROX .03"
- 3) CENTRE OF CAULKING TO BE APPROX .04" FROM EDGE OF HOUSING.
- 4) NUMBER OF CAULKS TO BE THE SAME AS REPORTED - SPACED BETWEEN THE OLD CAULKS.
- 5) ALLOWANCE FOR A FURTHER GAGE CHANGE WHEN NECESSARY.

HOUSING DEPTH TO BE: -  
WIDTH OF RACE OUTER TRACK PLUS 0.030"  $\pm$  .010"  $\pm$  .000"

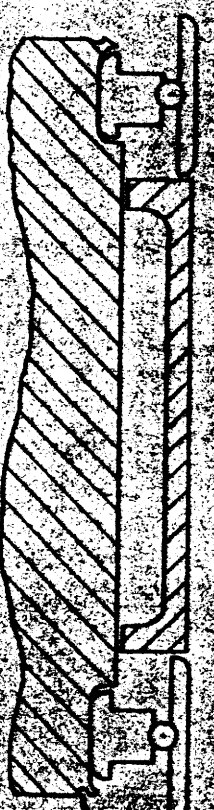
LIGHT CAULKING ONLY  
ON FLOATING BALL RACE
