AAP 721.79, VOLUME 2, PART 1

VAMPIRE INSTRUCTIONS

CONTENTS TO VAMPIRE INSTRUCTIONS

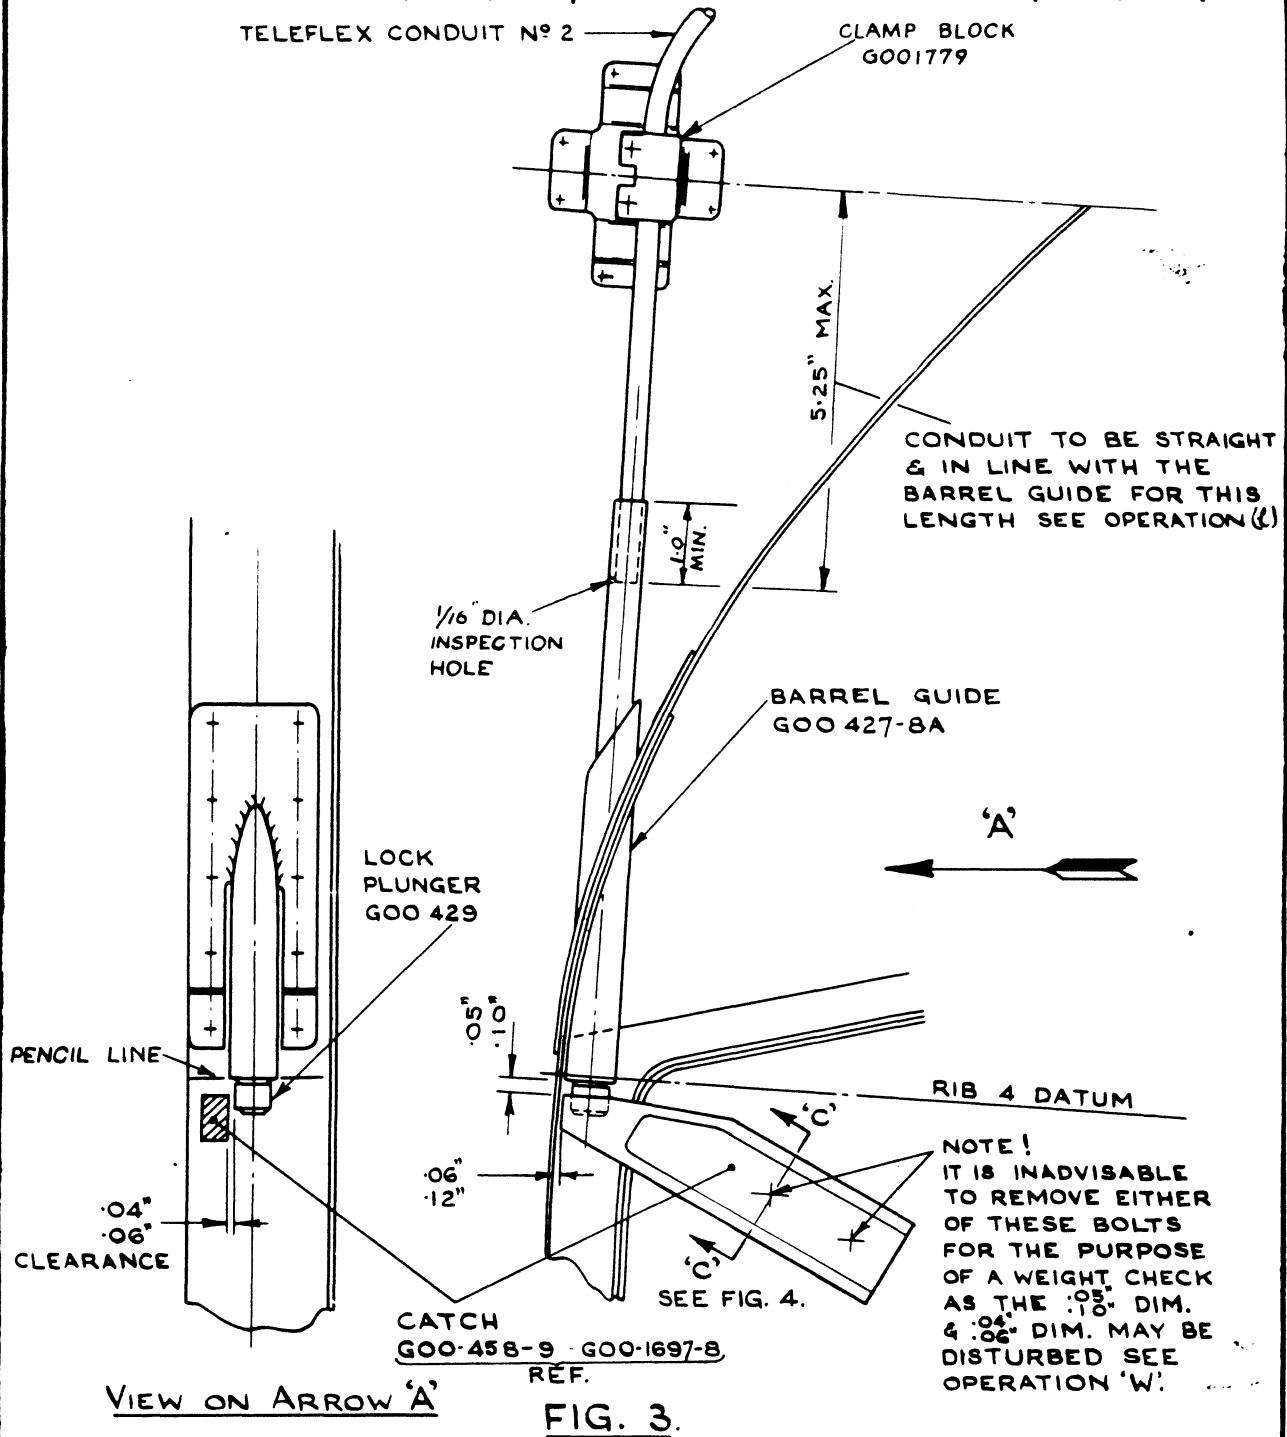
(i) The 5.25" maximum dimension (figure 3) is maintained.

(ii) The 1.0" minimum dimension (figure 3) is maintained. This may be checked through the 1/16" diameter inspection hole (figure 3) if the lock plunger and slide tube are temporarily assembled using the .35" dimension and the pencil line shown on figure 2.

(iii) The length of conduit inside the 5.25" maximum dimension (figure 3) is straight and in line with the barrel guide GOO427-8A (figure 3). This may be checked by ensuring that the slide tube and lock plunger (figure 2) can freely be slid back and forth on the conduit with the barrel guide temporarily assembled to the aircraft. This check should be carried out with the slide tube in various angular positions.

- (g) Refer to figure 3 and draw a pencil line on the wheel well wall to coincide with the outboard face of the barrel guide G00427-8A. Remove the barrel guide.

- (w) Raise the "D" door by hand and hold against stops. Manually move the plungers to the locked position by rotating the radius rod. (Note: If radius rod has not be disconnected in operation (v), $.500''$ diameter rods should be fitted in the barrel guides G00427-8A to represent the lock plungers G00429). Check the $.05''$ $.04''$ and $.06''$ $.10''$, $.06''$ and $.12''$ clearances shown on figure 3. If necessary refer to figure 4 and repack or move the door catches G00458-9, G001697-8 (figure 3).

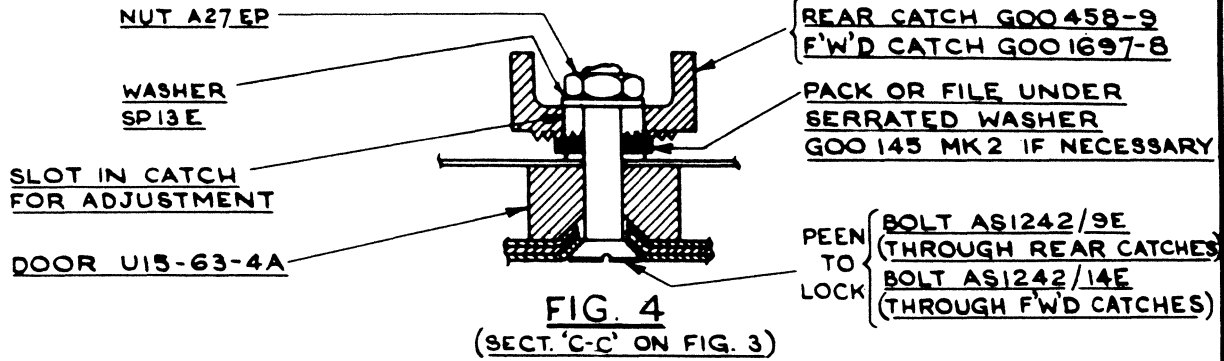
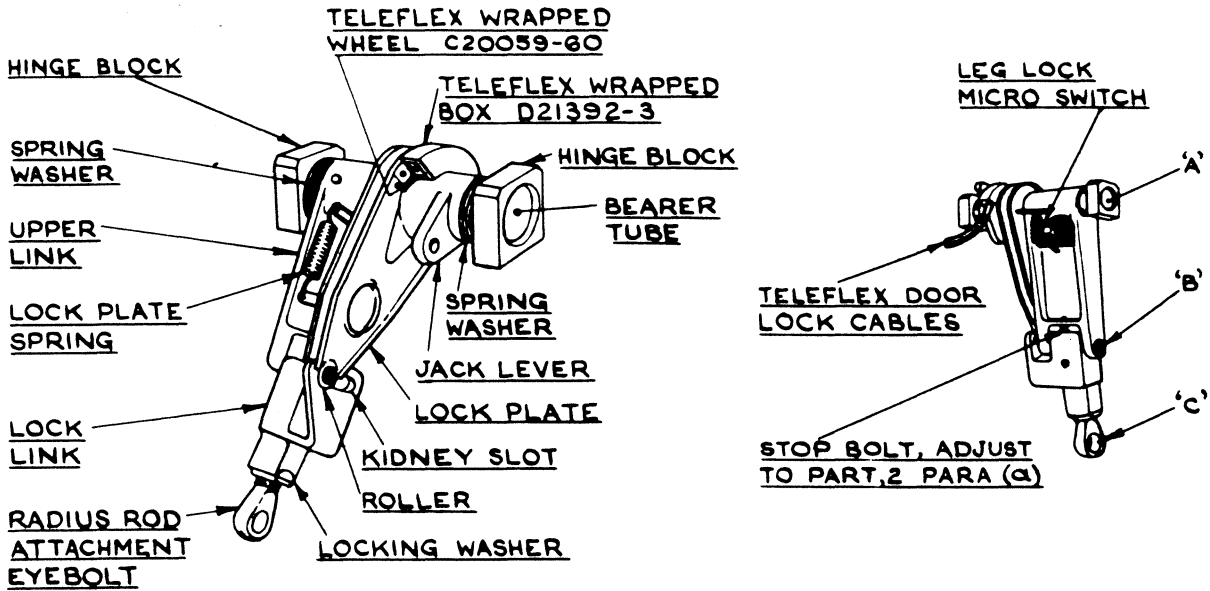
FIG. 5

- Notes:
- 1 The correct clearance can be attained by lining up the red mark painted on the lock plate with the red line painted on the lock link (figure 5). These are visible with the aid of a mirror and light through the slinging attachment access hole on top of the wing.
 - 2 Provided play can be felt in the lock plate with the undercarriage fully locked up, there is a positive clearance. The exact amount of this clearance cannot be gauged from the play. To fix the clearance if no red line is visible, lengthen the jack (no more than $\frac{1}{8}$ of a turn at a time) until a position is just reached where there is no play. Then shorten the jack $\frac{1}{8}$ to $\frac{1}{4}$ of a turn and lock. Re-check that play can be felt in the lock plate.

(iv) The top end of the inboard conduit is fully home in the wrap box D21392-3 (figure 5). This may be checked through the 1/16" diameter inspection hole in the wrapped box.

- (i) Remove all the teleflex conduits (figure 3) from the aircraft.
- (j) Spring the end of the teleflex cable out of the hole in the wrapped wheel C20059-60 (figure 5).

- (o) Spring the teleflex cable into the hole in the wrapped wheel C20059-60 (figure 5). It is to protrude .1" to .5" beyond the hole.

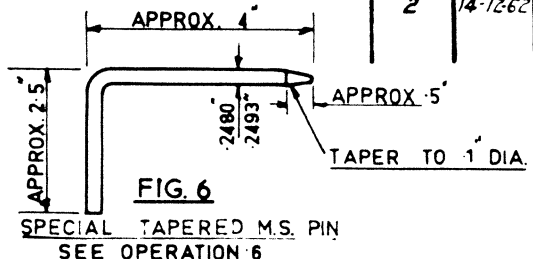
FIG. 6
SPECIAL TAPERED M.S. PIN
SEE OPERATION 6

Note: Ensure that the spring does not pick up and start to unwind the spacing wires on the teleflex cable (figure 6) when screwing it in position.

- (l) Grind both ends of the teleflex cable to a neat cone shape. All grinding to be done in the direction of the helix of the cable. Check that the grinding of the ends is adequate by ensuring that a new lock spring DS47/2 (figure 2) can easily be screwed on or off either end and has no tendency to pick up on the fine spacing wires of the teleflex cable (figure 6).

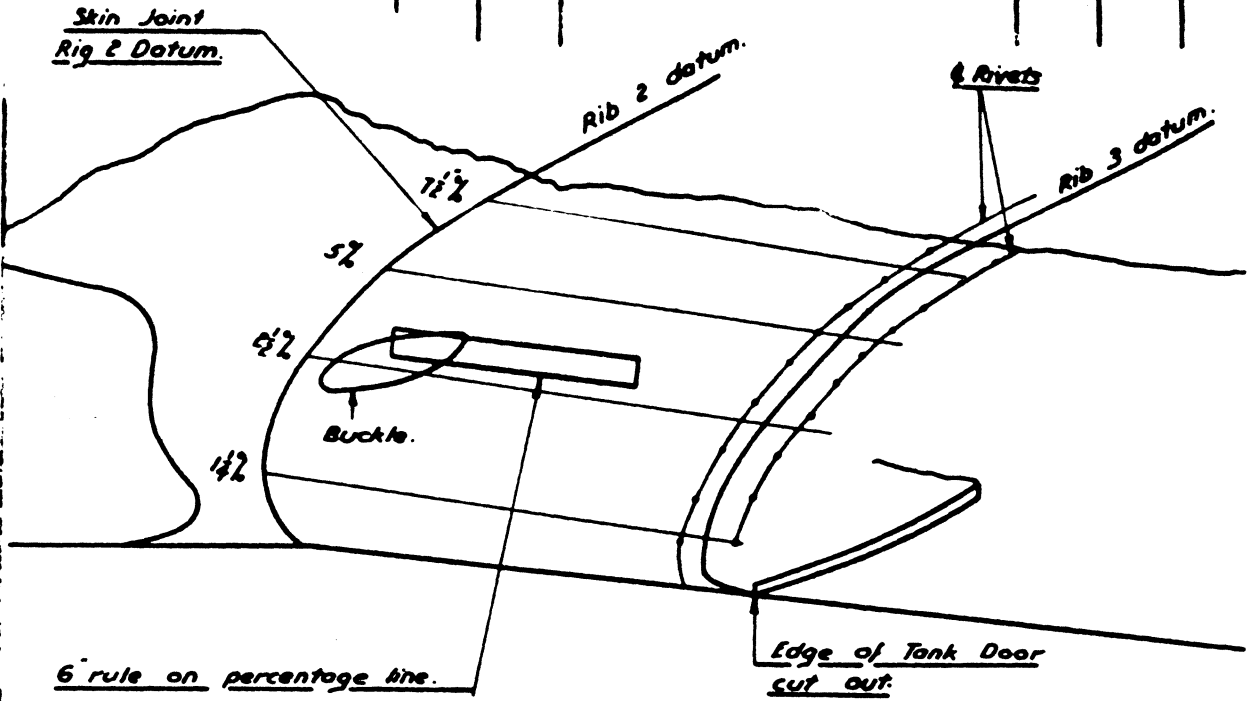
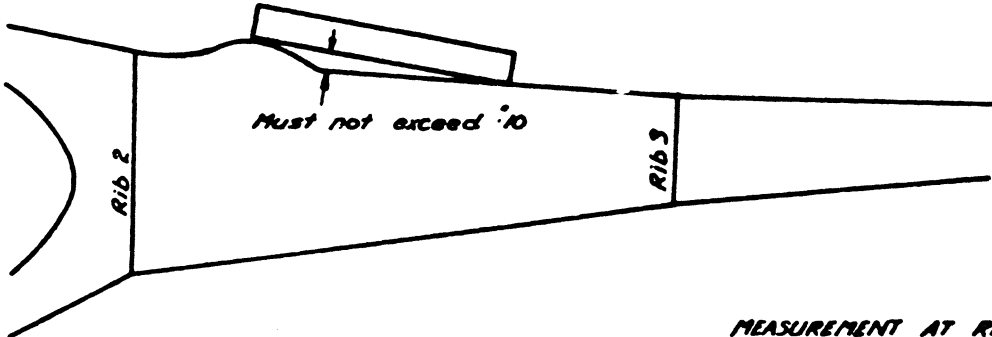
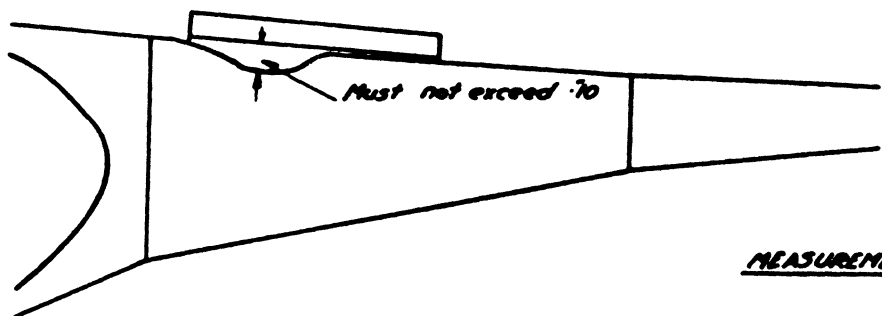
REFERENCE	ISSUED BY		TITLE		
	DIRECTORATE OF TECHNICAL SERVICES R. A. A. F.		METHODS FOR MEASURING BUCKLES BETWEEN RIB 2 AND RIB 3.		
LIMITS UNLESS STATED	MATERIAL		COMPONENT OF		
DECIMALS $\pm .010''$	SPEC.		MACHINE		
FRACTIONS $\pm \frac{1}{32}''$	TREATMENT		ENGINE		
ANGLES $\pm \frac{1}{2}^\circ$	FINISH		TECH. ORDER	D.T.S. SPECIAL INST. VAMPIRE/CS	
SURFACE FINISH	SCALE		DRAWING NO.	A11990	
AUSTRALIAN STANDARD ENC. DRAWG. PRACTICE A.S.621	DRAWN		APPROVED		DRWG.
	TRACED	NEW	CHECKED	7/8/53	SIZE
