## TECHNICAL NEWS SHEET

ISSUED FOR THE GENERAL GUIDANCE OF OPERATORS OF DE HAVILLAND AIRCRAFT AND ENGINES  
OFFICIAL INSTRUCTIONS TAKE PRECEDENCE OVER ANYTHING CONTAINED IN THIS BULLETIN

### INDEX series MAG (Military Airframe, General Circulation)

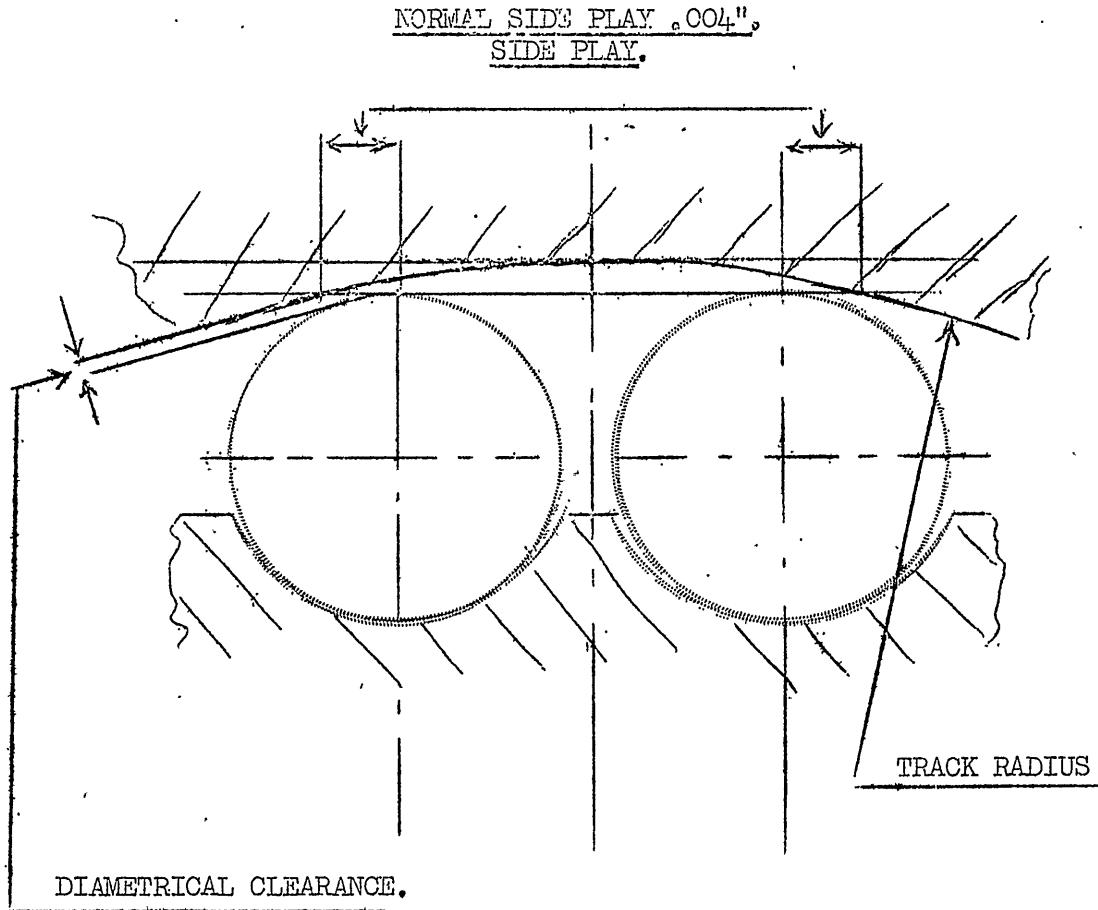
As can be seen below for the same diametrical clearance the normal side play of single row self aligning bearings is approximately five times that of the equivalent two row self aligning type.

When checking play on aircraft in service particular care should be taken in assessing the diametrical play. Side play can usually be treated as negligible unless end clearances etc. of the component concerned are seriously affected.
