17 TN 2/2/11 1050/8/2
DE HAVILLAND SERVICE

TECHNICAL NEWS SHEET

INDEX series V (Vampire Airframe, General Circulation)

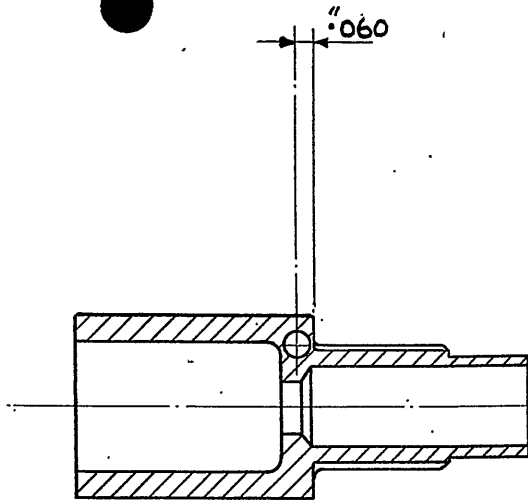
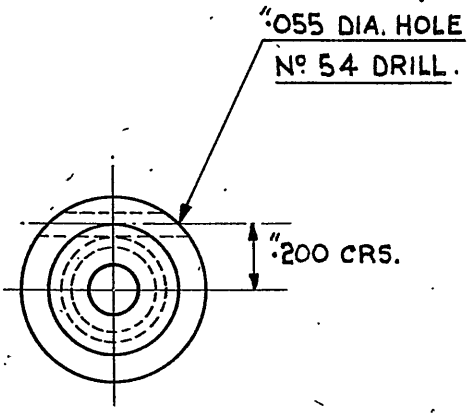
THE DE HAVILLAND AIRCRAFT CO., LTD., HATFIELD, HERTS.	M/c TYPE	M/c. REGn. No.	REPAIR TO :- DRILLING OF ADJUSTER FOR SWAGED END CABLE ASSEMBLY.	DR. BY	APP. BY	R. 00Q12. ISSUE
	VAMPIRE

" The embodiment of modification Vampire 698, or repair in accordance with Repair drawing No. OOD. 171 will render this servicing Instruction no longer necessary".

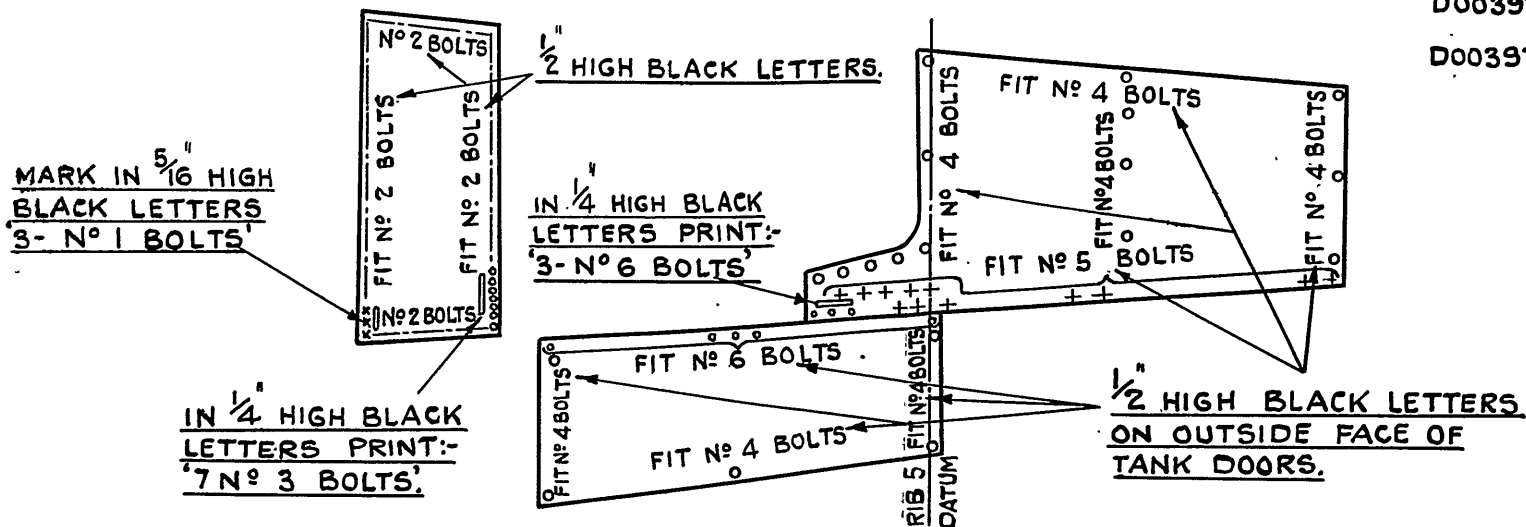
VIEW ON TANK DOORS SHOWING MARKING FOR BOLT LENGTHS.

BOLT PART N°	N° ON HEAD.
D001154	1
D001155	2
D006651	3
D003977	4
D003978	5
D003979	6

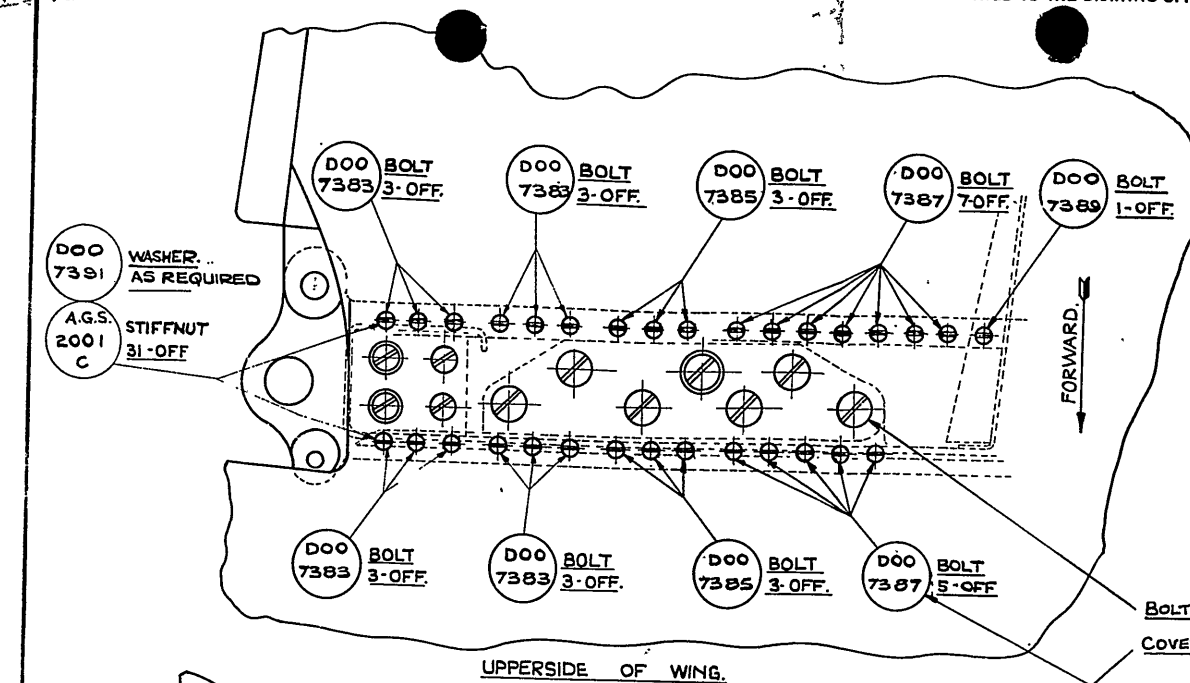
UPPERSIDE OF WING.

IMPORTANT. Care should be taken when making these checks that no confusion arises with 'crazing' or cracking of paint finish and the filler. This characteristic shows after very little flying and is not a sign that movement is occurring. The rivets must be checked for 'tilting' in accordance with Drg. R.OOD22K.

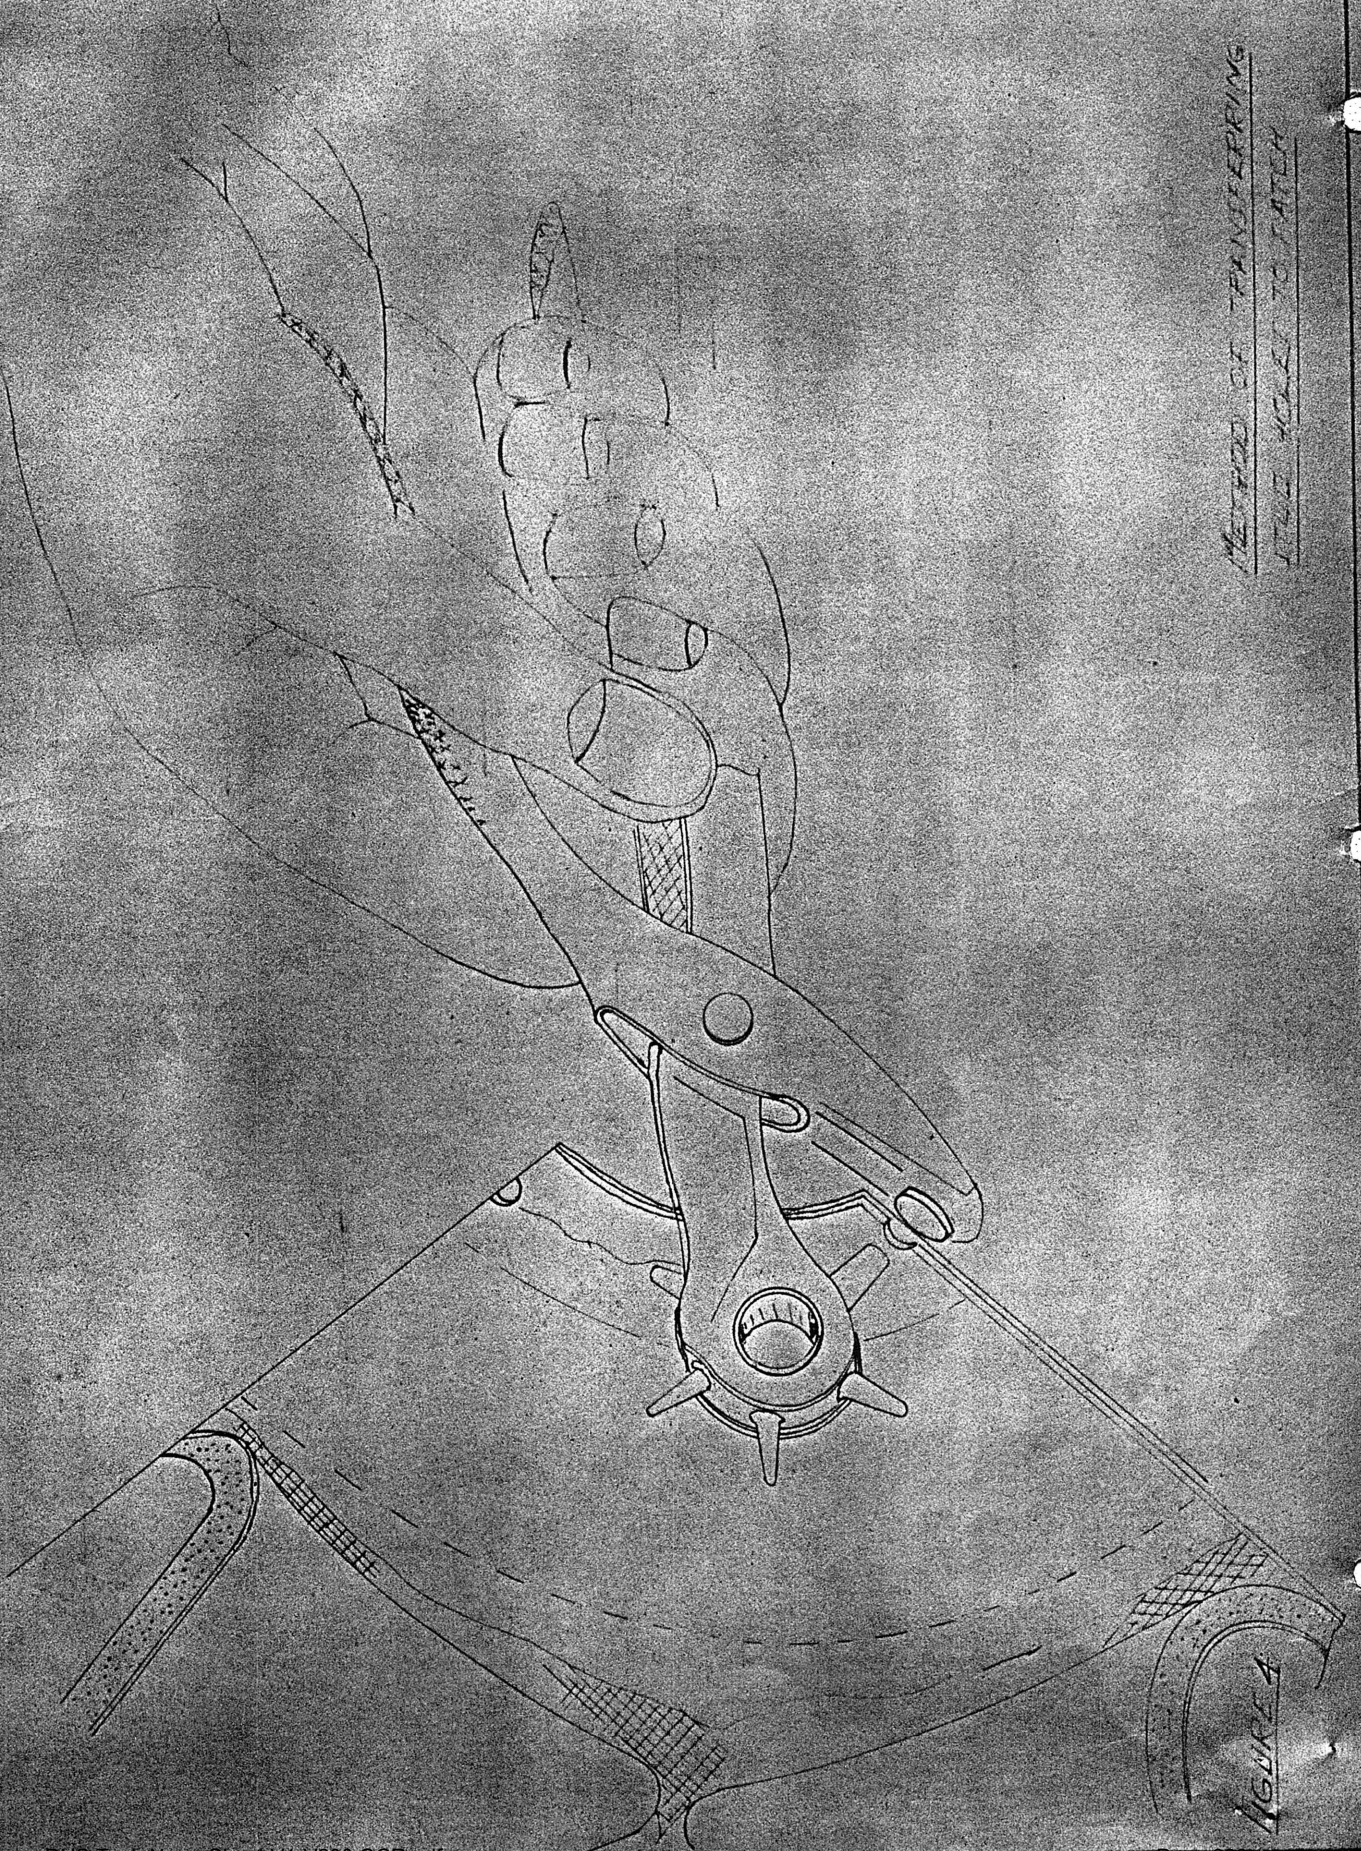
FIGURE 4

14. When the internal patch is secured, stud holes should be punched in the new material, for which purpose a leather punch is required. In order to locate the holes accurately the original holes in the tank lining may be used as a guidance providing these are not too severely damaged. See Fig.4. If at least two holes can be thus transferred the remaining ones may be marked through the flange of the metal fitting.

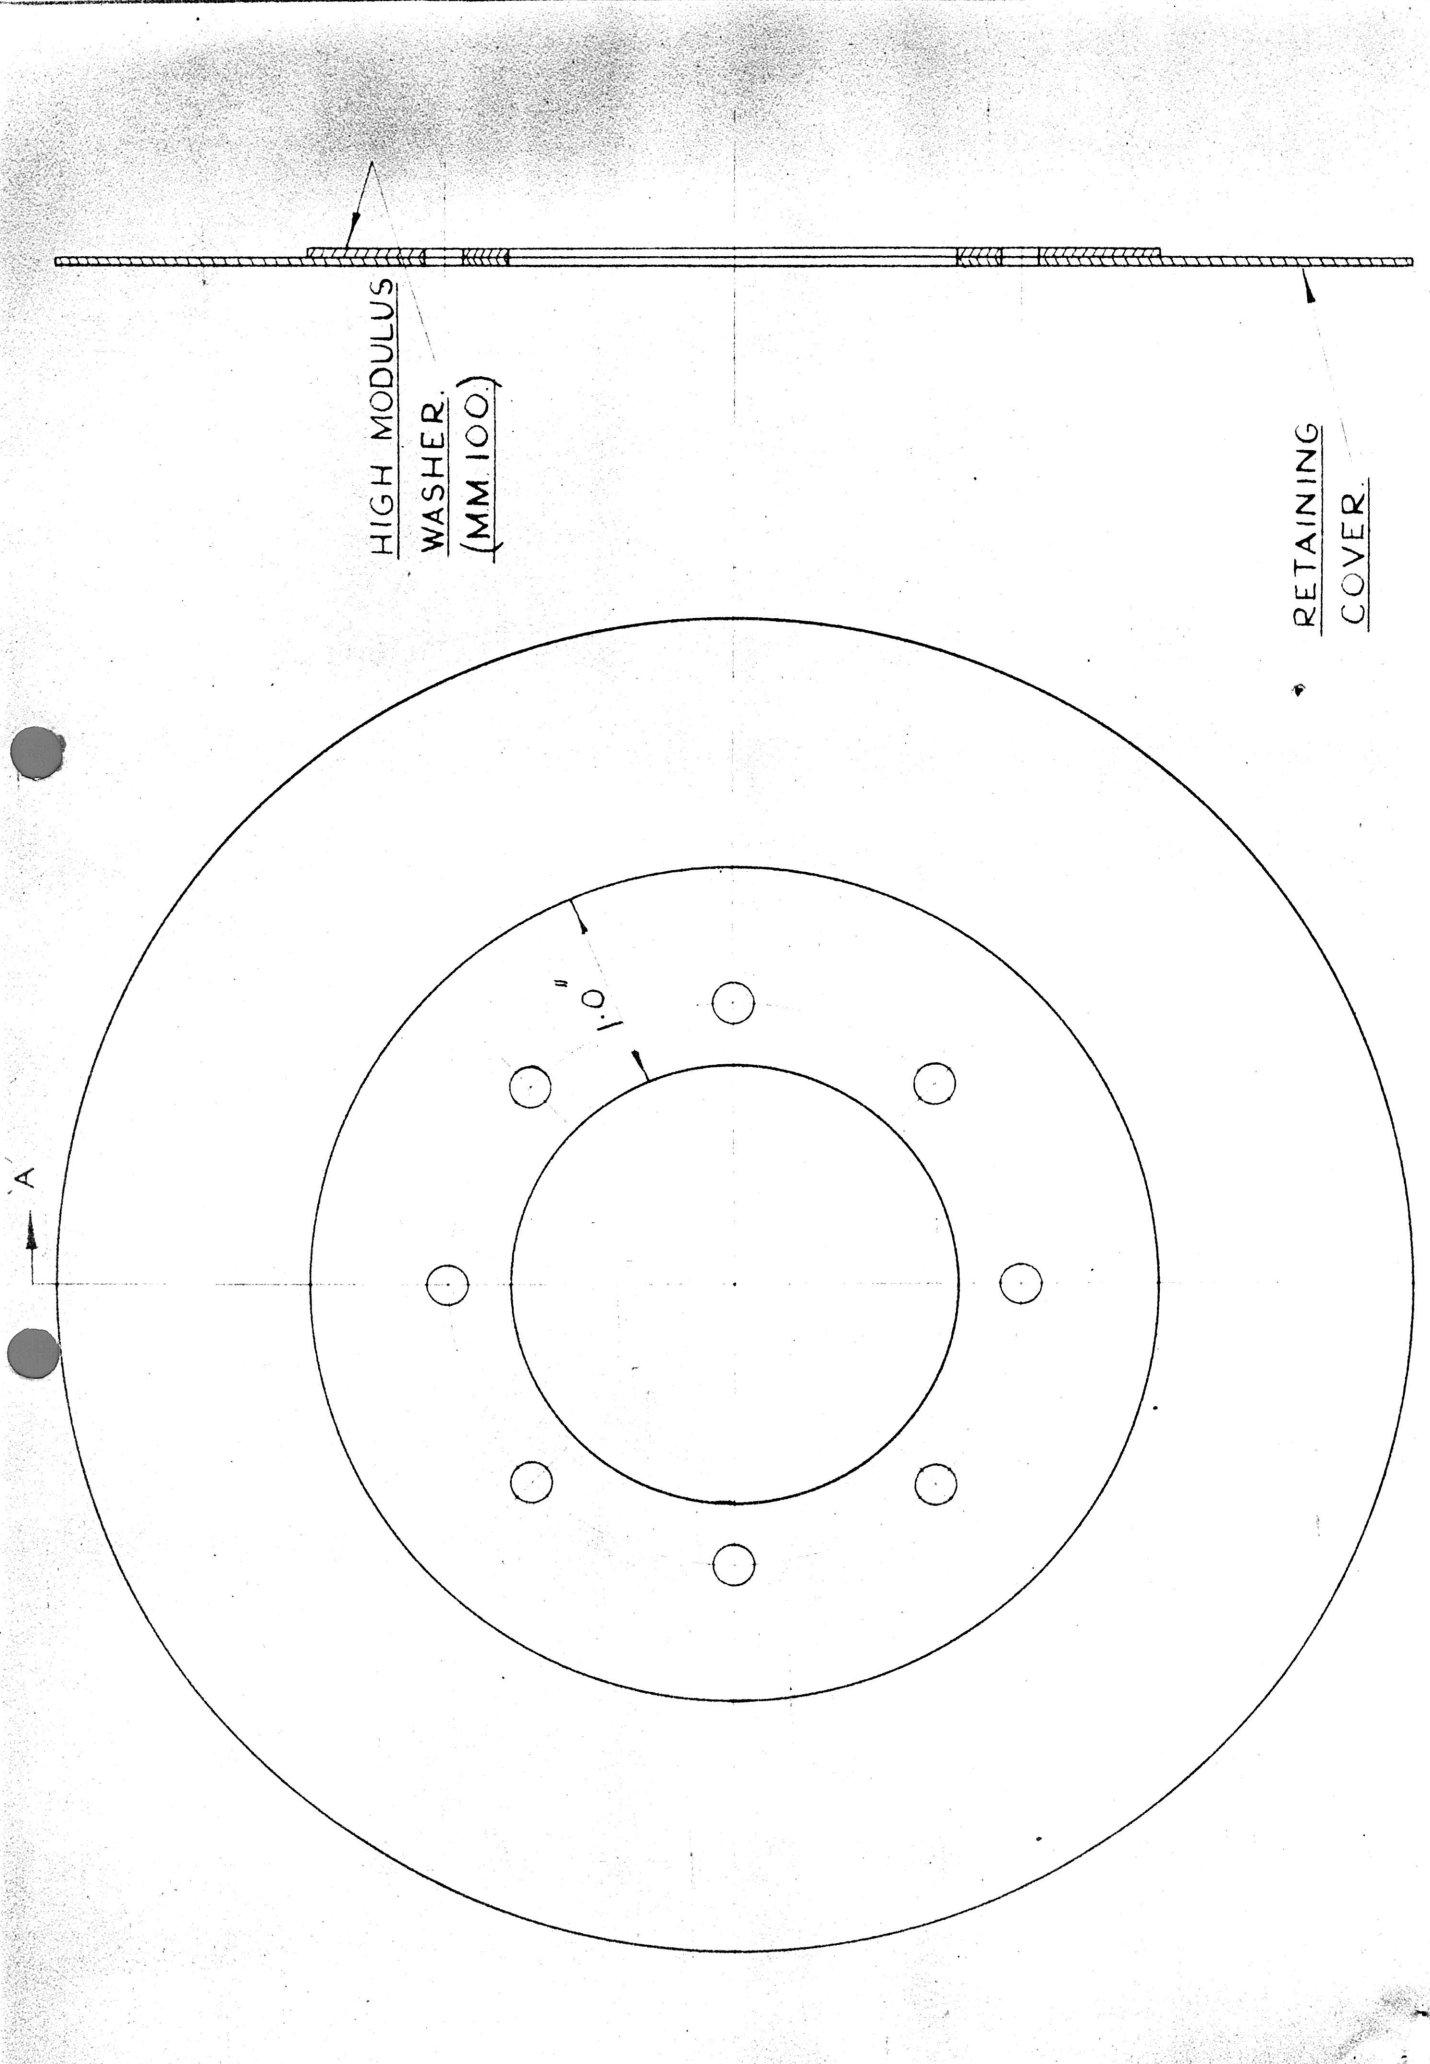
FIGURE 5.

15. When the holes have been punched in the new patch, the original tank lining should be pulled away from the patch over the area which has not been cemented. The old material can then be cut away around the marked circle, taking great care to ensure that the line of cutting is $\frac{1}{8}$ " clear of the flange of the fitting. Part of Fig. 5 illustrates this stage in the repair.

17. When the adhesion of the patch is complete, punch stud holes using the already punched holes in the interior patch for location. See Fig. 5.

COMPLETION OF INTERNAL PATCH, WITH TANK LINER CUT BACK, AND EXTERNAL PATCH SHOWN IN POSITION.

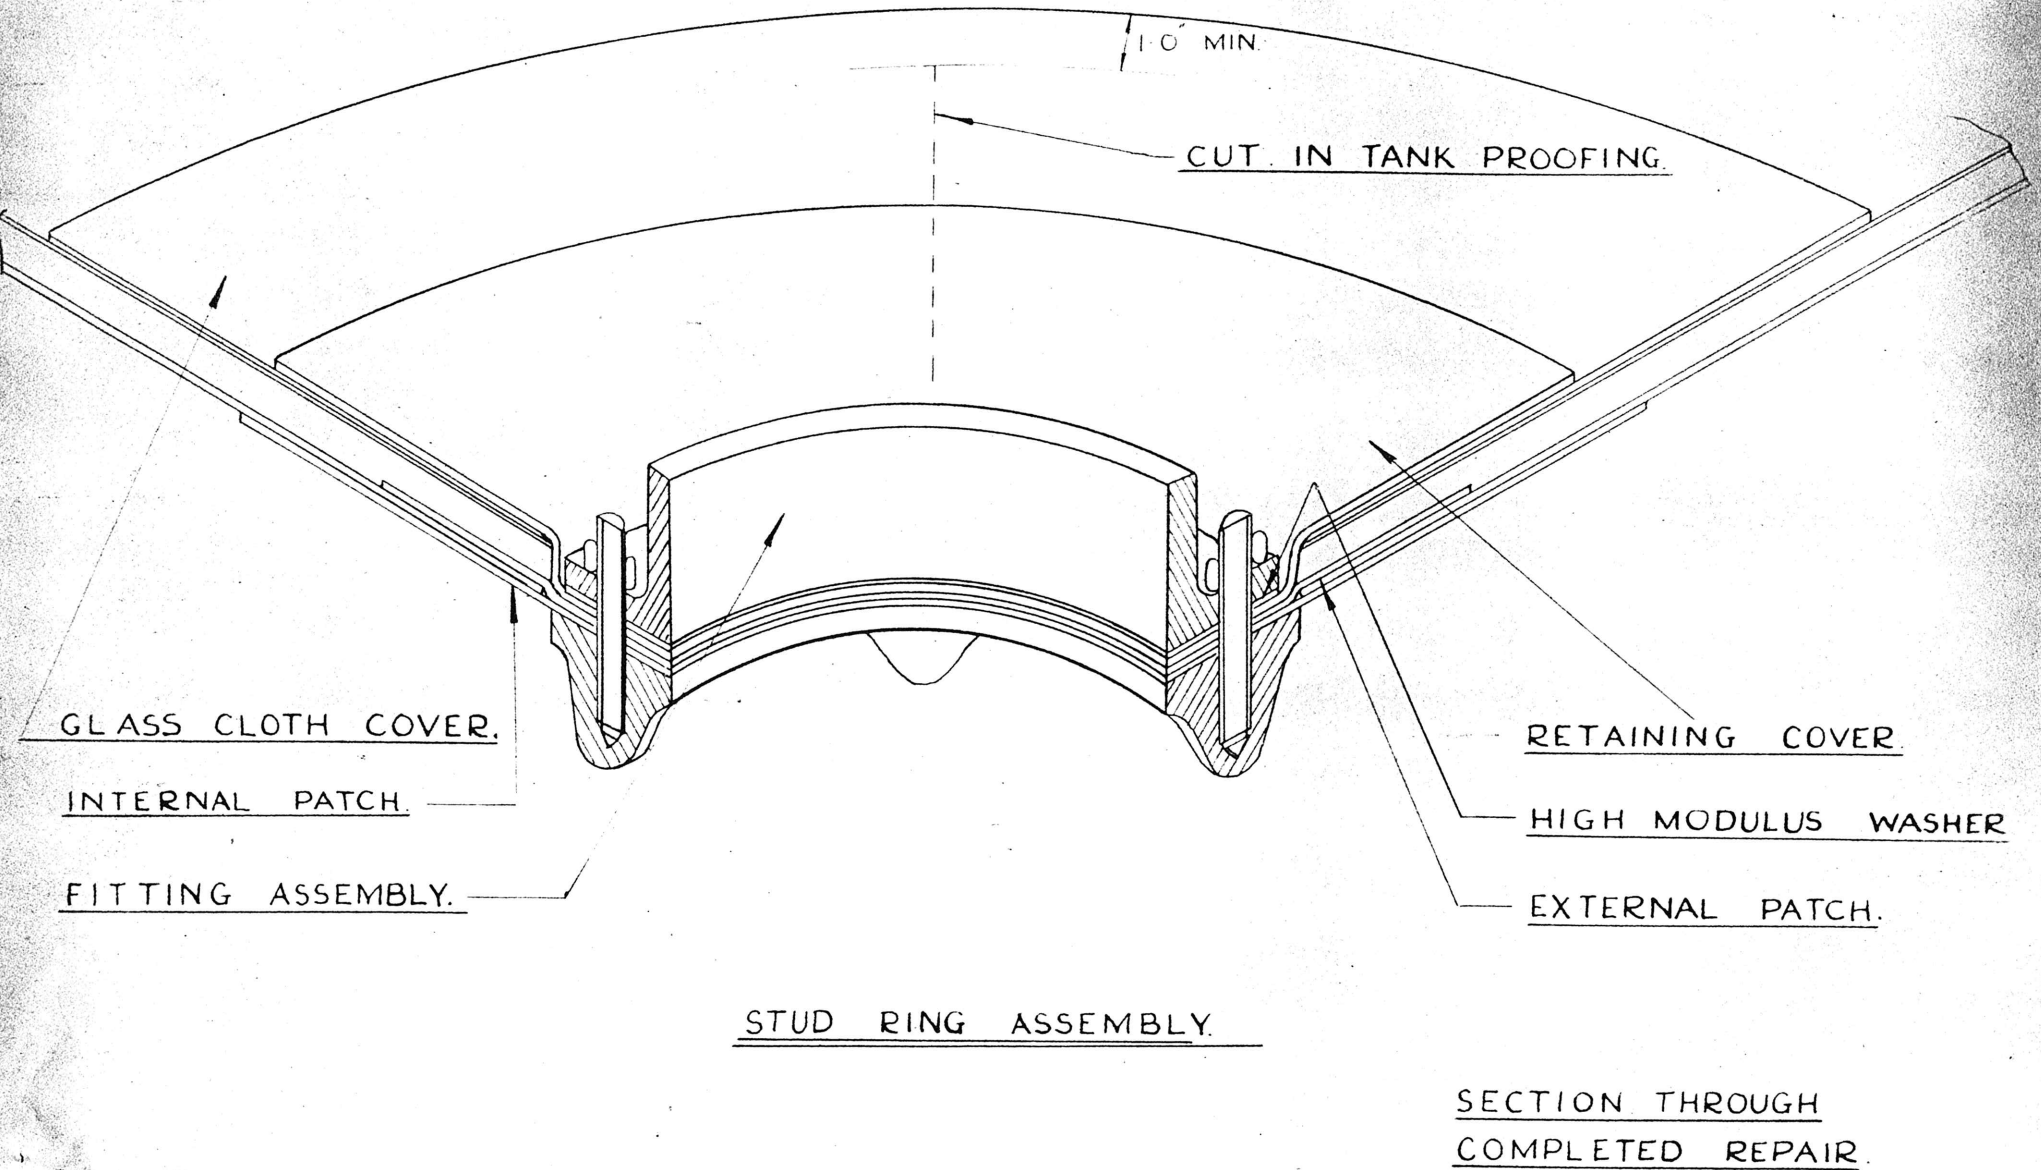
FIGURE 6.

21. When the MM.100 washer has been well rolled into position, the holes for the studs may be marked off using the fitting flange as a template, and the holes may then be punched. See Fig. 6.
