## TECHNICAL NEWS SHEET

SERIES V No 322

DATE 13.5.52.ISSUED FOR THE GENERAL GUIDANCE OF OPERATORS OF DE HAVILLAND AIRCRAFT AND ENGINES  
OFFICIAL INSTRUCTIONS TAKE PRECEDENCE OVER ANYTHING CONTAINED IN THIS BULLETINVAMPIRE AIRFRAME, GENERAL CIRCULATION.  
SUB HEADING 11, ELECTRICAL EQUIPMENT.Circuit Breakers, Type 'A', Stores Ref. 5C/2559,  
60, 61, 62, 63 and 64. Use with Trip Button  
Covers, Stores Ref. 5C/3610.

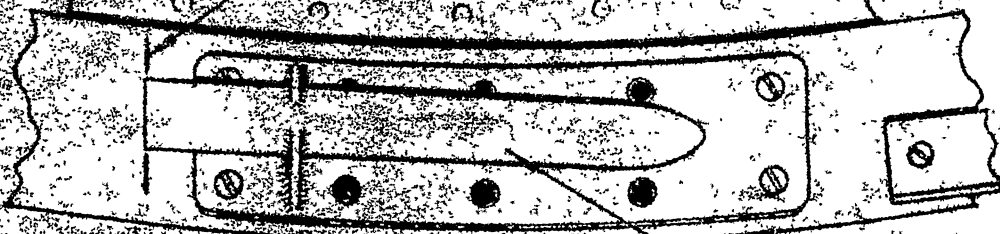
Fig 1

PENCIL LINE DRAWN ON WALL IN LINE WITH THE END OF THE GUIDE

(4) Adjustment Mark a pencil line on the structure level with the end of the plunger guide (A) as shown in Fig.1. Disconnect the undercarriage door and remove the wheel.

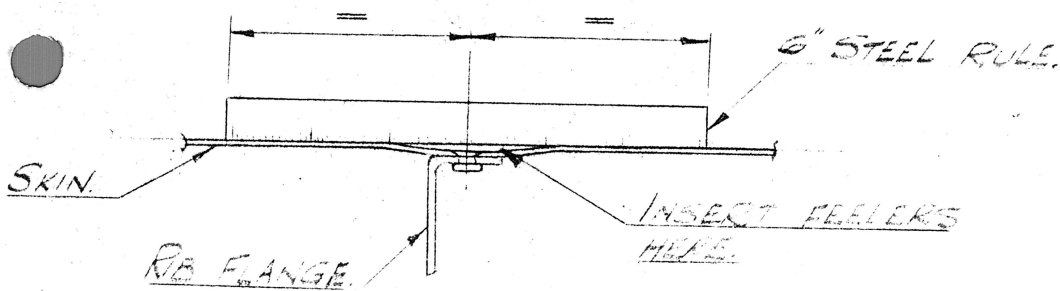
FIG. 2.

The resultant deformation shows in the form of local bumps at the stringer rib intersections which gives the appearance of depressions along the rib flange between the stringers. These can be as high as .035" measured as shown in Fig. 2. without affecting the strength of the complete wing.

A six inch straight edge is to be laid over the distortion, and must be placed in a spanwise direction as near as possible, parallel to the nearest stringer. The depth of the depression is then measured with feelers (See Fig 2).

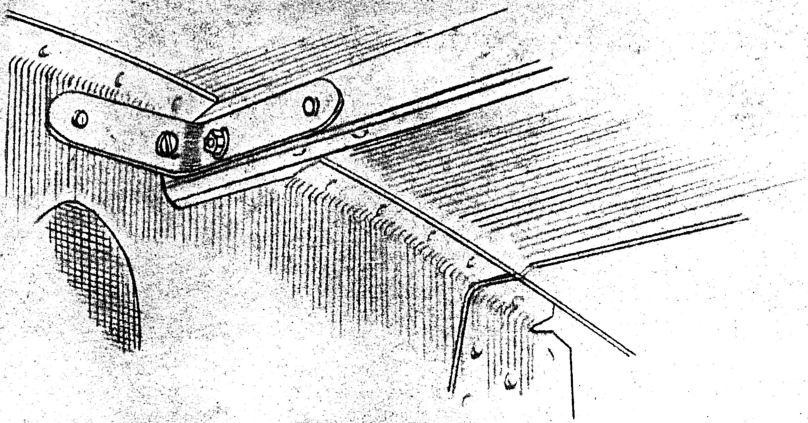
FIG. 3.

In the present construction of the wing, the stringers are attached to the Ribs by angle brackets - (See Fig. 3).

ANGLE BKT. ATTACHMENT.

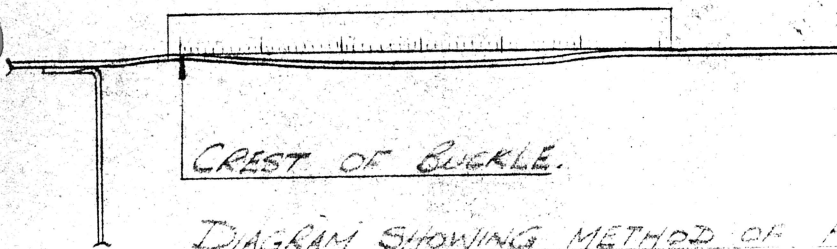
FIG. 4.

DIAGRAM SHOWING METHOD OF POSITIONING  
STRAIGHT-EDGE FOR MEASURING ALONG  
LINES 'AA' AND 'BB'

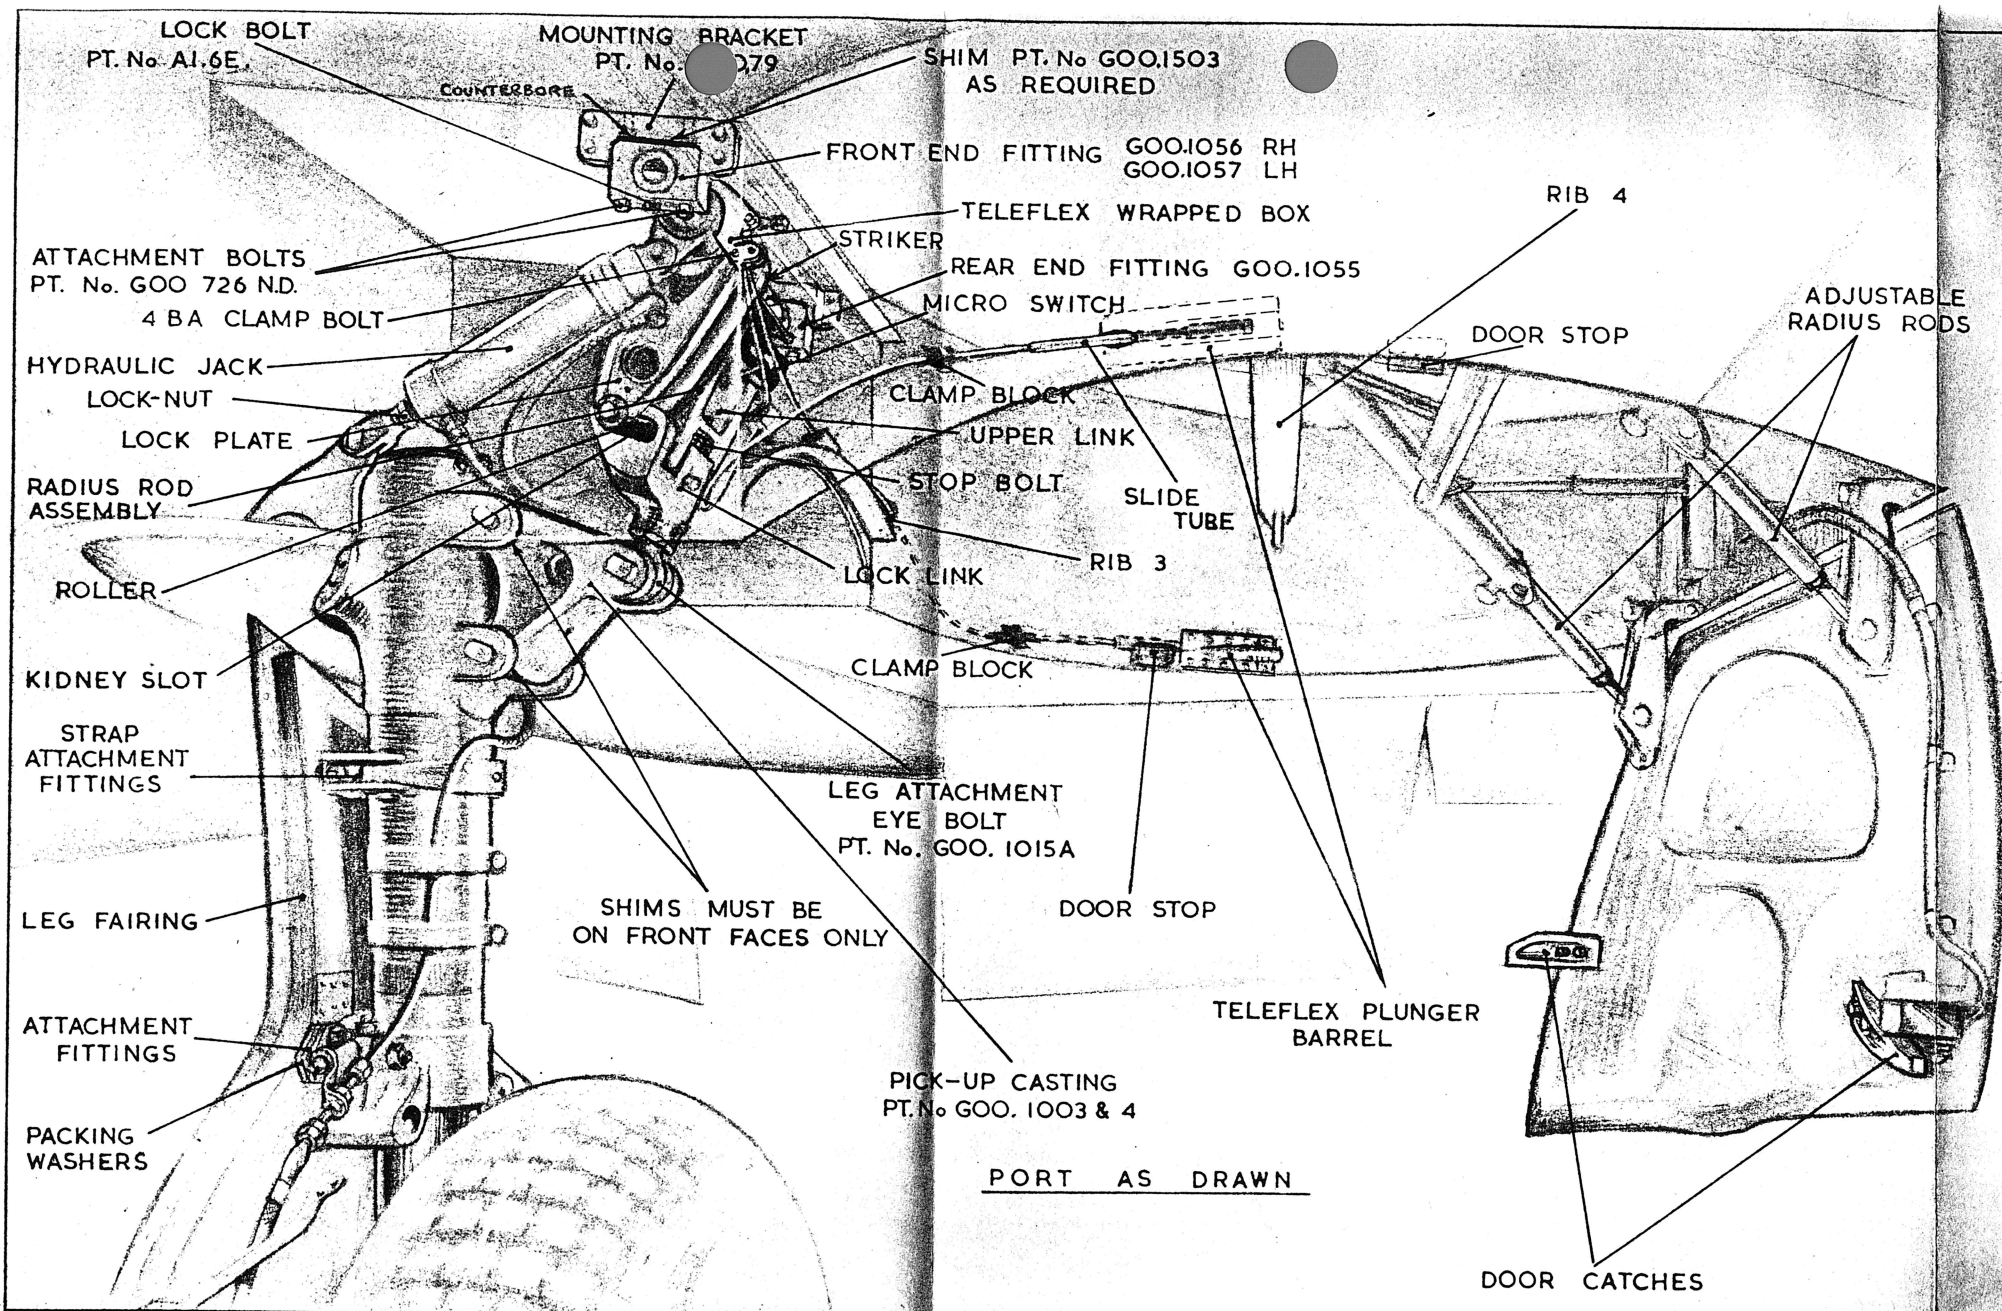
UNDERCARRIAGE ADJUSTMENTS VAMPIRE ALL MKS

3. As a result of conduits being found bent and in a semi-seized condition, special attention is drawn to S. I. Vampire 32 headed "Breakage of undercarriage door lock teleflex cables".
