# DE HAVILLAND SERVICE

## TECHNICAL NEWS SHEET

### INDEX series V (Vampire Airframe, General Circulation)

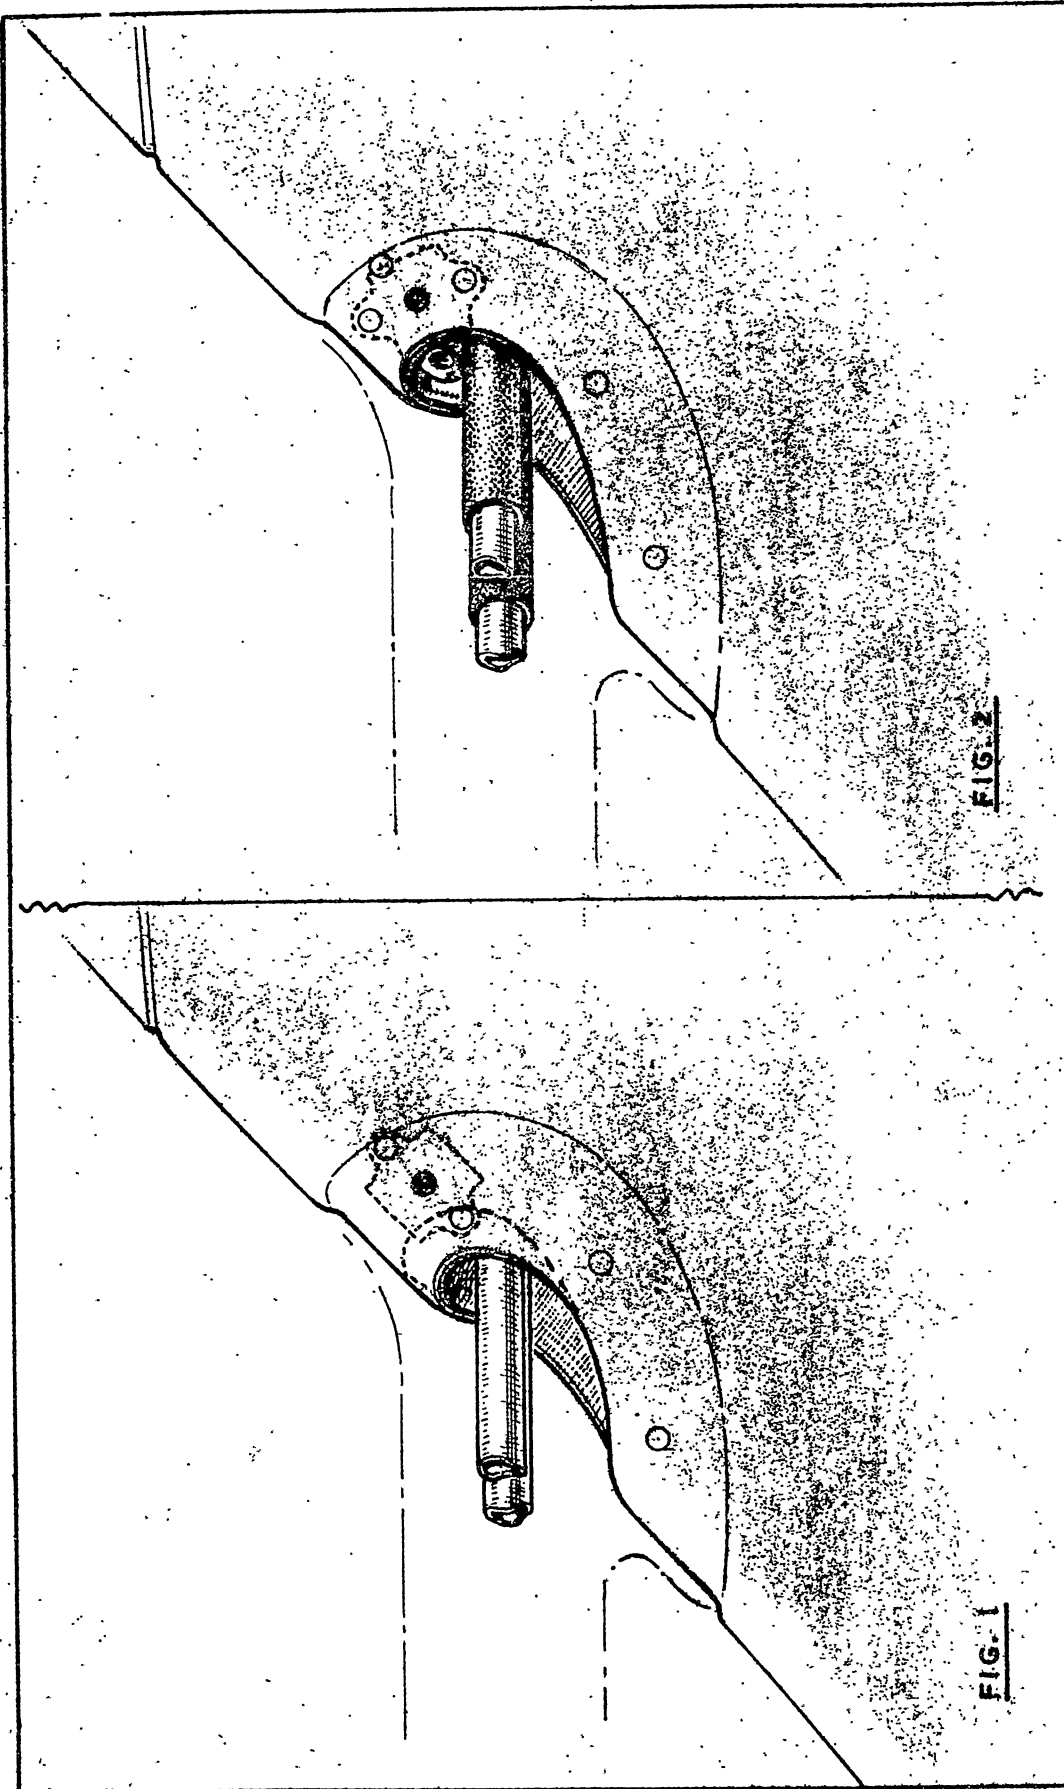
INDEX continued over-leaf

- (b) Examine the top two 4B.A. anchor nuts shown on ( Drawing ROOJ.75 attached) and if they are found to be secured as shown in fig.1. they are to be removed and rotated on their existing centre to the positions shown in fig.2. This is with their straight edge parallel to the fins of the joggle in the fin skin.
- (c) Cut the top half of the aperture back to the edge of the top anchor nuts and blend it with the lower half. Radius the edges and apply protective treatment.
- (d) Slide on over each pipe approximately two inches of protective sleeving. Sisto-flex or any suitable dimensioned rubber tubing may be used. The tubing to be positioned to provide protection for the pipes through the aperture.
- (e) Re-assemble the pipe connections and pitot head and test the system as laid down in the relevant publication.

- (a) Remove the pitot head and the connections on the ends of the relevant pipes from the fin.
  - (b) Examine the two top 4B.A. anchor nuts shown on (Drawing ROOJ. 75 attached) and if they are found to be secured as shown in fig. 1 they are to be removed and rotated on their existing centre to the positions shown in fig. 2. This is with their straight edge parallel to the edge of the joggle in the fin skin.

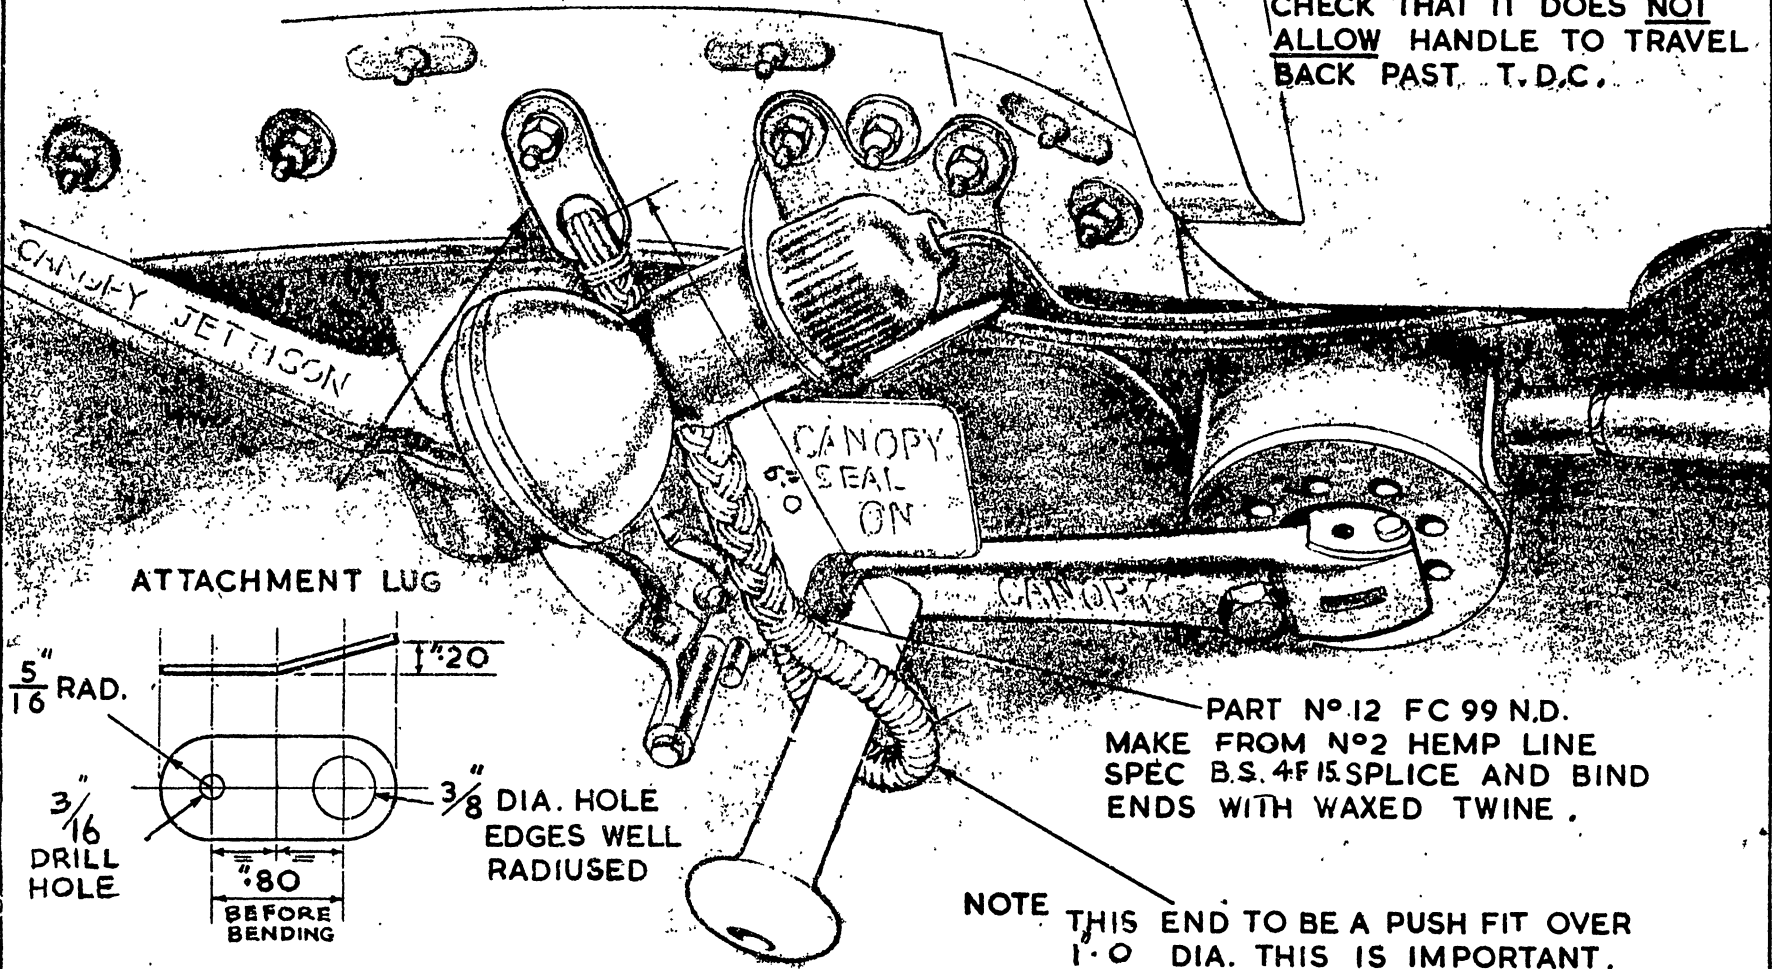
WHEN LANYARD IS FITTED  
CHECK THAT IT DOES NOT  
ALLOW HANDLE TO TRAVEL  
BACK PAST T.D.C.
