DE HAVILLAND SERVICE

TECHNICAL NEWS SHEET

SERIES V. No 531

VAMPIRE AIRFRAME, GENERAL CIRCULATION.
SUB HEADING 8 GENERAL.

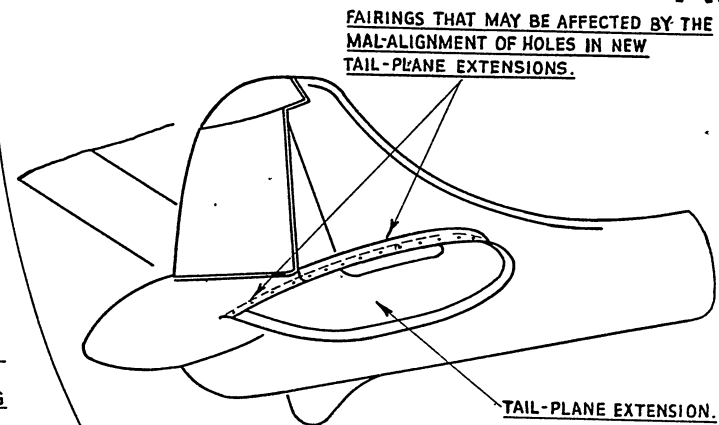
TYPICAL VIEW OF TAIL-PLANE EXTENSION.
(SEA VENOM MK. 20 DRAWN.)

THE SCHEME SHOWN BELOW CAN BE APPLIED TO A FLANGE WITH ANY NUMBER OF REDUNDANT HOLES.

THE DIMPLES OF HOLES FOUND REDUNDANT SHOULD BE FLATTENED.

PATCH PLATE.
18 SWG. SPEC. D.T.D. 610
LENGTH TO SUIT.

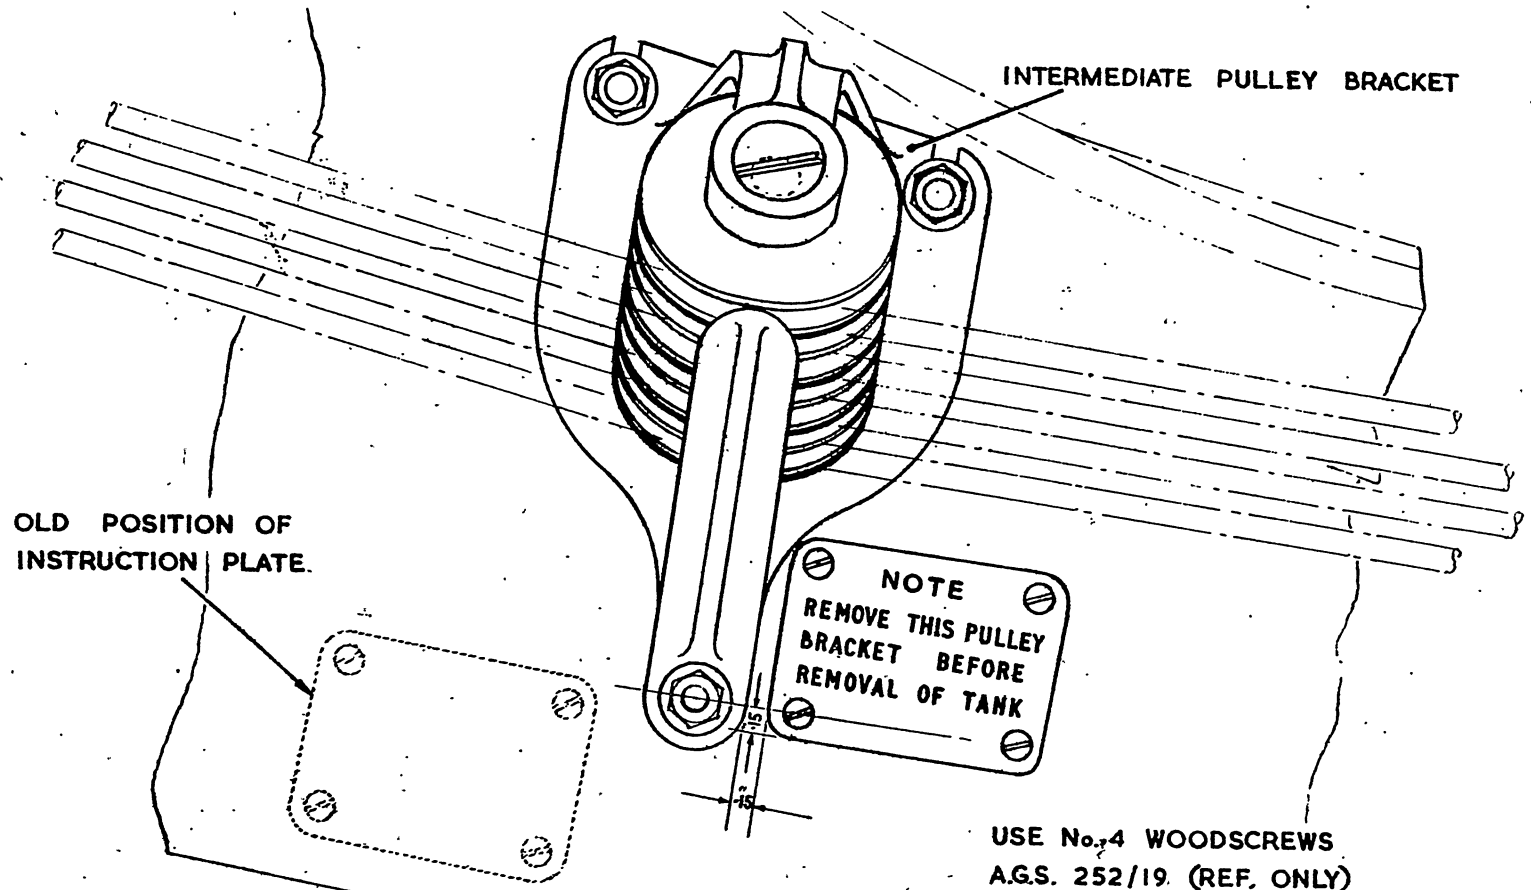
INTERMEDIATE PULLEY BRACKET

OLD POSITION OF INSTRUCTION PLATE.

Future aircraft produced will have the label positioned as per the Drawing R.12.FS.178. Action is in hand to include appropriate instructions regarding the removal of the pulley bracket in the relevant manuals.

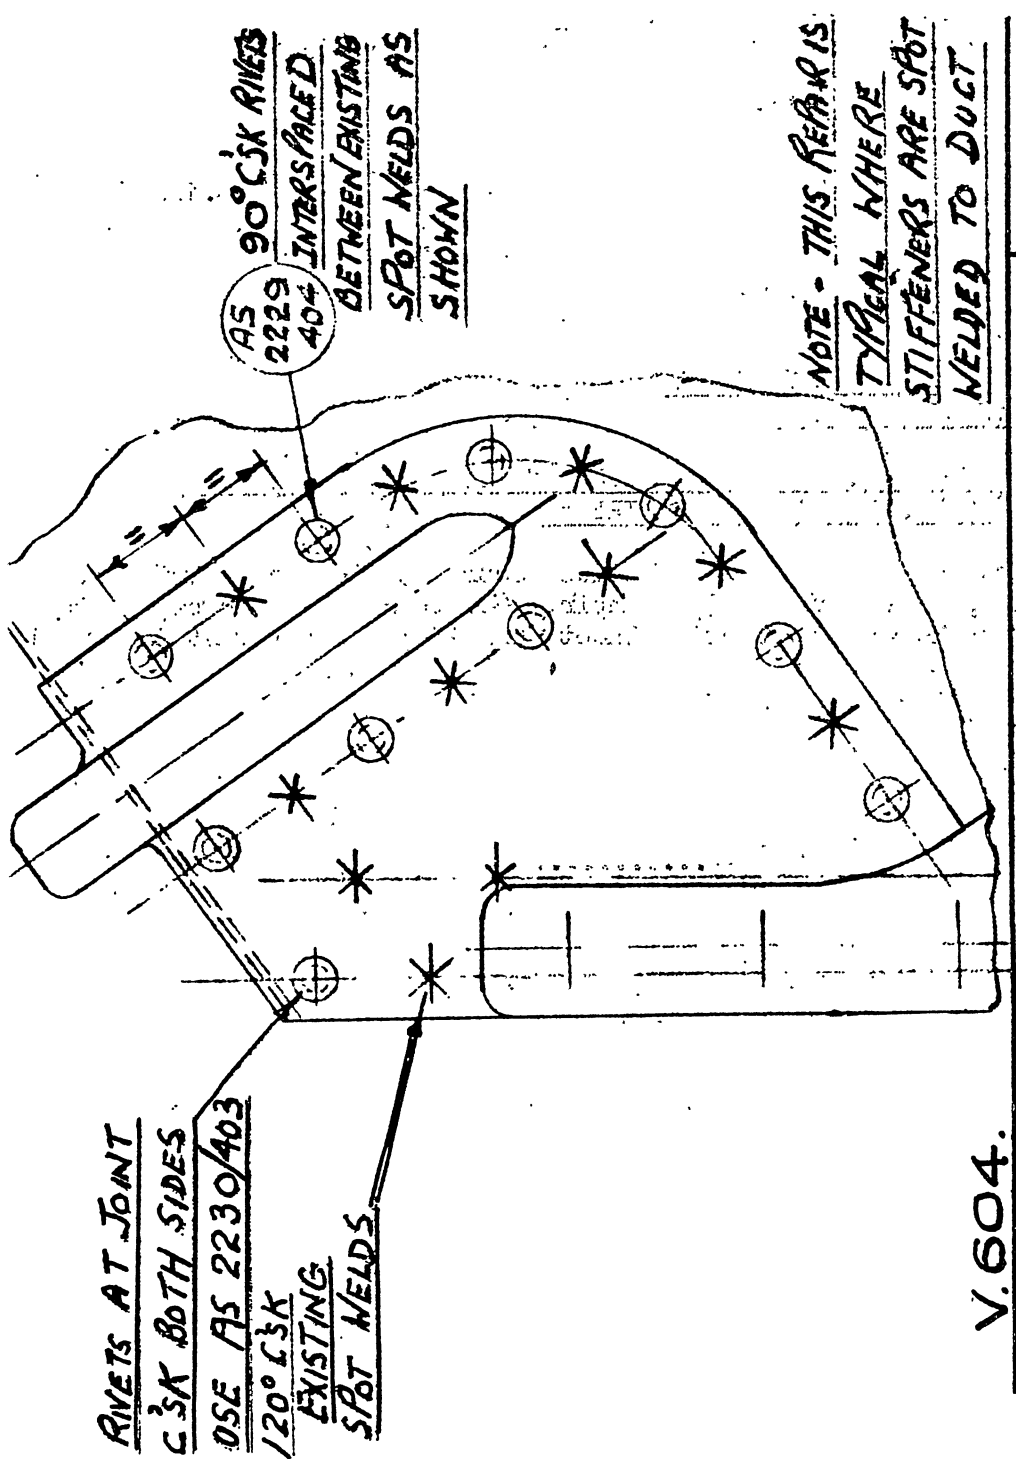
R.I.S. 138.

Where failure of the spot welds occurs on Air Ducts Part Nos. DOO and DOO1997A/2, Post Modification Vampire 880, these may be repaired in accordance with Repair Instruction Sheet No. 138; the relevant drawing is attached.

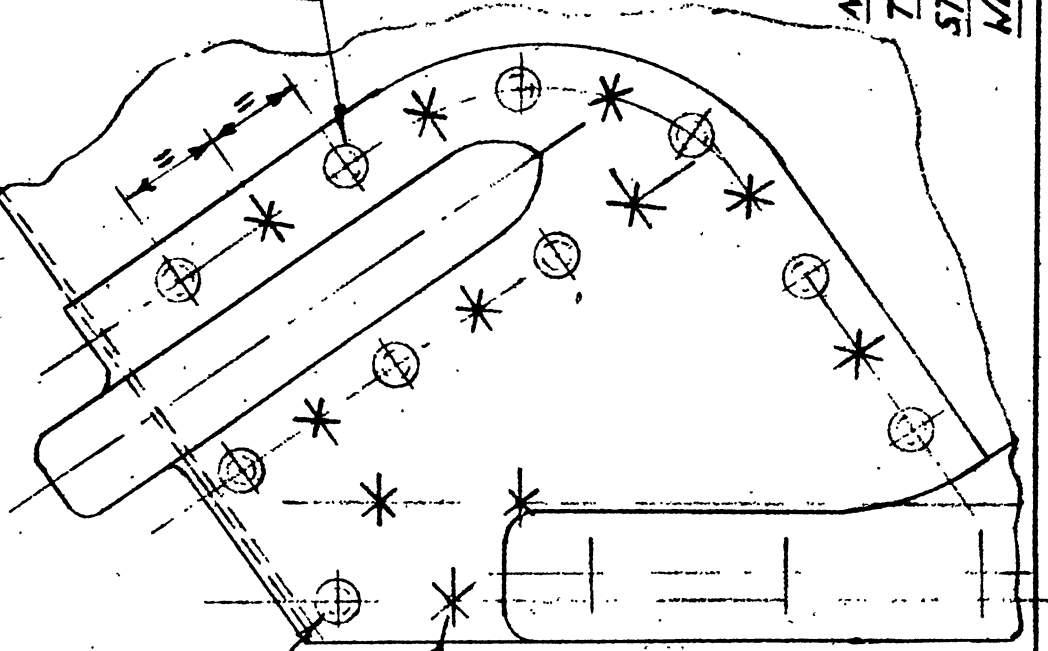
V.604.

NOTE - THIS REPAIR IS
TYPICAL WHERE
STIFFENERS ARE SPOT
WELDED TO DUCT

AS 2229
404
90° C3K RIVETS
INTERSPACED
BETWEEN EXISTING
SPOT WELDS AS
SHOWN

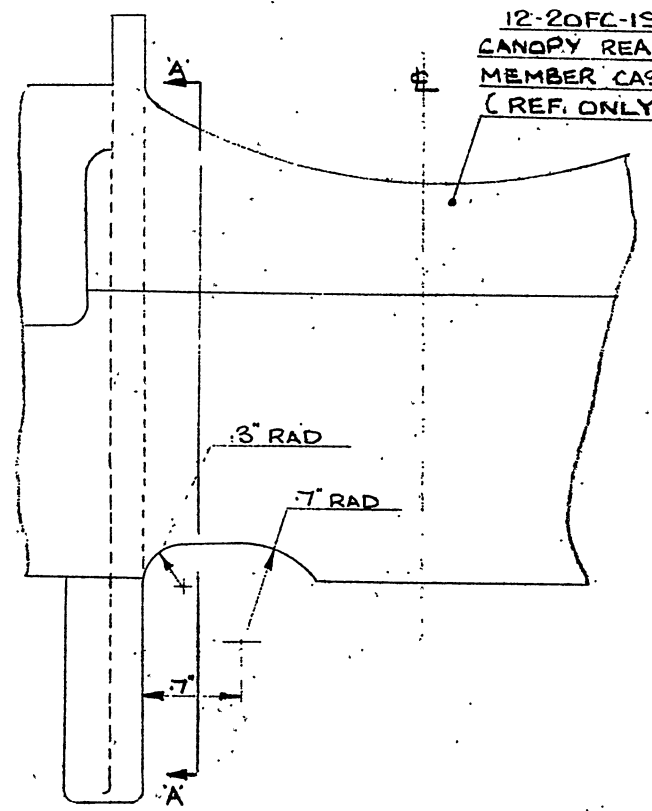
PART VIEW ON 'A-A'
SHOWING BEAD RELIEVED.

SCRAP VIEW SHOWING CUT-OUT TO
GIVE ADDED CLEARANCE FOR ROLLER
LEVERS.

TREATMENT:- SELENIOUS ACID IN
ACCORDANCE WITH D.T.D. 911

REPAIR TO:- CUT-OUT IN CANOPY
