Australian Air Publication 721.79

**Volume 2, Part 2
Book 3**

VAMPIRE MODIFICATIONS

(Nos 201 to 300)

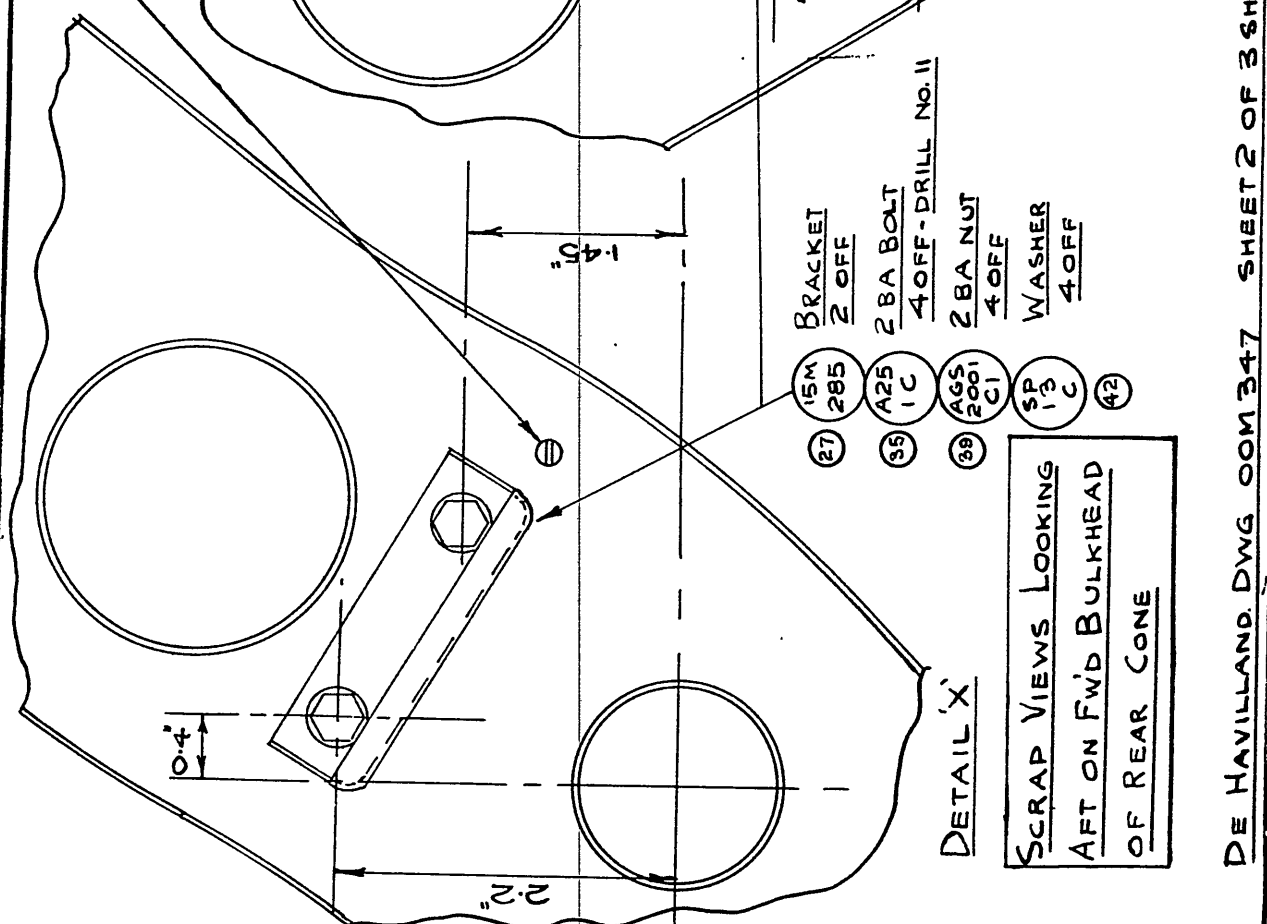
DE HAVILLAND DWG 00M347 SHEET 2 OF 3 SHEETS

REPOSITION BOLT FOR P-CLIP
TO CLEAR BRACKET AS & WHEN
NECESSARY

REFERENCE		ISSUED BY		TITLE	
				INSTALLATION OF FIRE EXTINGUISHER MOUNTING BRACKETS ON REAR CONE	
LIMITS UNLESS STATED	MATERIAL			COMPONENT OF	SAFETY EQUIPMENT
DECIMALS ± .010"	SPEC.			MACHINE	VAMPIRE MK 33
FRACTIONS ± 1/32"	TREATMENT			ENGINE	GOBLIN
ANGLES ± 1°	FINISH			TECH. ORDER	VAMPIRE MOD. NO 204
SURFACE FINISH	SCALE			DRAWING NO.	A 12969/2
AUSTRALIAN STANDARD	DRAWN	B.J.G.	APPROVED	DRWG. A SIZE	
ENG. DRWG. PRACTICE A.S.21	TRACED		CHECKED

- (viii) Repair the finish as necessary using aluminium cellulose enamel, item 6.
- (ix) If Vampire Mods. 227 and 204 (D.H. Aust. Mods. V. 702 and V. 609) are being incorporated concurrently, re part-number the cone EC15-3AND, and re-assemble on the aircraft using existing attachment items. If the other modification is not being incorporated do not alter the part number.

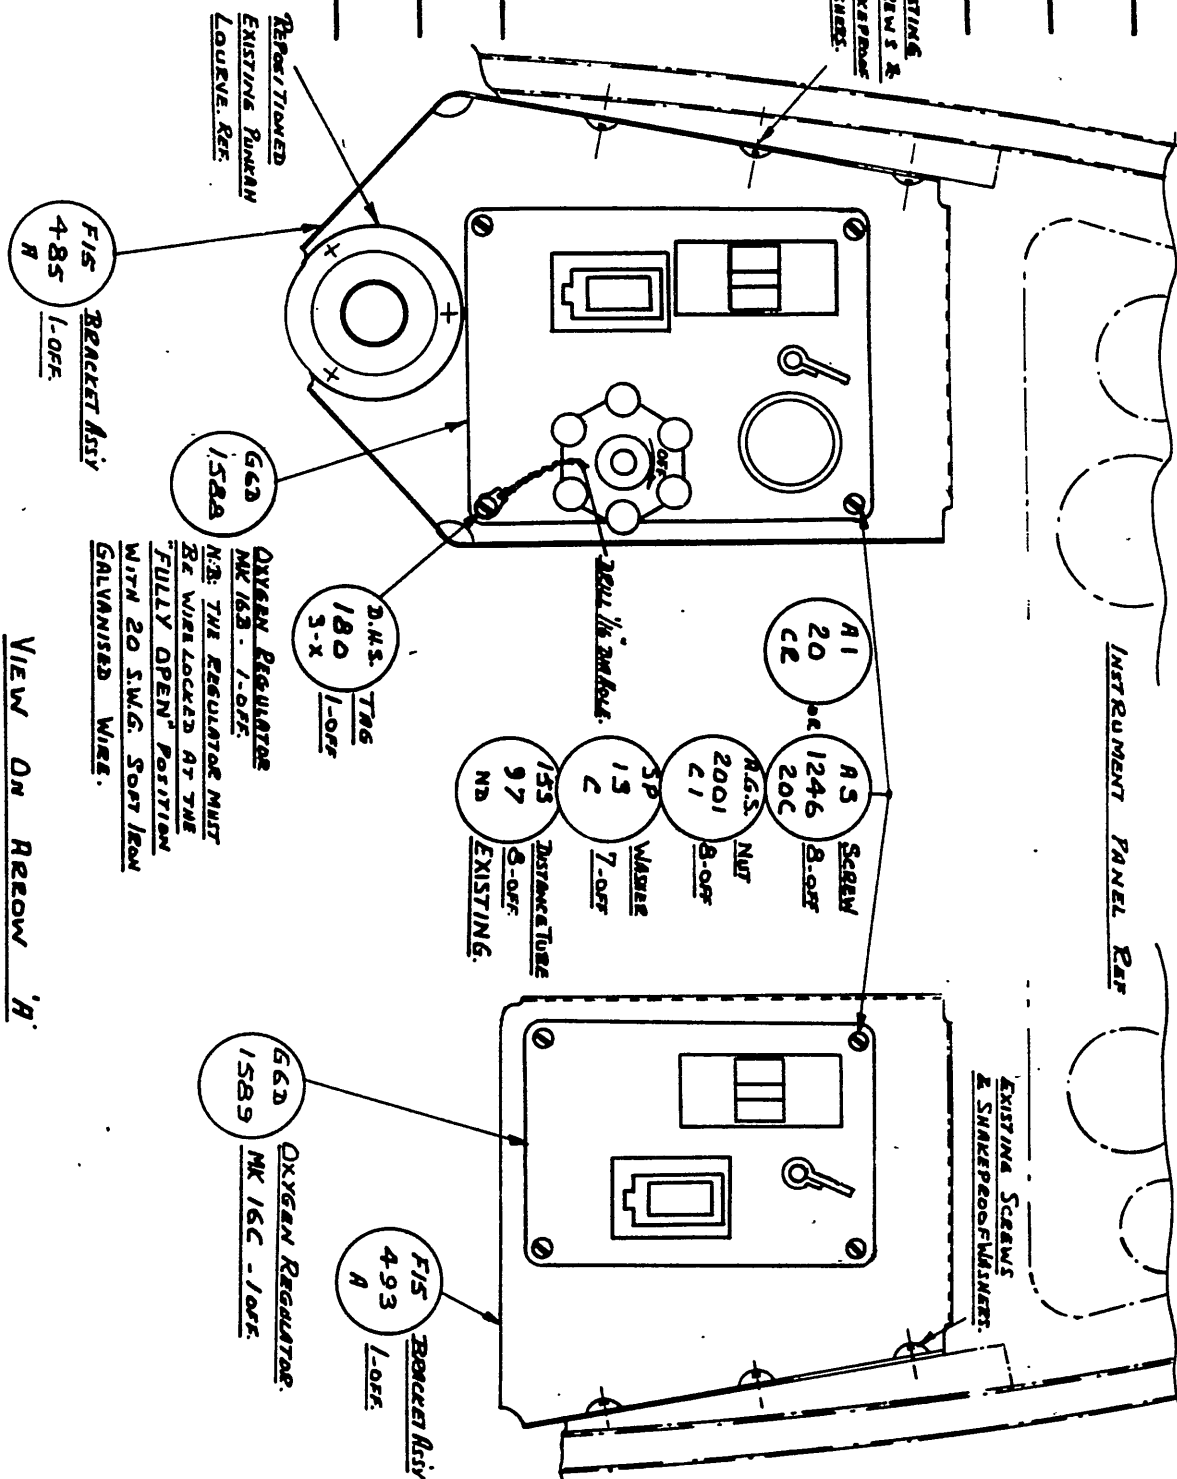
DE HAVILLAND DRAWING N° DOM 356 SHEET N° 2 OF 3 SHEETS.

REFERENCE		ISSUED BY				TITLE	
		DEPARTMENT OF AIR DIRECTOR GENERAL OF ENGINEERING				ASSEMBLY OF OXYGEN REGULATORS 2 MOUNTING BRACKETS.	
LIMITS UNLESS STATED		MATERIAL				COMPONENT OF	
DECIMALS	± .010"	SPEC.				MACHINE	VAMPIRE MARK 83
FRACTIONS	± 1/32"	TREATMENT				ENGINE	GOBLIN
ANGLES	± 1°	FINISH				TECH. ORDER	
SURFACE FINISH		SCALE				DRAWING NO.	A 12894 SHEET 2
AUSTRALIAN STANDARD		DRAWN		APPROVED			
ENG. DWG. PRACTICE A.3.121		TRACED		CHECKED			
							DWG. A SIZE

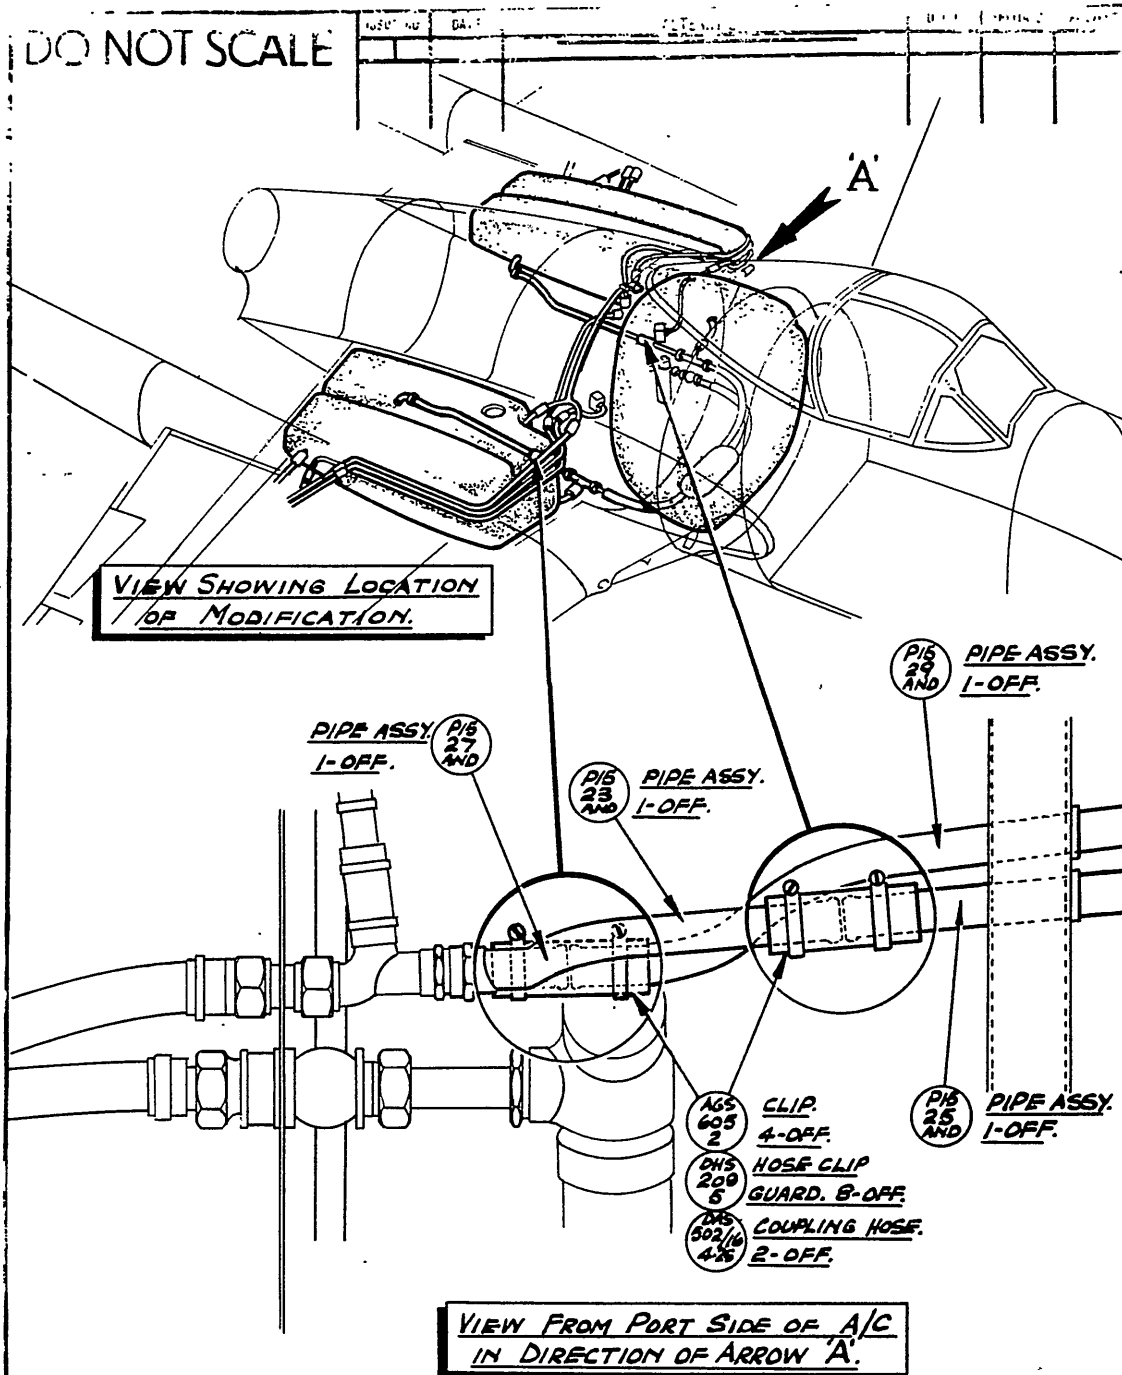
DEHAVILLAND DRWG. No. 00M316. NO OF SHEETS. 1.

REFERENCE	ISSUED BY		TITLE	
			FUEL FEED LINES - FLEXIBLE JOINTS - INTRODUCTION.	
LIMITS UNLESS STATED	MATERIAL		COMPONENT OF	
DECIMALS $\pm .010"$	SPEC.		MACHINE	
FRACTIONS $\pm \frac{1}{32}"$	TREATMENT		ENGINE	
ANGLES $\pm 1^\circ$	FINISH		TECH. ORDER	
SURFACE FINISH	SCALE		DRAWING NO.	A12640
AUSTRALIAN STANDARD	DESIGN	APPROVED		
ENG. PRWG. PRACTICE A.S.21	THAGED	CHECKED

1. This modification authorizes the introduction of a flexible fuel joint to the fuel feed lines, that run from the port and starboard No. 1 wing tanks, at the rear of rib 1, past the lower cowl supporting ring, to elbows on the fireproof bulkhead. Difficulty has been experienced when it became necessary to replace, on the aircraft, either a port, or starboard pipe in one length. This modification now allows the fitting of the pipe line in two separate lengths, joined by a rubber hose connection.

(iv) Refer to A.A.P. 702.1 A.E.I.Gs Part 6, Instruction No. 5. If fuel feed pipes Part No. P003615AND, Ident No. A79/503134 Starboard or Part No. P003611AND, Ident No. A79/503133 are to be placed in the aircraft and they are found difficult to fit, refer to attached drawing, cut the pipe, clean with file, and remove the filings, bell to suit.

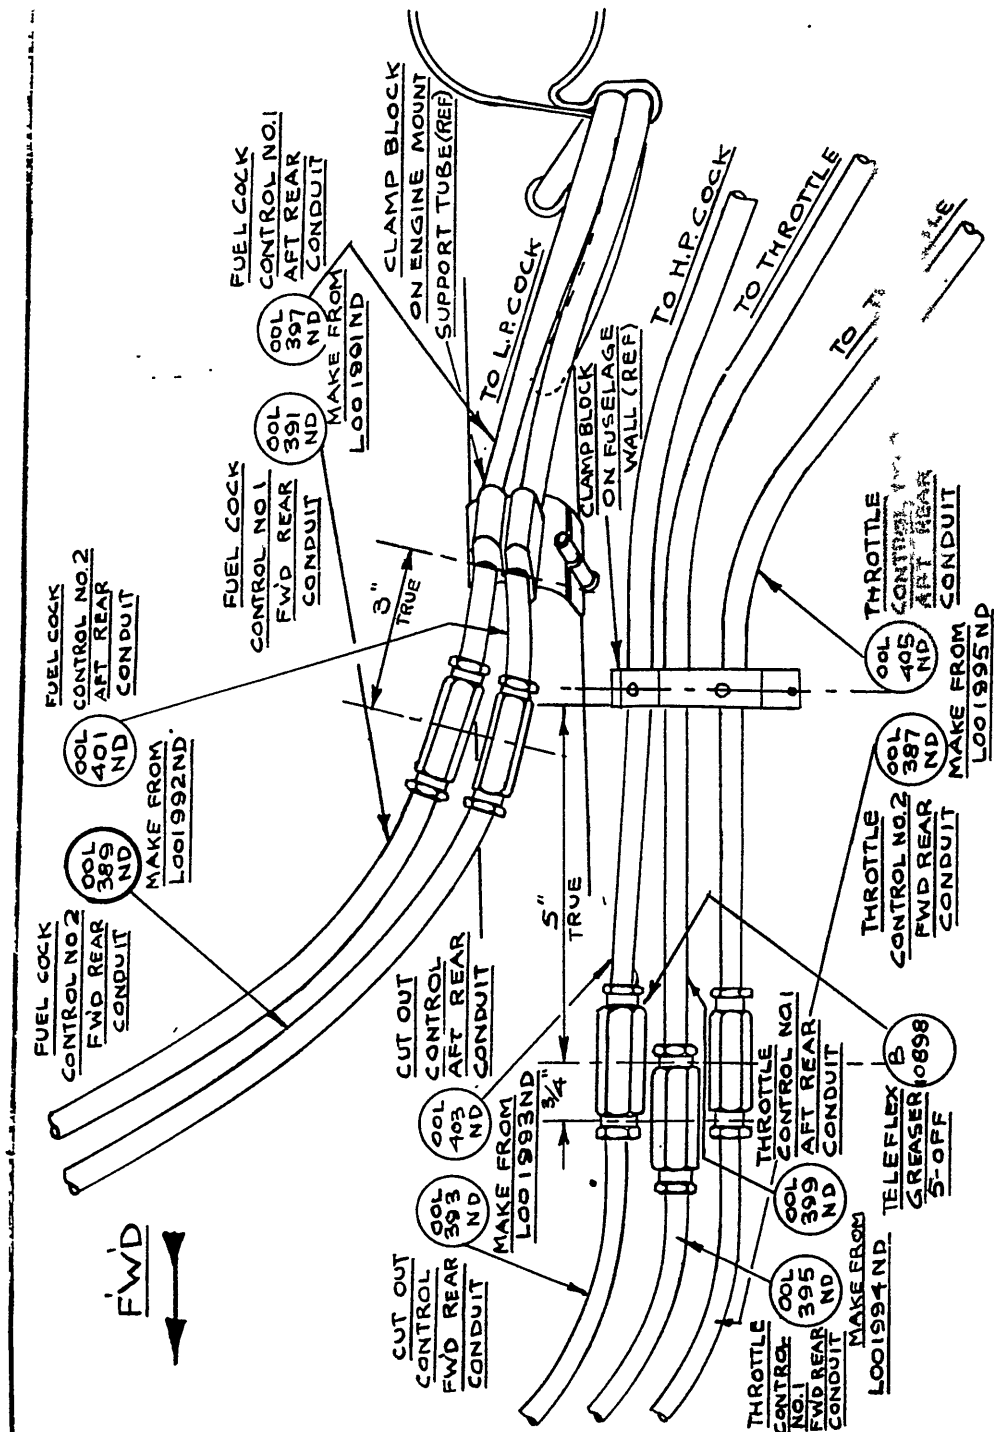
DE HAVILLAND DWG OOM-346 SHEET 1 OF 1 SHEET

VIEW ON TELEFLEX CONTROLS IN MAIN TANK BAY
LOOKING TO STARBOARD WITH FUSELAGE SKIN REMOVED

- (xxii) Replace the Reflex control clamp block removed in para (viii) using the attachment items retained in the same paragraph.
- (xxiii) Re-rig the engine controls as per RAAF Publication No 828 Sect 4 Chapter 3 Para 124 and 125, and AEIG 7/1/7, using tab washers, item 2, on the turnbuckle connectors in the ammunition bay.

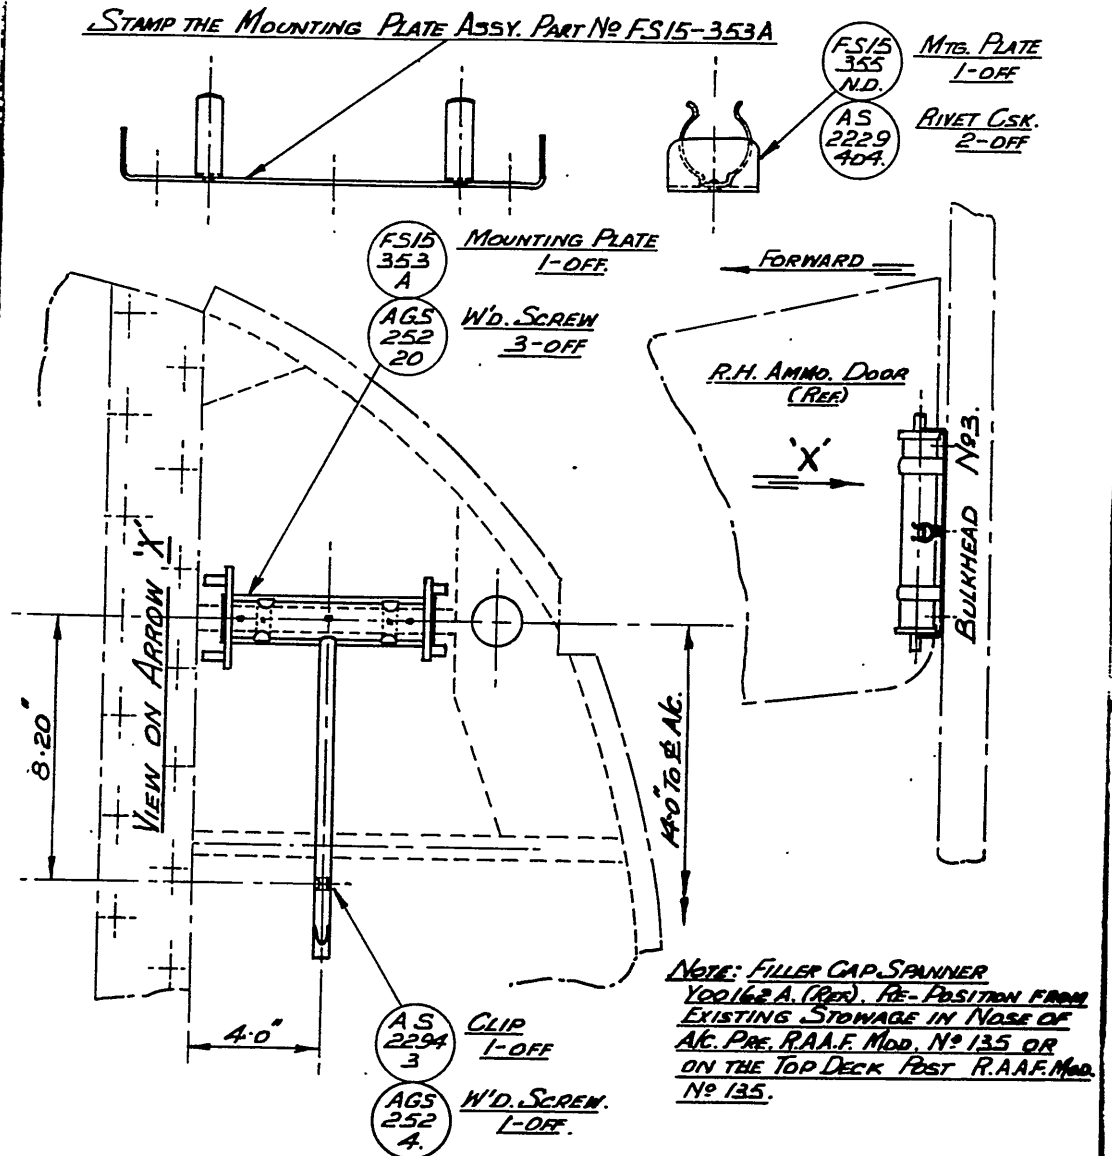
DE HAVILLAND DRWG. NO 00M 329 NO OF SHEETS 1.

STAMP THE MOUNTING PLATE ASSY. PART NO FS15-353A

- (iii) Open the starboard ammunition door, refer to the same drawing and mark off the positions for the mounting plate assembly and the spring clip, item 5, on the forward face of No. 3 bulkhead. Secure the mounting plate assembly into position with 3 woodscrews, item 2. Secure the spring clip, item 5, into position, with one woodscrew, item 3. Replace the tank filler cap spanner in the three clips and close the starboard ammunition door.

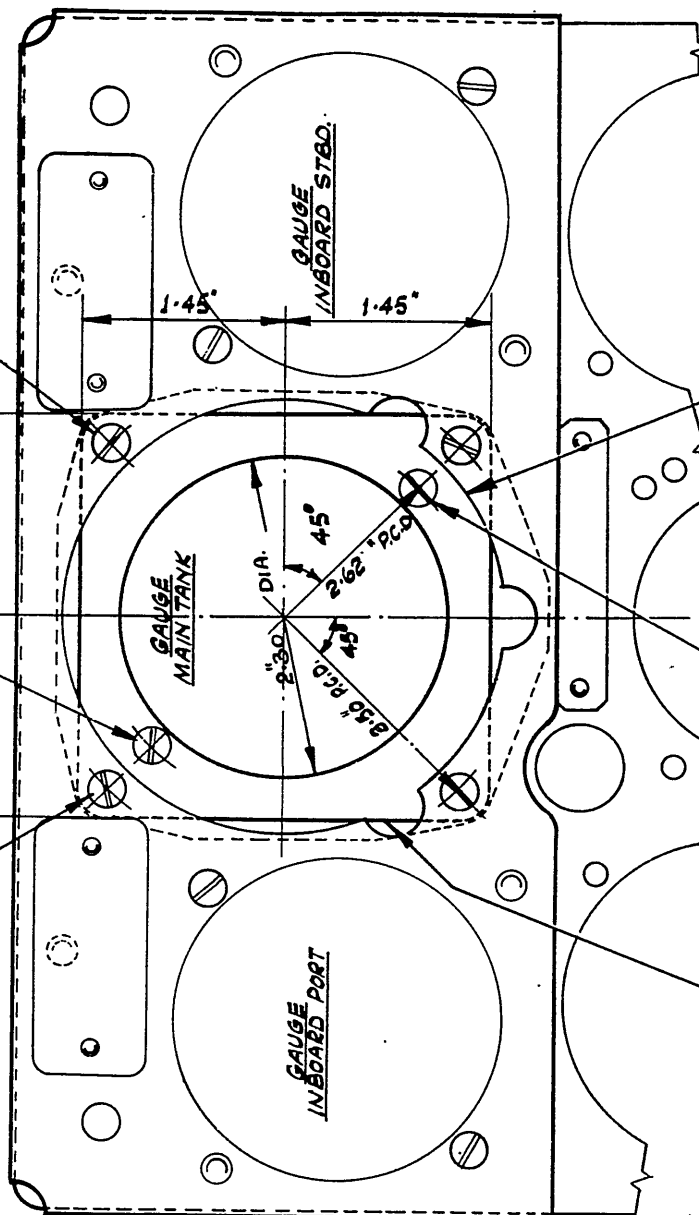
DRILL 2 HOLES IN ADAPTOR
PLATE WITH NO. 11 DRILL TO
LINE UP WITH THE HOLES IN
THE CONTENTS GAUGE.

DRILL 4 HOLES IN ADAPTOR
PLATE WITH NO. 25 DRILL TO
PICK UP WITH THE EXISTING
HOLES IN PANEL

REMOVE STOP CLOCK AND
RETAIN FOR REASSEMBLY.
ON STBD. INSTRUMENT PANEL.
FIT ADAPTOR PLATE & MAIN
TANK CONTENTS GAUGE PREVIOUSLY
IN POSITION IMMEDIATELY BELOW.

- (viii) Replace the bottom centre instrument panel, using the existing bolts. Reconnect the electrical connections to the main tank gauge and repair any paint finish locally with item 7.

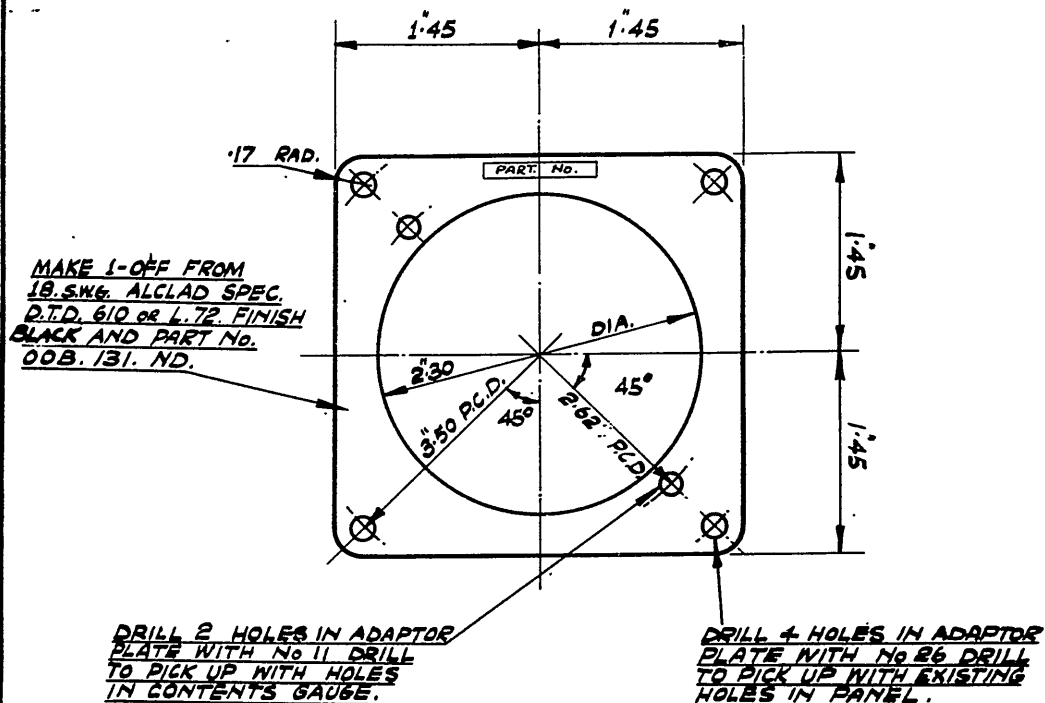
DE HAVILLAND DRWG. 00M327. No. OF SHEETS. 3. SHEET No. 3.

REFERENCE		ISSUED BY			TITLE		
		DIRECTORATE OF TECHNICAL SERVICES R. A. A. F.			FUEL CONTENTS GAUGE & STOP CLOCK ~ INTRODUCTION.		
LIMITS UNLESS STATED		MATERIAL			COMPONENT OF		
DECIMALS	± .010"	SPEC.			MACHINE	VAMPIRE MK 30 & 31	
FRACTIONS	± 1/32"	TREATMENT			ENGINE	NENE 2 V H	
ANGLES	± 1/2°	FINISH			TECH. ORDER	VAMPIRE MOD. No 231	
SURFACE FINISH		SCALE			DRAWING NO.	A12692	
AUSTRALIAN STANDARD		DRAWN	APPROVED				BRWG. A SIZE
ENG. DRWG. PRACTICE A.3.121		TRACED	CHECKED

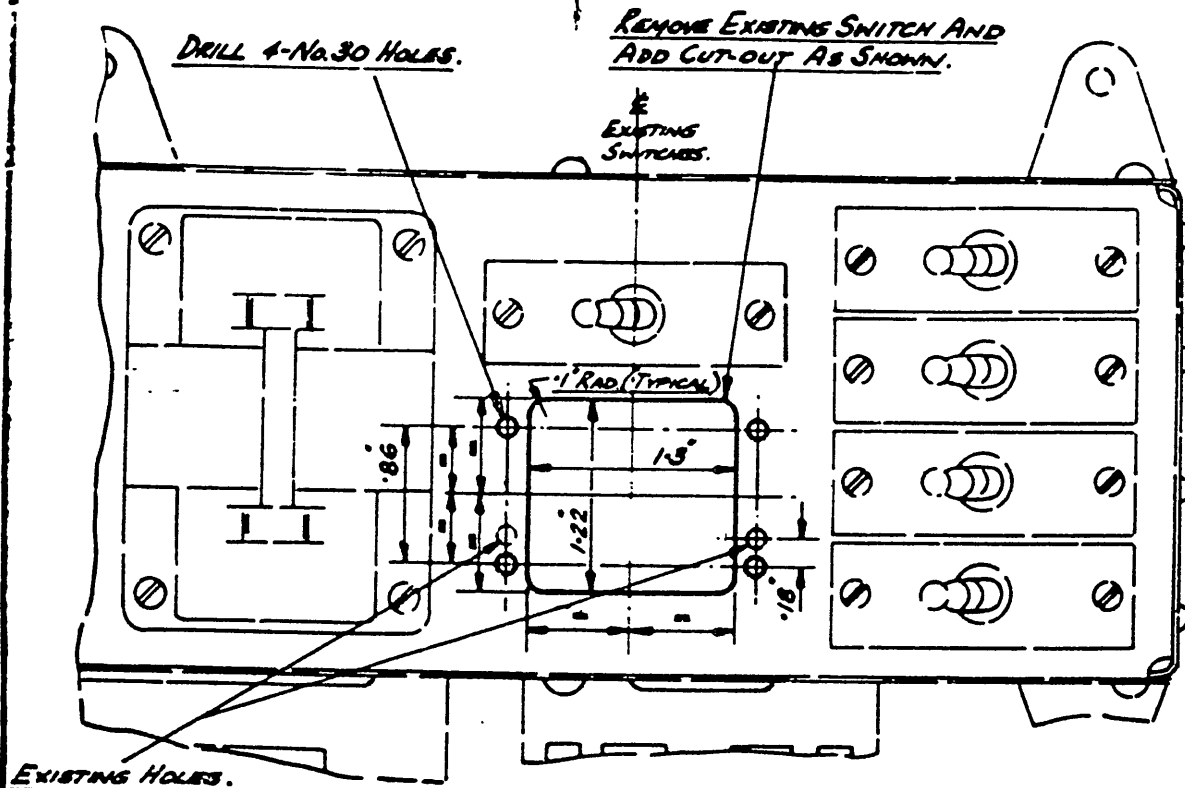
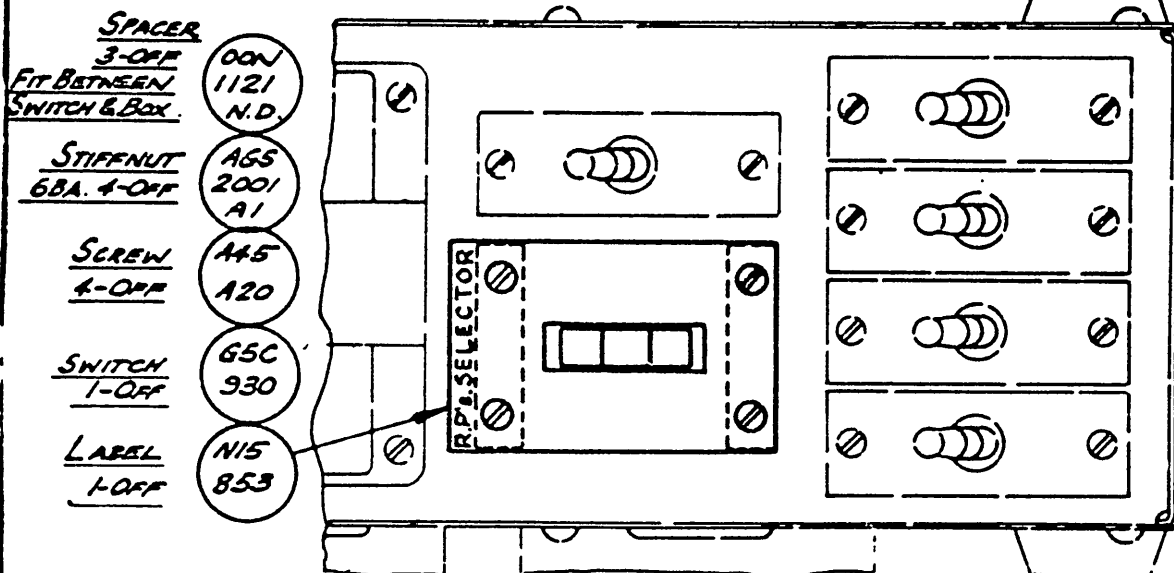
MODIFICATIONS TO R.P. & Bombs JUNCTION BOX. (MK.31 R/C ONLY)
 DE HAVILLAND DES. NO. 00M341 SHT. 1 OF 11

REFERENCE	ISSUED BY			TITLE	
	DEPT. OF AIR DIRECTORATE OF MECHANICAL & ELECTRICAL ENGINEERING			PROVISION FOR FIRING ROCKET PROJECTILES SINGLY, IN PAIRS OR SALVO	
LIMITS UNLESS STATED	MATERIAL			COMPONENT OF	
DECIMALS $\pm .010"$	SPEC.			MACHINE	
FRACTIONS $\pm \frac{1}{32}"$	TREATMENT			ENGINE	
ANGLES $\pm \frac{1}{2}^\circ$	FINISH			TECH. ORDER	VAMPIRE MOD 232
SURFACE FINISH AUSTRALIAN STANDARD ENG. DRWG. PRACTICE A.3.221	SCALE			DRAWING NO.	A 12980 SHEET 1 OF 11
	DRAWN		APPROVED		DRWG. A SIZE
	TRACED		CHECKED

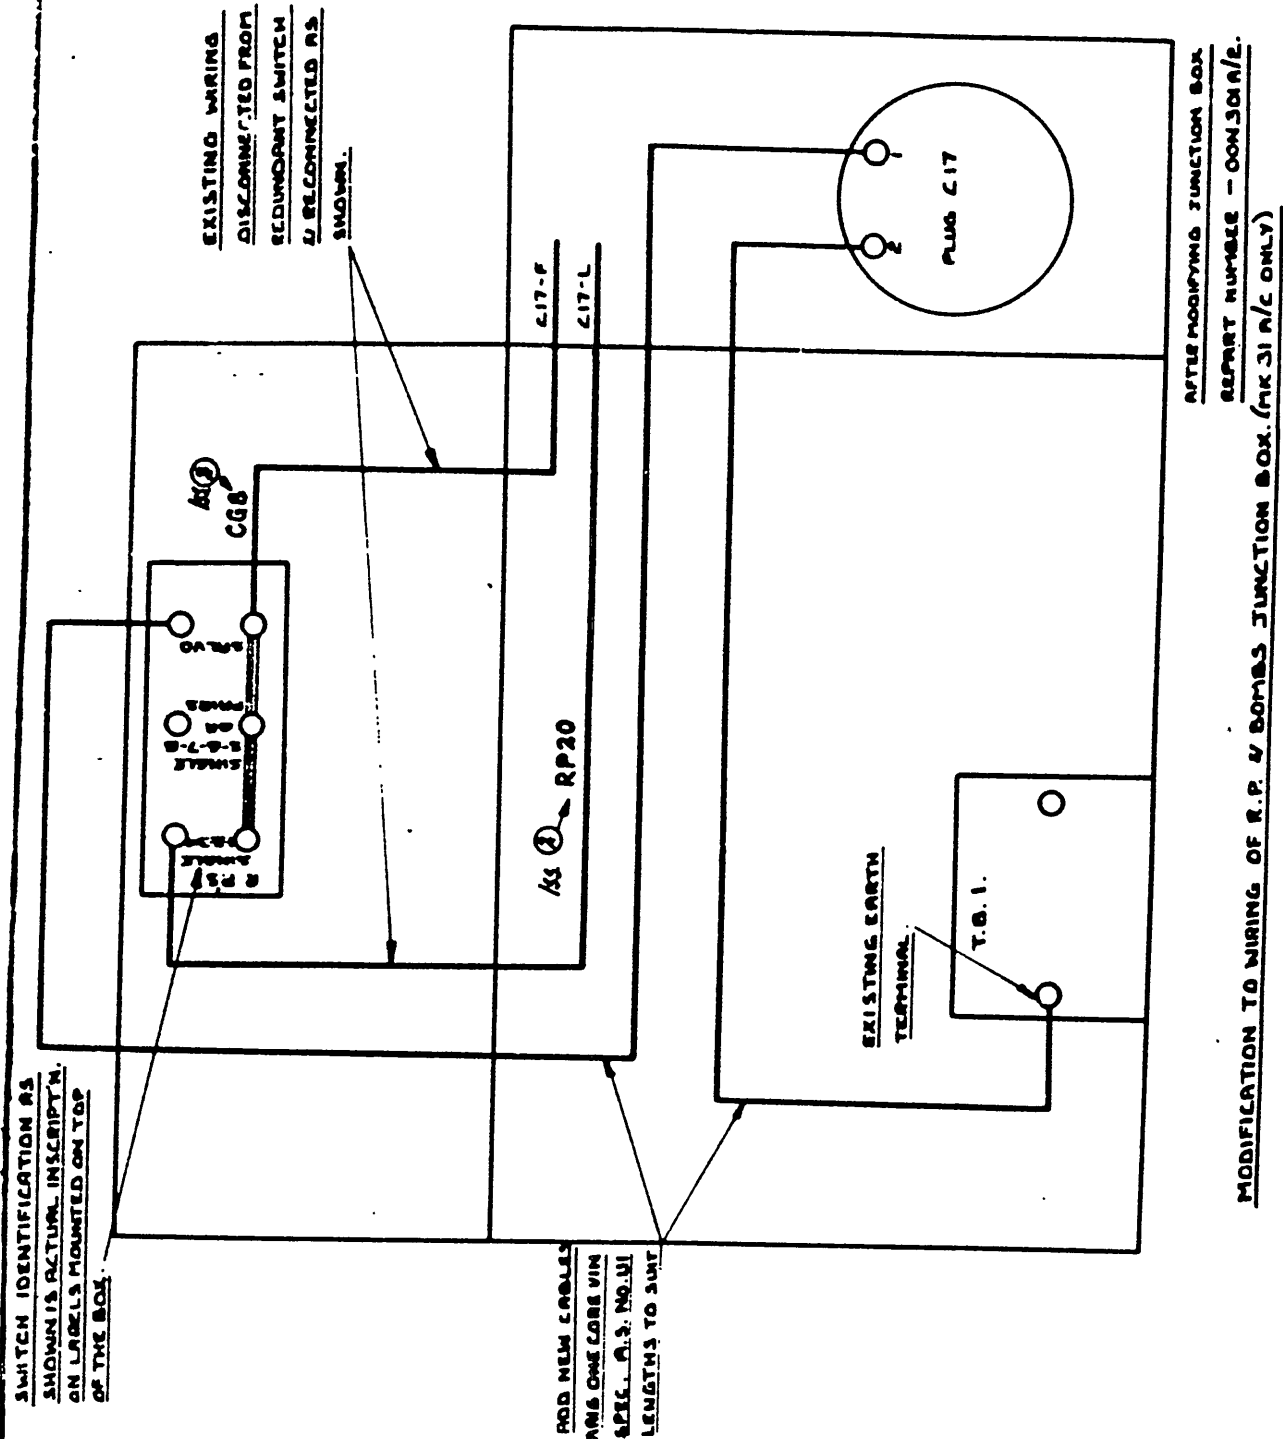
DE HAVILLAND DRAWING NO. DDM 341 SHEET 2 OF 11 SHEETS.

REFERENCE		ISSUED BY		TITLE	
		DEPT. OF AIR DIRECTORATE OF MECHANICAL & ELECTRICAL ENGINEERING		PROVISION FOR FIRING ROCKET PROJECTILES SINGLY, IN PAIRS OR SALVO.	
LIMITS UNLESS STATED		MATERIAL		COMPONENT OF	
DECIMALS	$\pm .010"$	SPEC.		MACHINE	
FRACTIONS	$\pm \frac{1}{32}"$	TREATMENT		ENGINE	
ANGLES	$\pm \frac{1}{2}^\circ$	FINISH		TECH. ORDER	VAMPIRE MOD. 232
SURFACE FINISH AUSTRALIAN STANDARD ENG. DRWG. PRACTICE		SCALE		DRAWING NO.	A 12980 SHEET 2 OF 11
		DRAWN			DRWG. A SIZE
		TRACED		APPROVED CHECKED

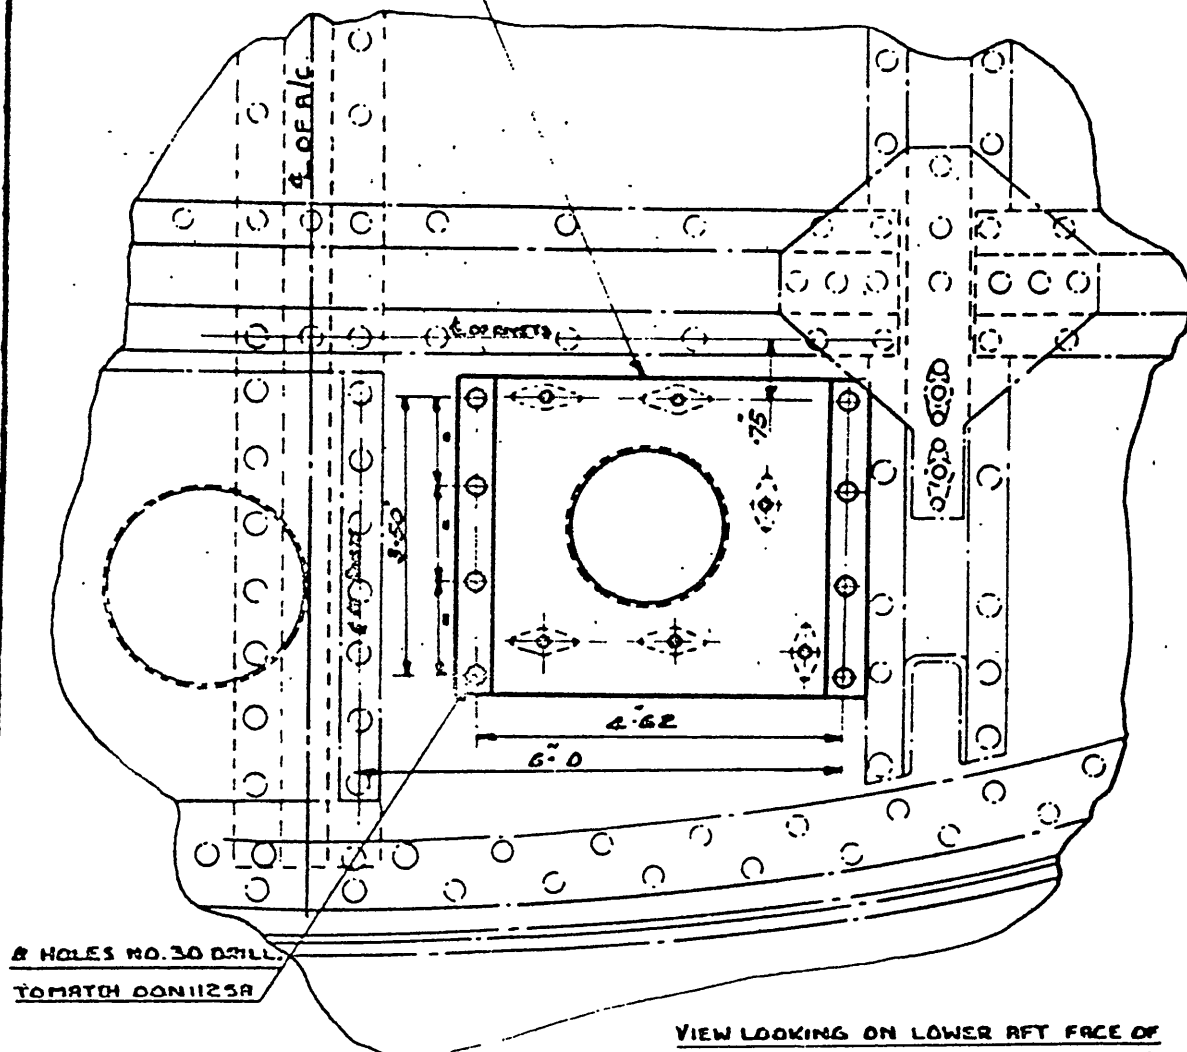
VIEW LOOKING ON LOWER RFT FACE OF
BULKHEAD NO. 4. (MK. 31 R/L. ONLY)

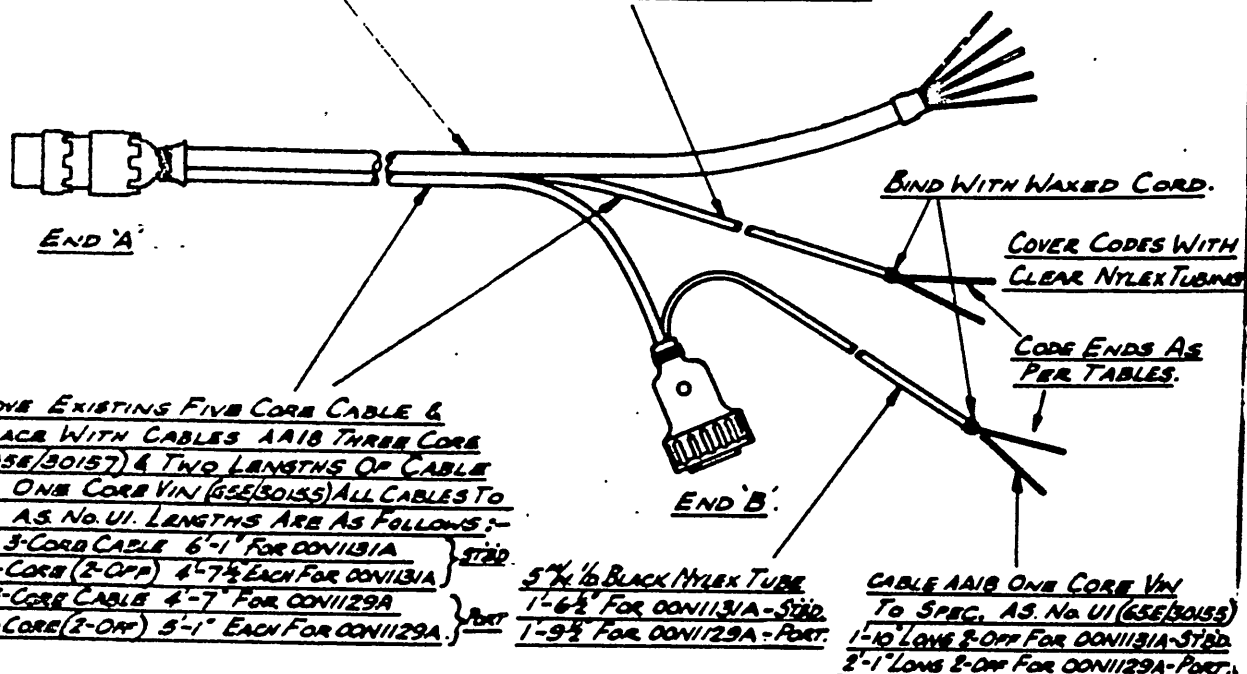
5/16" I.D. BLACK NYLEX TUBING
4'-4" LONG FOR OONI131A - STBD.
4'-9 1/2" LONG FOR OONI129A - PORT.

REMOVE EXISTING FIVE CORE CABLE & REPLACE WITH CABLES AA18 THREE CORE VIN(65E/30157) & TWO LENGTHS OF CABLE AA18 ONE CORE VIN(65E/30155) ALL CABLES TO SPEC. AS NO. U1. LENGTHS ARE AS FOLLOWS:-
AA18 3-CORE CABLE 6'-1" FOR OONI131A } STBD.
AA18 1-CORE (2-OFF) 4'-7 1/2" EACH FOR OONI131A }
AA18 3-CORE CABLE 4'-7" FOR OONI129A } PORT
AA18 1-CORE (2-OFF) 5'-1" EACH FOR OONI129A }

5/16" BLACK NYLEX TUBE
1'-6 1/2" FOR OONI131A - STBD.
1'-9 1/2" FOR OONI129A - PORT.

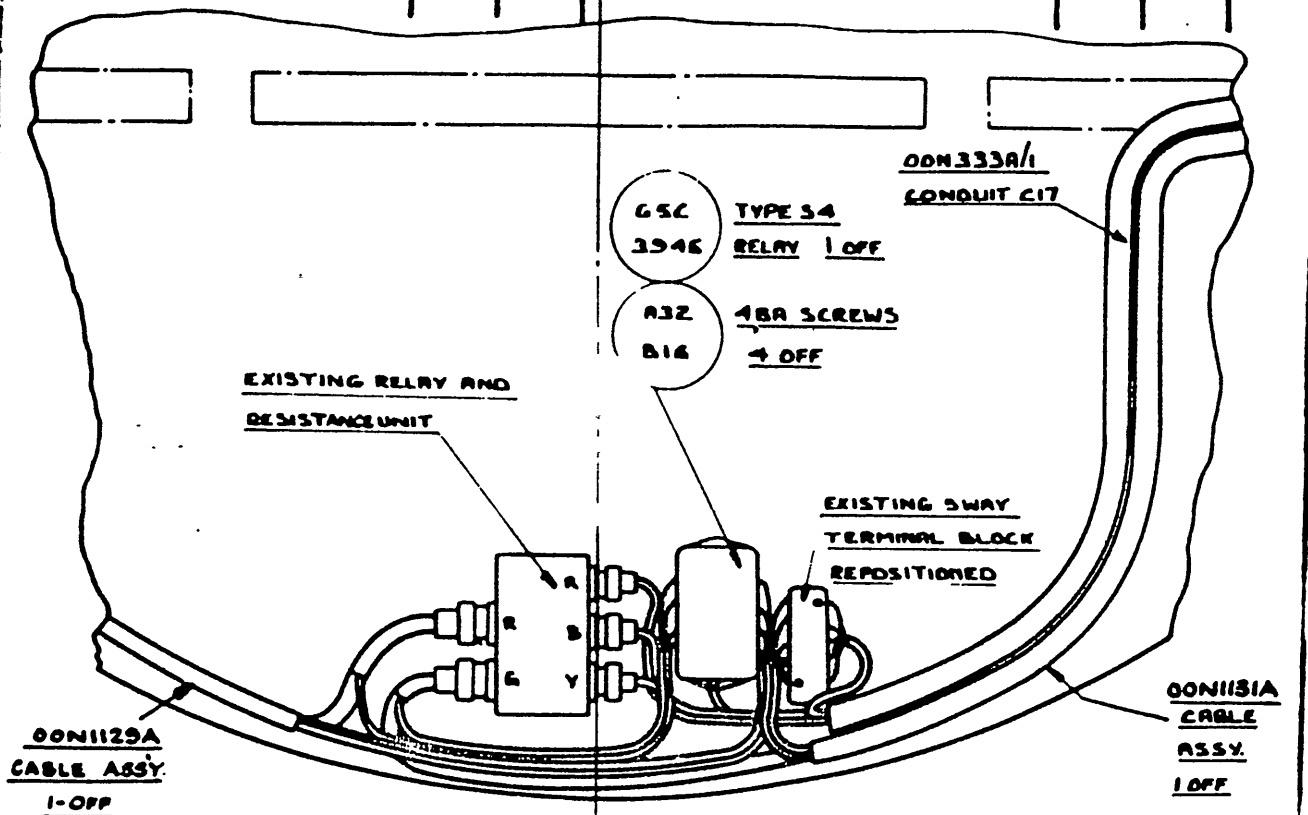
INSTALLATION OF EQUIPMENT ON LOWER AFT FACE OF BULKHEAD NO. 4 (MK. 31A/C ONLY)

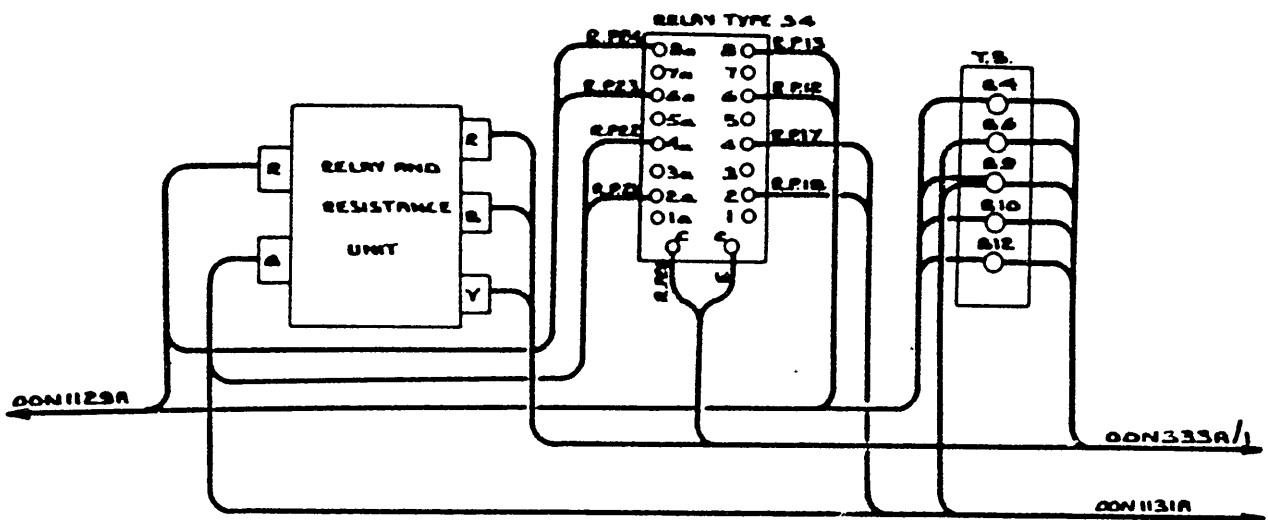
WIRING OF EQUIPMENT

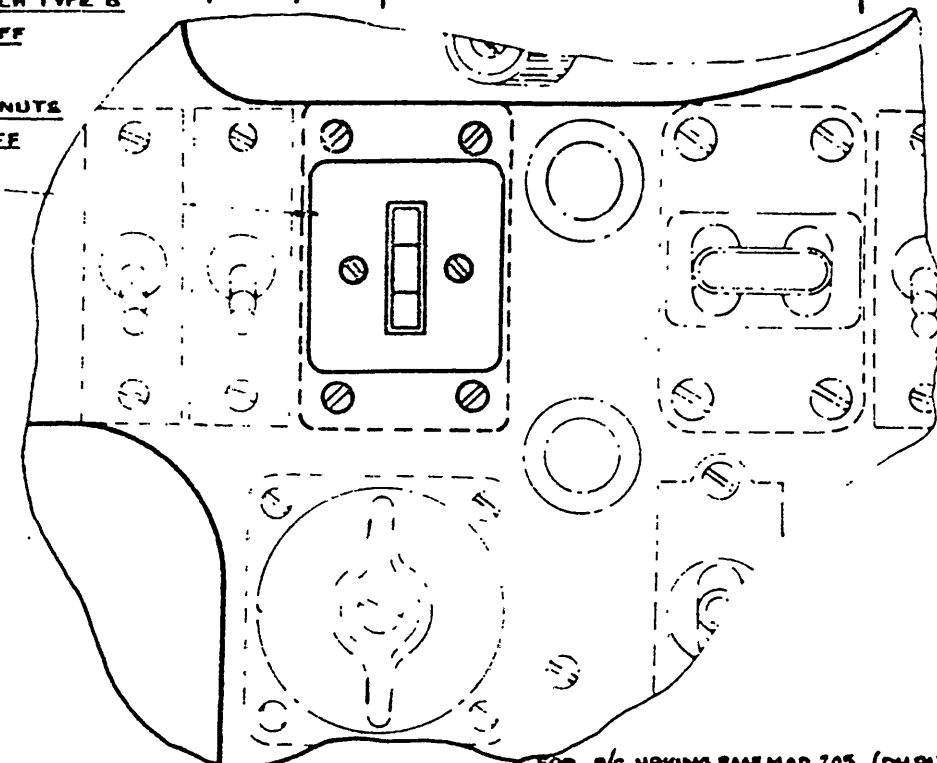
(MK 35 A/C ONLY)

FOR A/C HAVING RAAF MOD. 205 (D.H. AUST. MOD. V691) INCORPORATED.
ADDITION OF NEW EQUIPMENT ON INSTRUMENT PANEL

Existing wire coded 'RP3' (Pl. No. NIS-375A) previously connected to RP/Pairs/Salvo switch and terminal 3 on RP/Bombs Master switch, is to be re-coded 'CG' & re-connected as shown between RP/Bombs Master switch terminal 6 & new Singles/Pairs/Salvo switch.

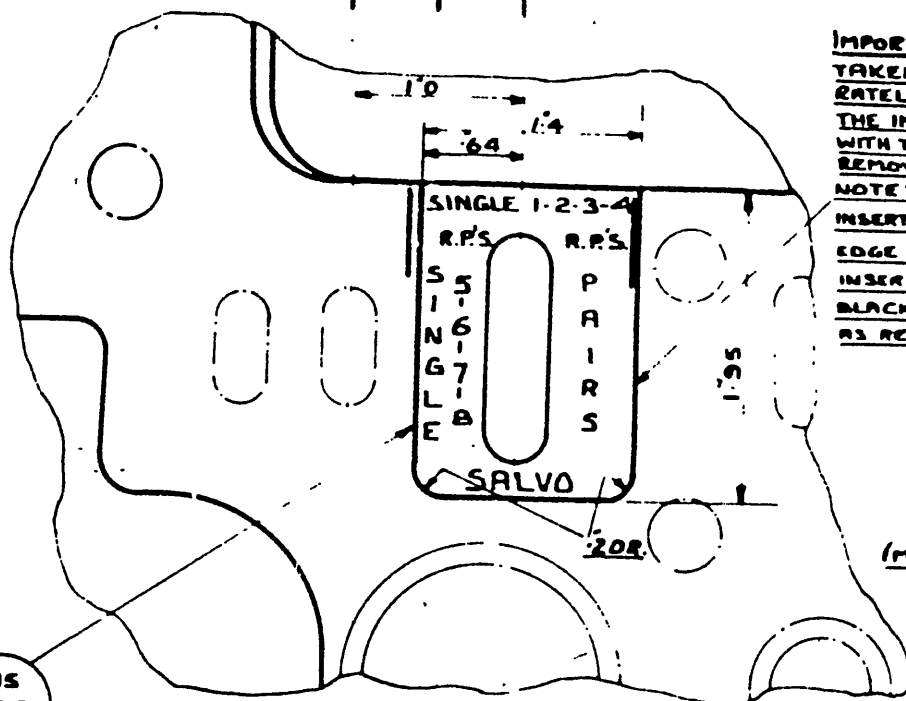
IMPORTANT NOTE: CARE MUST BE TAKEN TO CUT THE PANEL ACCURATELY TO DIMS. SHOWN AND THAT THE INSERT IS FITTED IN FLUSH WITH THE FRONT FACE OF THE PANEL. REMOVE ALL EXCESS CEMENT. NOTE: AFTER CEMENTING THE INSERT IN POSITION, THE NEW EDGE ON FOUR SIDES OF THE INSERT IS TO BE PAINTED OVER BLACK USING PAX PRINT (1 G.28) AS REQUIRED

FOR A/C HAVING R.A.A.F. MOD. 205 (D.H. RUST. MOD. V681) INCORPORATED MODIFICATION TO LIGHTING PANEL (R.H. INSTRUMENTS & SWITCHES)

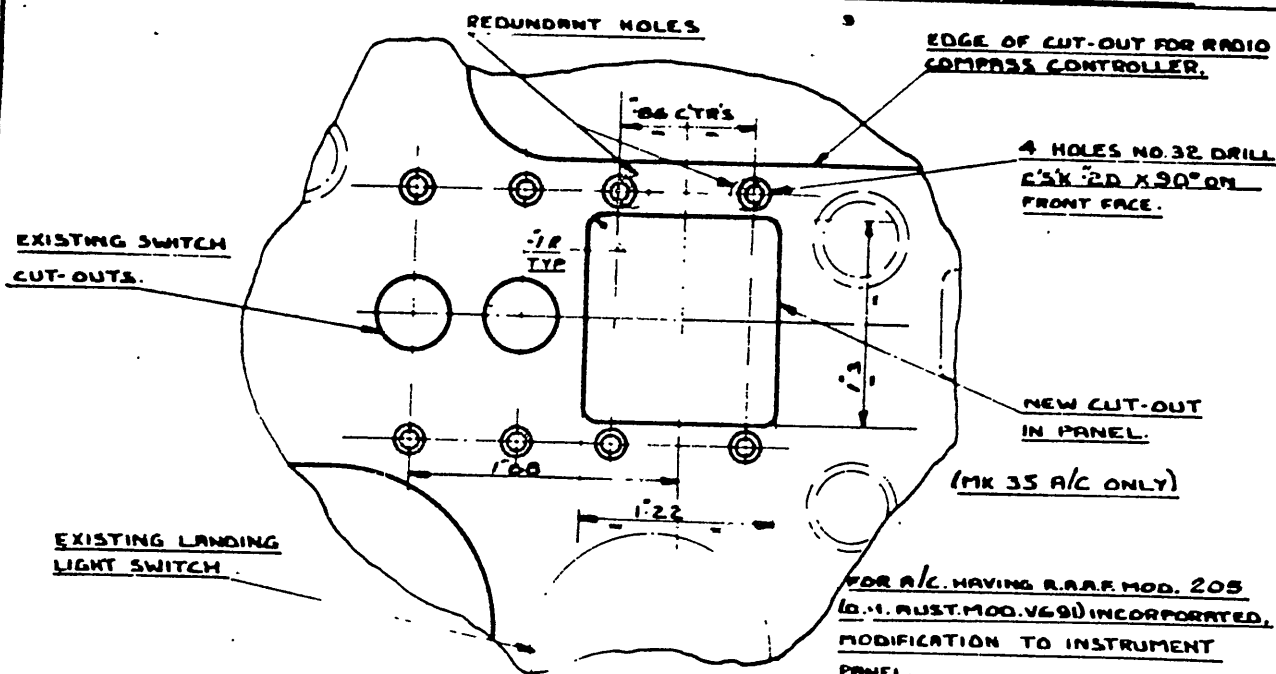
(MK 35 A/C ONLY)

FOR A/C HAVING R.A.A.F. MOD. 205 (D.H. RUST. MOD. V681) INCORPORATED, MODIFICATION TO INSTRUMENT PANEL.

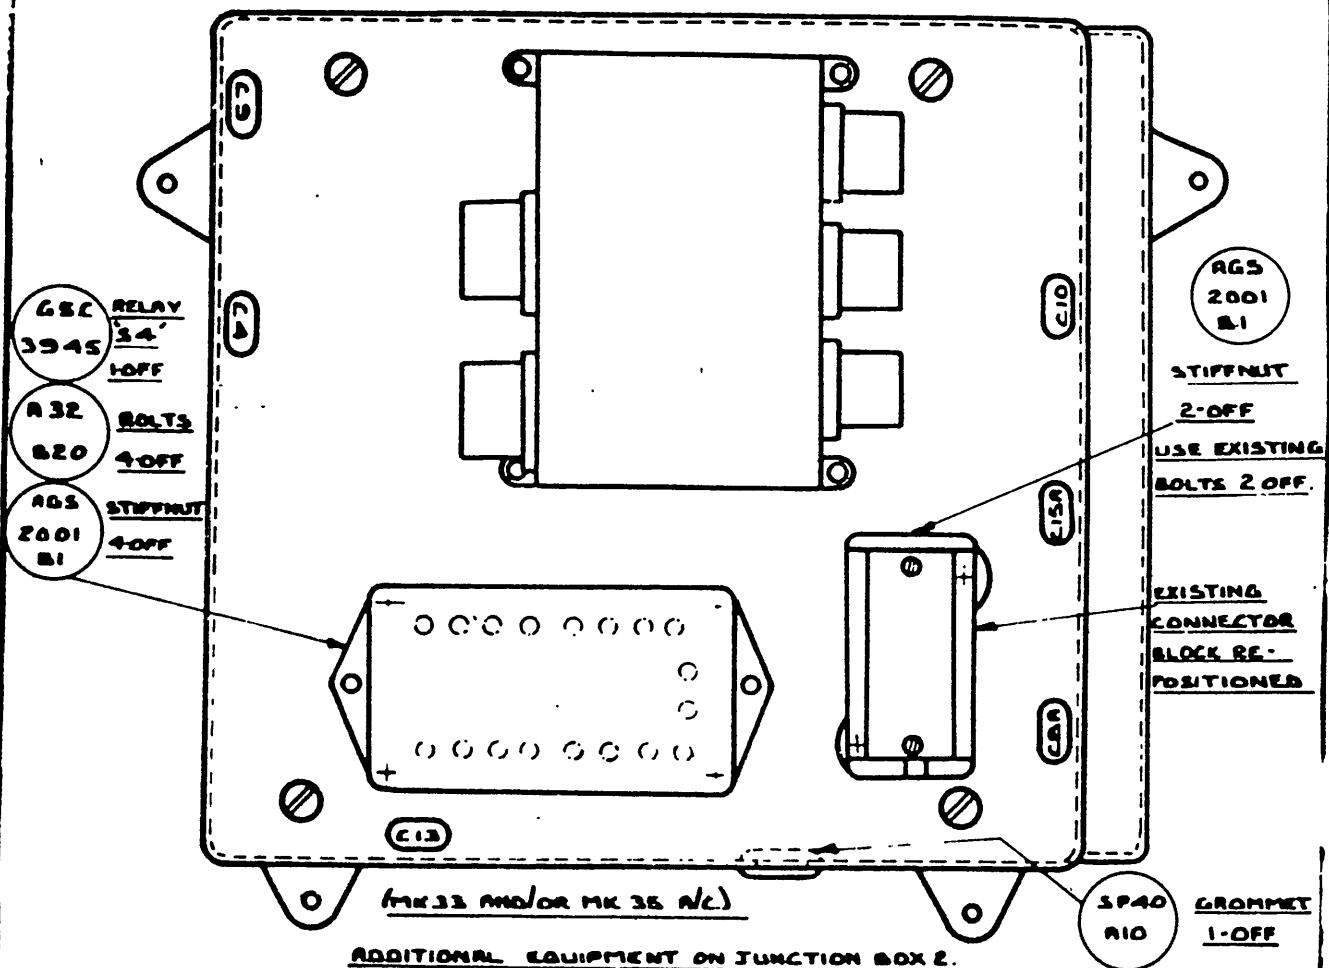
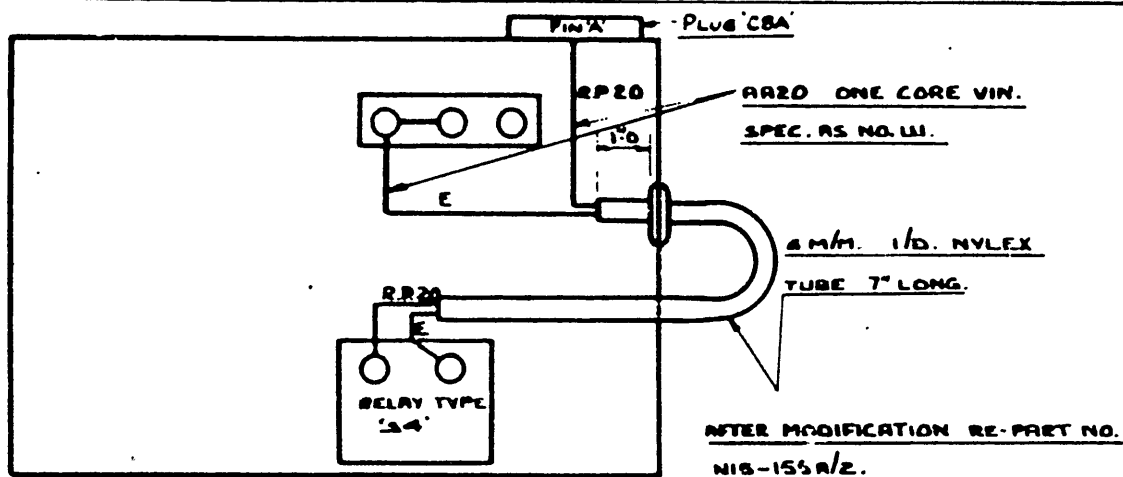
MODIFICATION TO JUNCTION BOX 2 WIRING.
(MK 33 AND/OR MK 35 N/C)
