Australian Air Publication 721.79

**Volume 2, Part 2
Book 3**

VAMPIRE MODIFICATIONS

(Nos 201 to 300)

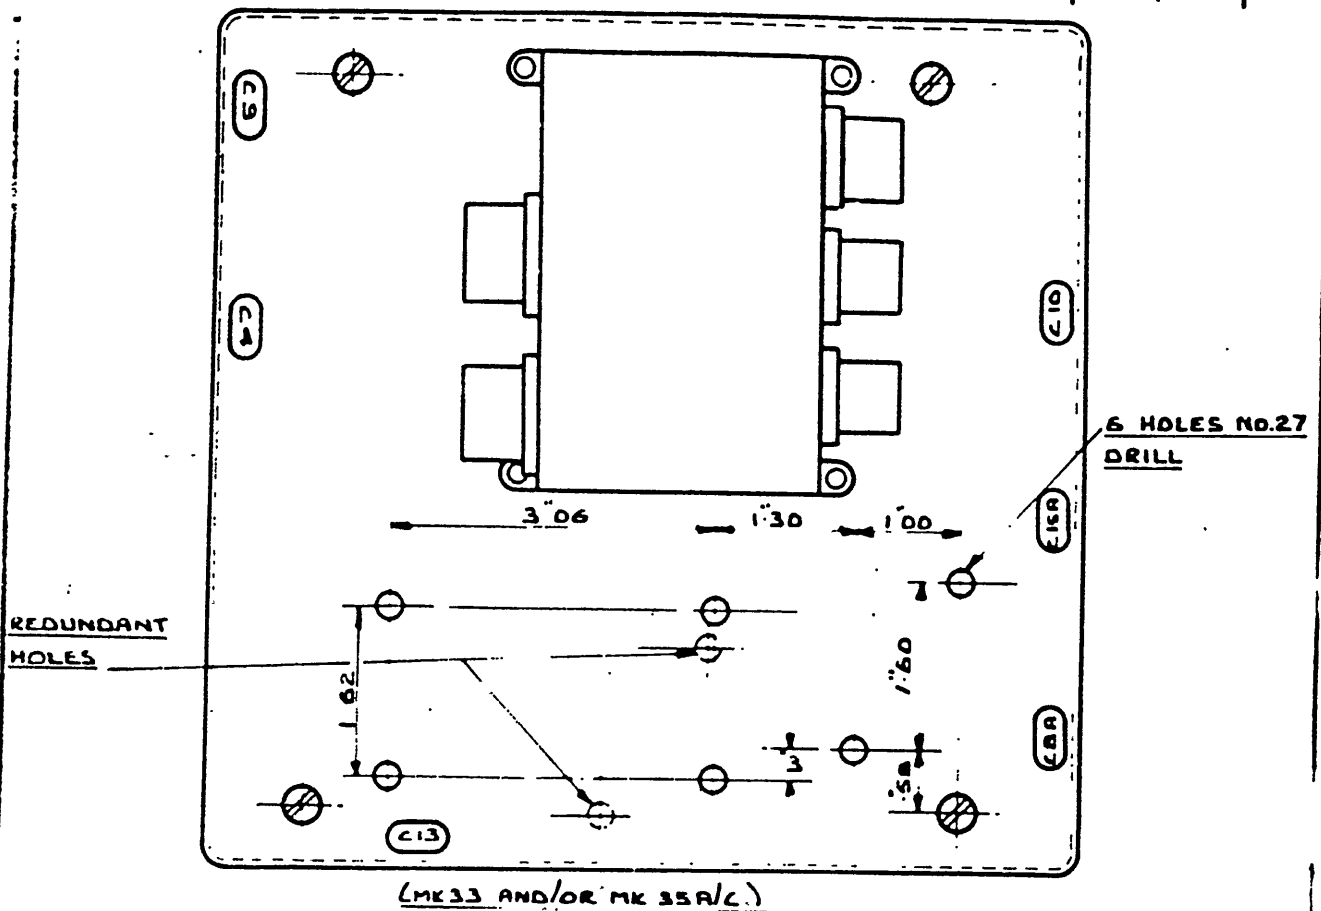
MODIFICATION TO JUNCTION BOX '2' LID ASSY.

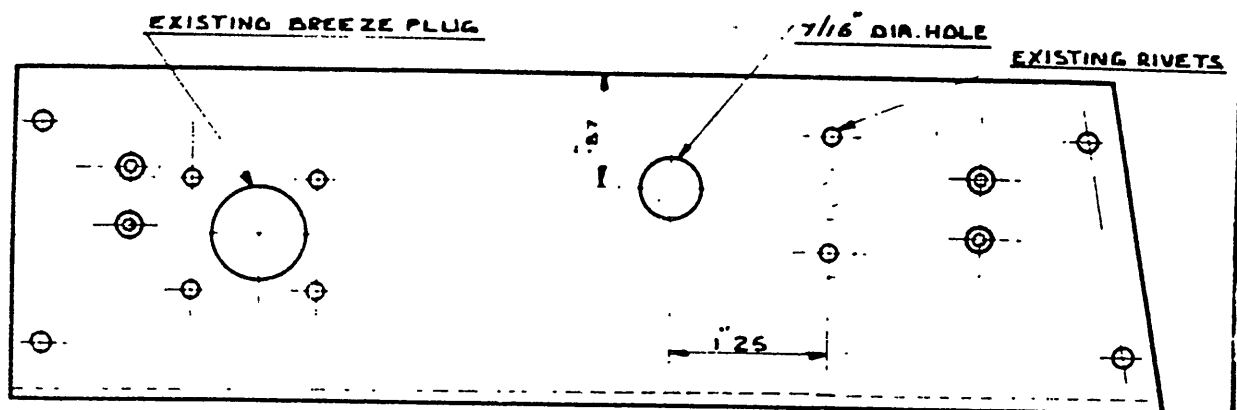
MODIFICATION TO BASE PLATE OF BOX (MK.33 AND/OR MK.35 A/C.)

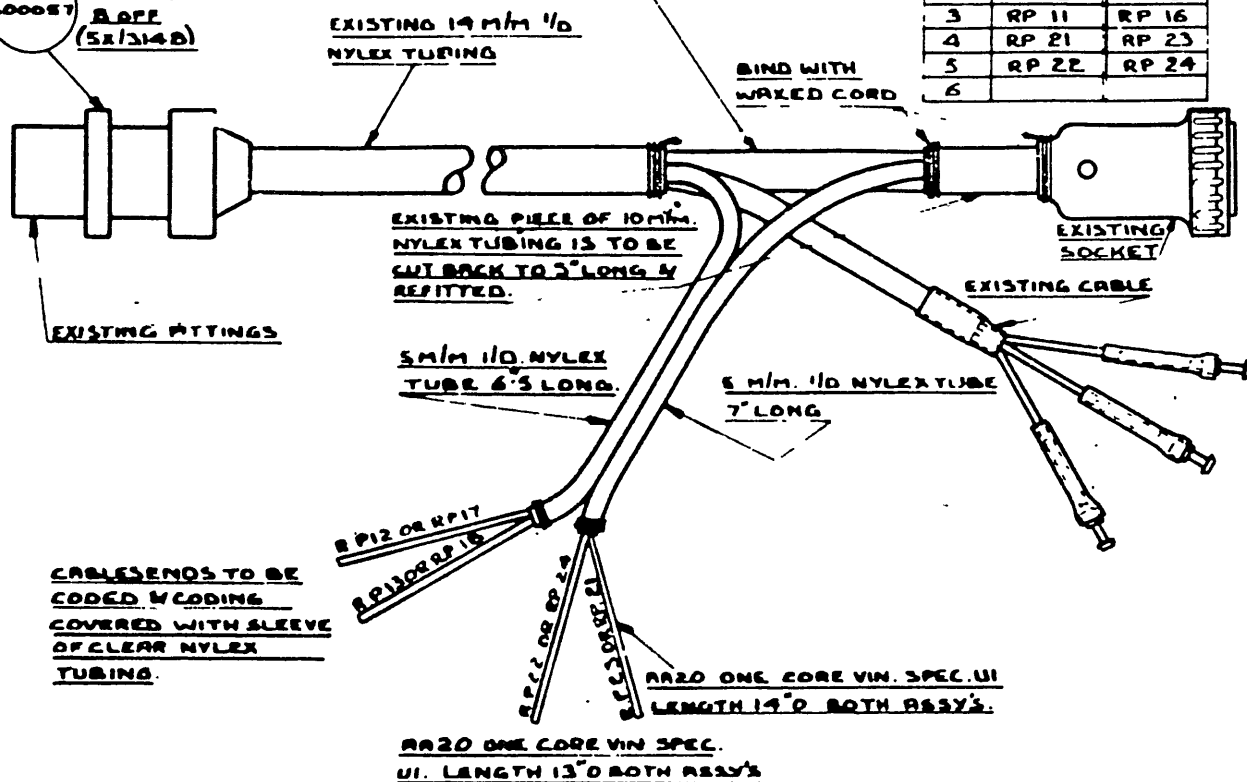
CABLE ENDS TO BE
CODED & CODING
COVERED WITH SLEEVE
OF CLEAR NYLEX
TUBING.

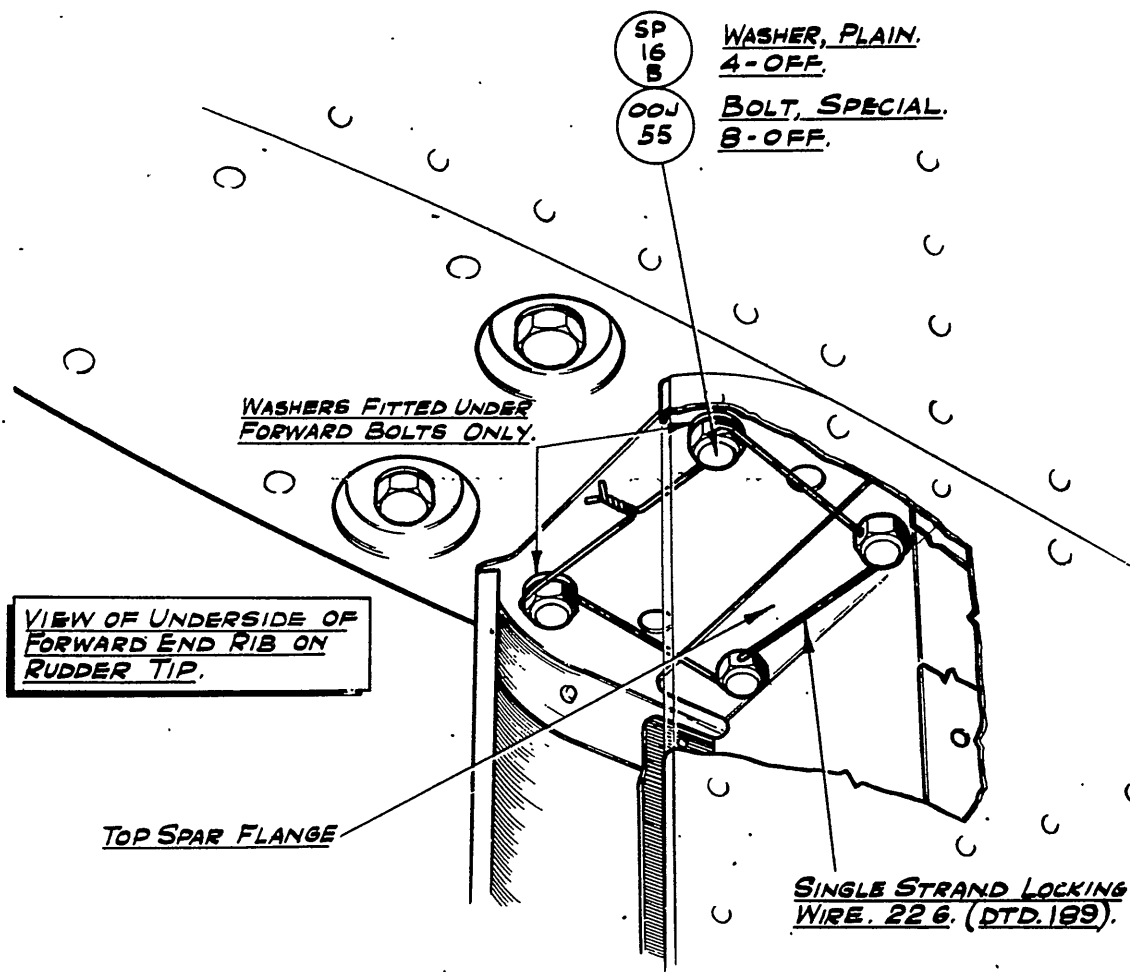
DEHAVILLAND DRWG. 00M332. No. of SHEETS 1.

REMOVE AND DISCARD THE EXISTING 2-4BA. BOLTS ATTACHING THE TOP SPAR FLANGE AND THE 2-4BA. BOLTS AND PLAIN WASHERS ATTACHING THE FRONT END OF THE LOWER TIP RIB. FIT THE 4 NEW SPECIAL BOLTS, FIT ONE PLAIN WASHER UNDER FORWARD 2 BOLTS ONLY. LOCK THE 4 BOLTS AS SHOWN ABOVE.. REPEAT ON SECOND RUDDER.

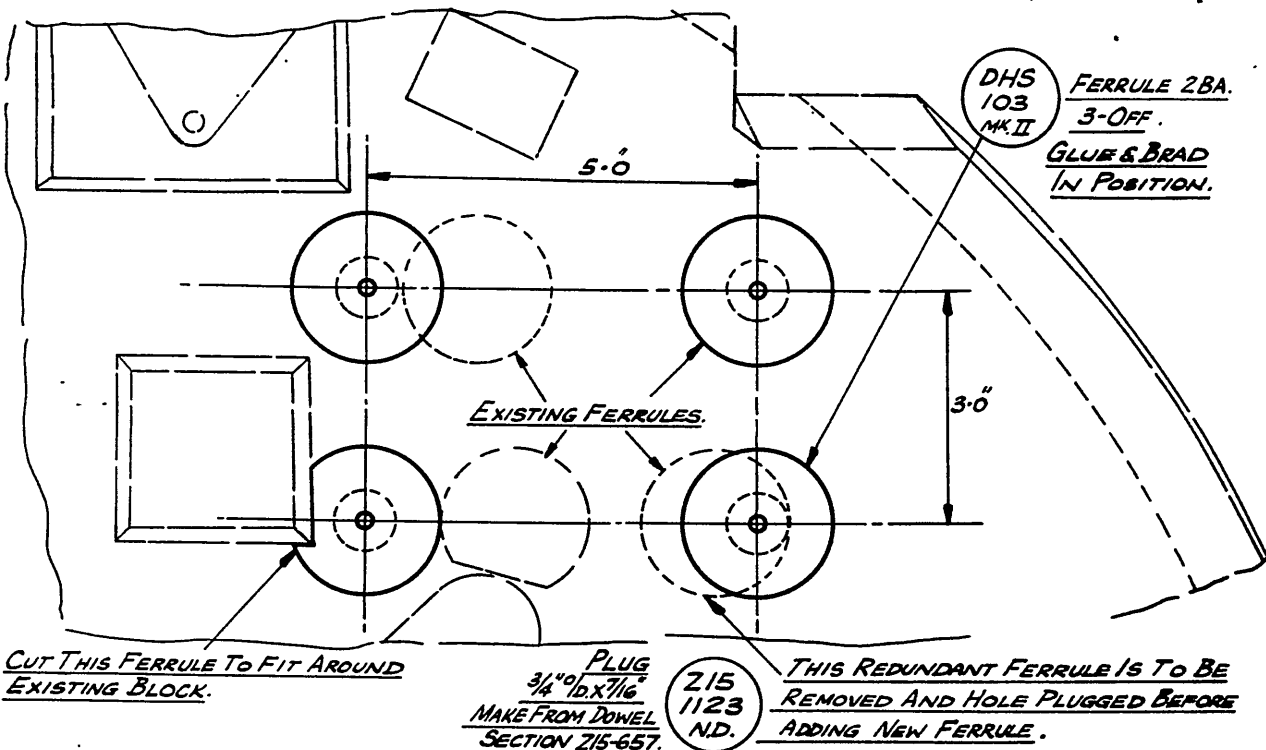
ADDITIONAL FERRULES ON FORD. FACE OF BULKHEAD No.2.

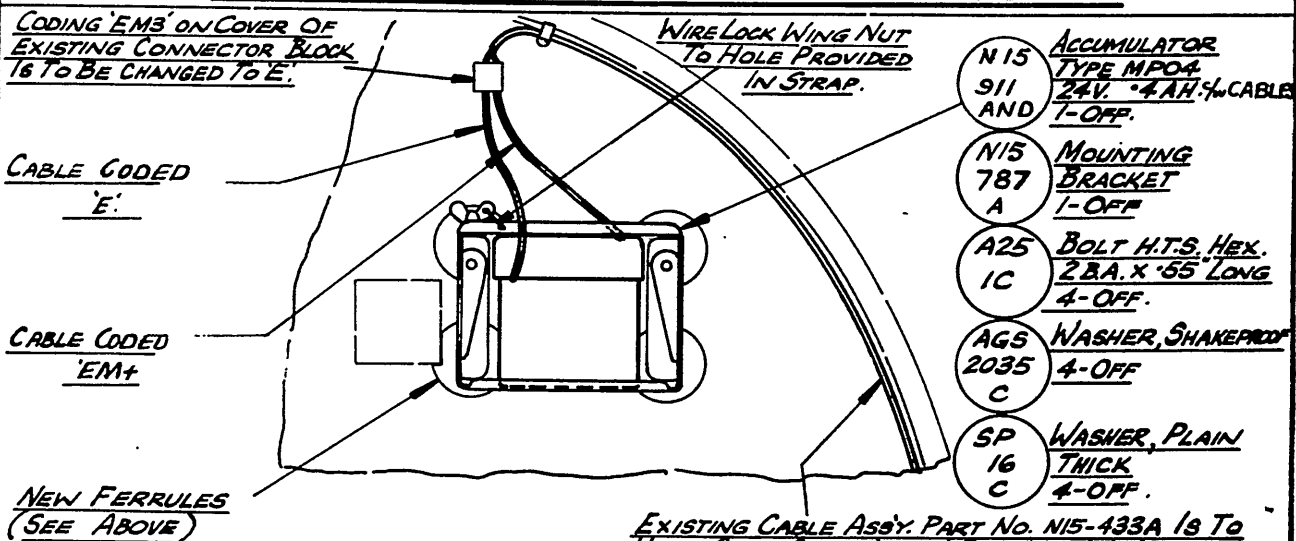
DE HAVILLAND DRG. No. 00M348 SHT.1. No. OF SHEETS 4.

VIEW ON FORD. FACE OF BULKHEAD No.2 LOOKING AFT.

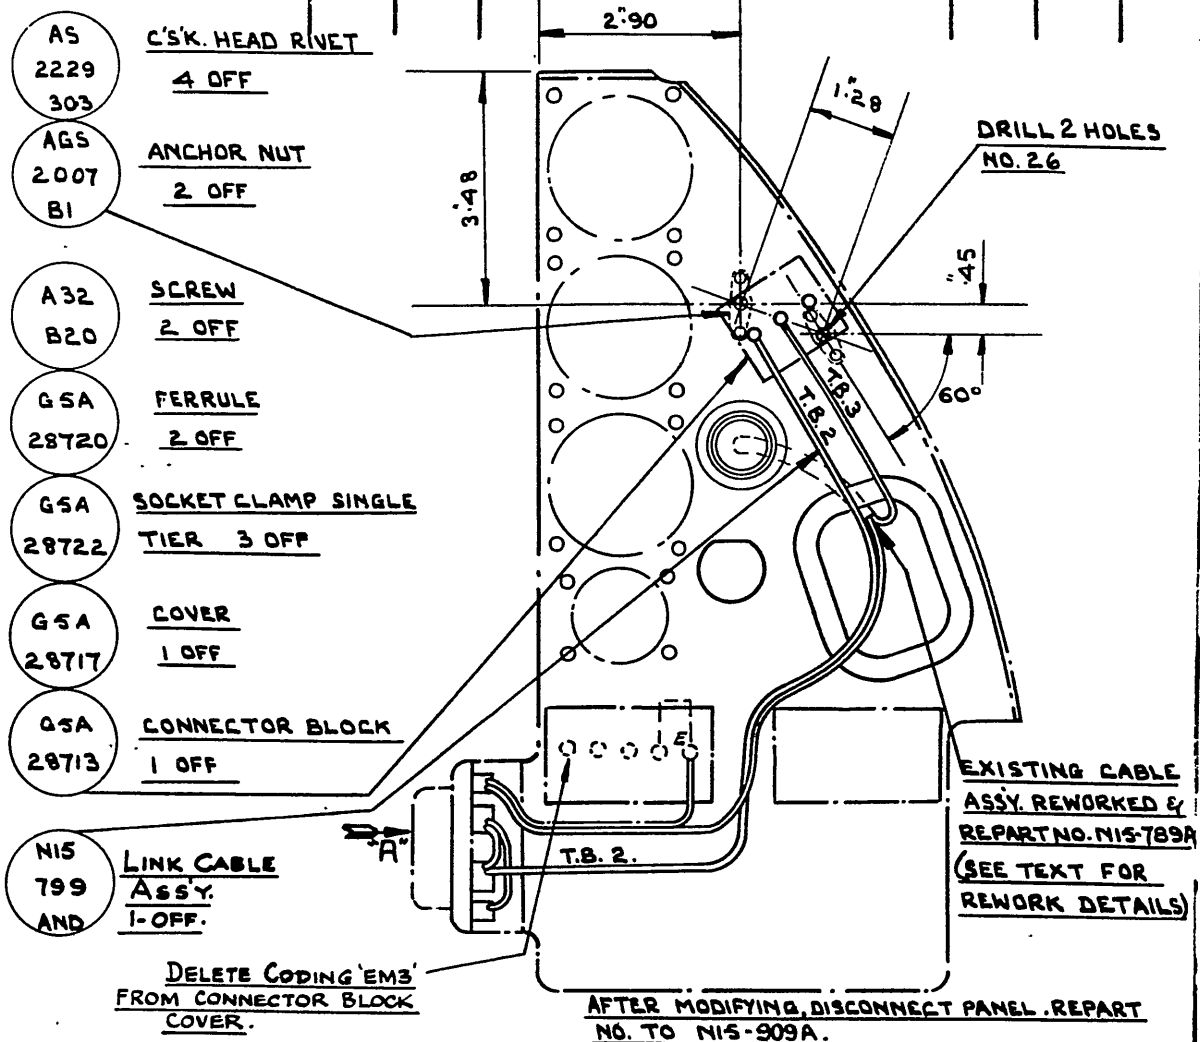
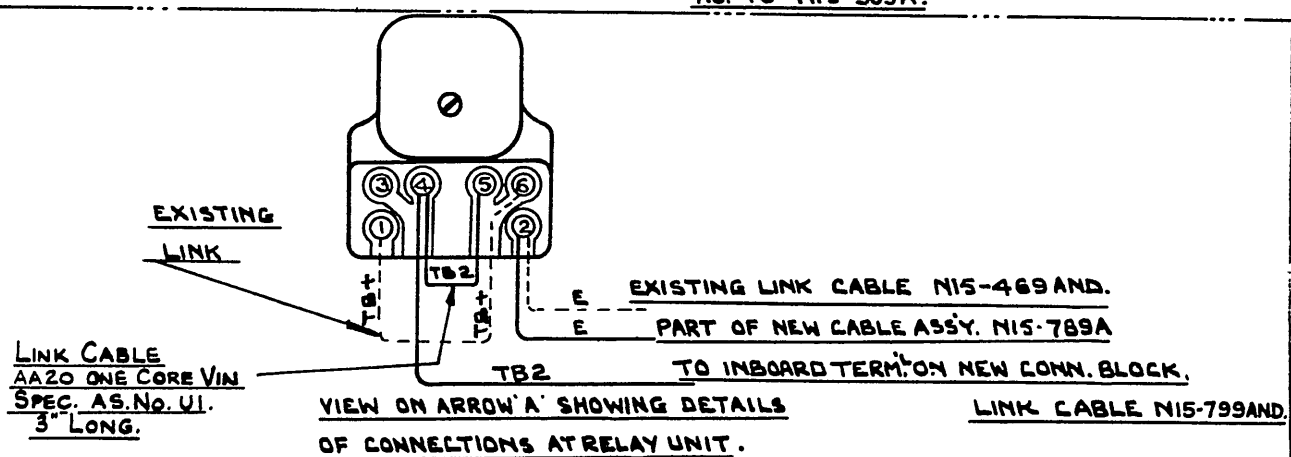
DE HAVILLAND DRAWING No. 00M348 SHEET 2 OF 4 SHEETS.

REFERENCE	ISSUED BY		TITLE	
			INTRODUCTION OF AN ALKALINE BATTERY TYPE MP04.	
LIMITS UNLESS STATED	MATERIAL		COMPONENT OF	ELECTRICAL SYSTEM
DECIMALS ± .010"	SPEC.		MACHINE	VAMPIRE MK 33
FRACTIONS ± 1/32"	TREATMENT		ENGINE	GOBLIN
ANGLES ± 1°	FINISH		TECH. ORDER	VAMPIRE MOD 237
SURFACE FINISH AUSTRALIAN STANDARD ENG. DRWG. PRACTICE A.3.21	SCALE		DRAWING NO.	A 12971/2
	DRAWN	APPROVED		DRWG. A SIZE
	TRACED	CHECKED

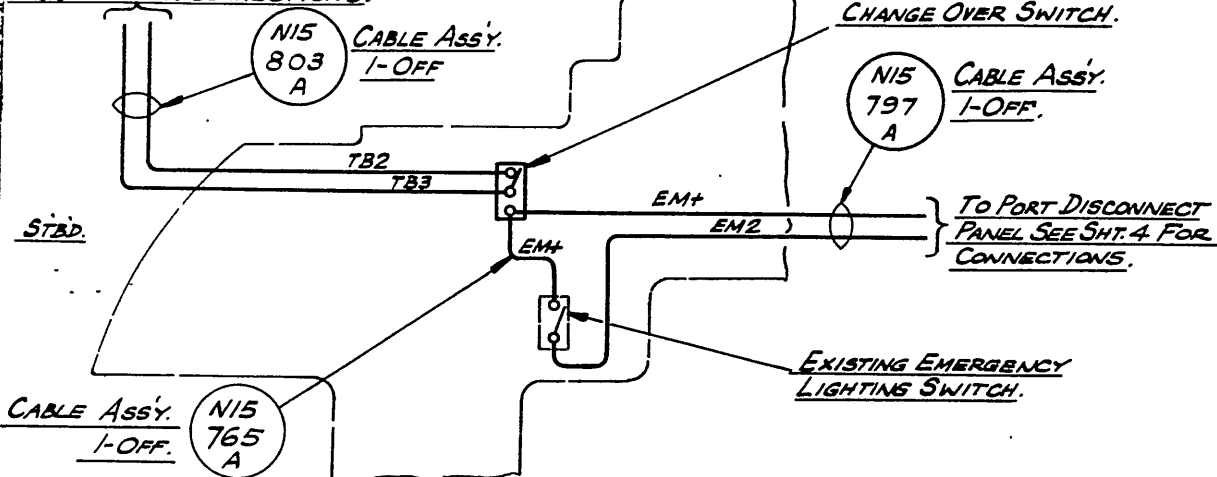
AFTER CARRYING OUT ALL CHANGES
REPORT NUMBER INSTR. PANEL F15-551A/2.
TO STD. DISCONNECT PANEL
SEE SHT 4 FOR CONNECTIONS.

VIEW ON BACK OF INSTRUMENT PANEL SHOWING CONNECTIONS
FOR EMERGENCY POWER SUPPLIES.

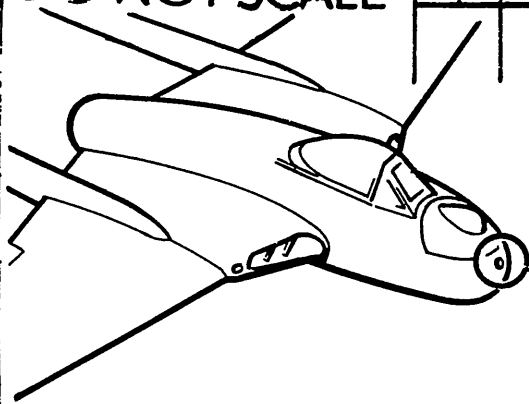
ATTACHMENT OF WINDOW MOUNTING TO FIXED NOSING.

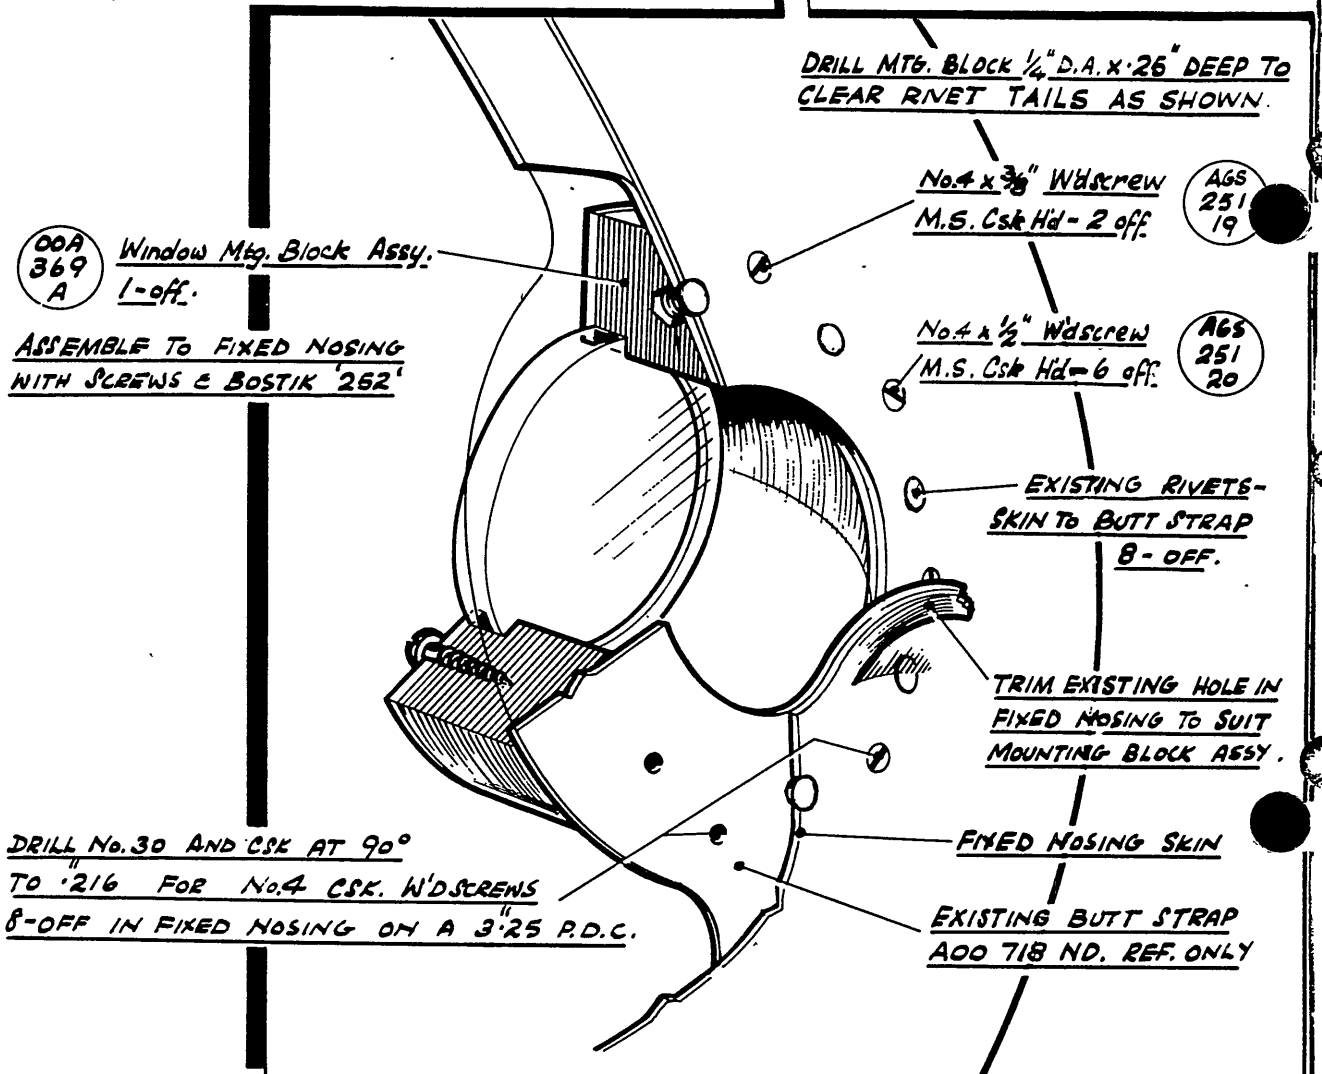
DE HAVILLAND DRWG. No. 00M 360. No of SHTS. 5 SHT. No. 1

REFERENCE	ISSUED BY				TITLE	
	Dept. of Air Directorate of Mechanical and Electrical Engineering				TO MAKE PROVISION FOR A G.S.R.P. CAMERA IN LIEU OF A G45B CAMERA.	
LIMITS UNLESS STATED	MATERIAL				COMPONENT OF	
DECIMALS $\pm .010$ "	SPEC.				MACHINE	
FRACTIONS $\pm \frac{1}{32}$ "	TREATMENT				ENGINE	
ANGLES $\pm \frac{1}{2}^\circ$	FINISH				TECH. ORDER	Vampire Mod. 239
SURFACE FINISH	SCALE				DRAWING NO.	A 12982
AUSTRALIAN STANDARD ENG. DRWG. PRACTICE A.S.CZ1	DRAWN		APPROVED			Sheet 1 of 5
	TRACED		CHECKED

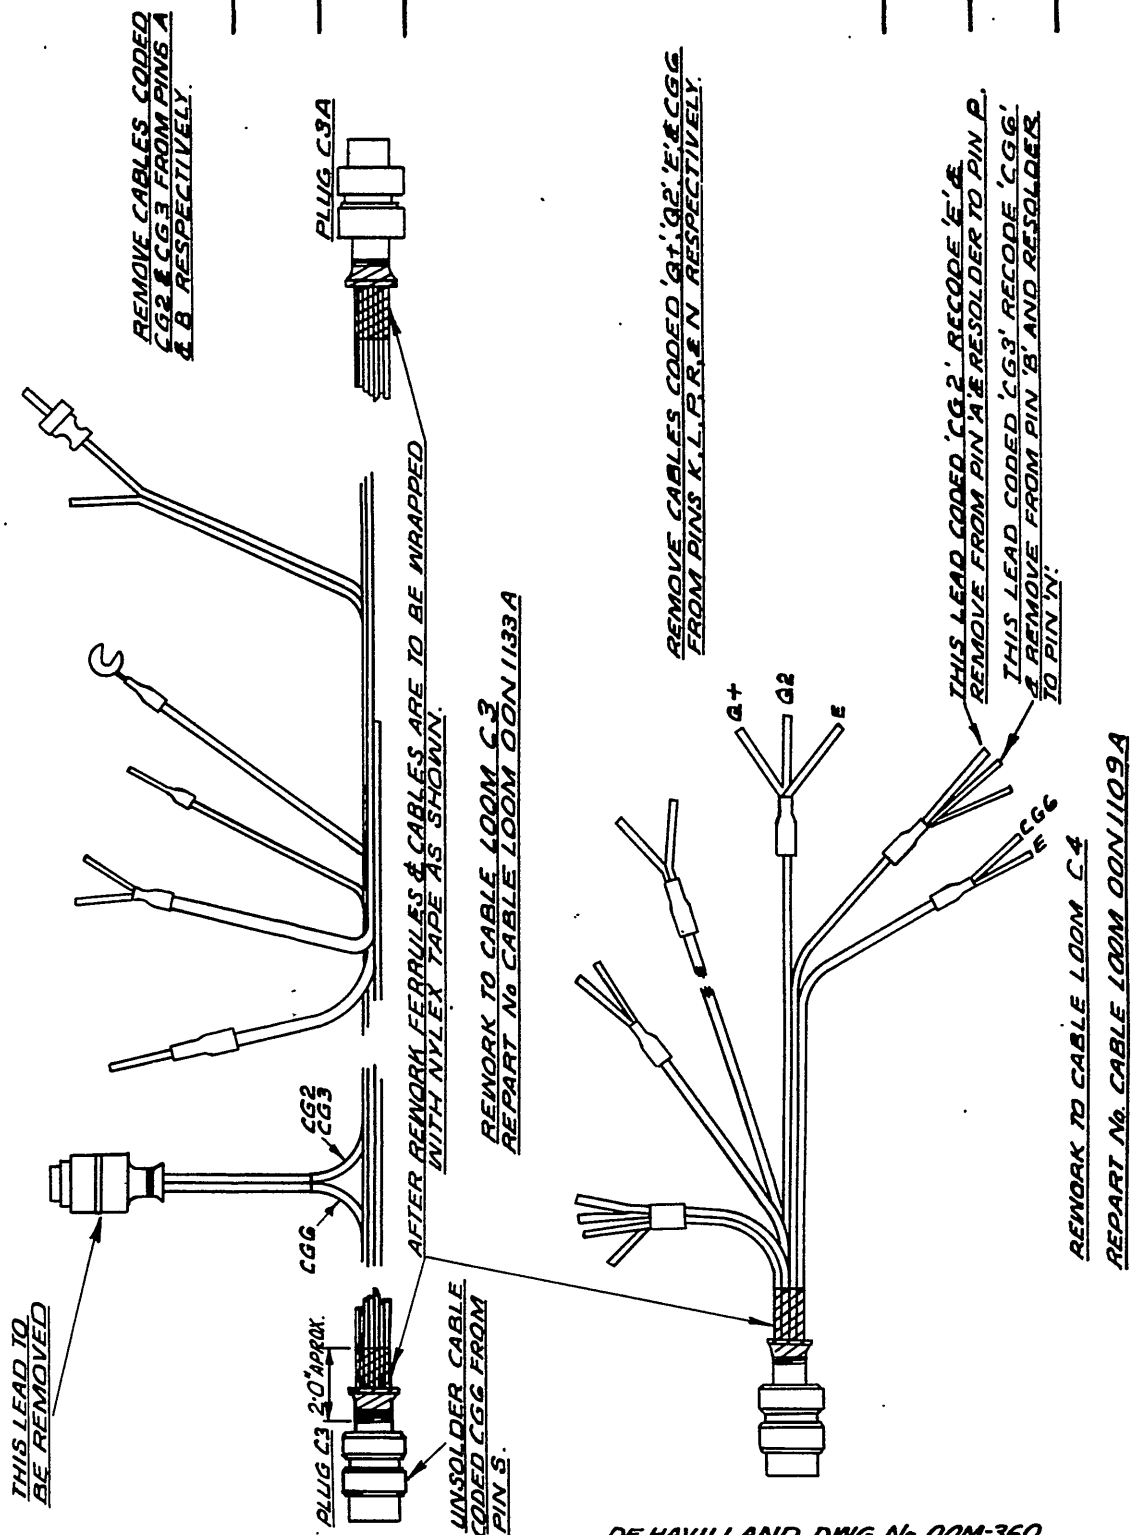
DE HAVILLAND DWG No. 00M-360
SHEET 3 OF 5

REFERENCE	ISSUED BY			TITLE	
	DEPARTMENT OF AIR DIRECTORATE OF AERONAUTICAL ENG.			TO MAKE PROVISION FOR A G.S.A.P. CAMERA IN LIEU OF A G45B CAMERA	
LIMITS UNLESS STATED	MATERIAL			COMPONENT OF	
DECIMALS ± .010"	SPEC.			MACHINE	
FRACTIONS ± 1/32"	TREATMENT			ENGINE	
ANGLES ± 1°	FINISH			TECH. ORDER	VAMPIRE MOD N° 239
SURFACE FINISH AUSTRALIAN STANDARD ENG. DRWG. PRACTICE A.S. 221	SCALE			DRAWING NO.	A12982 SHEET 3.
	DRAWN		APPROVED		DRWG. A SIZE
	TRACED		CHECKED

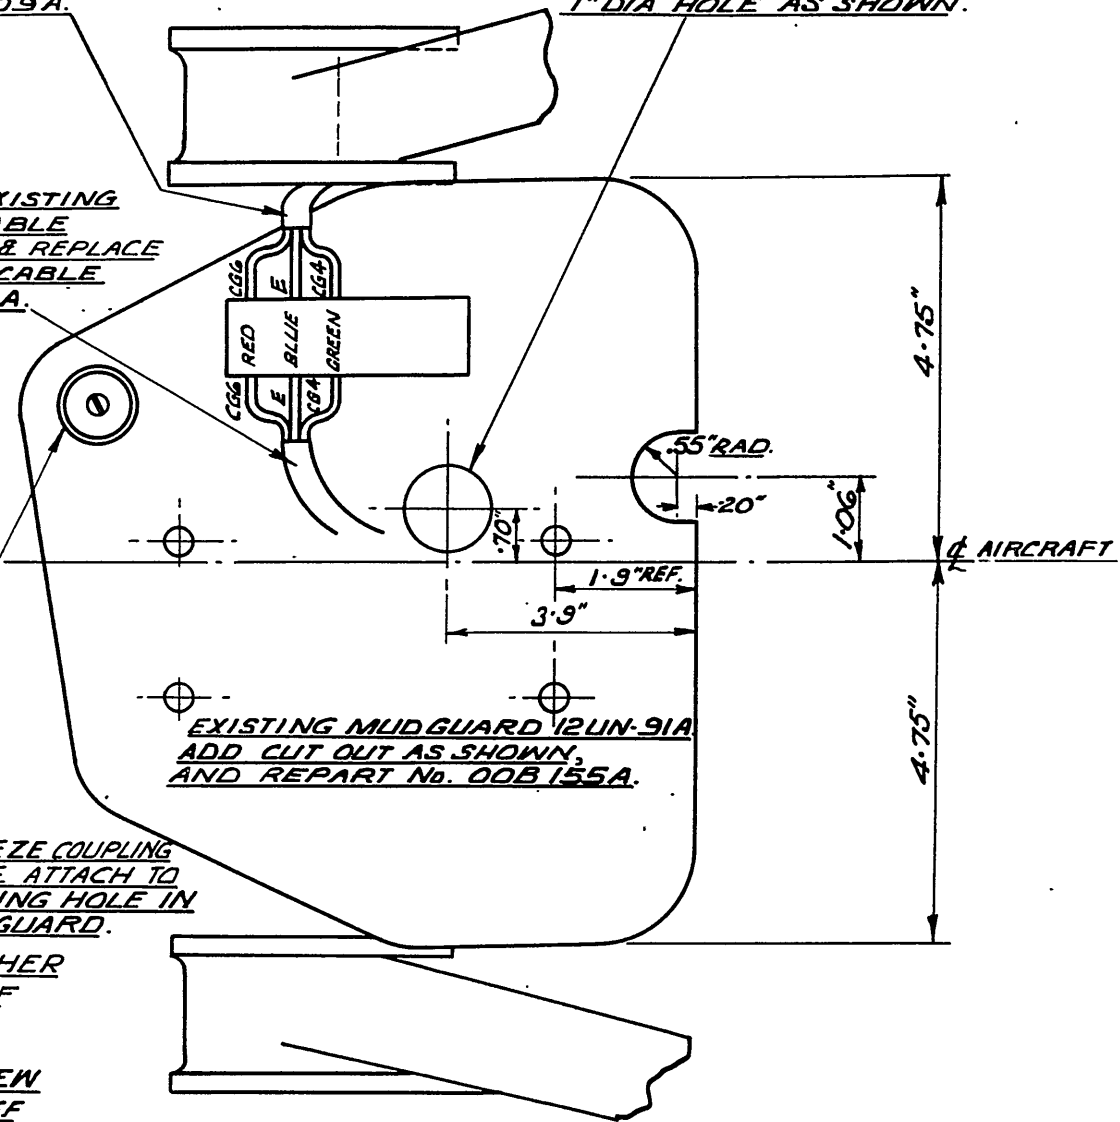
MUDGUARD 800-933A MAY BE
MODIFIED TO 12 LIN 91A BY ADDING
1" DIA HOLE AS SHOWN.

REMOVE EXISTING
CAMERA CABLE
NOD-272A & REPLACE
WITH NEW CABLE
00N-1107A.

H128F
18764 BREEZE COUPLING
1-OFF. ATTACH TO
EXISTING HOLE IN
MUDGUARD.

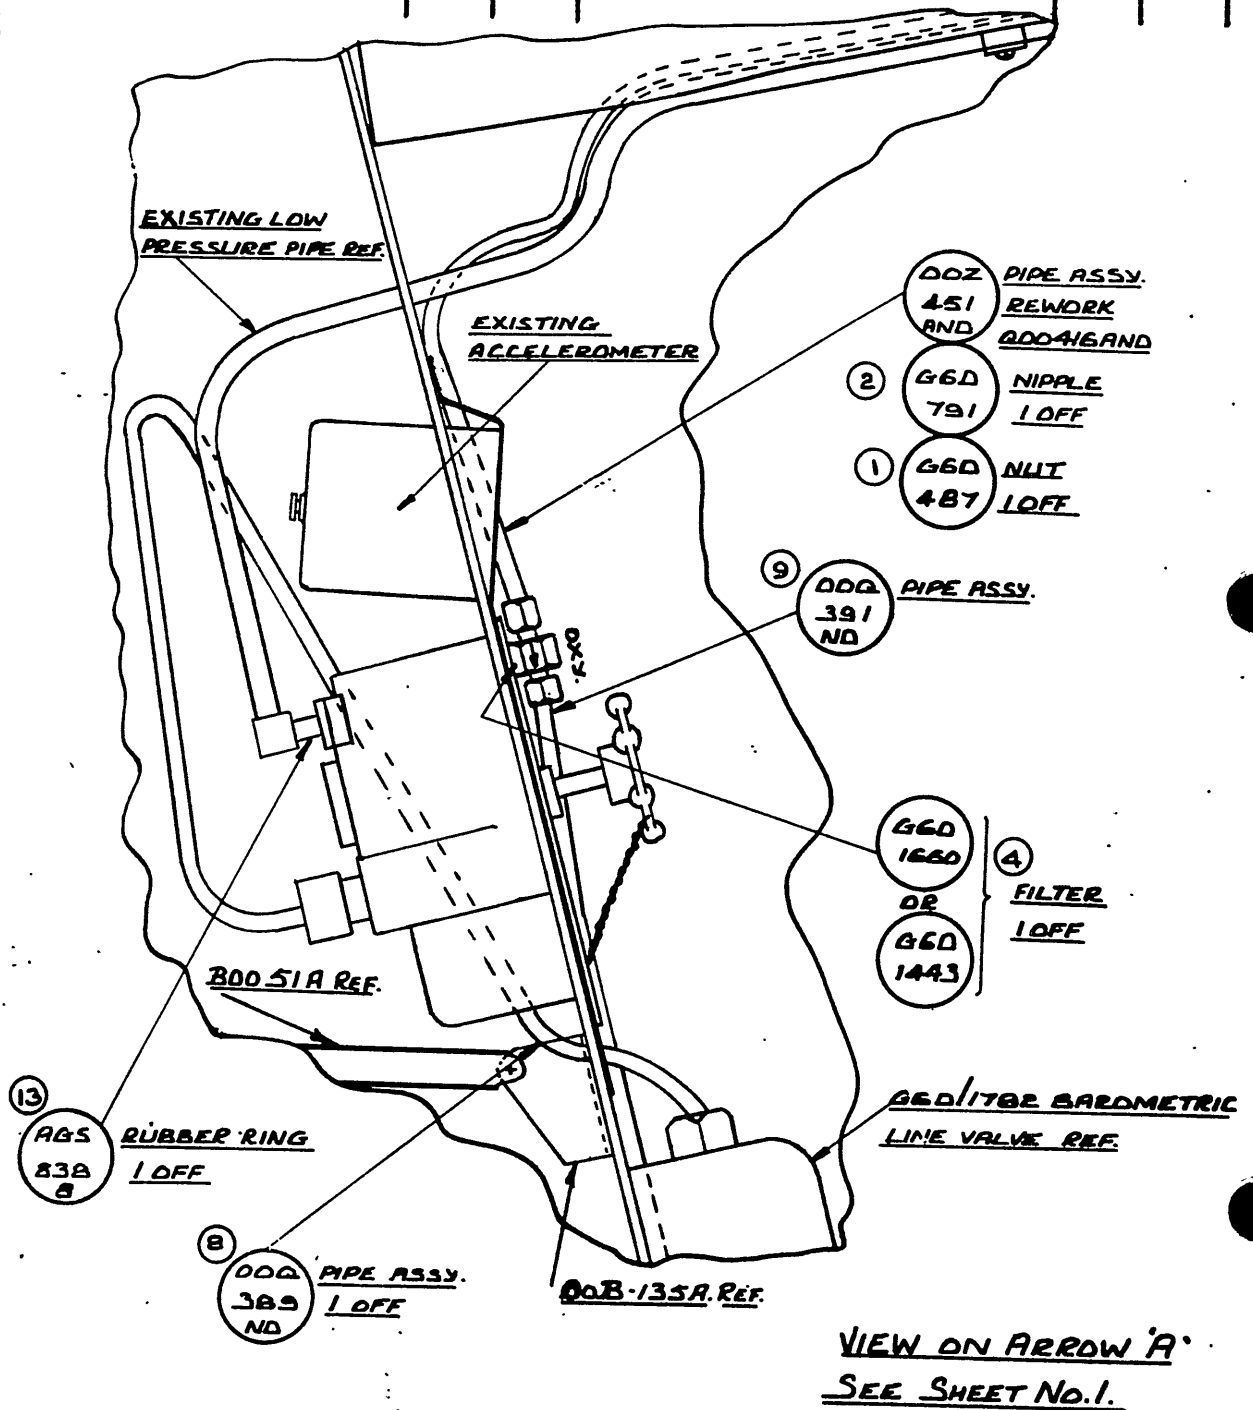
DE HAVILLAND DRAWING NO. DDM349 SHEET 2 OF 3 SHEETS.

REFERENCE	ISSUED BY		TITLE	
	Department of Air Directorate of Mechanical & Electrical Engineering.		R.H. INSTRUMENT PANEL — REWORK.	
LIMITS UNLESS STATED	MATERIAL		COMPONENT OF	
DECIMALS $\pm .010"$	SPEC.		MACHINE	Vampire
FRACTIONS $\pm \frac{1}{32}"$	TREATMENT		ENGINE	
ANGLES $\pm \frac{1}{2}^\circ$	FINISH		TECH. ORDER	Vampire Mod. 240
SURFACE FINISH AUSTRALIAN STANDARD ENG. DRWG. PRACTICE A.9.121	SCALE		DRAWING NO.	A128825ht.2
	DRAWN	APPROVED		DRW A SIZE
	TRACED	CHECKED

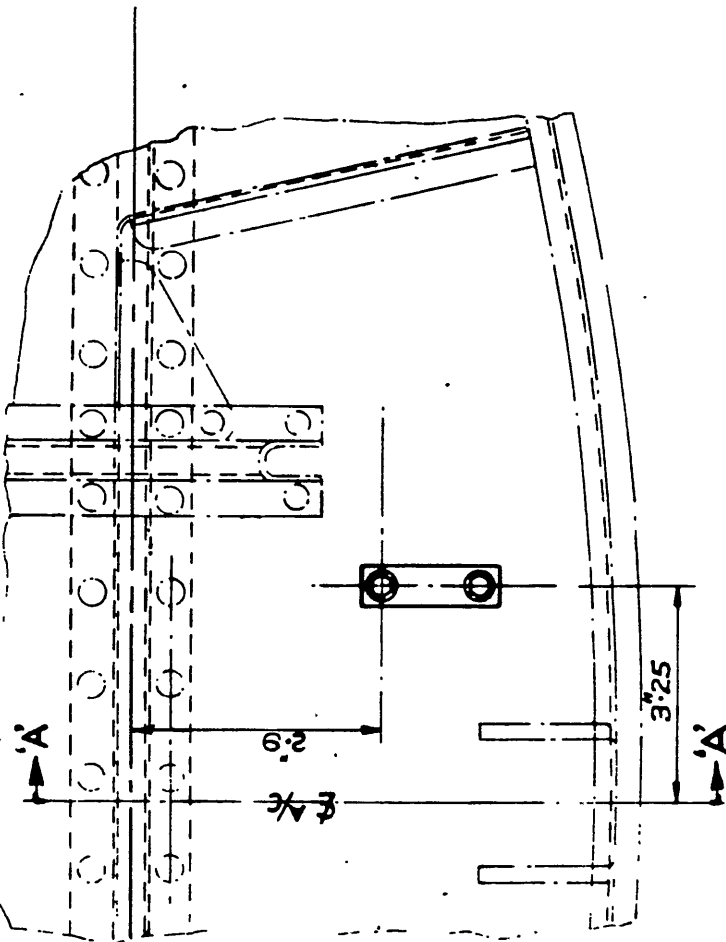
VIEW LOOKING ON AFT FACE OF FIREPROOF BULKHEAD.

INSTALLATION OF CLAMP BLOCK.

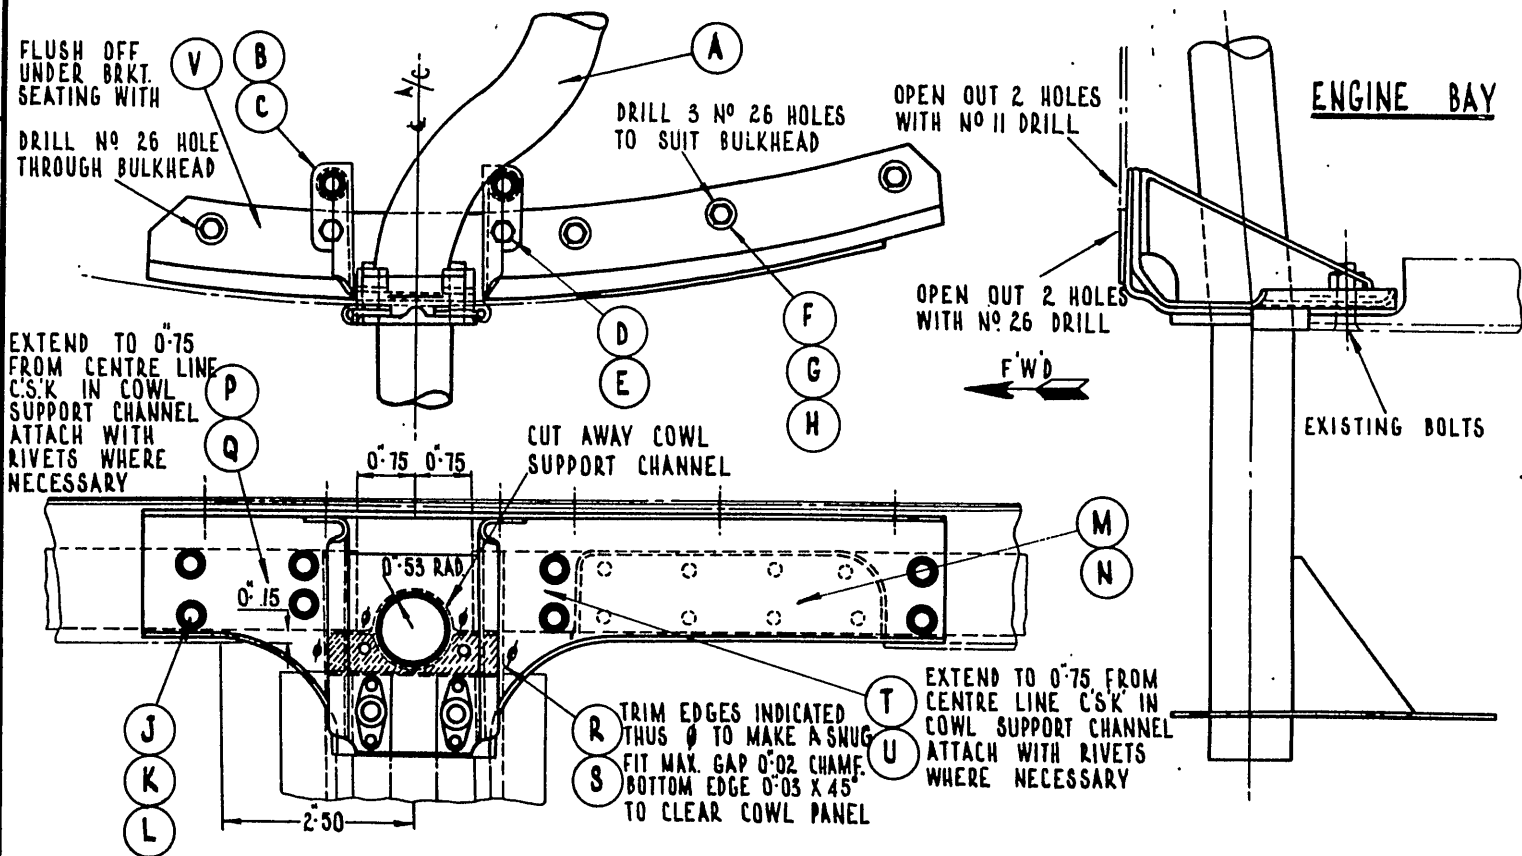
INSTALLATION OF VENT PIPE ASSY. ON REAR FACE OF FIREPROOF BULKHEAD

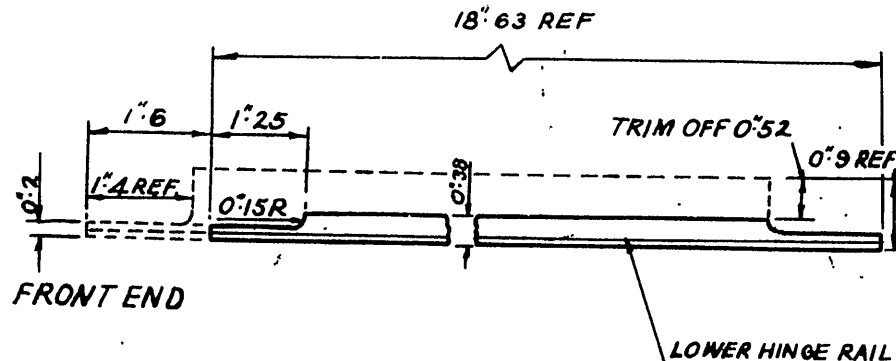
TRIM THE HINGE AND PACKING 1'6
 TRIM THE HINGE RAIL TO THE NEW SHAPE DETAILED
 FINISH THE HINGE RAIL WITH MATCHING CELLULOSE
 TO SPEC. D.T.D 772 ALUMINIUM.

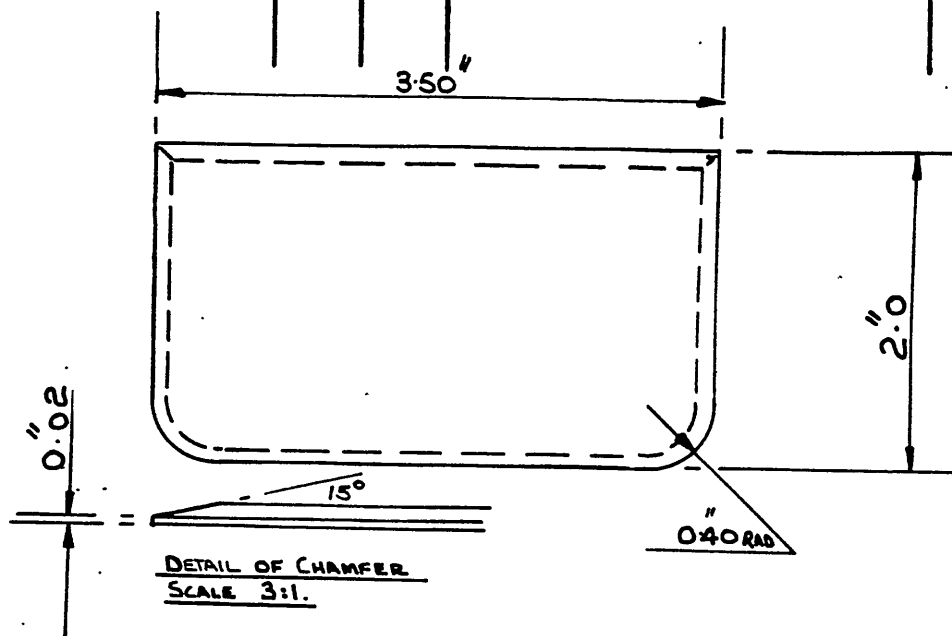
MAKE FROM ALLCAD-L72-18SWG FINISH ^{ANODISE} ~~CERAMIT GREEN~~ **BLANKING PLATE** **ISEC-119**

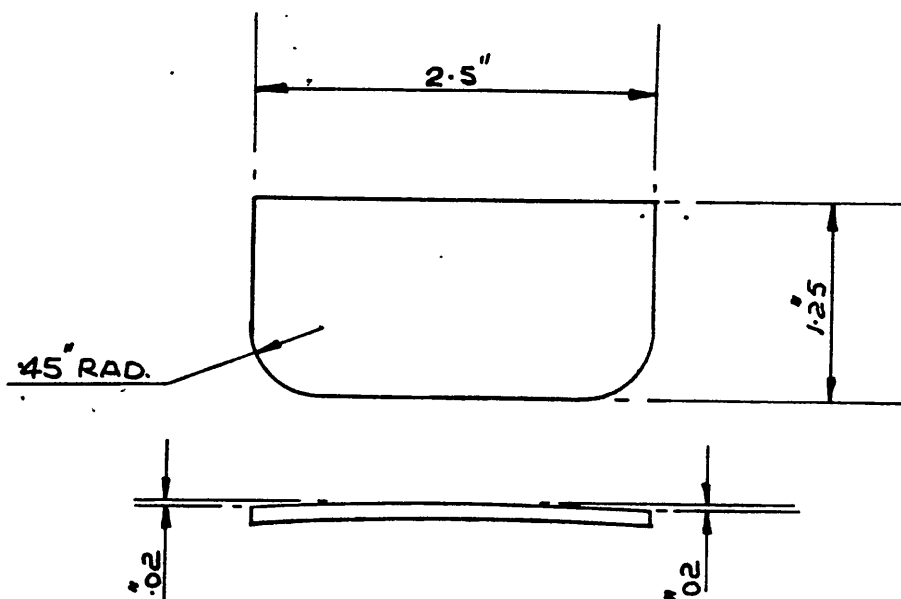
MAKE FROM ALLCAD-L72-12SWG FINISH ^{ANODISE} ~~CERAMIT GREEN~~ **INSERT PLATE** **ISEC 121**

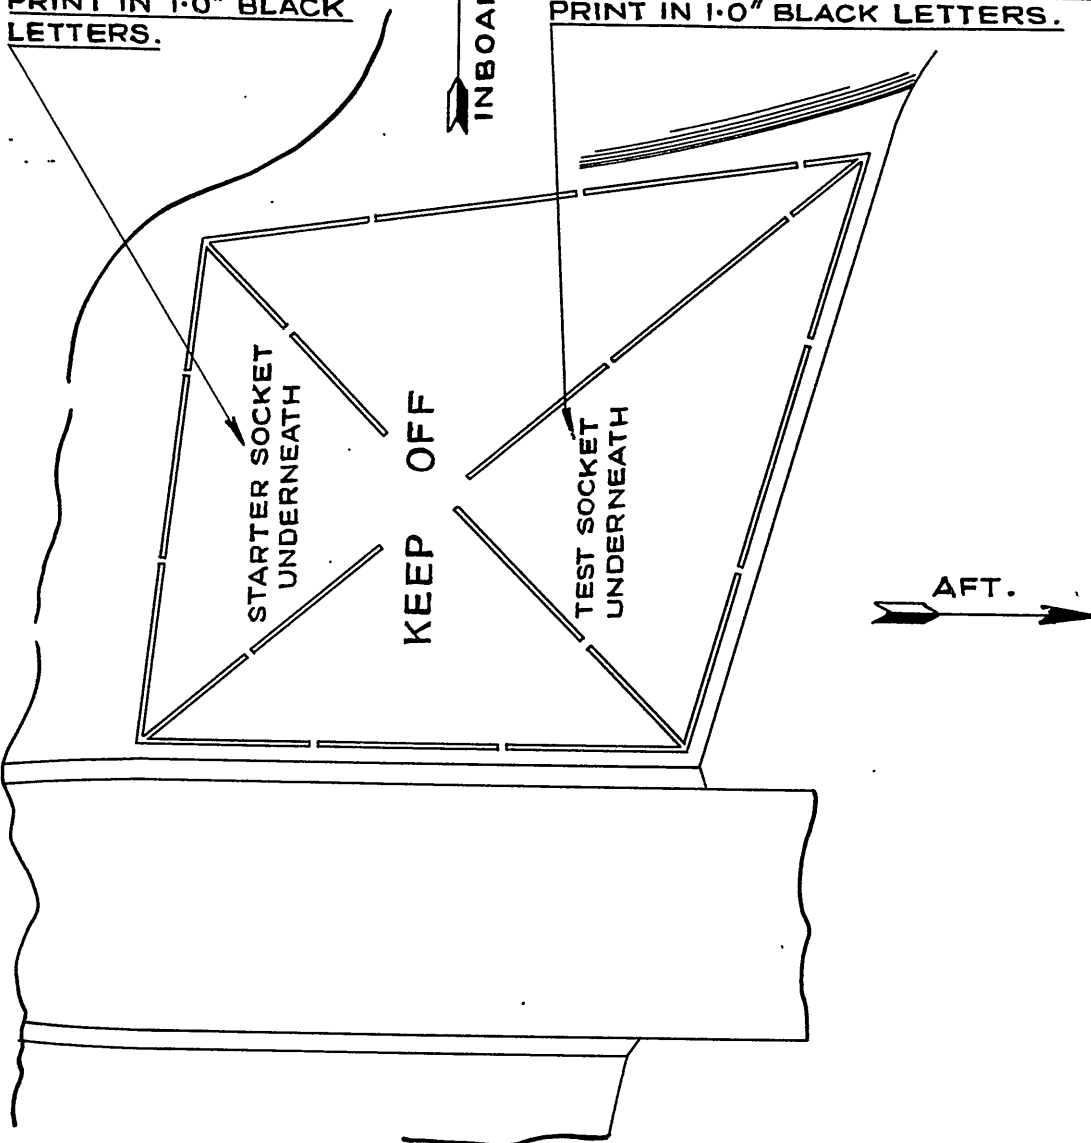
"TEST SOCKET UNDERNEATH"
TO READ "STARTER SOCKET
UNDERNEATH" (AS DRAWN)
PRINT IN 1.0" BLACK
LETTERS.

ALTER EXISTING NOTE "STARTER
SOCKET UNDERNEATH" TO READ
"TEST SOCKET UNDERNEATH" (AS DRAWN)
PRINT IN 1.0" BLACK LETTERS.

VIEW ON TOP SURFACE OF PORT FLAP SHROUD (INBOARD)

- (xiii) Repair the finish to both inner and outer surfaces of the flap shroud, using items 33, 34 and 39, and finish using item 38. Rework the external markings to drawing A13212, sheet 3, using items 35 - 36.
- (xiv) The flap shroud is now to be re-identified as part number D006251A/41. Locate No on shroud rib No 1.
- (xv) Re-connect the aircraft batteries and replace the gun bay doors. Re-charge hydraulic system.

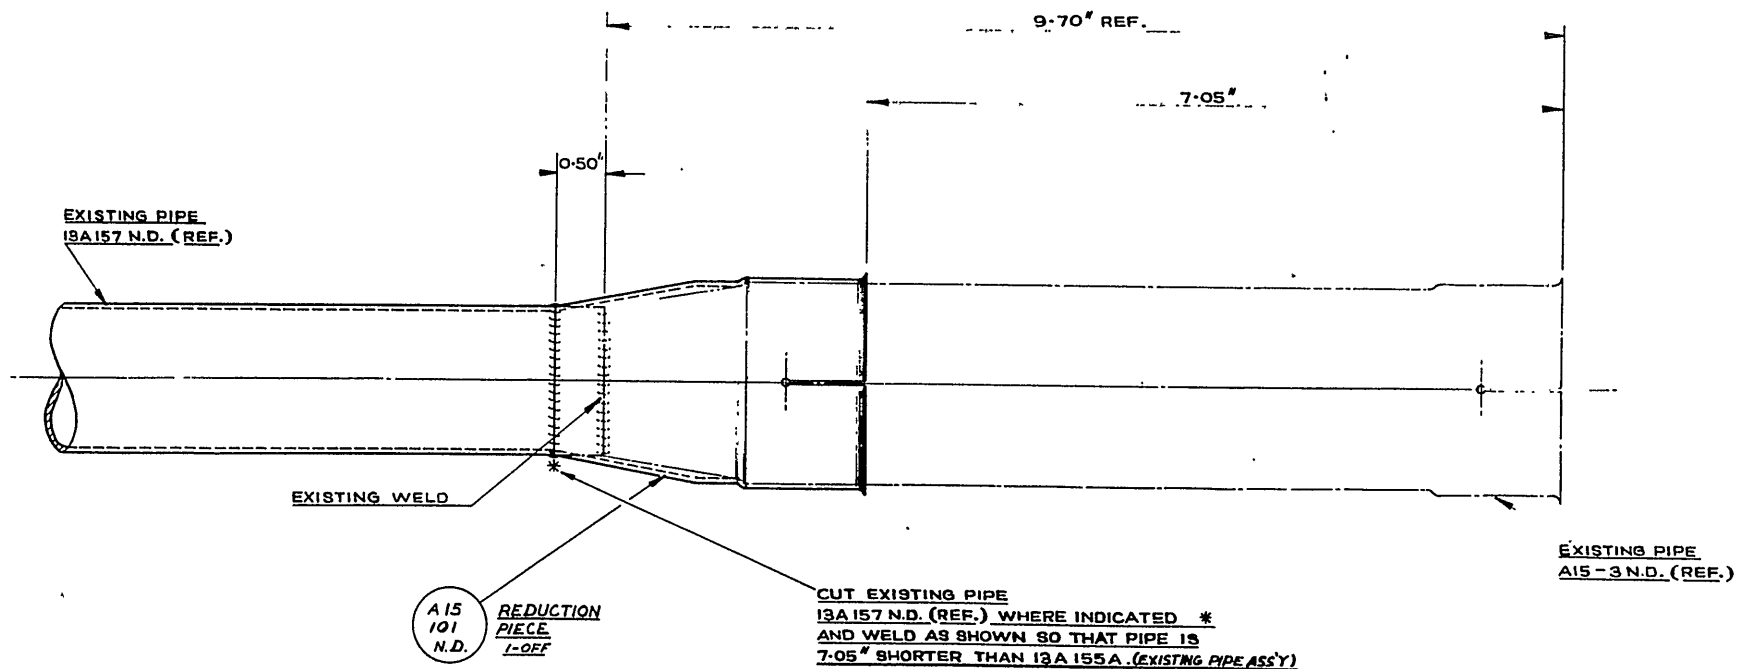
AFT END OF CANNON HEATING PIPE
13A155A (REF.)

NOTE: REMOVE EXISTING PIPE ASSY
13A-155A FROM AIRCRAFT
AND REWORK AS SHOWN.
AFTER REWORK RE-PART N°
AS A15-103A.

FINISH CLEAN PIPE INTERNALLY WITH HOT
TRICHLOROETHYLENE
PRIME EXTERNALLY WITH ZINC
CHROMATE AND FINISH WITH
COCKPIT GREEN.

- (ix) * "Using the existing clips which were retained in operation (ii), replace the cannon heating pipe which was reworked to A15-103A in operation (v). AL. 192

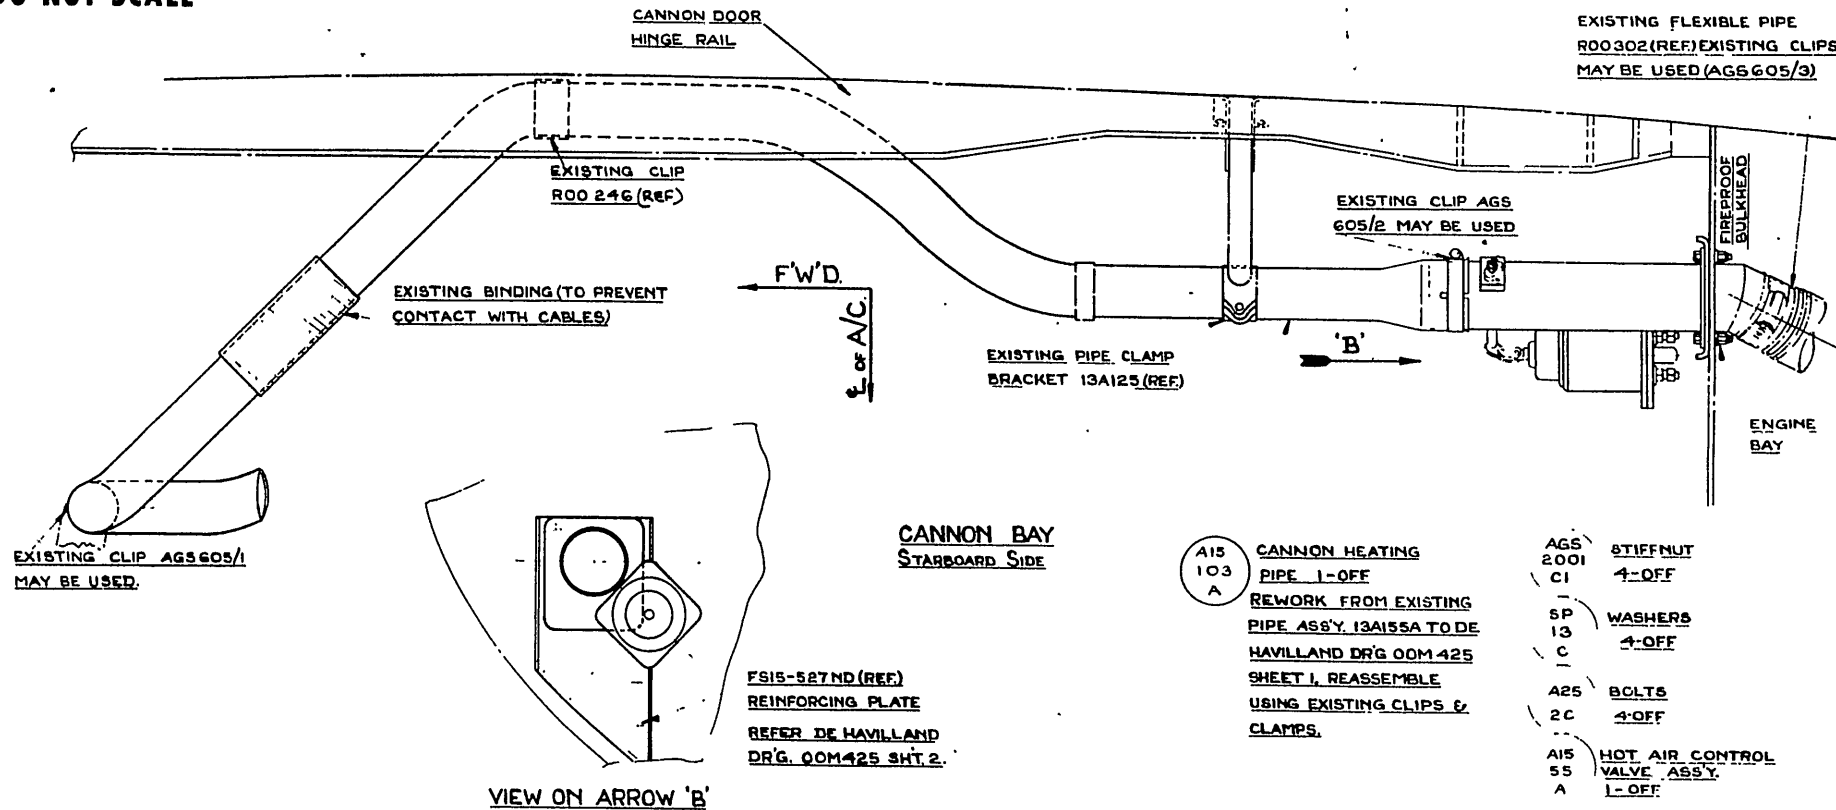
PLAN VIEW ON ST'BD. SIDE OF GUN BAY.
