Australian Air Publication 721.79

**Volume 2, Part 2
Book 3**

VAMPIRE MODIFICATIONS

(Nos 201 to 300)

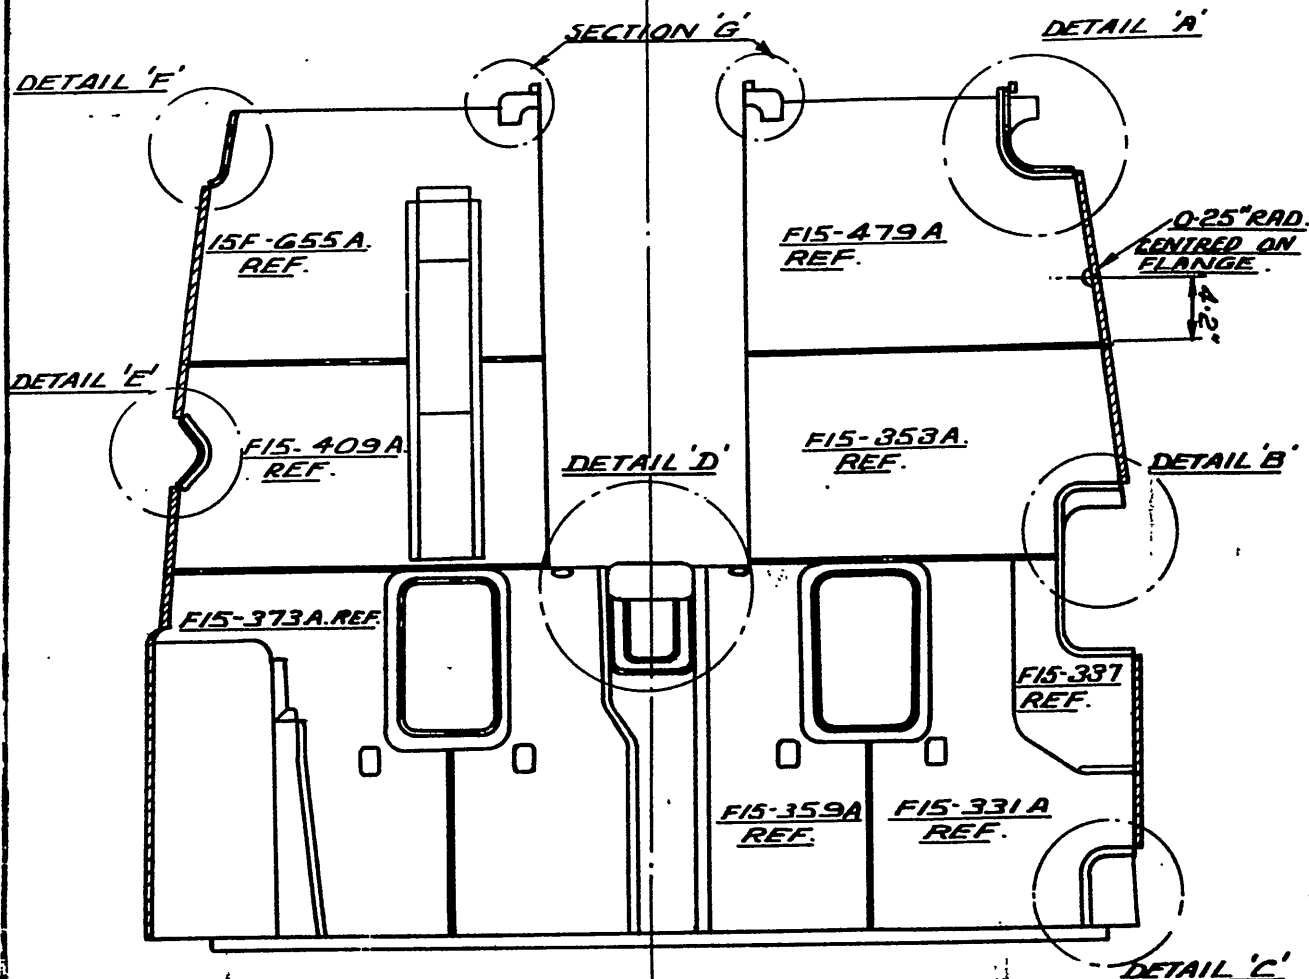
REPRESENTS
SYNTHETIC RUBBER SPONGE SECTION
AUTOGI. TRIM TO SUIT ON ASS'Y &
ATTACH WITH "PLIOBOND".

ANY GAPS REMAINING WHICH COULD
ALLOW FOREIGN OBJECTS TO FIND THEIR
WAY UNDER THE FALSE FLOOR TO BE
SEALED WITH 'LASSOBAND' ADHESIVE
TAPE

- (xiv) Any gaps remaining which could allow foreign objects to find their way under the false floor are to be sealed with "Lassoband" adhesive tape item 34. If white tape is used it must be sprayed lightly with matt black cellulose enamel item 33, after fitting.
 - (xv) Resecure the dust covers around each control column using existing screws, washers etc removed in paragraph (iii).
 - (xvi) Replace both ejection seats in accordance with AAP 721:79/33, Vol 1, Section 3, Chapter 1.
 - (xvii) Re-assemble the aircraft canopy hatch in accordance with AAP 721:79/33, Vol 1, Section 3, Chapter 1, Page 4.
- (d) Tests : Check functioning of canopy hatch mechanism.
- (e) Recording : Record this Modification in the air-frame log book.

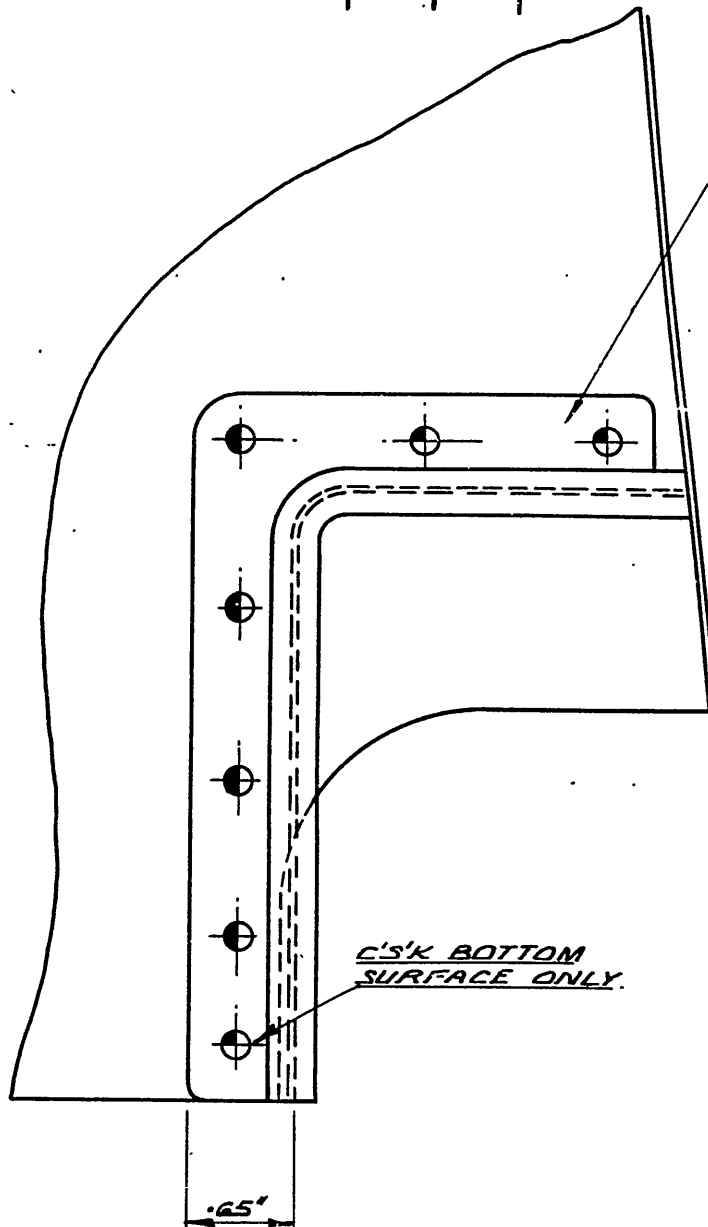
F15
785
A
GUARD ASS'Y
1- OFF

Position guard assy item 1. Drill 5 holes No 26 in panel in conjunction with guard assy. Attach 5-off anchor nuts item 18 using 10-off rivets item 25. Rivets to be flush on top surface of panel. Position screen item 3 as indicated. Drill 2 holes No 26 in panel in conjunction with screen. Attach 2-off anchor nuts item 18 using 4-off rivets item 25. Assemble guard assy to panel using 5-off bolts item 15 and 5-off washers item 17. After the panel has been replaced in the aircraft the screen can be assembled on to the panel using 2-off bolts item 16. Re-identify Panel as Part No F15-638A, Ident No A79/504108.

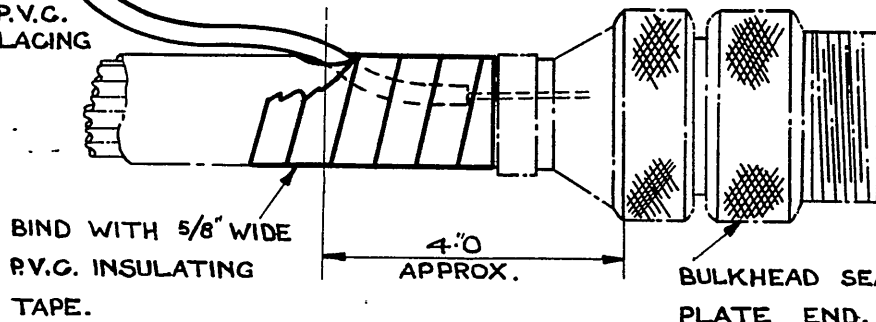
CABLE TO CONSIST OF AA16 ONE CORE VIN. TO SPEC. AS NO.2UI, 3'-3" LONG, COVERED WITH 4 M/M. 1/DIA. NYLEX TUBING AS SHOWN. (2'-6" LONG)

INTRODUCE A HOLE IN THE OUTER NYLEX TUBE OF THE CONDUIT ASS'Y. TO ACCEPT THE CABLE, THEN UNSCREW THE COUPLING NUT AND PULL BACK THE NYLEX TUBING. CONNECT CABLE END TO PIN 'P'.

AFTER REWORK RE-PART NO TO 00N1169A

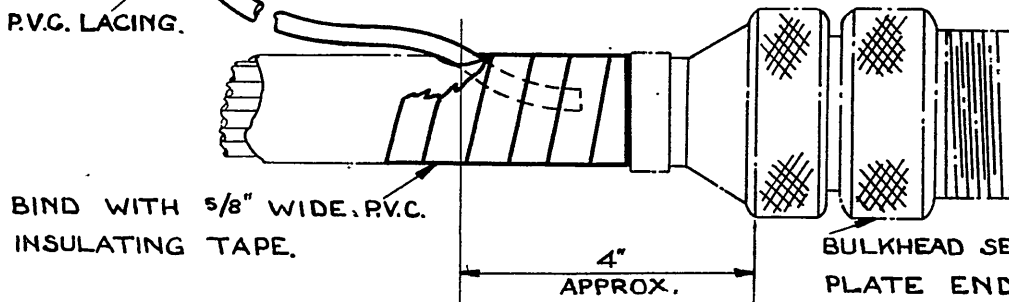
INTRODUCE A HOLE IN THE OUTER NYLEX TUBE OF THE CONDUIT ASS'Y. TO ACCEPT THE CABLE, THEN UNSCREW THE COUPLING NUT AND PULL BACK THE NYLEX TUBING. CONNECT CABLE ENDS AS FOLLOWS:-

PIN	CODE
P	GF6A
R	GF6

AFTER REWORK RE-PART NO. TO 00N1165A

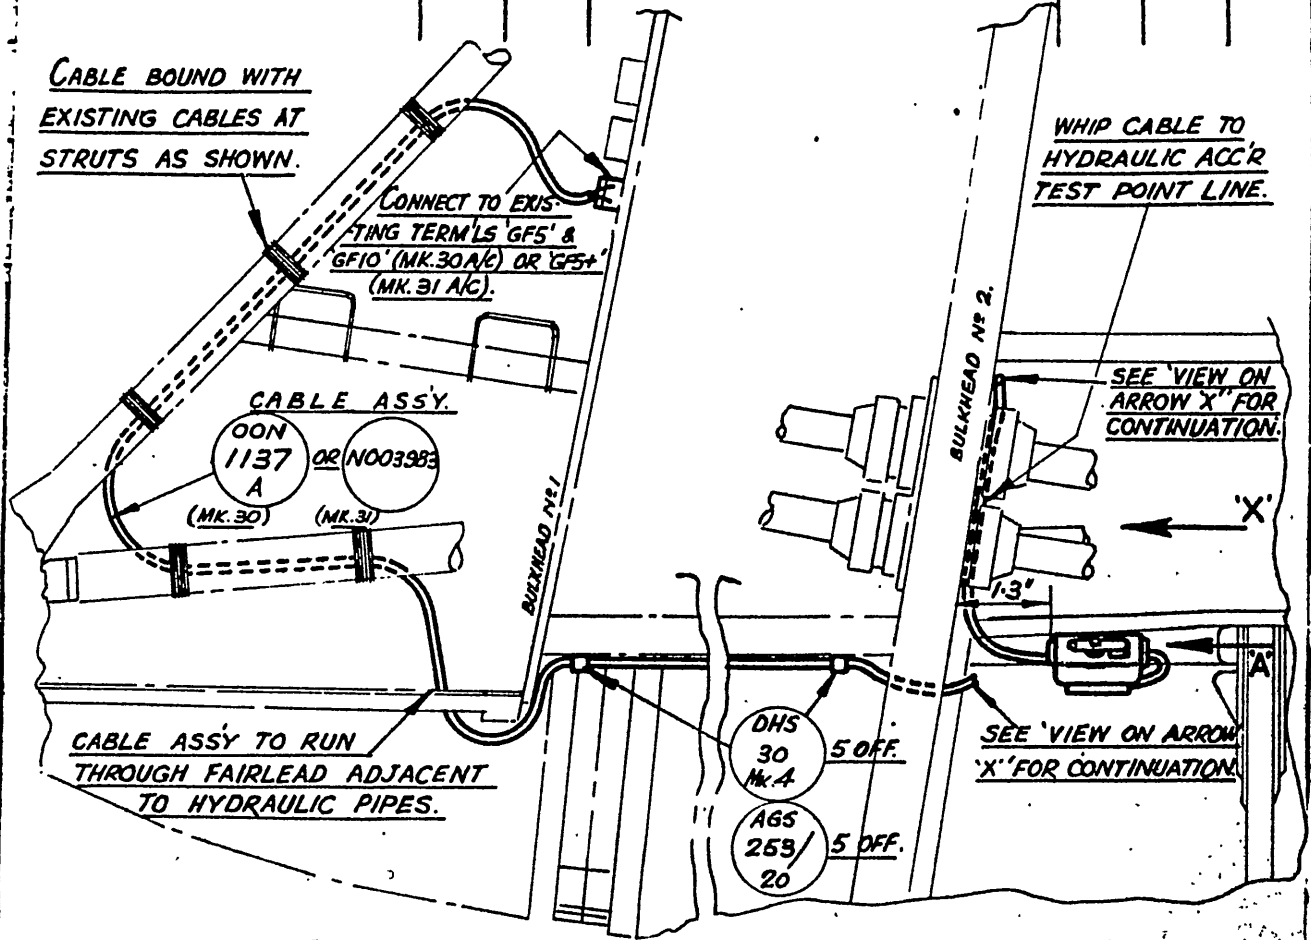
INSTALLATION OF WIRING IN GUN BAY & NOSE.

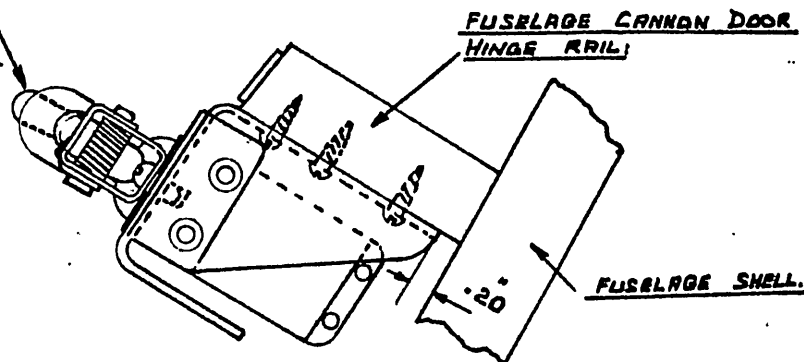
VIEW ON ARROW A

AGS
2035
B

SHAKE PROOF WASHER
2-OFF

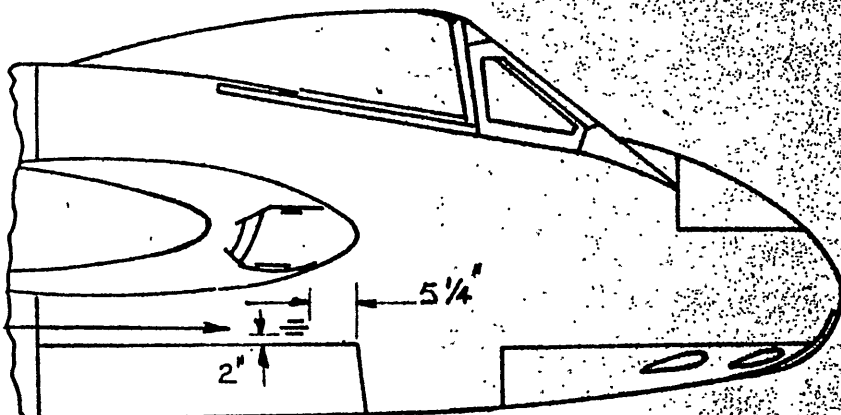
ADD THE FOLLOWING STENCIL
ON STD SIDE OF AIRCRAFT
IN RED LETTERS.

GUNFIRE — 1/2" HIGH LETTERS.
TEST SWITCH — 1/2" " "
INSIDE — 1/4" " "
.2 BETWEEN LETTERS.

ADDITION OF EXTERNAL MARKING.

- (viii) Refer to drawing AL3095, sheet 2, clean exterior of aircraft locally at new stencil position and add new lettering using paint (item 13) as required.
 - (ix) Replace the port cannon spout fairing.
 - (x) Function gun firing circuit (see para (d) Tests).
 - (xi) Reconnect accumulator leads.
 - (xii) Replace the gun bay doors.
 - (xiii) Replace the detachable nose panel.
- (d) Tests : Function the gun firing circuit whilst operating the test switch.

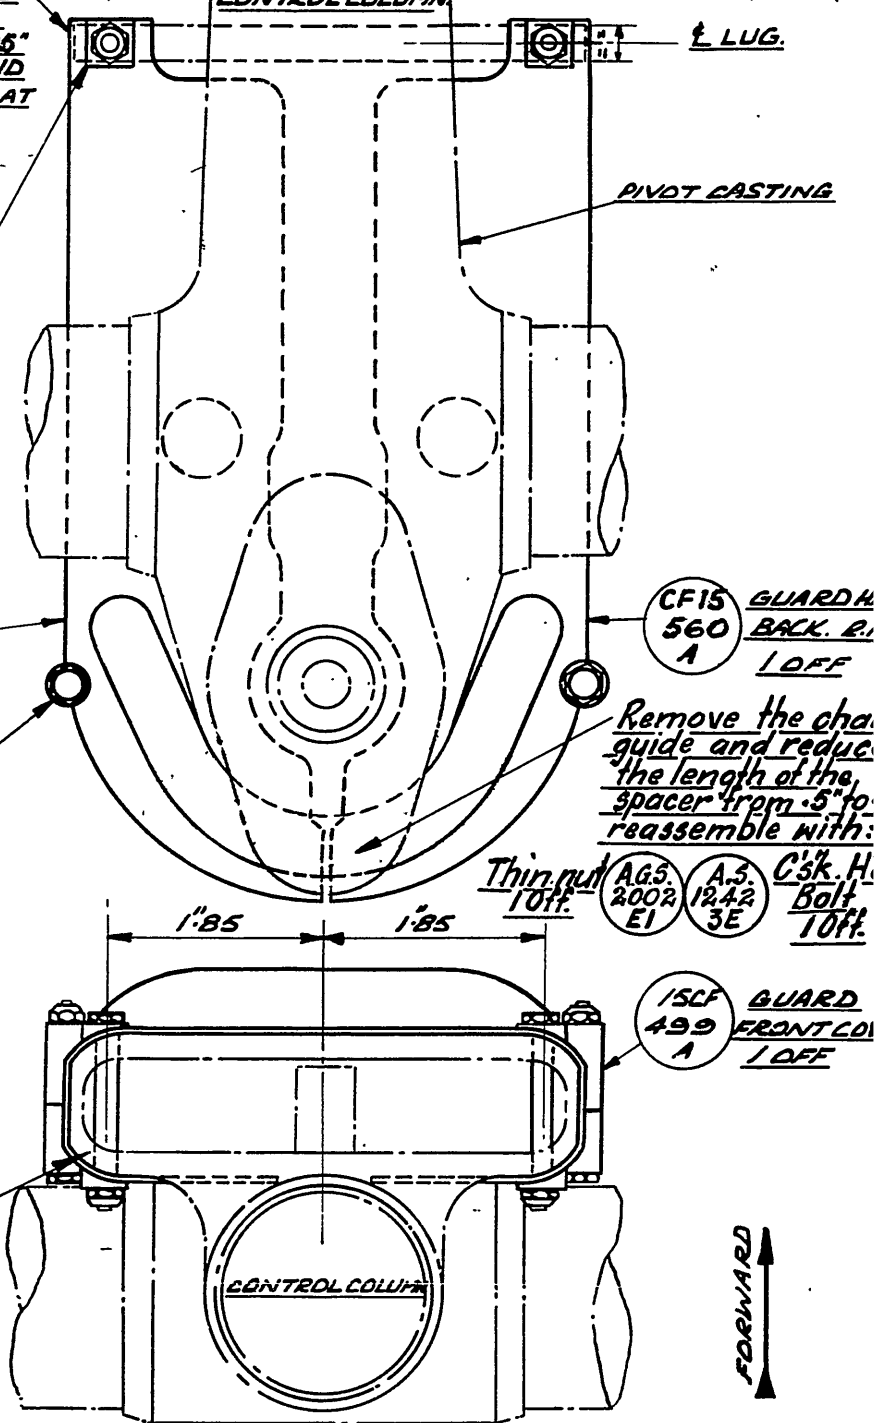
DRILL EXISTING LUG ON PIVOT CASTING TWO HOLES NO.27 AND HALF BACK GUARDS TO SUIT.

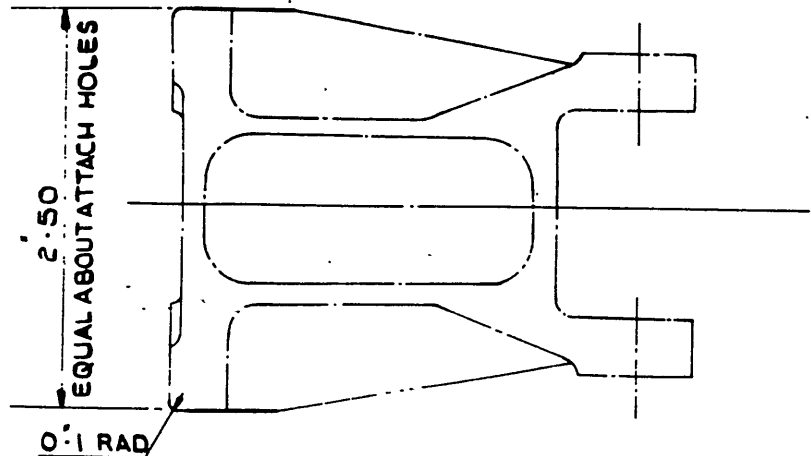
FIG.1.

AFTER MODIFICATION RE-NUMBER
BRACKET J001981 -REF.

MODIFICATION TO UPPER HINGE BRACKET J00825 -REF

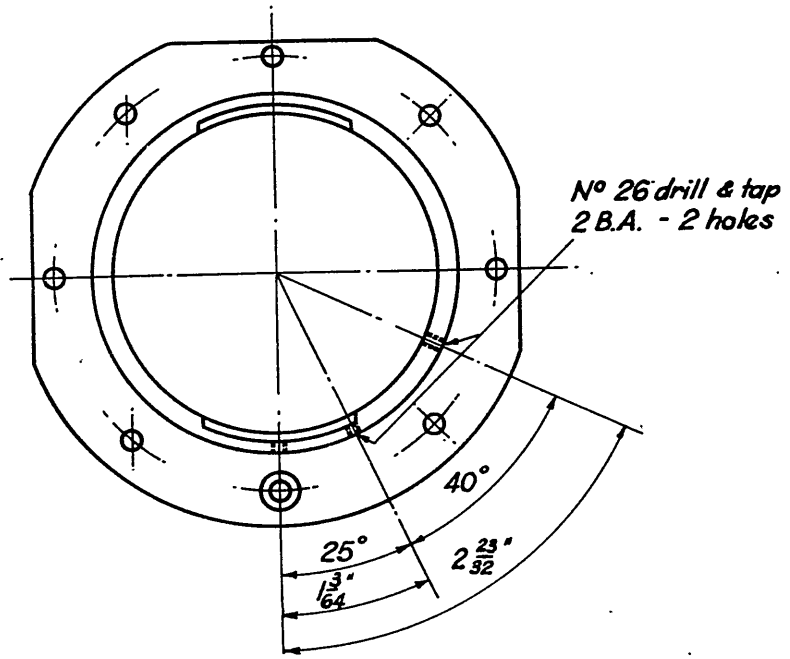
Note : Part Nos S0041 & S0042 modified as drawn.
Part Nos S0043 & S0044 modified opposite hand.

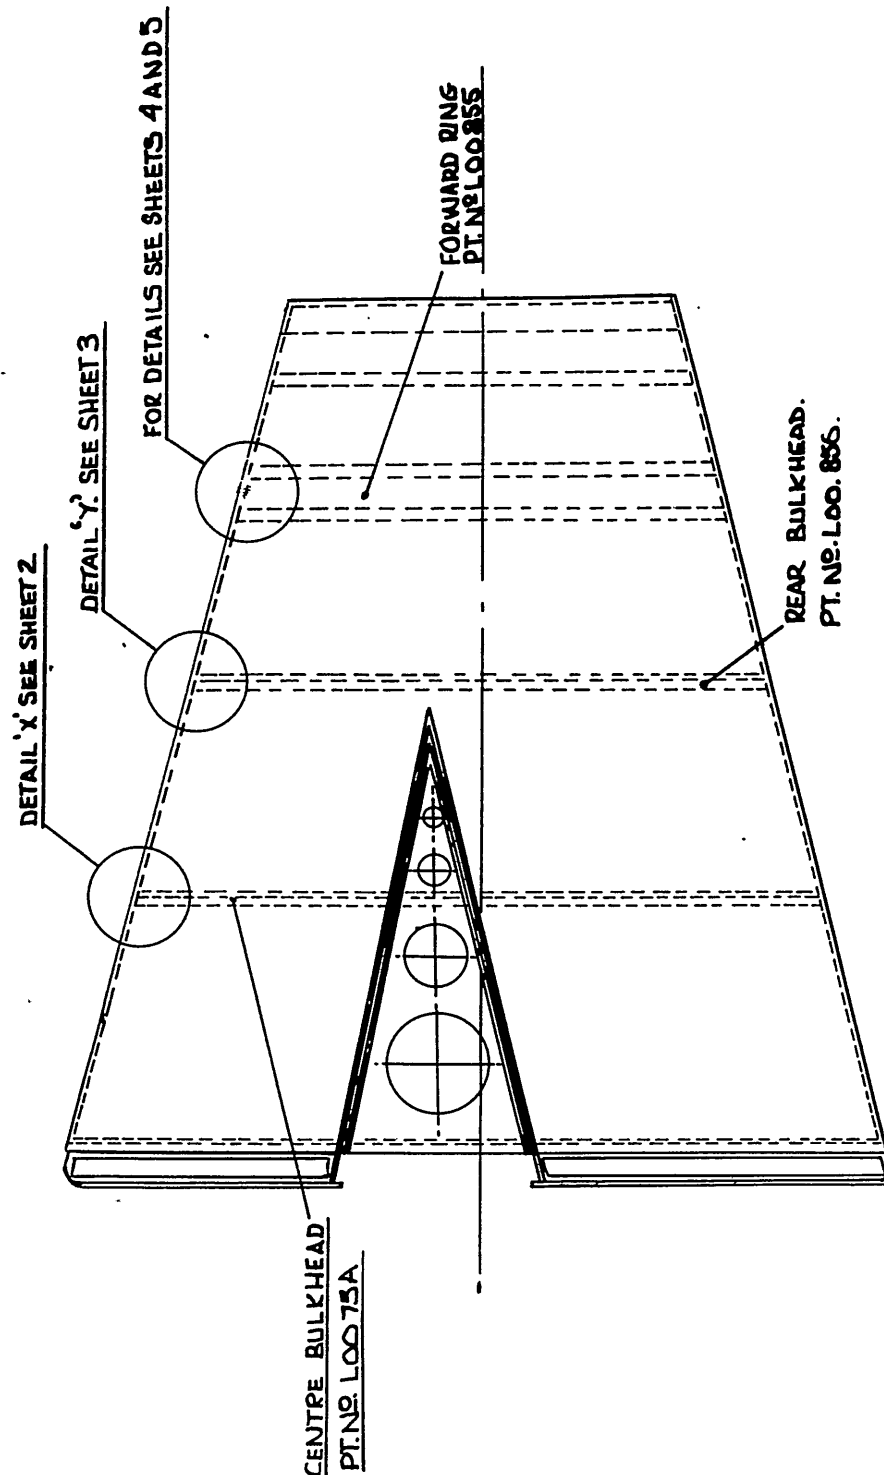
DE HAVILLAND DRAWING COM369. SHEET 1. OF 5. SHEETS

VIEW OF REAR CONE SHOWING THE THREE POINTS TO BE MODIFIED

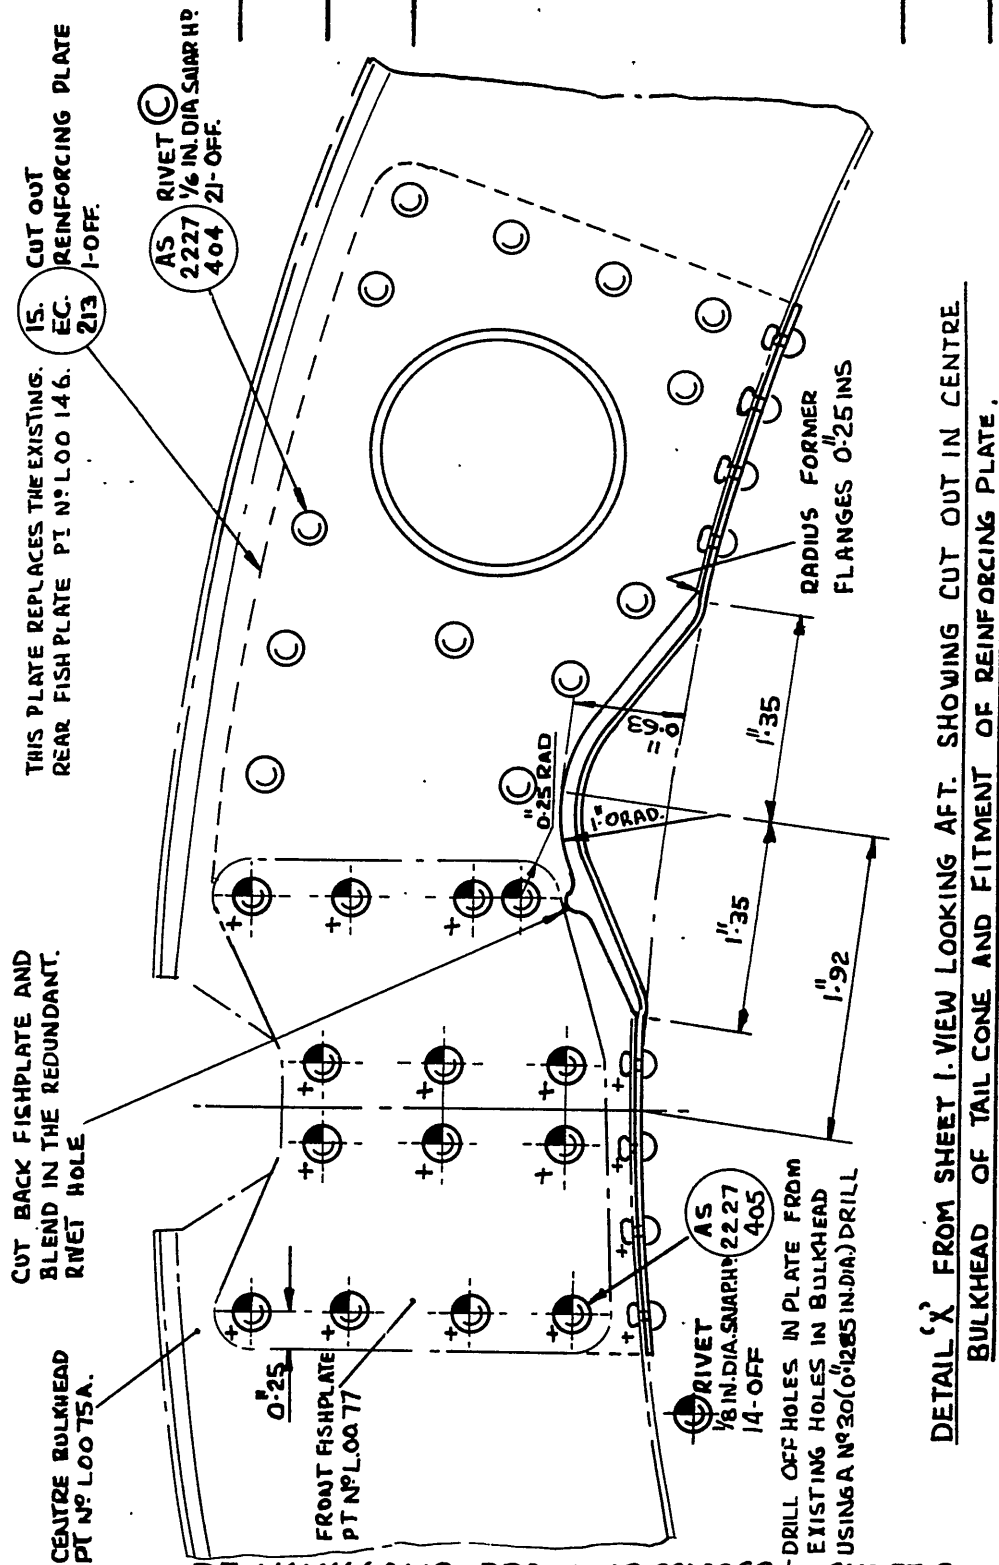
DE HAVILLAND DRAWING DOM 369. SHEET 2 OF 5 SHEETS

DETAIL 'X' FROM SHEET I. VIEW LOOKING AFT. SHOWING CUT OUT IN CENTRE BULKHEAD OF TAIL CONE AND FITMENT OF REINFORCING PLATE.

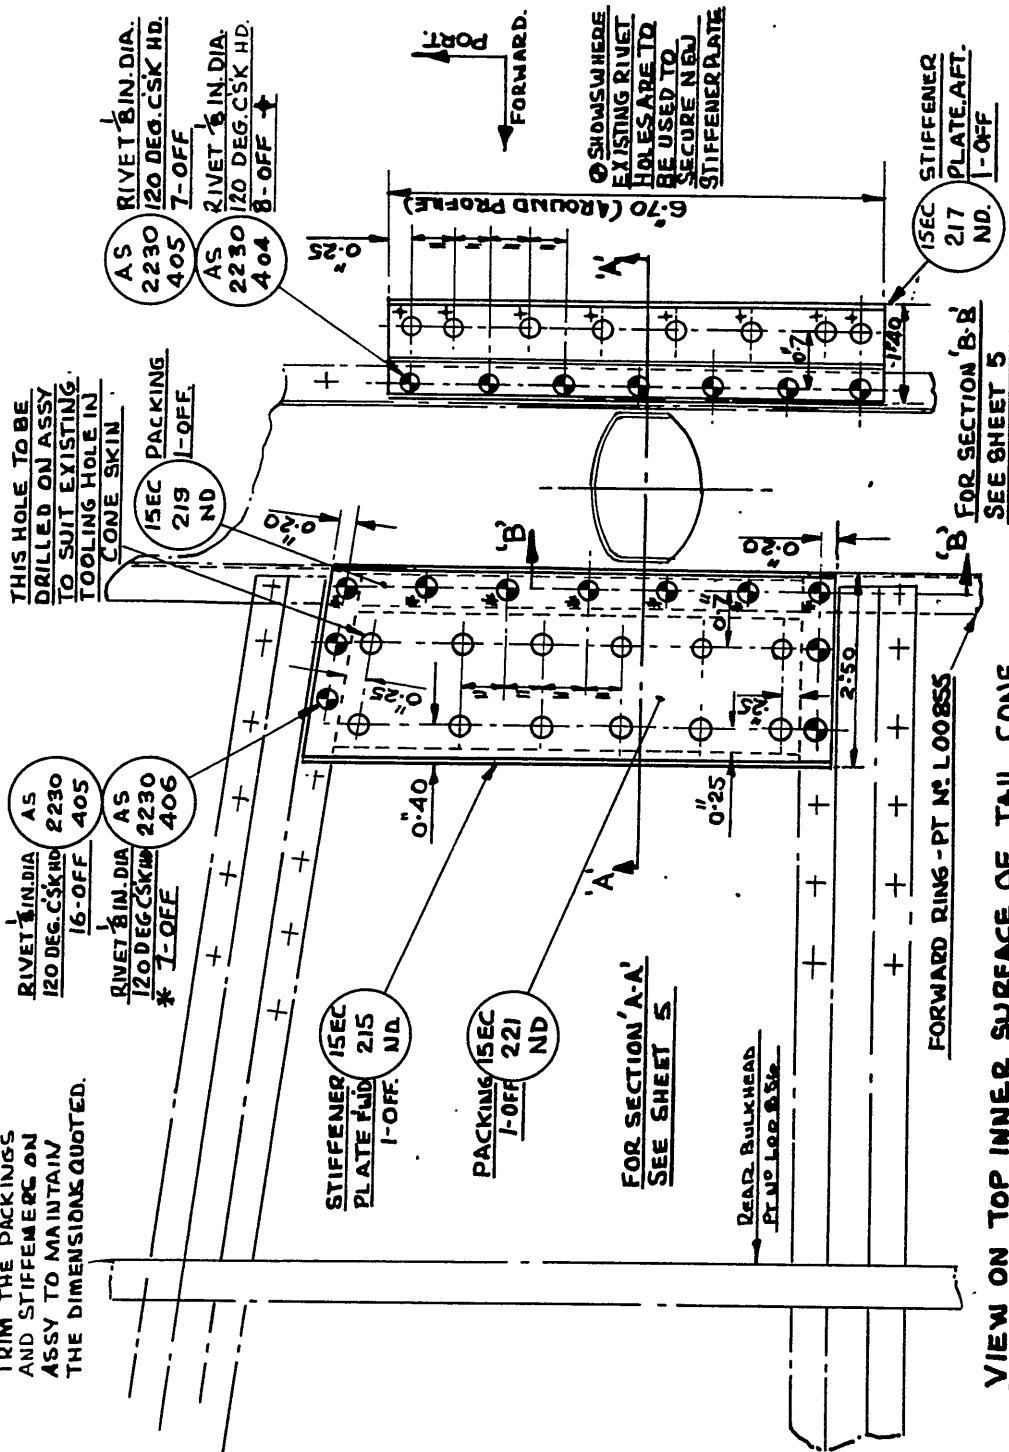
DE HAVILLAND DRAWING ODM 369

DRILL ALL RIVET HOLES USING A N° 35 (0.110 IN DIA) DRILL. DIMPLE C'SK THE OUTER CONE SKIN 120 DEG X 0.250 IN DIA. AND THE PACKINGS AND STIFFENERS TO SUIT TRIM THE PACKINGS AND STIFFENERS ON ASSY TO MAINTAIN THE DIMENSIONS QUOTED.

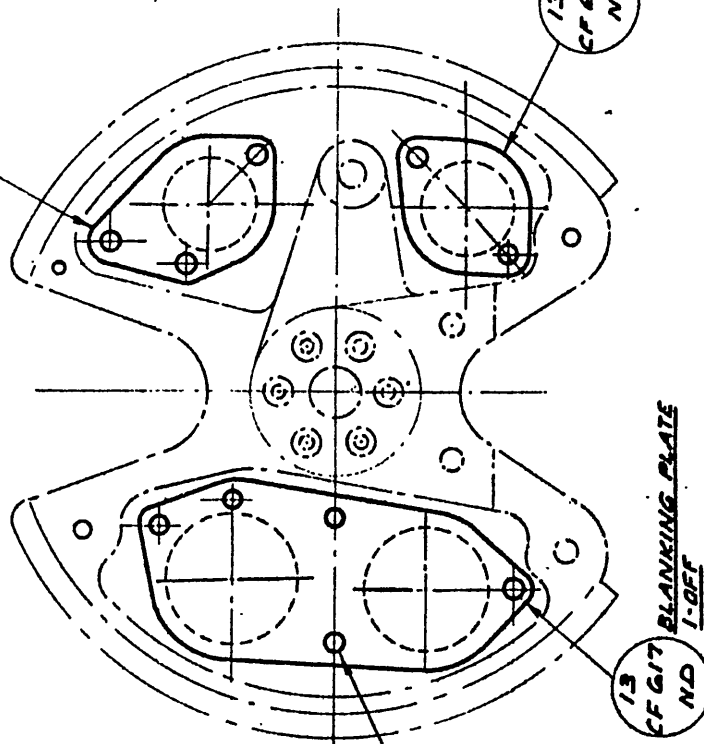
DE HAVILLAND DRG NO. 00M380.

13
CF 615
ND
BLANKING PLATE
1-OFFNOTE: COAT THE MATING
SURFACES OF THE PLATES
AND PULLEY WITH COMPOUND,
PIGMENTED VARNISH
JOINTING.POSITION BLANKING PLATES
TO COVER HOLES
AS SHOWN.13
CF 613
ND
BLANKING PLATE
1-OFFQUADRANT PULLEY K00G2
(REF.) WITH PLATES ATTACHED
BECOMES PART NO. K0015B1 (REF.)NOTE: REPAIR FINISH WHERE
NECESSARY USING
FINISH. HINT: BLACK.

RIVET 1/8" x 2227
SNAP HEAD
10-OFF
DRILL 10 NO. 30
(1285 DIA) HOLES IN
QUADRANT PULLEY.

- (viii) Refer to the drawing and approximately position as shown, the three new Blanking Plates (items 1, 2 and 3) on the inboard side of the Port Pulley and on the outboard side of the Starboard Pulley. Drill the attachment rivet holes in the Pulley with a No 30 (.1285 in dia) drill, using the holes in the Blanking Plates as a guide. Deburr all holes. Coat the mating surfaces of the new Blanking Plates and the Pulleys with pigmented varnish jointing compound (item 12), then rivet together using $\frac{1}{8}$ " dia. Snap Head rivets (item 4). Repair the finish locally using black enamel (item 10) and re-identify as part No K001581.

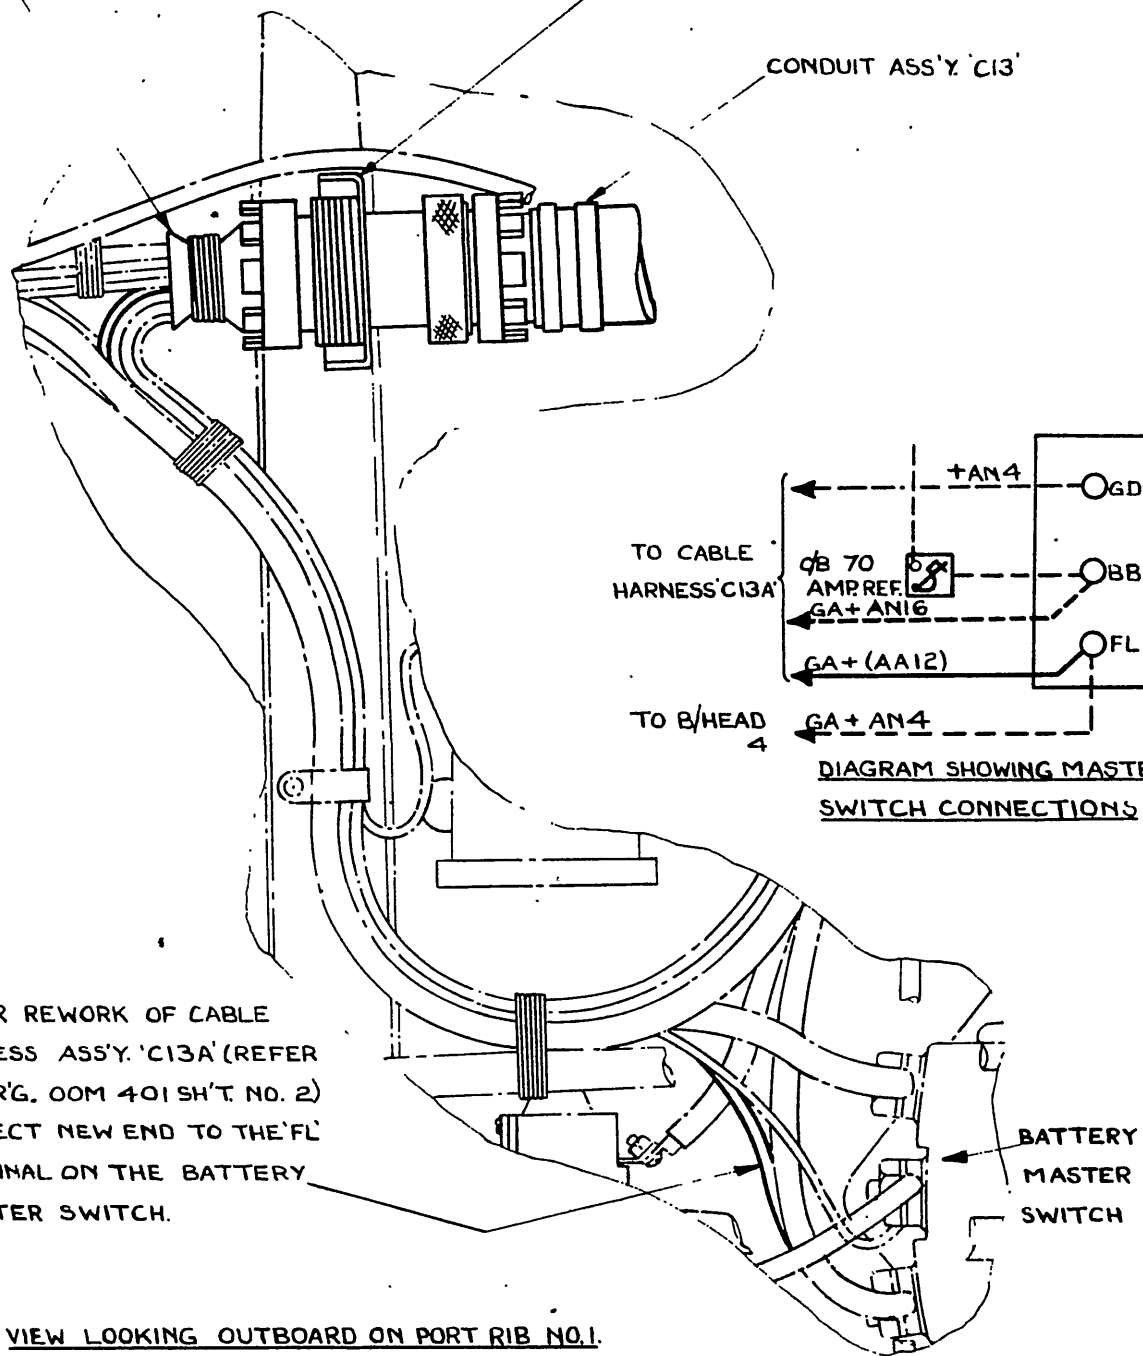
VIEW LOOKING OUTBOARD ON PORT RIB NO.1.

AFTER REWORK OF CABLE
HARNESS ASS'Y. 'C13A' (REFER
TO DR'G. OOM 401 SH'T. NO. 2)
CONNECT NEW END TO THE 'FL'
TERMINAL ON THE BATTERY
MASTER SWITCH.

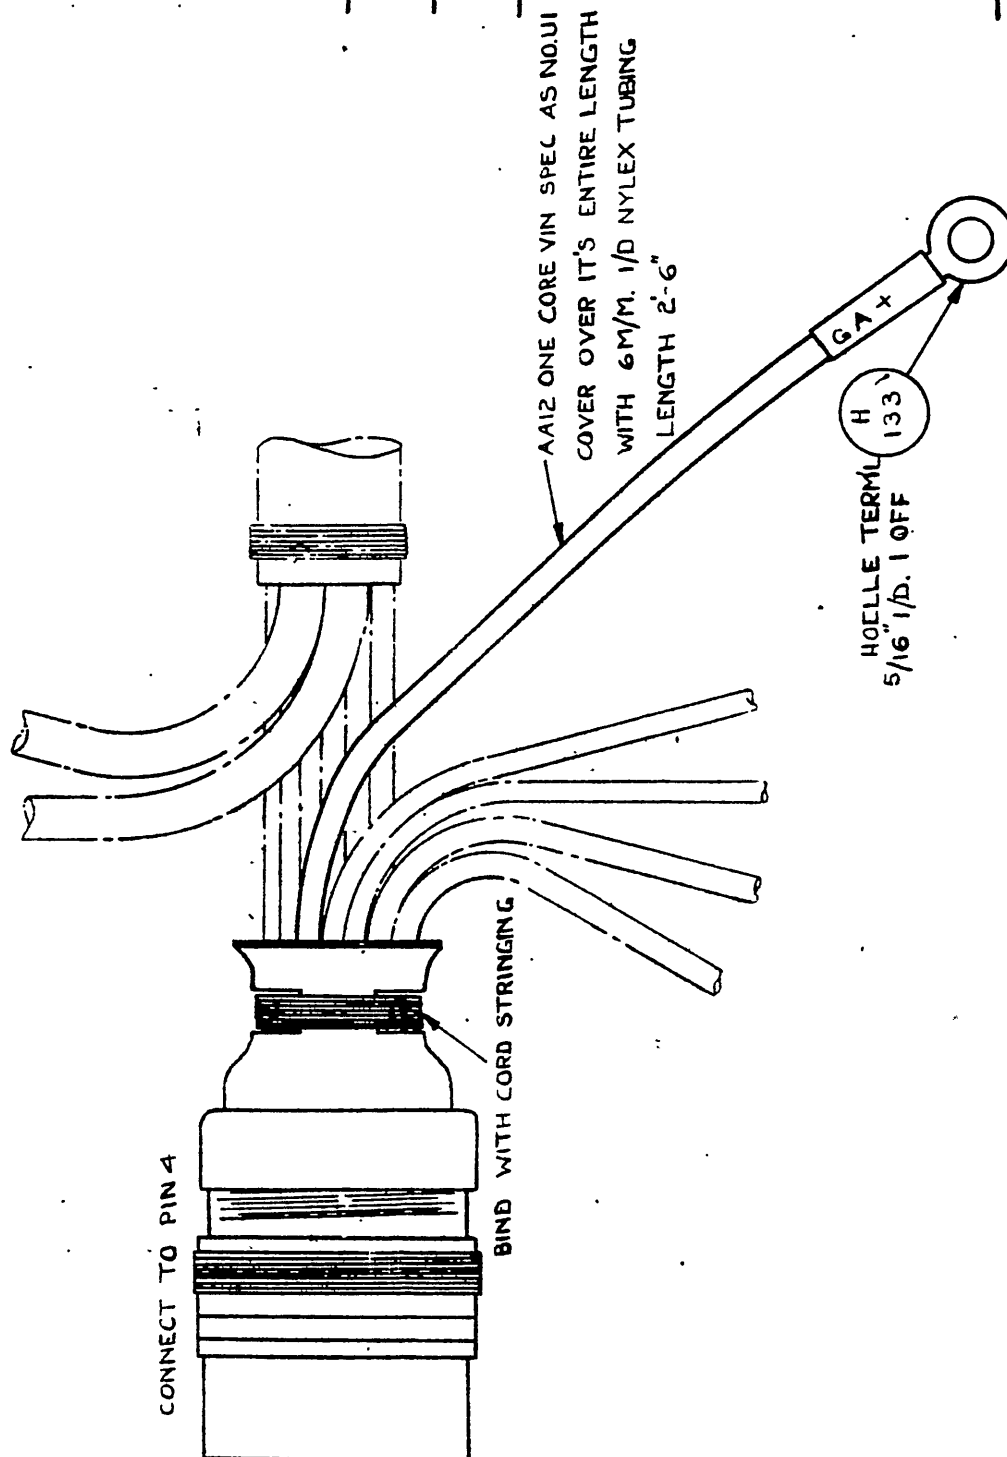
DE HAVILLAND DRAWING NO. 00M401 SHEET 2 OF 7 SHEETS.

REWORK TO EXISTING NO0945A/1 CABLE HARNESS ASS'Y C13A

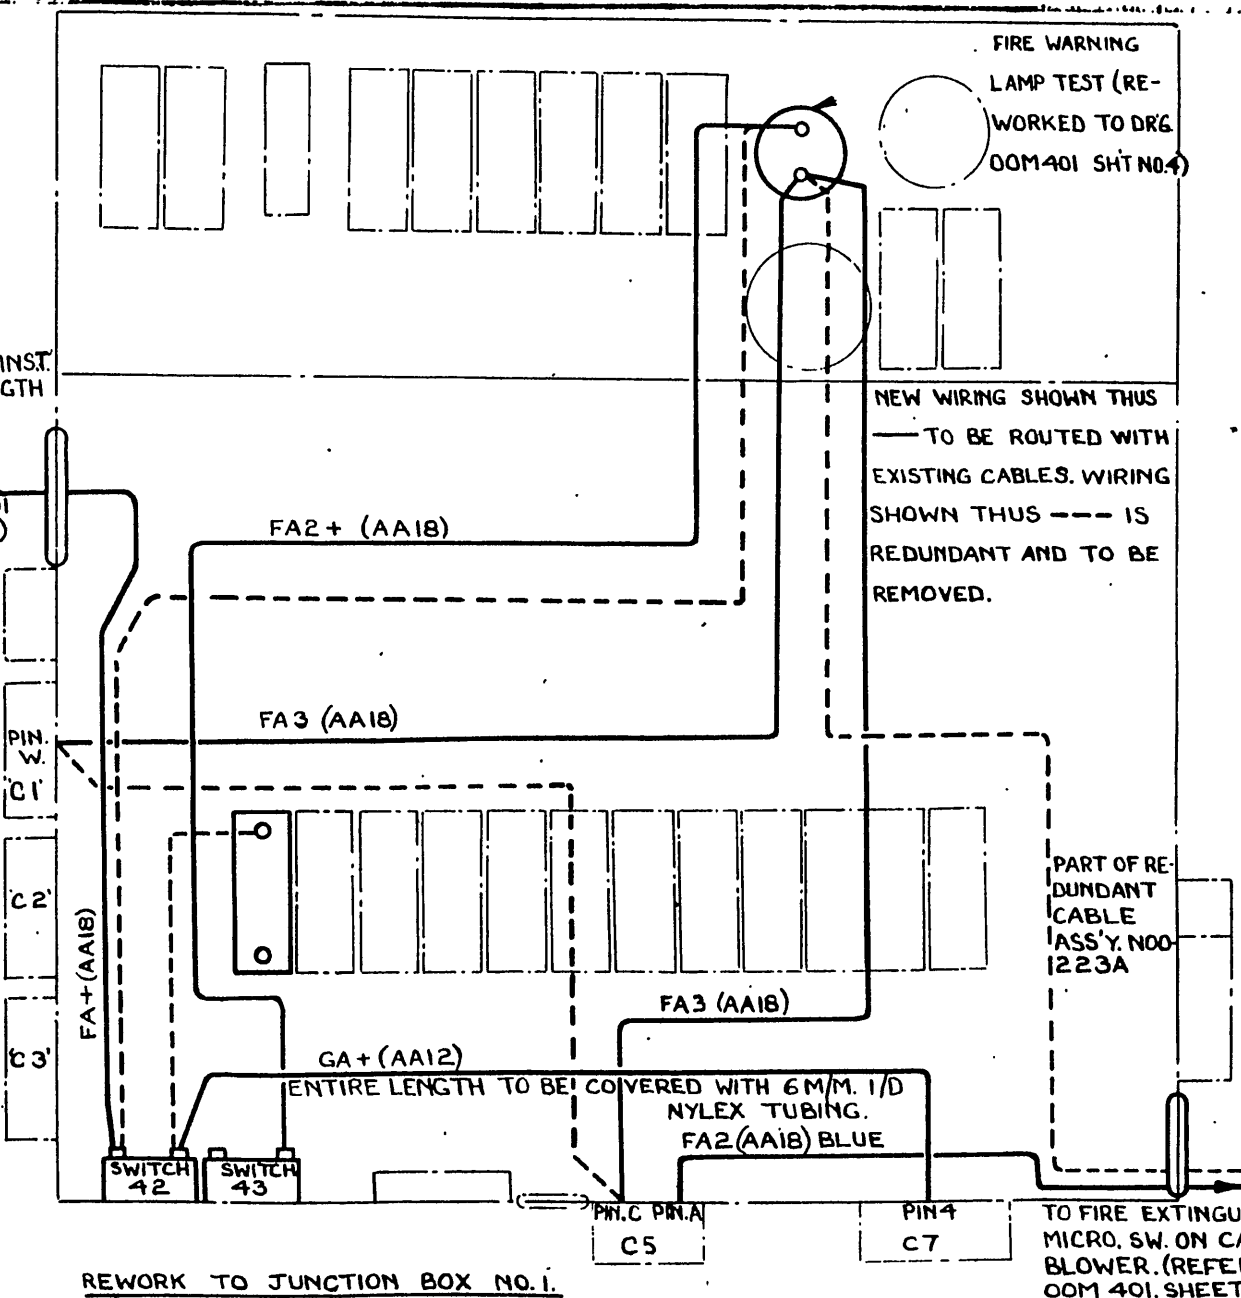
REWORK TO JUNCTION BOX NO. 1.

TO GSC /6311
SW. ON TOP CTR. INST.
PANEL PIN. 1. LENGTH
OF CABLE 7'-5"
ROUTE WITH
CONDUIT C1 (REF
TO DRG. OOM 401
SHEETS 4 & 7.)

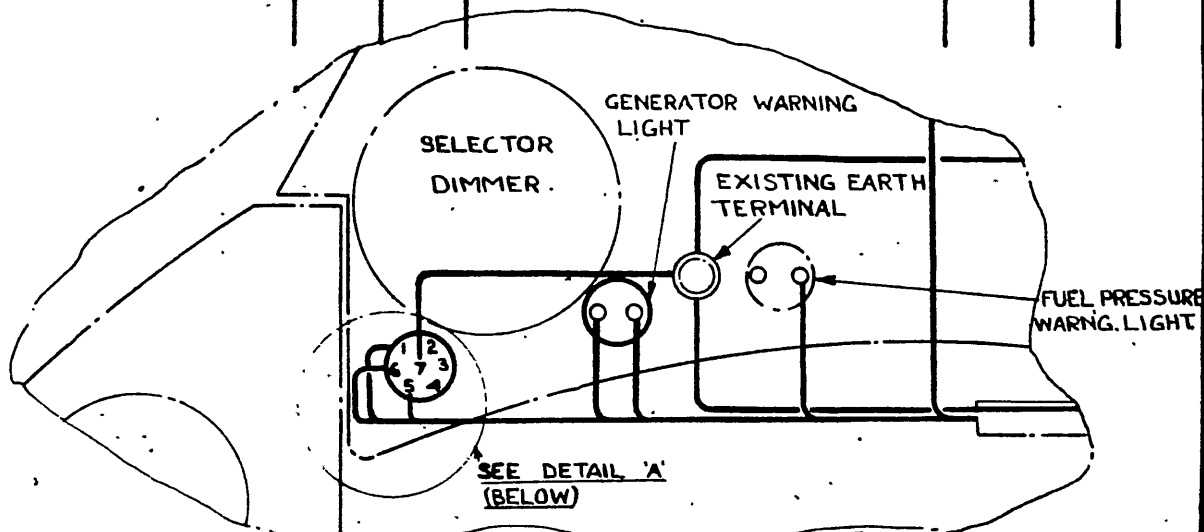
VIEW ON REAR FACE OF TOP CENTRE INSTRUMENT PANEL.

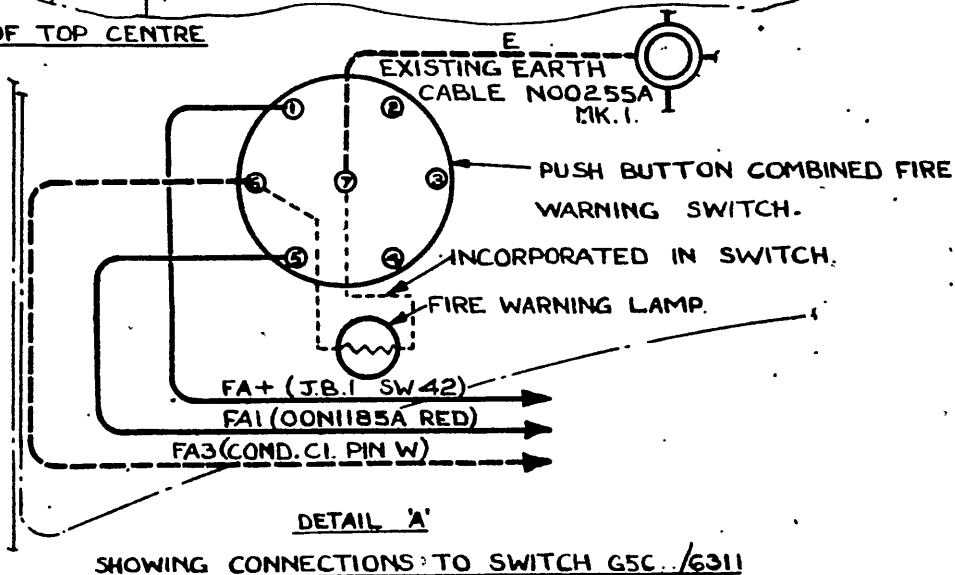
OBLITERATE "ENGINE EXTINGUISHER" WITH RED PAINT.

REMOVE EXISTING LABEL "ENGINE FIRE" & REPLACE WITH NEW LABEL 00N1139 AND AS2230/304 RIVETS 2 OFF

- (xiv) Disconnect wiring and remove Junction Box 1 from the cockpit.
- (xv) Refer to drawing A13129 Sheet No 4. On the top panel of Junction Box 1 remove the label "ENGINE FIRE" and replace with new label OON1139, item 4, attach with rivets item 6. Obliterate from the push button cover "ENGINE EXTINGUISHER" with red paint item 14.

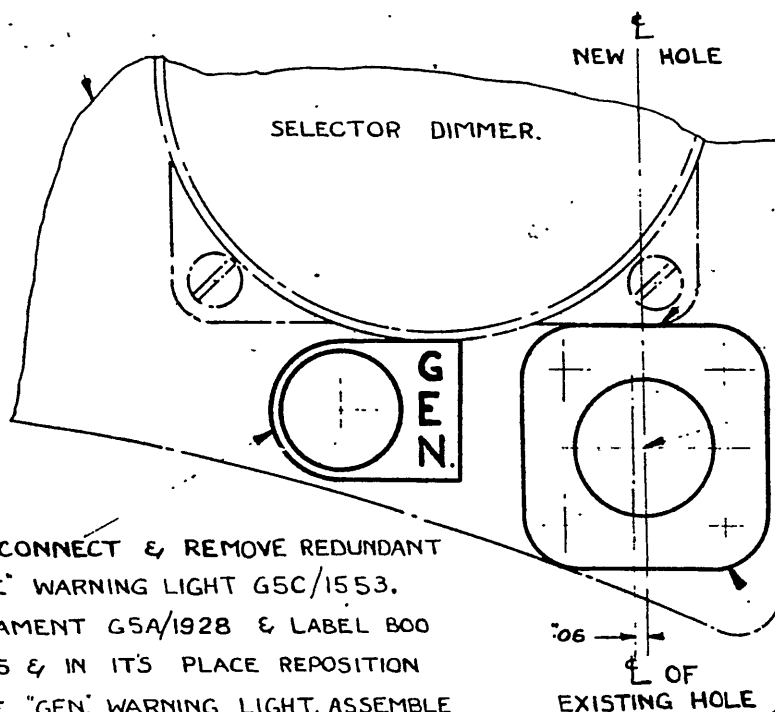
SWITCH GUARD TO BE UP AGAINST THE
G.G.S. CONTROL UNIT & OFFSET AS
SHOWN. THEN DRILL 4 NO.26 DIA.
HOLES & OPEN OUT THE HOLE TO
SUIT THE GUARD (.875 DIA. REF)

THE EXISTING EARTH CABLE
(N00255 MK.1) DISCONNECTED
FROM REDUNDANT FIRE WRNG
LIGHT TO BE CONNECTED
TO TERMINAL NO.7.(CENTRE)

DISCONNECT & REMOVE REDUNDANT
'FIRE' WARNING LIGHT G5C/1553.
FILAMENT G5A/1928 & LABEL B00
475 & IN ITS PLACE REPOSITION
THE "GEN." WARNING LIGHT. ASSEMBLE
WITH NEW LABEL 00B 159

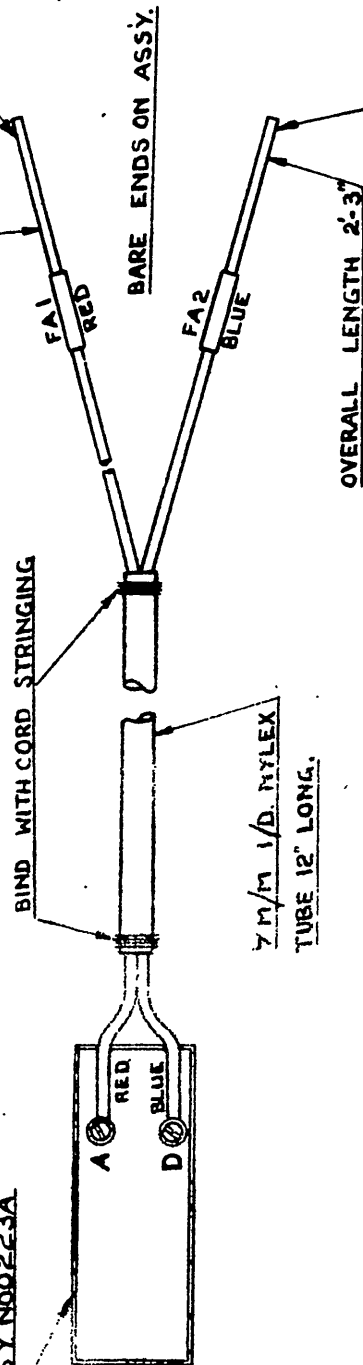
EXISTING G5C/4099 MICRO
SWITCH REMOVED FROM CABLE
ASSY NO 00223A

CONNECT TO PIN A AT PLUG 'C5'
IN J.B.1 (REFER TO DRG. OOM 401
SHEET NO.3.)

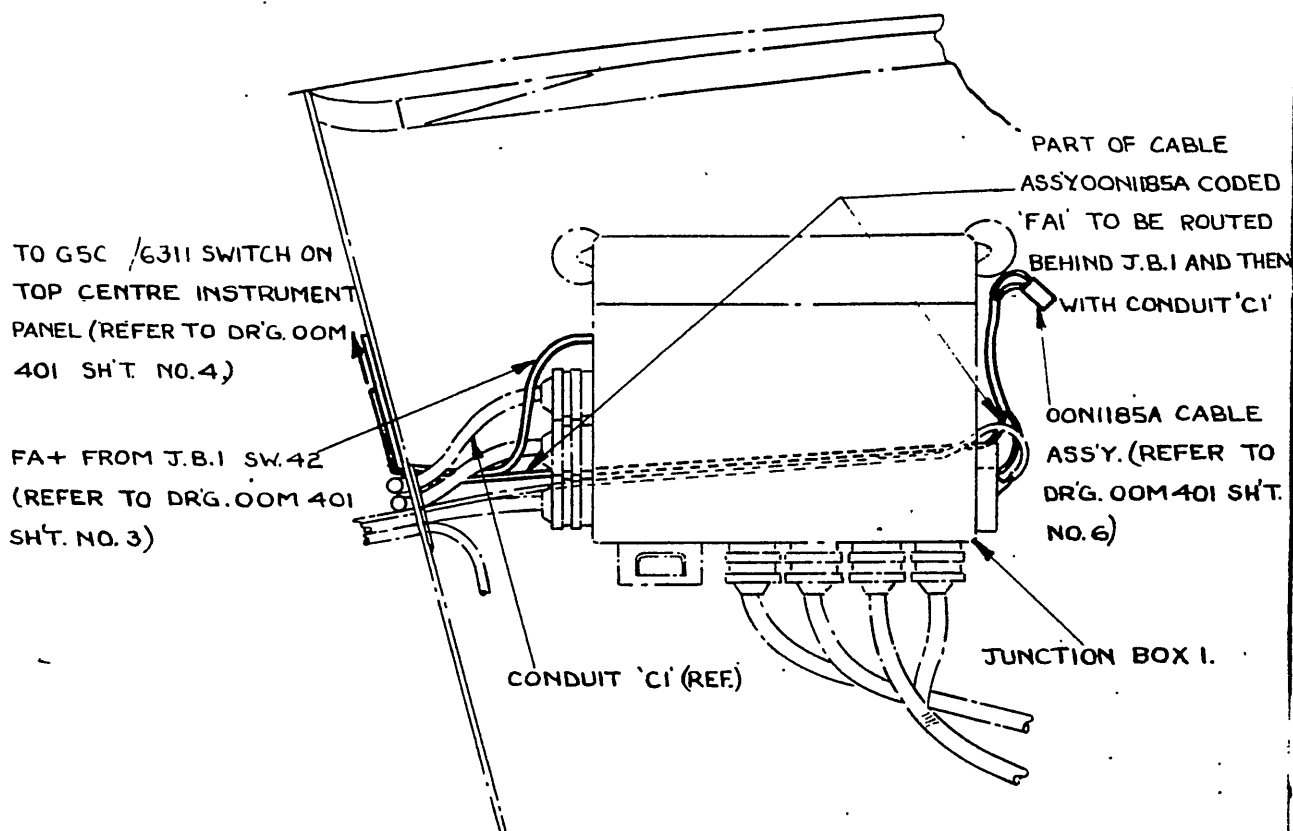
CABLE CONSISTING OF AA12 ONE CORE VIN COVERED IN IT'S ENTIRE LENGTH WITH 6 M/M 1/DIA. AND AGAIN WITH 10 M/M. 1/DIA. NYLEX TUBING.

INTRODUCE A HOLE IN THE OUTER NYLEX TUBE OF THE CONDUIT ASS'Y. TO ACCEPT THE CABLE, THEN UNSCREW THE COUPLING NUT AND PULL BACK THE NYLEX TUBING. CONNECT CABLE ASS'Y. TO 'PIN 4'.

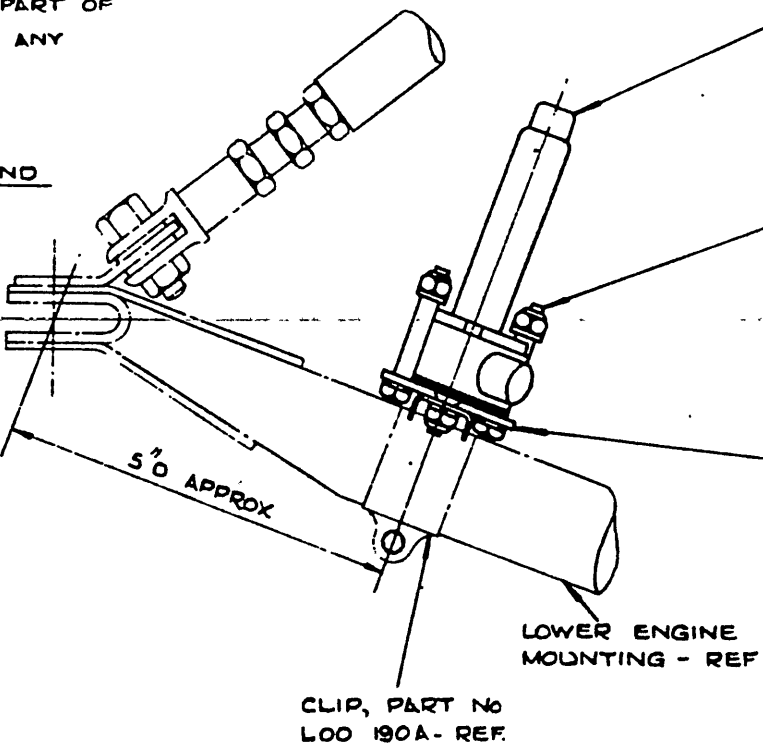
IMPORTANT NOTE
 FIRE DETECTOR OPERATING HEADS MUST NOT BE SHROUDED BY ANY PART OF THE STRUCTURE OR ANY ACCESSORY
 STBD.- AS DRAWN.
 PORT - OPPOSITE HAND

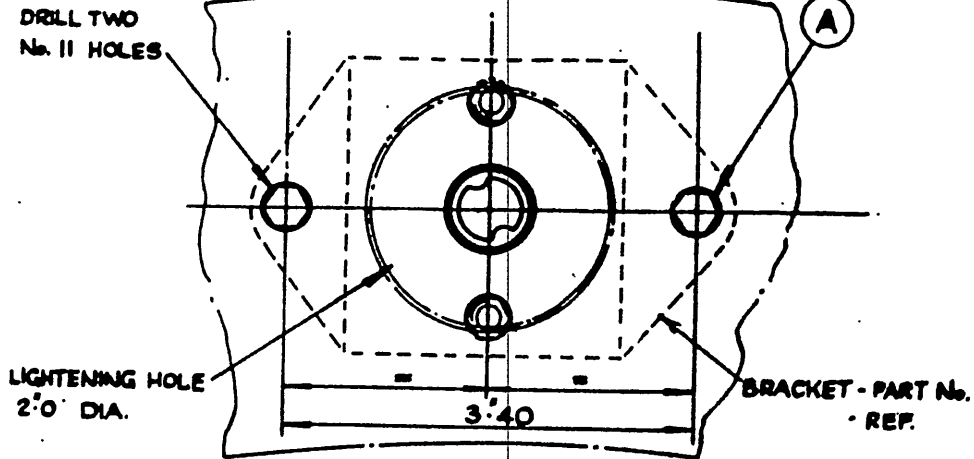
FIG. 1

VIEW ON ARROW 'A'

WASHERS TO BE FITTED
UNDER NUTS AND BOLT HEADS

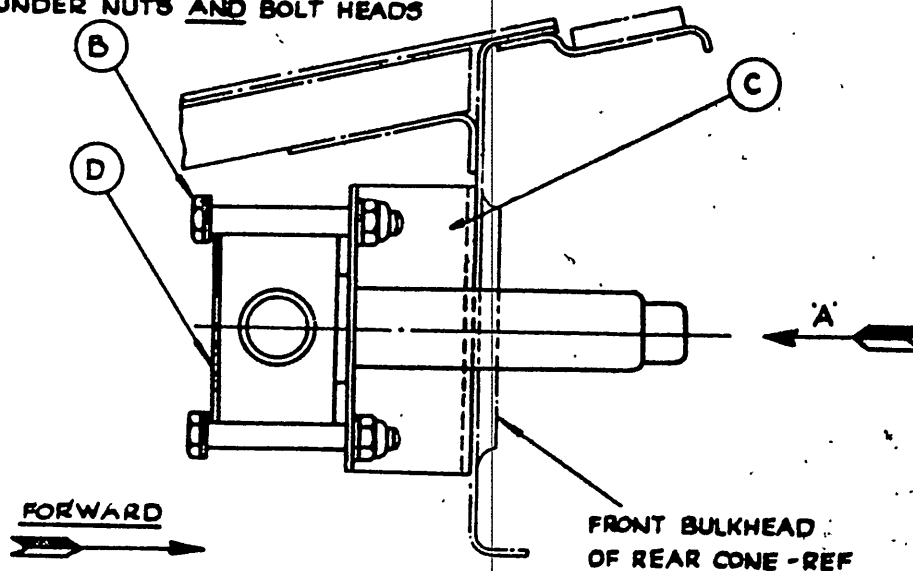
FIG. 2

SECTION 'A-A' - SHEET 6
