Australian Air Publication 721.79

**Volume 2, Part 2
Book 3**

VAMPIRE MODIFICATIONS

(Nos 201 to 300)

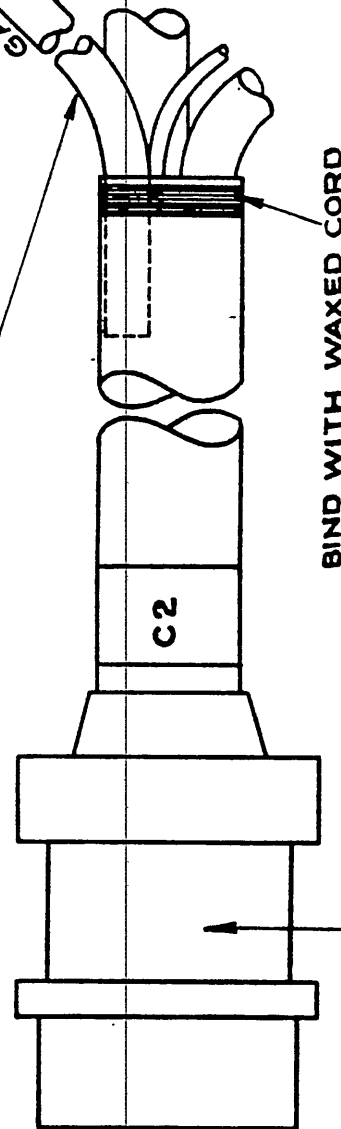
DE HAVILLAND DRG. No. 00M389

NOTE: THIS CABLE IS TO CONSIST OF 2 CORES OF AA16 ONE CORE VIN CABLE EACH 6'-6" LONG & EACH COVERED WITH 4 M/M. NYLEX TUBING 6'-4-5" LONG, 2- OFF, OVER THEIR ENTIRE LENGTH. THESE CABLES ARE THEN COVERED WITH 8 M/M. NYLEX TUBING 5'-10-5" LONG FROM THE LUG TO 1" INSIDE THE LARGEST NYLEX TUBING, AS SHOWN.
SOLDER BOTH CORES TOGETHER IN THE LUG & CONNECT OTHER ENDS AT BREEZE SOCKET IN THE USUAL MANNER TO PINS "Y" & "Z".

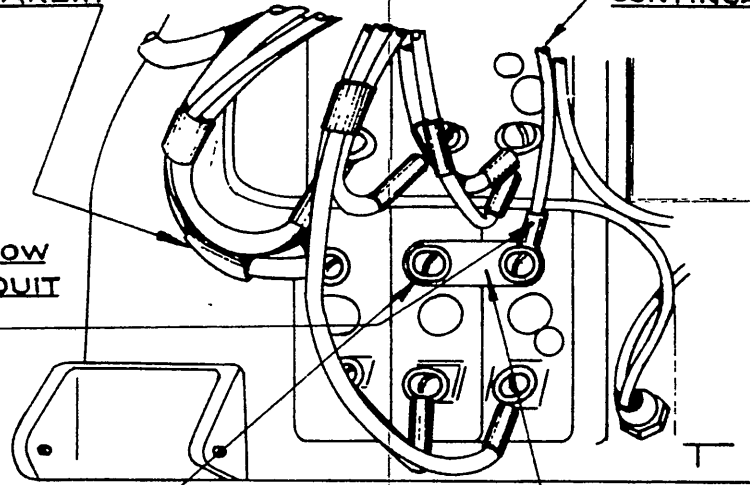
NOTE: COMPLETELY WRAP BARE LUG, BUS BAR AND TERMINAL SCREWS WITH BLACK NYLEX TAPE.

VIEW ON BACK OF INSTRUMENT PANEL - LOWER STBD. CORNER -

REMOVE BUS BAR AND REWORK AS SHOWN AT DETAIL "A"

- (viii) Completely wrap bare lug, bus bar and terminal screws with black nylex insulating tape, Item 12.
- (ix) Raise and secure instrument panel. Replace canopy jettison handle and re-wire lock.

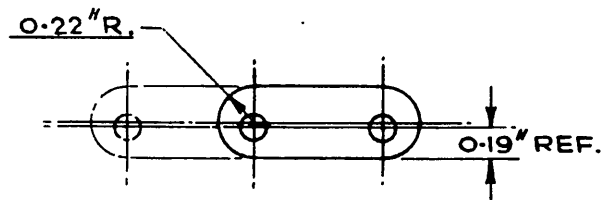
DETAIL "A"

SHOWING REWORK TO EXISTING BUS BAR OON 837

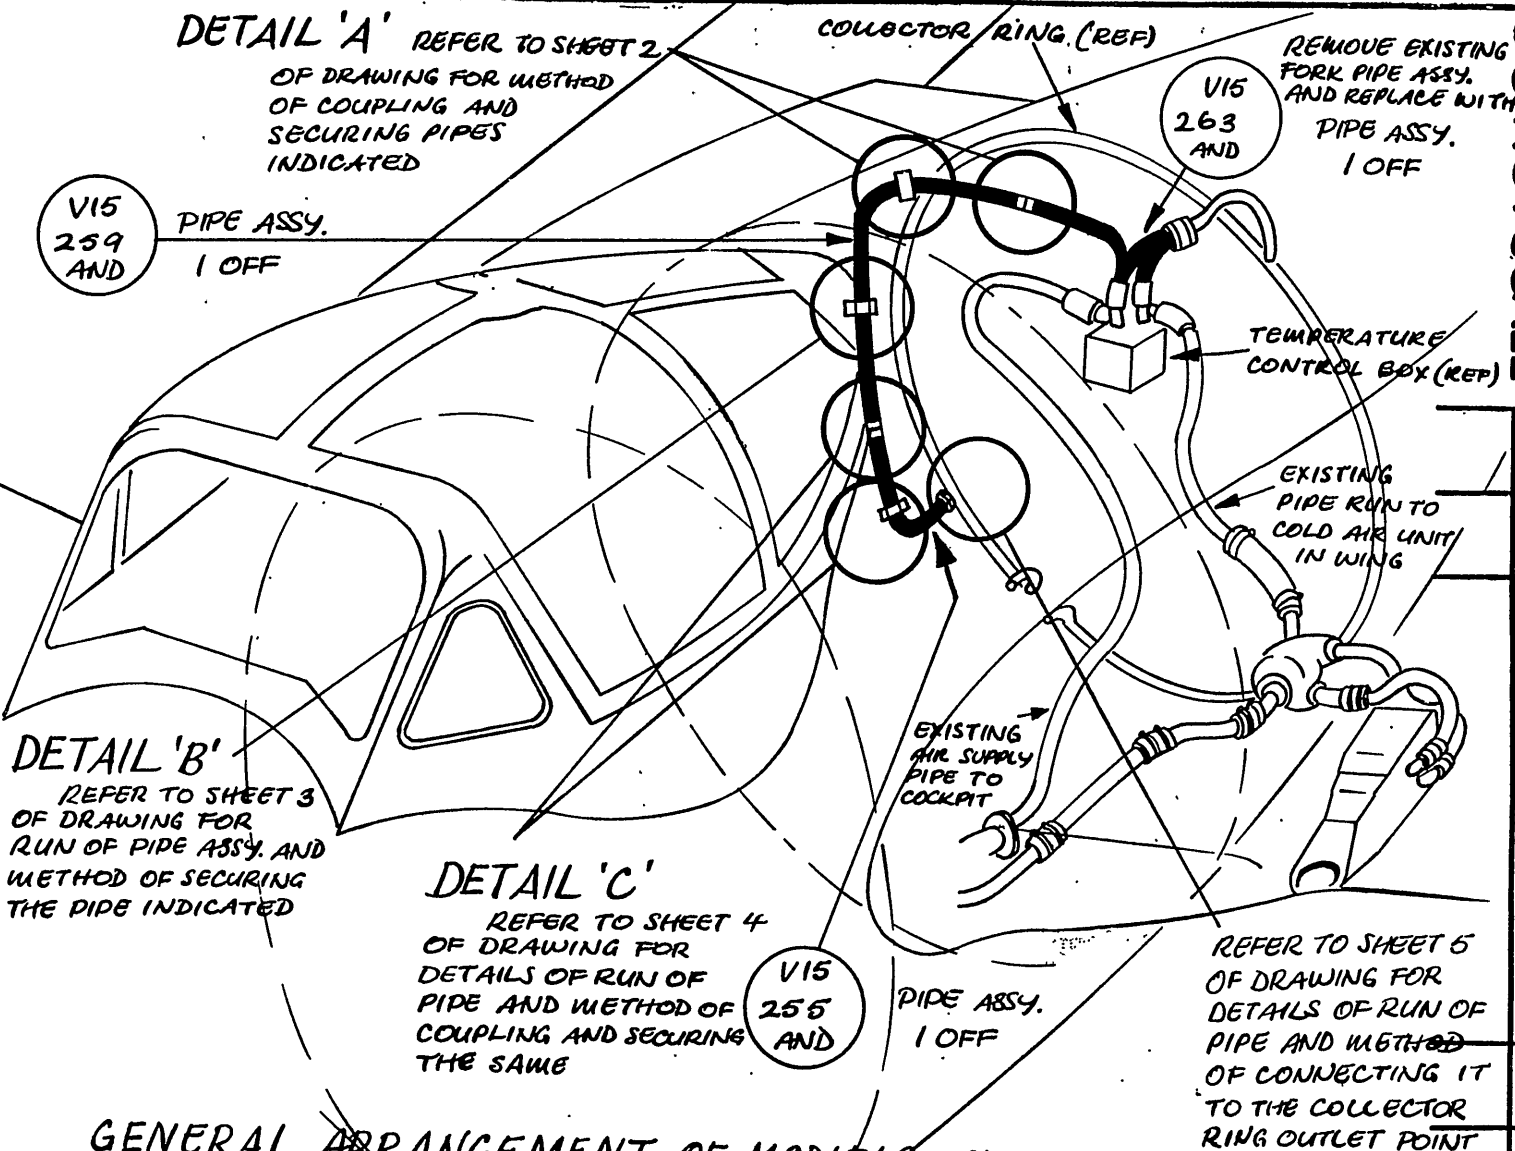
DE HAVILLAND DRAWING. DOM/446

GENERAL ARRANGEMENT OF MODIFICATION TO AIR CONDITIONING SYSTEM

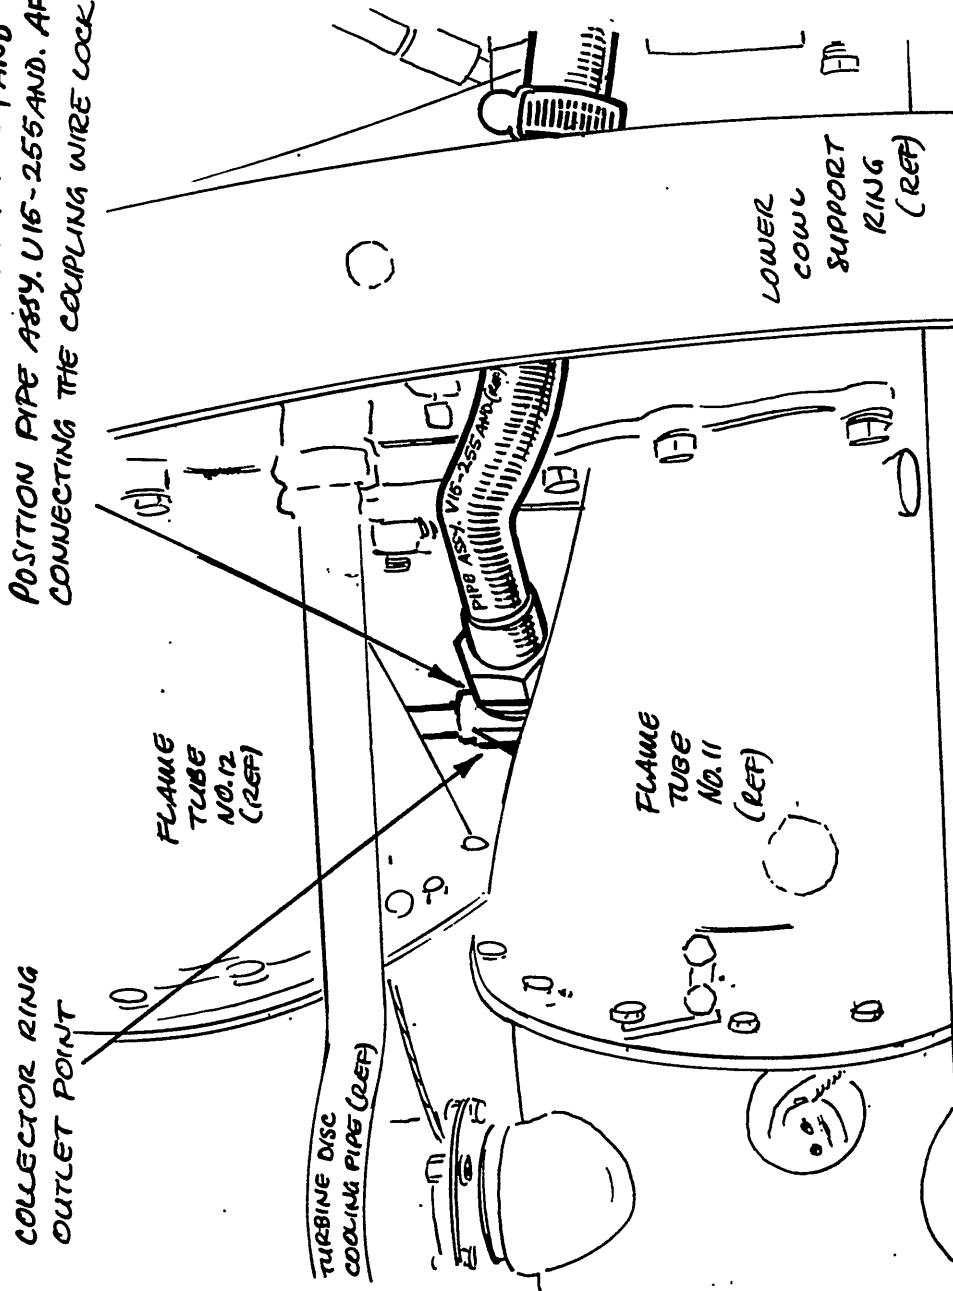
DE HAUVILLAND DRAWING N° 00M 445

REMOVE EXISTING BLANKING SLEEVE,
NIPPLE PLUG AND SPLIT PIN, AND
POSITION PIPE ASSY. U16-255 AND. AFTER
CONNECTING THE COUPLING WIRE LOCK.

VIEW ON COLLECTOR OUTLET POINT
BETWEEN FLAME TUBES 11 and 12

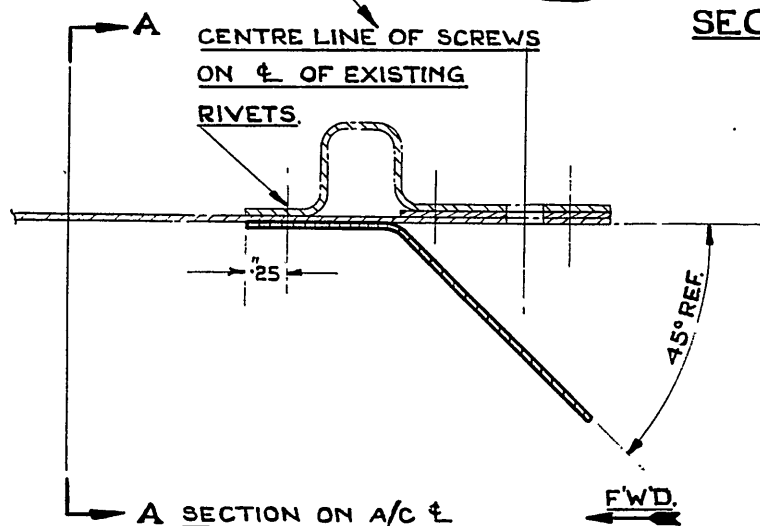
DE HAVILLAND DRAWING NO. 00M 419 SHEET 1 OF 1 SHEET

SECTION 'A-A'

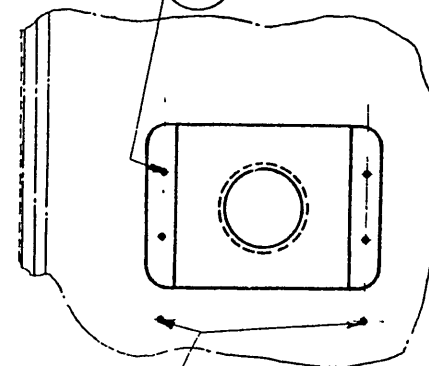
BRACKET ASSY. TO BE MOVED UP 0.5
THE UPPER 4 OF THE EXISTING HOLES
ARE TO BE BACK DRILLED THROUGH
BRACKET USING A NO.81 DRILL.
BRACKET TO BE RE-ATTACHED USING:-

AS 2227 505
R.D. H.D. RIVET
4 OFF

THESE TWO REDUNDANT HOLES
TO BE FILLED USING:-

AS 2229 404
C'SK. RIVET
2 OFF
C'SK. TO BE ON
FWD. FACE

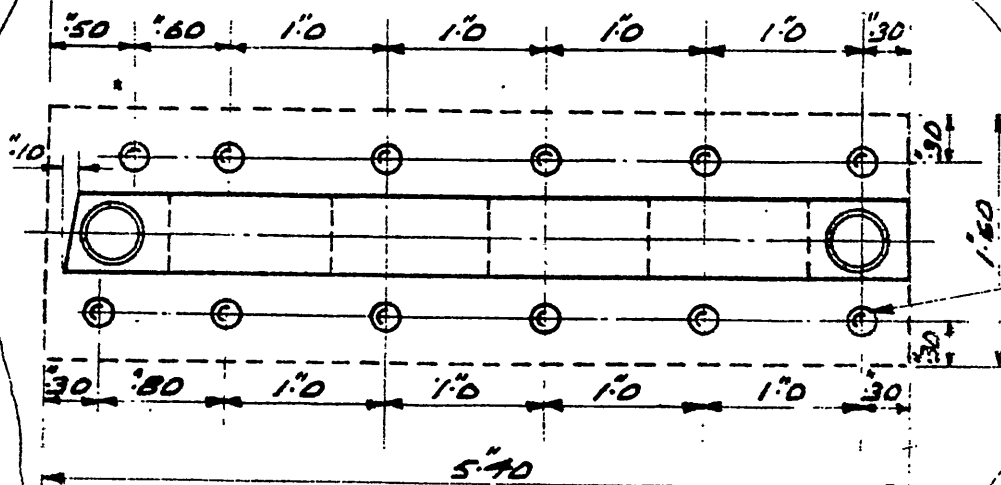
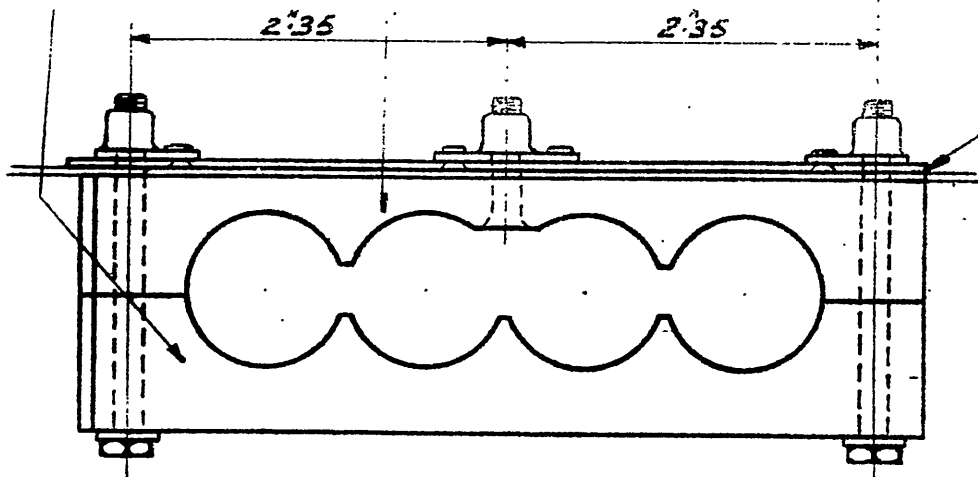
DE HAVILLAND DRG. NO. DDM393 SHEET 3 OF 3 SHEETS.

AS
2227
306

RIVETS
12 OFF
DRILL 12 NO. 40
HOLES

S15 1197 ND CLAMP
S15 1195 ND CLAMP
A25 16C 2BA HEX. WASHER
SP 13C BOLT 2BA.
AS 1242 4C CSK. 1 OFF
BLOCK HALF (FWD) BLDCK HALF (REAR) 2 OFF 2 OFF

FS15 REINFORCE.
553 PLATE
AND ASS'Y.

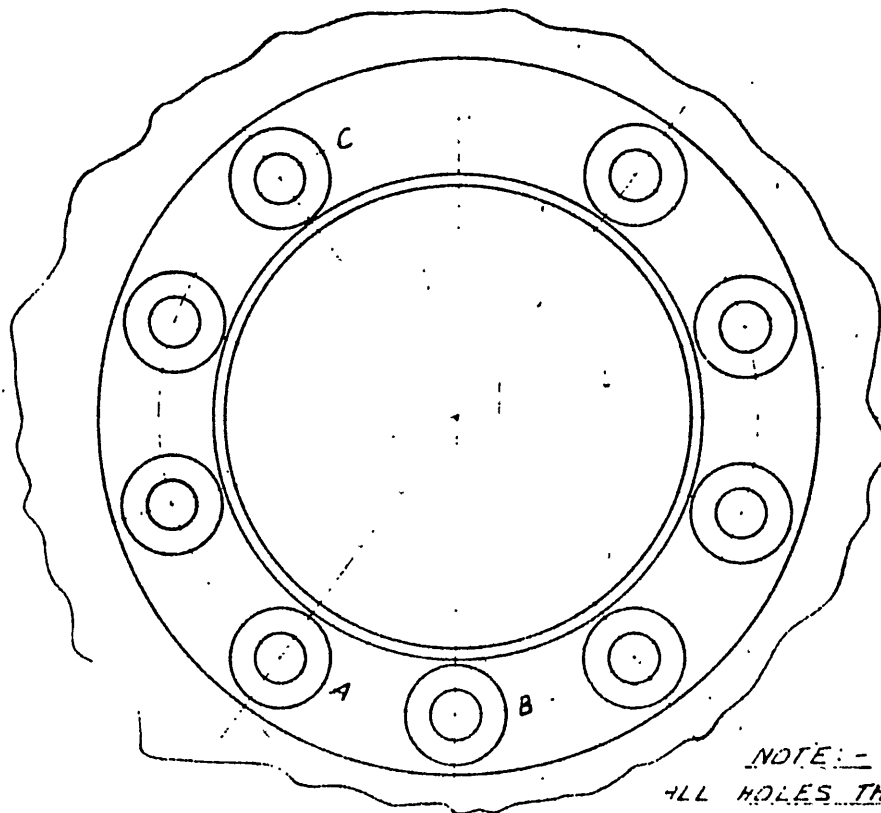
MARKING OF
TORQUE PLATE

NOTE!
LETTERS ARE TO BE
VIBRO ETCHED OR
LIGHTLY STAMPED.

NOTE:-
ALL HOLES THAT HAVE TO
BE REAMED OVERSIZE,
ARE TO HAVE THE APPROP-
RIATE LETTER STAMPED
AS SHOWN.

- (xiv) All reamed holes are to have their bolt sizes marked initially with pencil ie "A", "B" or "C" and when bolt selection and fitment has been confirmed, these holes are to be lightly stamped or "vibro-etched" at positions as indicated on Drawing A13273 Sheet 4. When bolt holes require reaming, the greatest possible care is to be taken to ensure that such reaming is kept to an absolute minimum. Any axles with holes larger than .330 are to be replaced by a serviceable item.

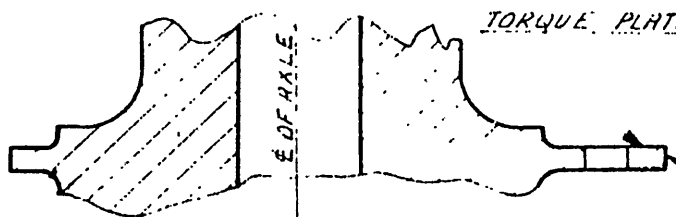
MARKING OF AXLE

TORQUE PLATE MOUNTING FACE

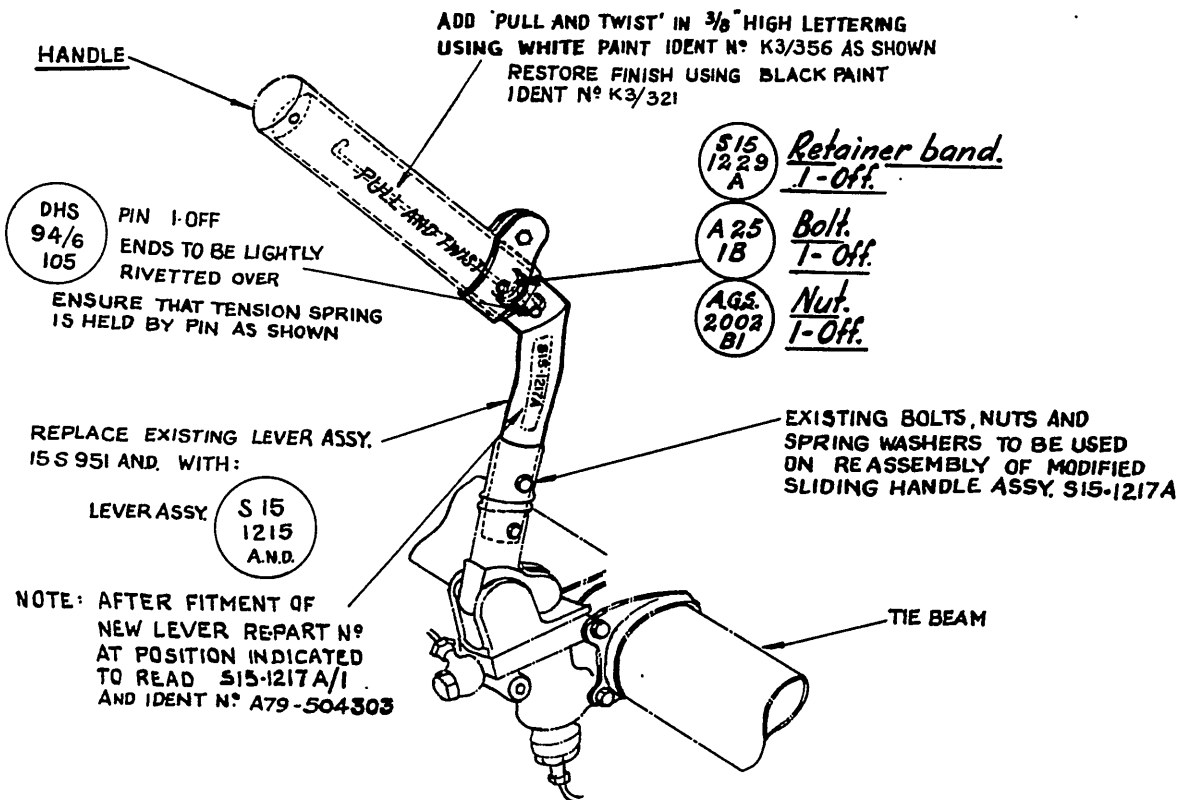
DE HAVILLAND DRG. N° 00M420

ISSUE NO.	DATE	ALTERATION	D. I. L.	INITIALS	APPROVED
2	29.5.59	Retainer band called for and shown pictorially.			
3	17.6.59	Position of Retainer band reversed pictorially.

1. This modification is introduced to overcome defects, experienced in service both locally and overseas in which the handle cracked in vicinity of the welded section joint, this modification replaces the lever portion of the handle with one of heavier gauge and also provides locking action in the extended position of the handle.

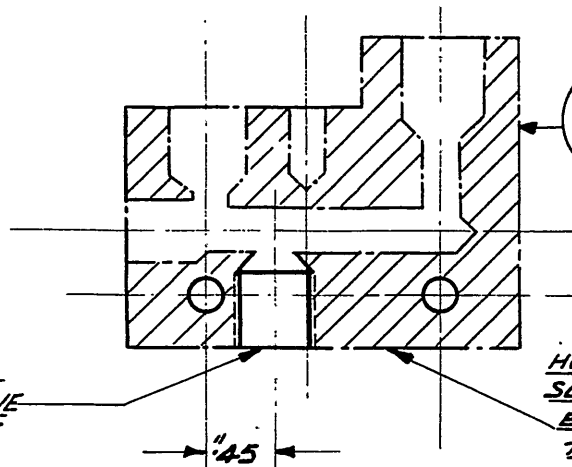
DETAIL 'A'

DRILL 29/64" E1 TAP
1/4" B.S.P. THREAD
DEPTH .45. REMOVE
ALL BURRS WHERE
HOLE RUNS INTO
MAIN FEED GALLERY

HOLE MUST BE DRILLED
SQUARE TO THIS FACE TO
ENSURE SEALING OF
THE JOINTING WASHER

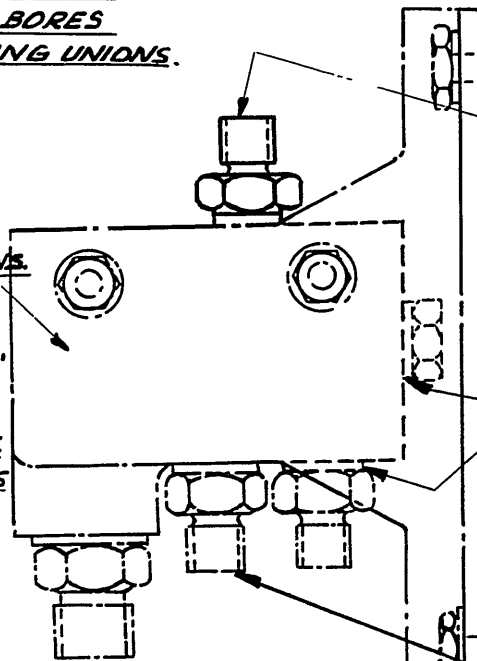
REMOVE ALL CONNECTS
AND REMOVE UNIT
FROM BRACKET FOR
REWORK TO DETAIL 'A'
ABOVE

RE-ASSEMBLE TO BRKT.
USING EXISTING BOLTS
WASHERS ETC.

FIT THE FOLLOWING
ITEMS IN THE HOLE JUST
DRILLED:-

AGS 90B REDUCING UNION A 1 OFF

1. To prevent further fracturing of the feed pipe between the cylinders on the torque plate, a redesigned pipe run has been introduced. This necessitates a new union in the dummy maxaret units and provision for a bleeding point on the lower brake cylinder.

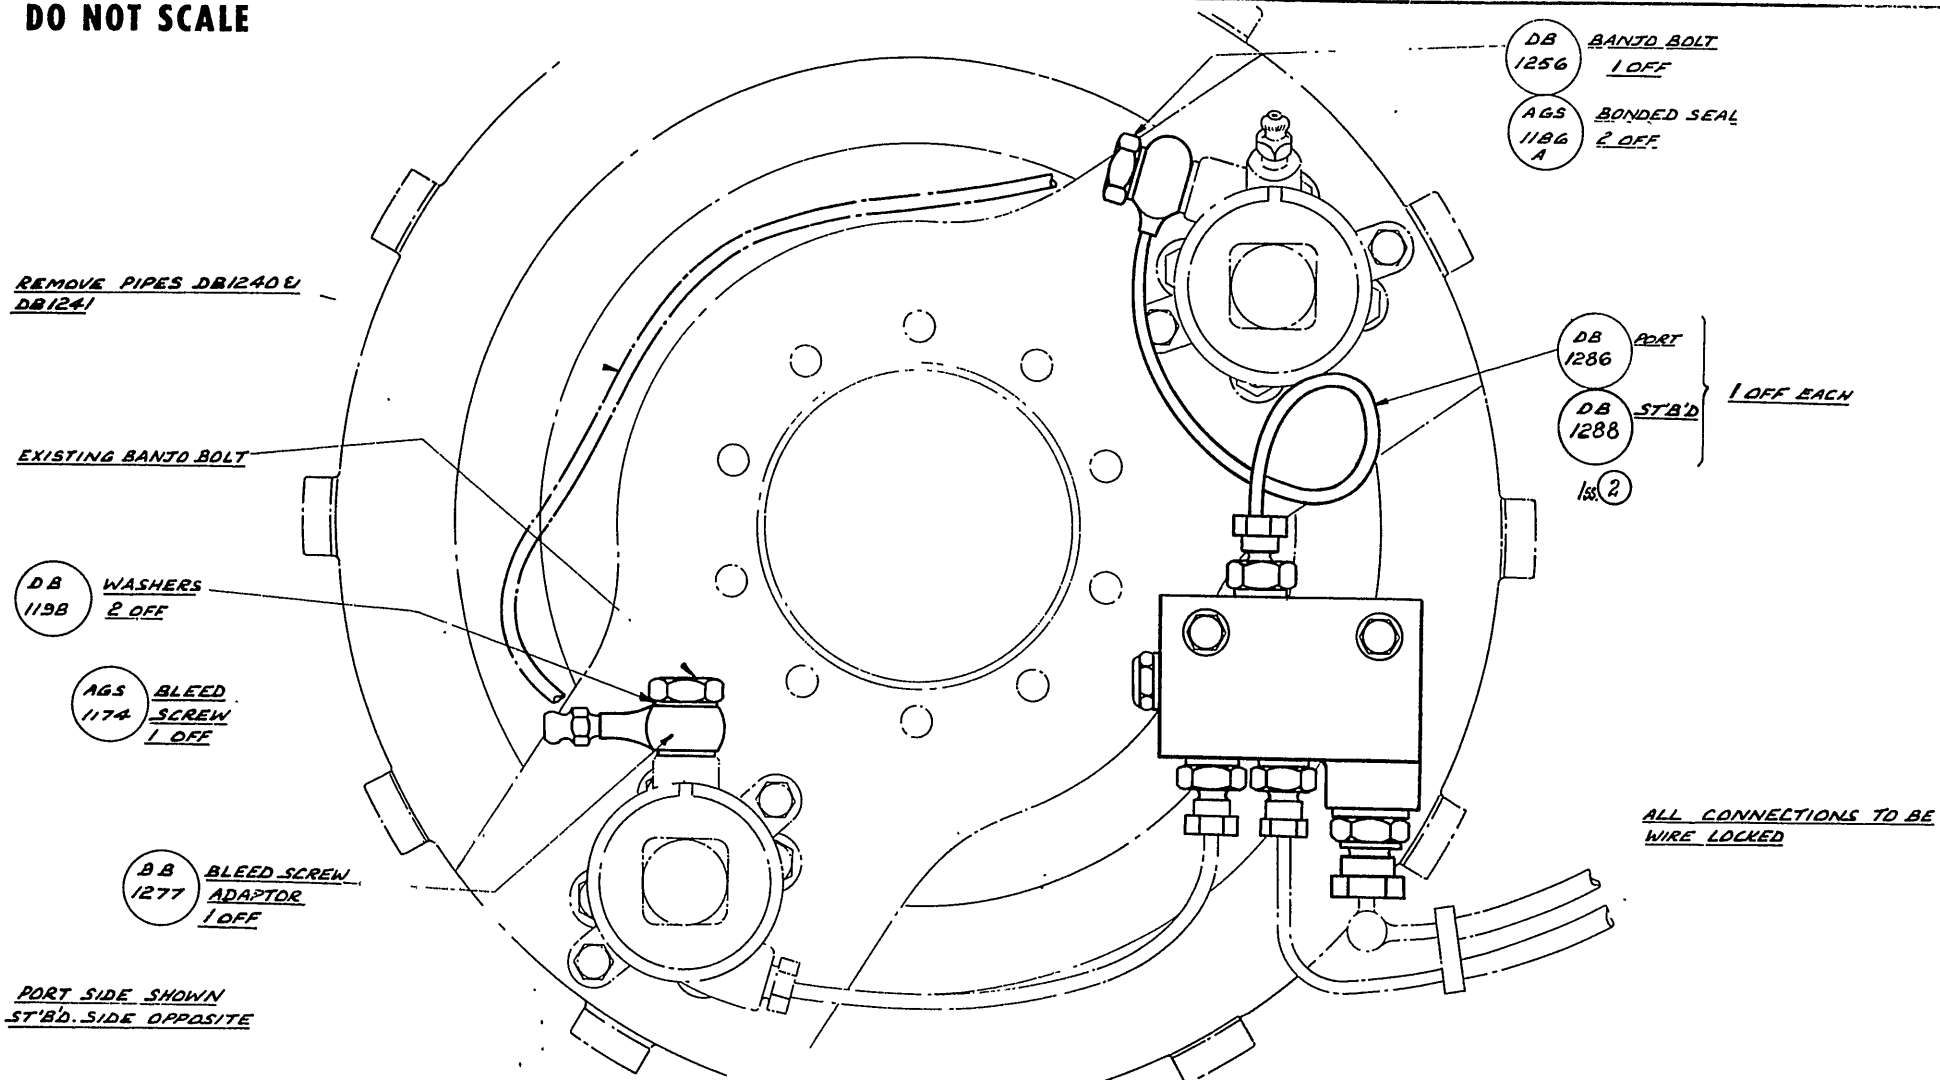
DE HAVILLAND DRAWING NO. DDM 406 SHEET 2 OF 2 SHEETS.

1. NO.	DATE	ALTERATION	D. I. L.	INITIALS	APPROVED	REFERENCE	ISSUED BY	TITLE
2	11.12.58	DB1286 and DB1288 were:- DB1274 and DB1276 respectively.						RE-ROUTING OF BRAKE PIPES ON THE PORT & STBD. BRAKE TORQUE PLATES
						LIMITS UNLESS STATED	MATERIAL	COMPONENT
						DECIMALS $\pm .010"$	SPEC.	OF
						FRACTIONS $\pm \frac{1}{32}"$	TREATMENT	MACHINE
						ANGLES $\pm 1^\circ$	FINISH	ENGINE
						SURFACE FINISH		TECH. ORDER
						AUSTRALIAN STANDARD		VAMPIRE M ¹ No 7
						ENG. DWG. PRACTICE AS SET		NO. A-130
						APPROVED		SHEET 2.
						CHECKED		SIZE

2. (a) This work is to be carried out on all Vampire Mk 35A aircraft and on Vampire Mk 35 aircraft Serial No A79-600 to A79-650 inclusive except those aircraft which are modified to RAAF Vampire Mod No 294 (V746) - redesigned 107° torque plates. A79-651 and subsequent will have Mod 296 incorporated during manufacture.
- (b) Aircraft embodied with Mod 296 at any time prior to 1st February 1959 and are not yet fitted with Mod 294, are to have the upper feed pipes Part Nos DB1274 and DB1276 removed and replaced by the modified pipes DB1286 and DB1288.

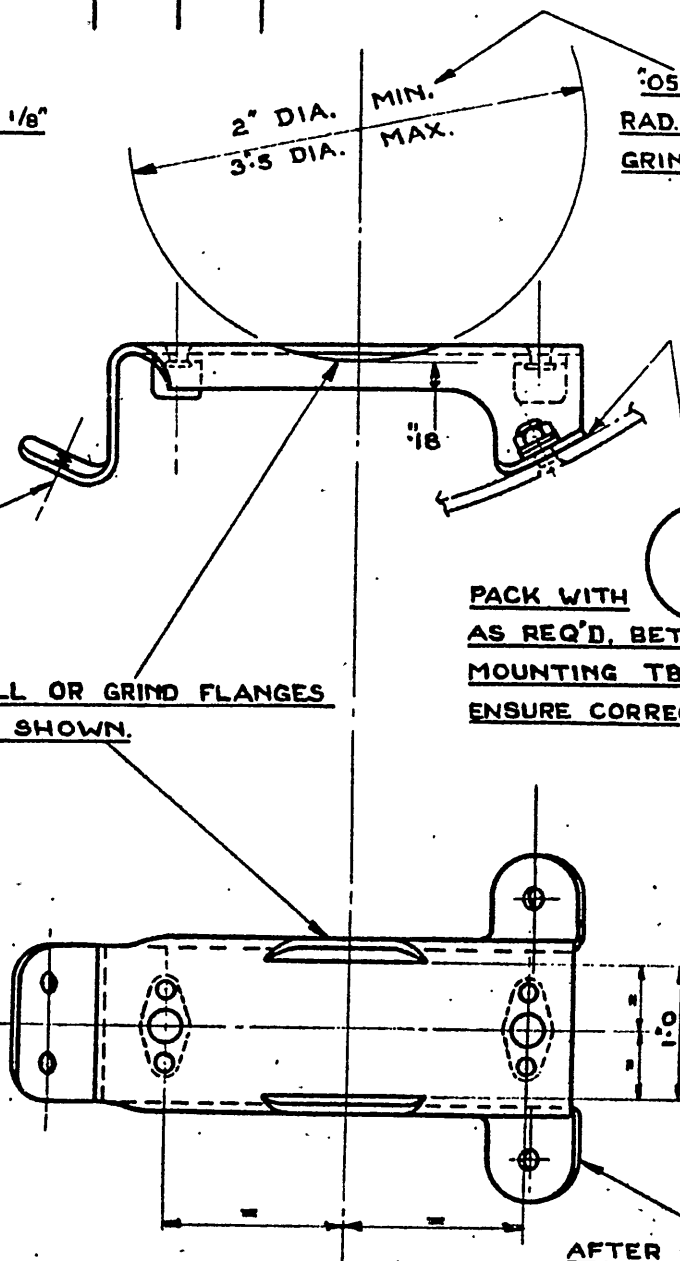
DE HAVILLAND DRAWING NO. 00M418

PACK WITH
AS REQ'D, BETWEEN SKIN &
MOUNTING TB15-5A/1 REF. TO
ENSURE CORRECT ALIGNMENT.

AFTER REWORK REPORT NO.
MOUNTING TB15-5A/1.
RE-FINISH EXPOSED METAL
WITH ITEMS 4 & 5.

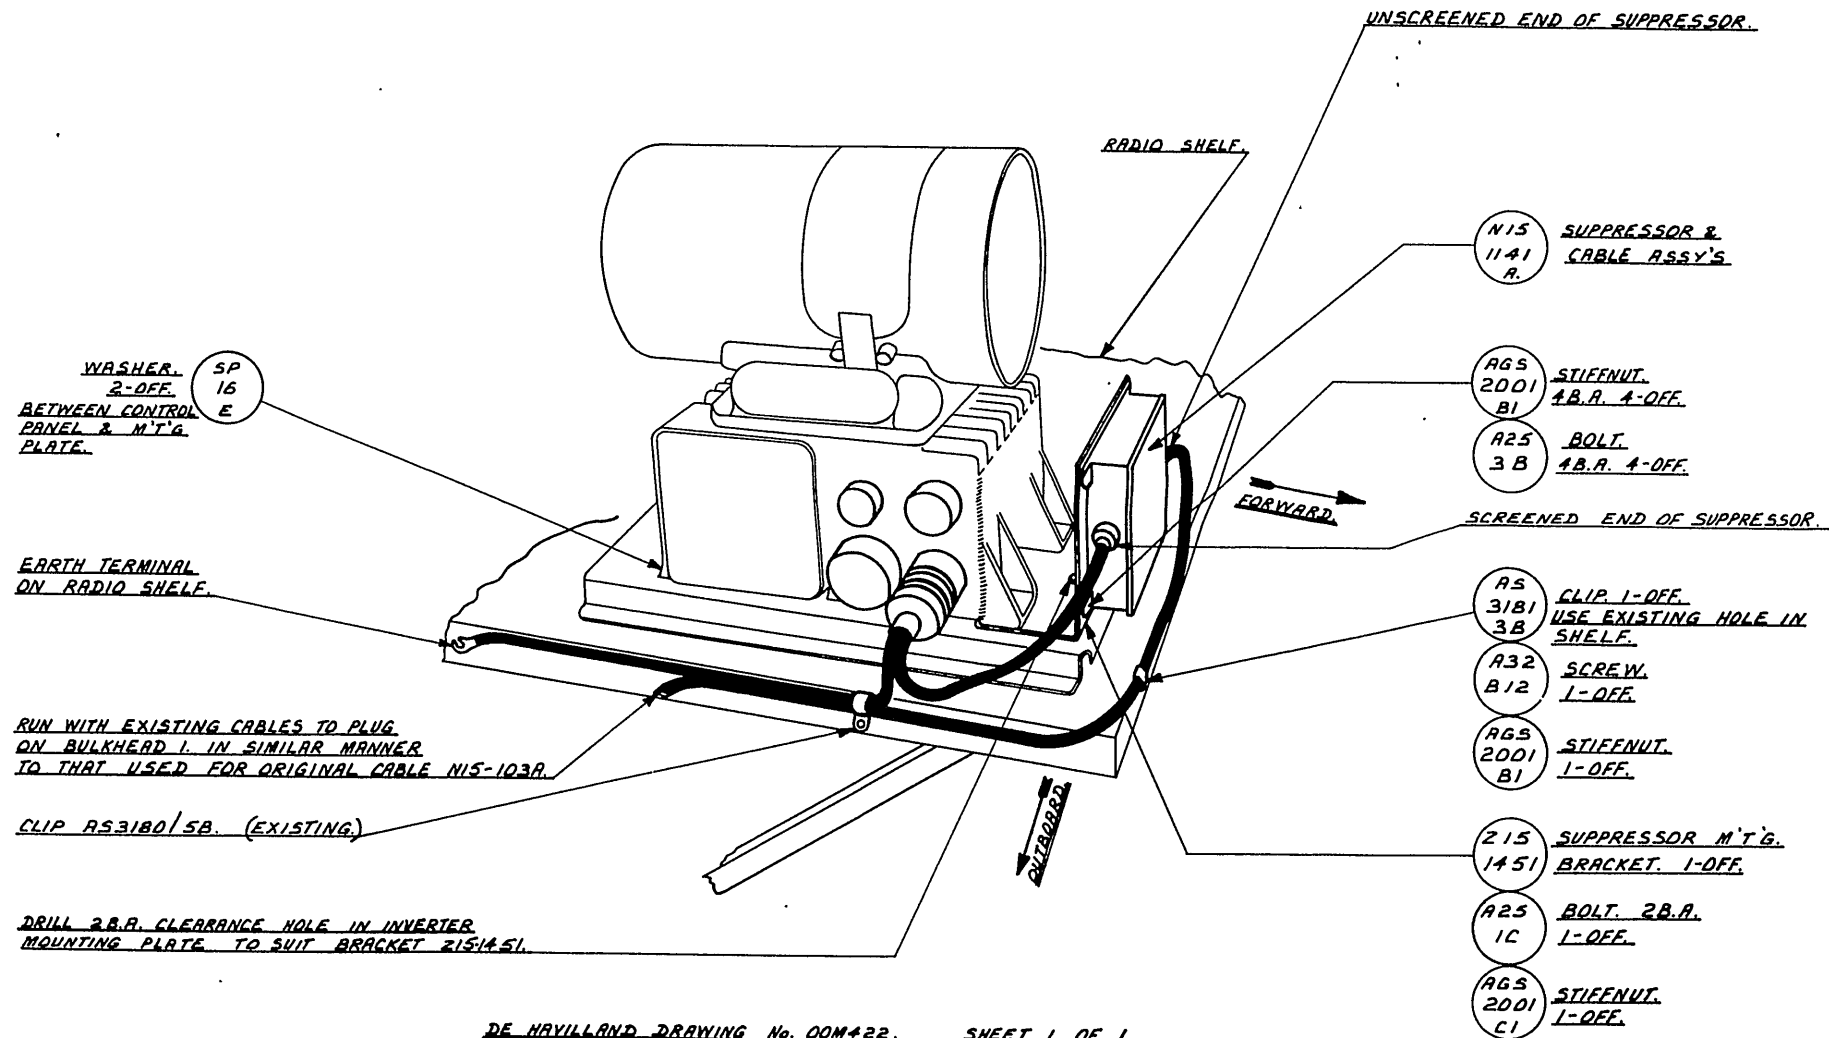
DE HAVILLAND DRAWING No. 00M422. SHEET 1 OF 1.

ISSUE NO.	DATE	ALTERATION	B.I.L.	INITIALS	APPROVED	REFERENCE	ISSUED BY	TITLE
								SUPPRESSOR TYPE P1 IN THE OUTPUT SUPPLY FROM THE TYPE 100A INVERTER.
						LIMITS UNLESS STATED		COMPONENT OF
						DECIMALS $\pm .010''$	MATERIAL	MACHINE
						FRACTIONS $\pm \frac{1}{32}''$	TREATMENT	ENGINE
						ANGLES $\pm \frac{1}{2}^\circ$	FINISH	TECH. ORDER
						SURFACE FINISH	SCALE	
						AUSTRALIAN STANDARD	DRAWN	DRAWG. B
						ENG. DWS. PRACTICE A 9 021	D. W.	017E
							APPROVED	DRAWING NO. A13263
