Australian Air Publication **721.79**

VAMPIRE MODIFICATIONS

(Nos 301 to 400)

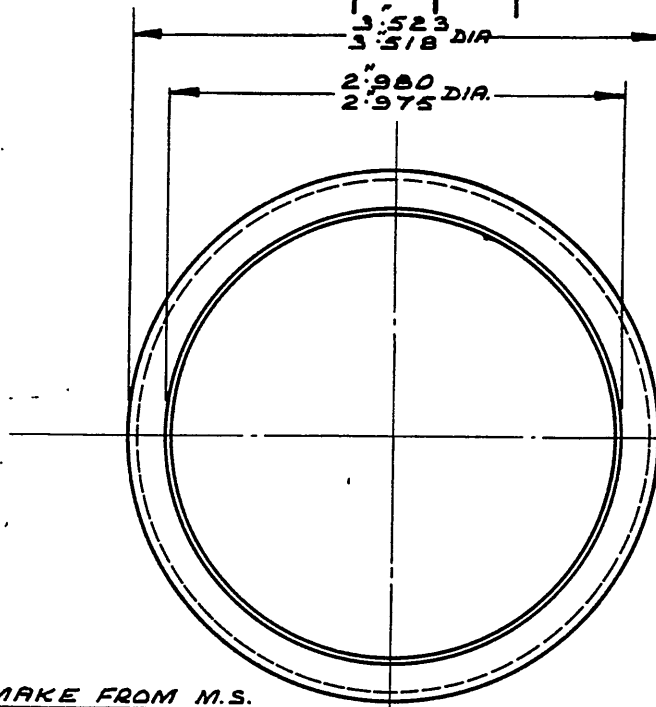
MAKE FROM M.S.
LAD PLATE TO DTD904

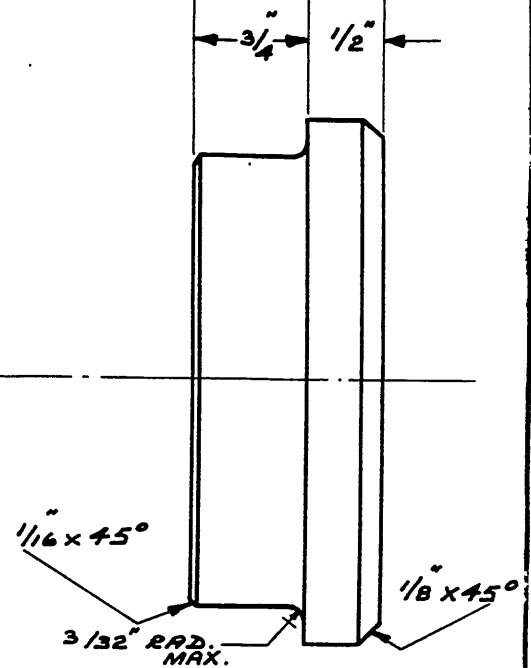
DST 4765
FOR CUP 362.

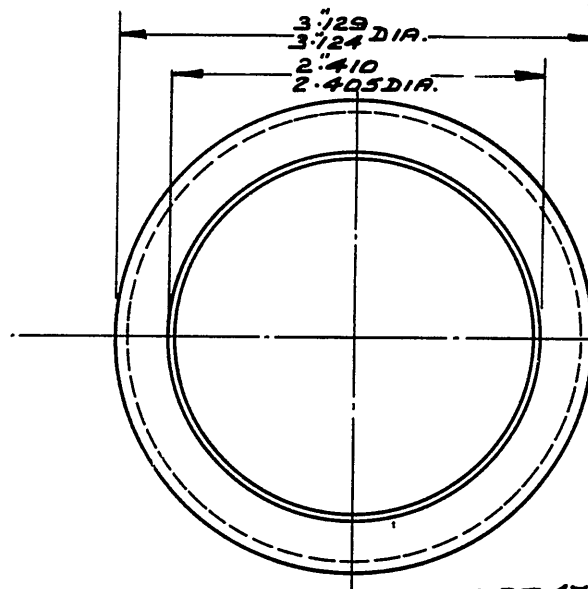
DST 4766
FOR CUP 11315

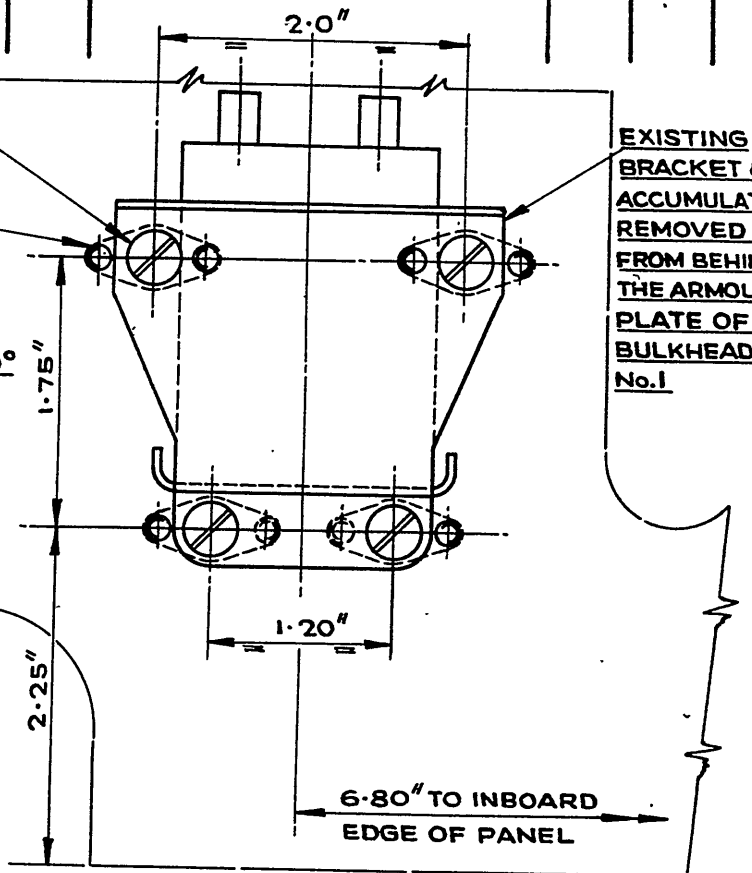
**DETAIL "A"
VIEW LOOKING F'W'D. ON
AFT. FACE OF THE LOWER
L.H. INSTRUMENT PANEL.**

GSC
430
**TERMINAL
BLOCK
1-OFF**

AGS
252
4
**No.2 WOODSCREW
5/8" LONG.
2-OFF.**

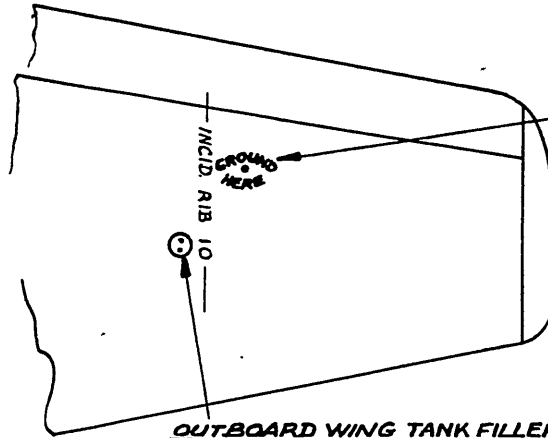
ON BOTH PORT AND STARBOARD WINGS IN 1/2" HIGH RED LETTERS PRINT, (USING ITEM 15) "GROUND HERE," AROUND HOLE FOR SOCKET.

PLAN VIEW OF TOP SURFACE PORT WING

OUTBOARD WING TANK FILLER CAP

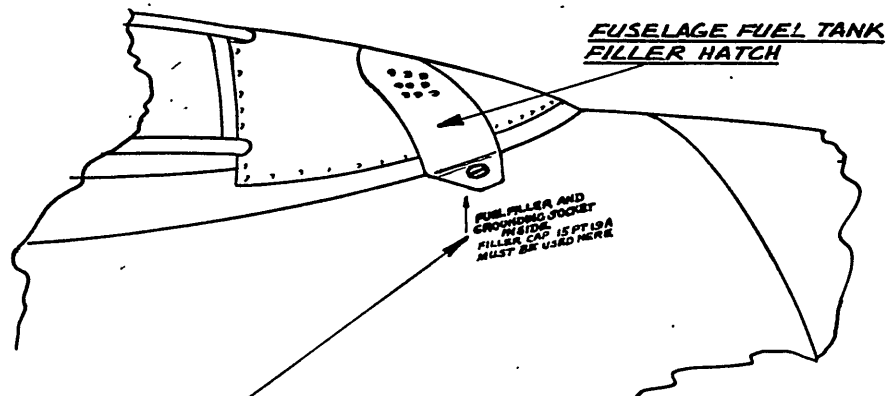
FUSELAGE FUEL TANK FILLER HATCH

DELETE THE EXISTING NOTE "FUEL FILLER INSIDE" AND USING ITEM 15 ADD THE NOTE "FUEL FILLER AND GROUNDING SOCKET INSIDE." PRINT IN 1/2" HIGH RED LETTERS.

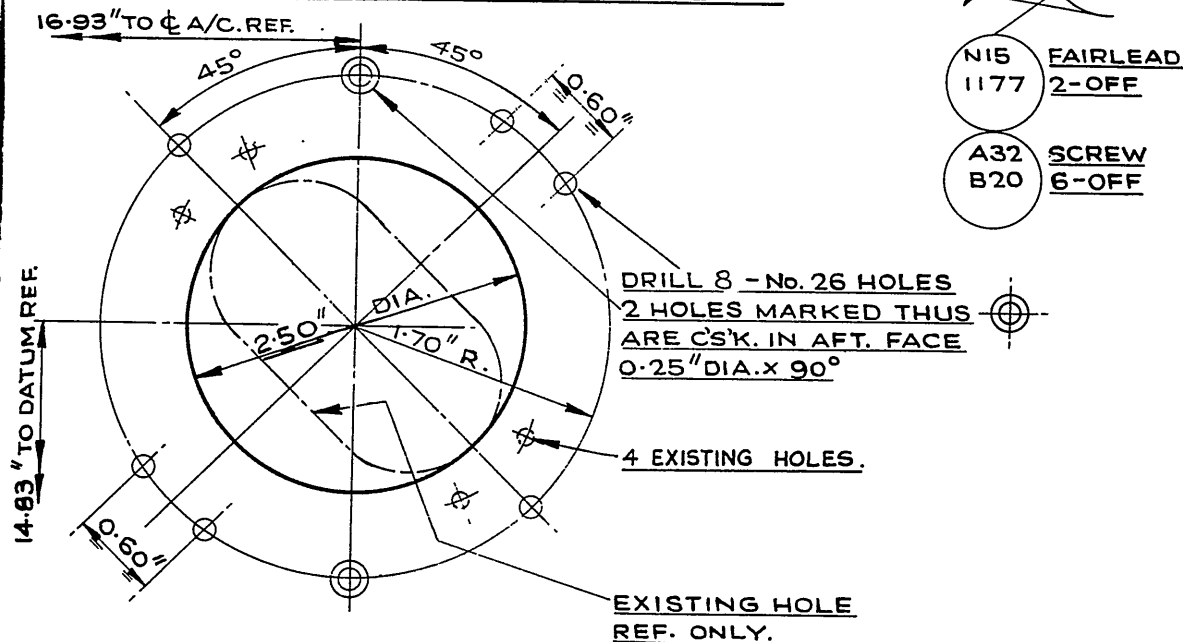
VIEW ON AFT FACE OF BULKHEAD No. 4 STARB'D. SIDE

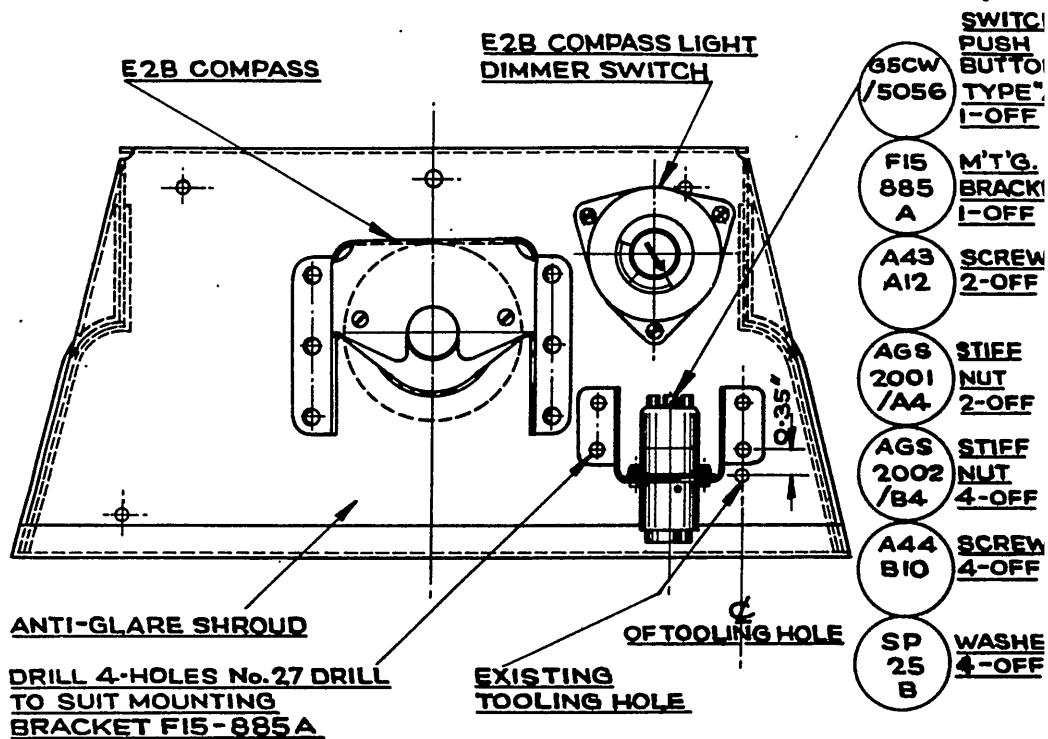
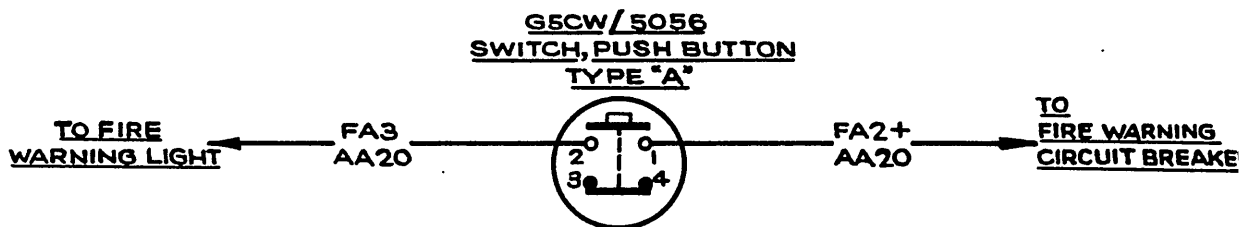
DIAGRAM SHOWING TERMINAL CONNECTIONS OF PUSH BUTTON SWITCH.

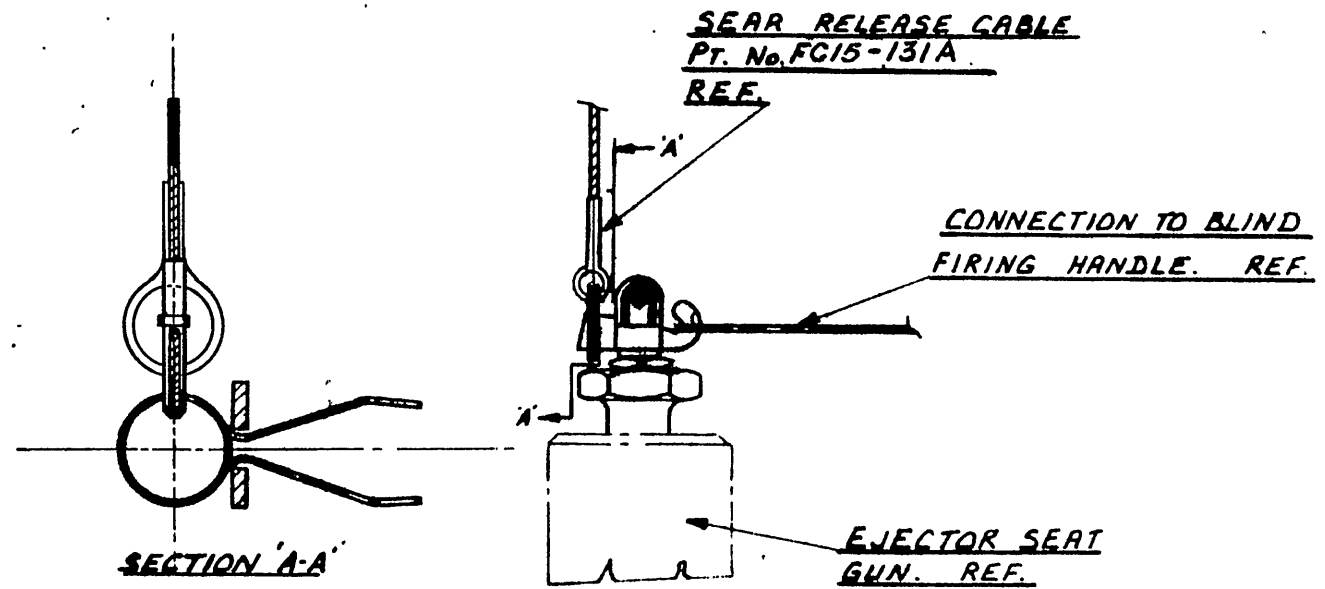
VIEW ON SEAT GUN
SHOWING ATTACHMENT OF GUN
SAFETY SEAR RELEASE CABLE.

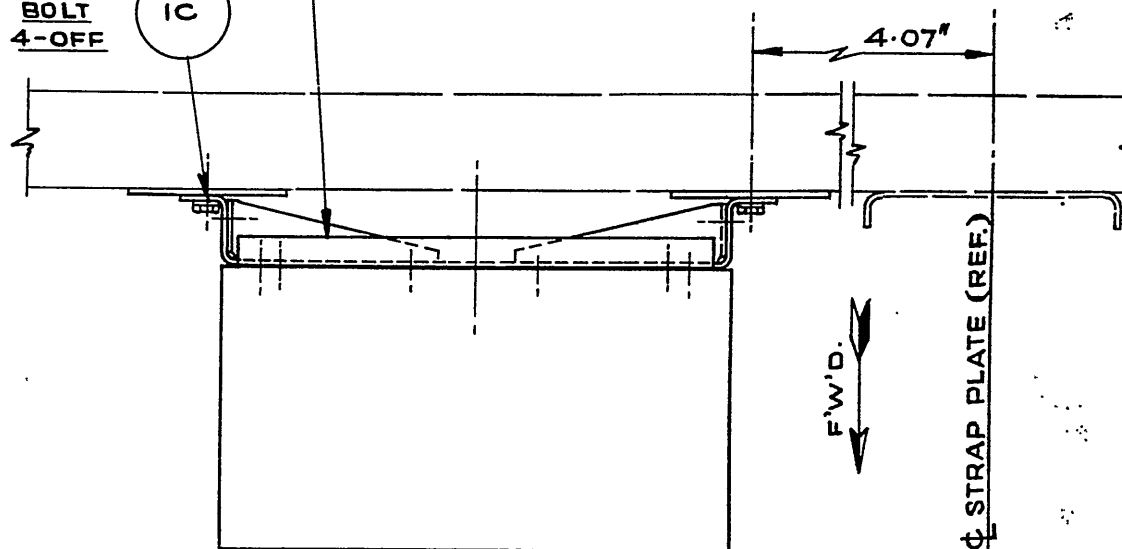
FATIGUE METER
MK. 2B. TO BE FITTED
AS & WHEN REQUIRED.
NOTE:-
ATTACHMENT BOLTS
ARE SUPPLIED WITH
FATIGUE METER.

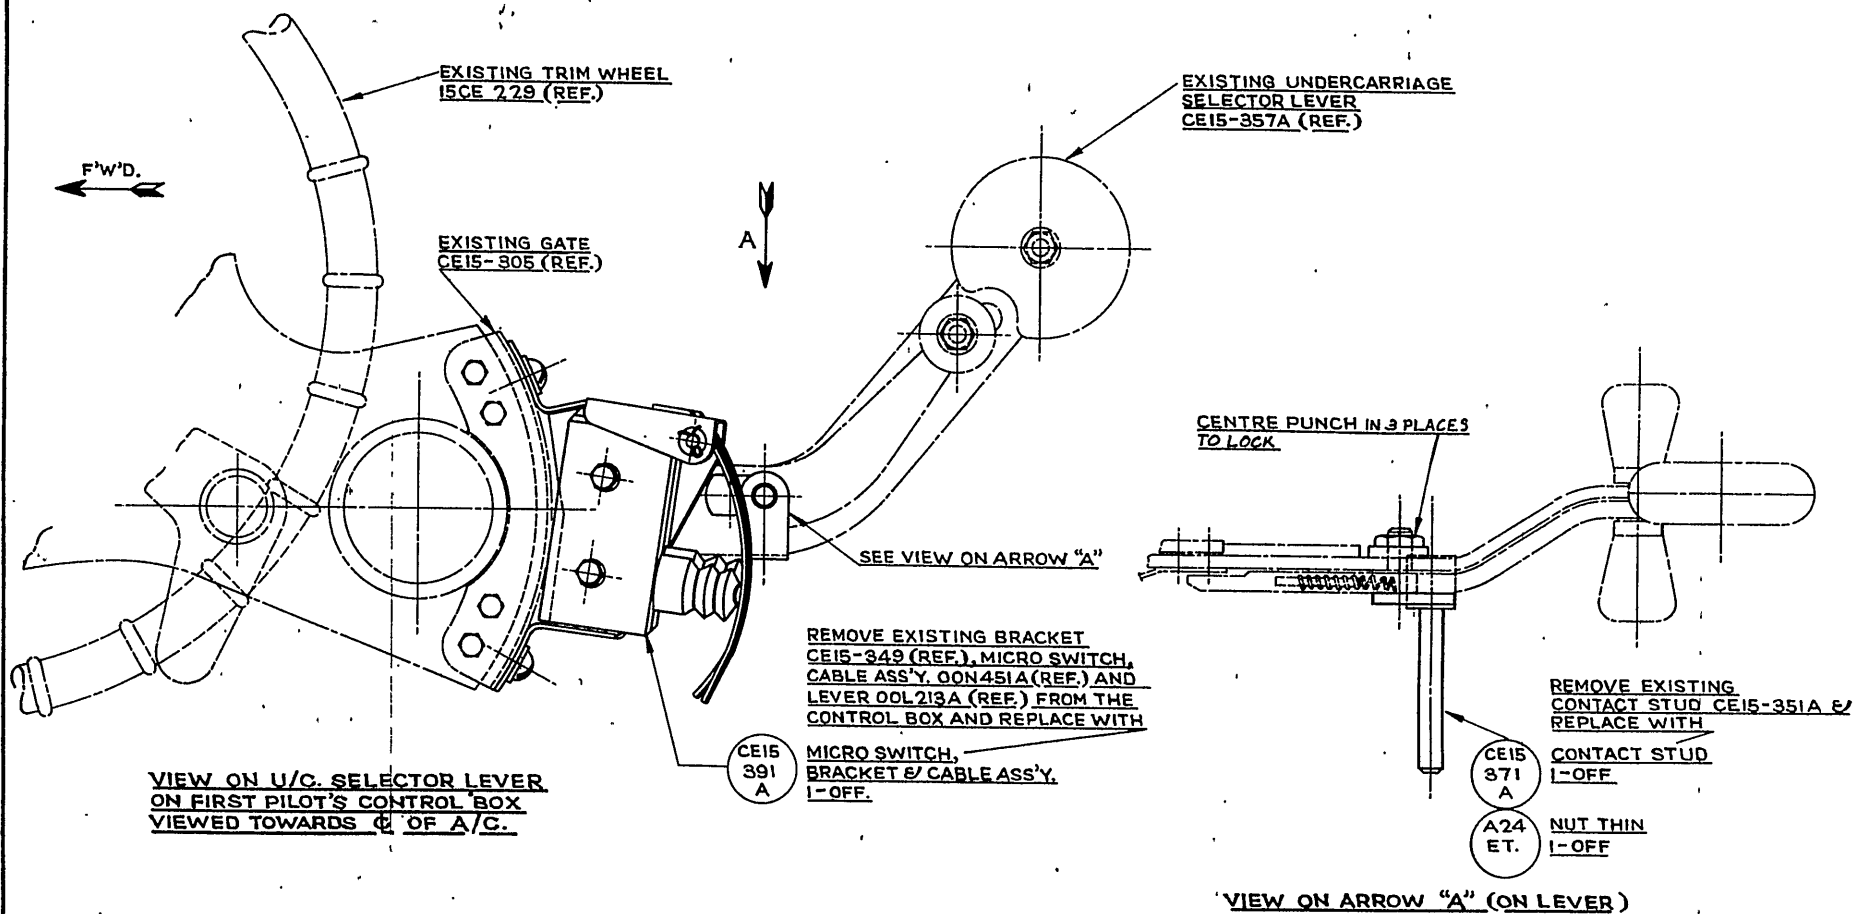
REPOSITION FERRULE 50 LOWER THAN EXISTING POSITION. REPLACE FERRULE WITH:-

REMOVE EXISTING SINGLE TIER SOCKET & REPLACE WITH:-

VIEW ON STARBOARD SIDE.

- (vii) Refer to Drawing Sheet 1. Remove from the undercarriage selector lever the existing contact stud assembly (item 14) and replace with new contact stud assembly (item 2). Using a new nut (item 5) for assembly, and centre punch in three places to lock. Using item 10, finish any exposed surfaces black. Repart No as CE15-383A.

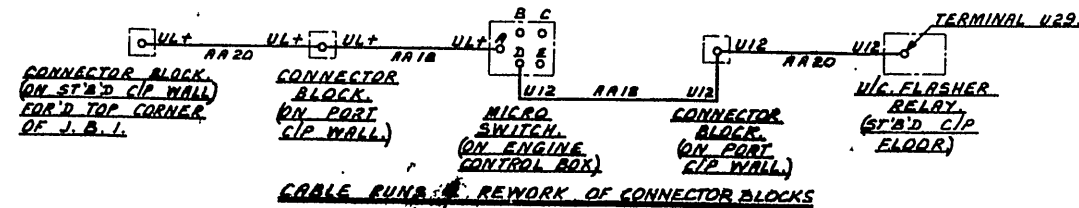
CABLE RUNS & REWORK OF CONNECTOR BLOCKS

- (viii) Referring to Drawing Sheet 2, locate a "P" clip on the port cockpit wall immediately aft of the engine control box. Remove this clip and retain it for reassembly. Remove the existing ferrule to which this clip was attached and plug the hole left in the fuselage wall with the spruce plug (item 3). Reposition and fit new ferrule (item 6) to the above drawing and replace the "P" clip. Using item 10, refinish any exposed surfaces black.

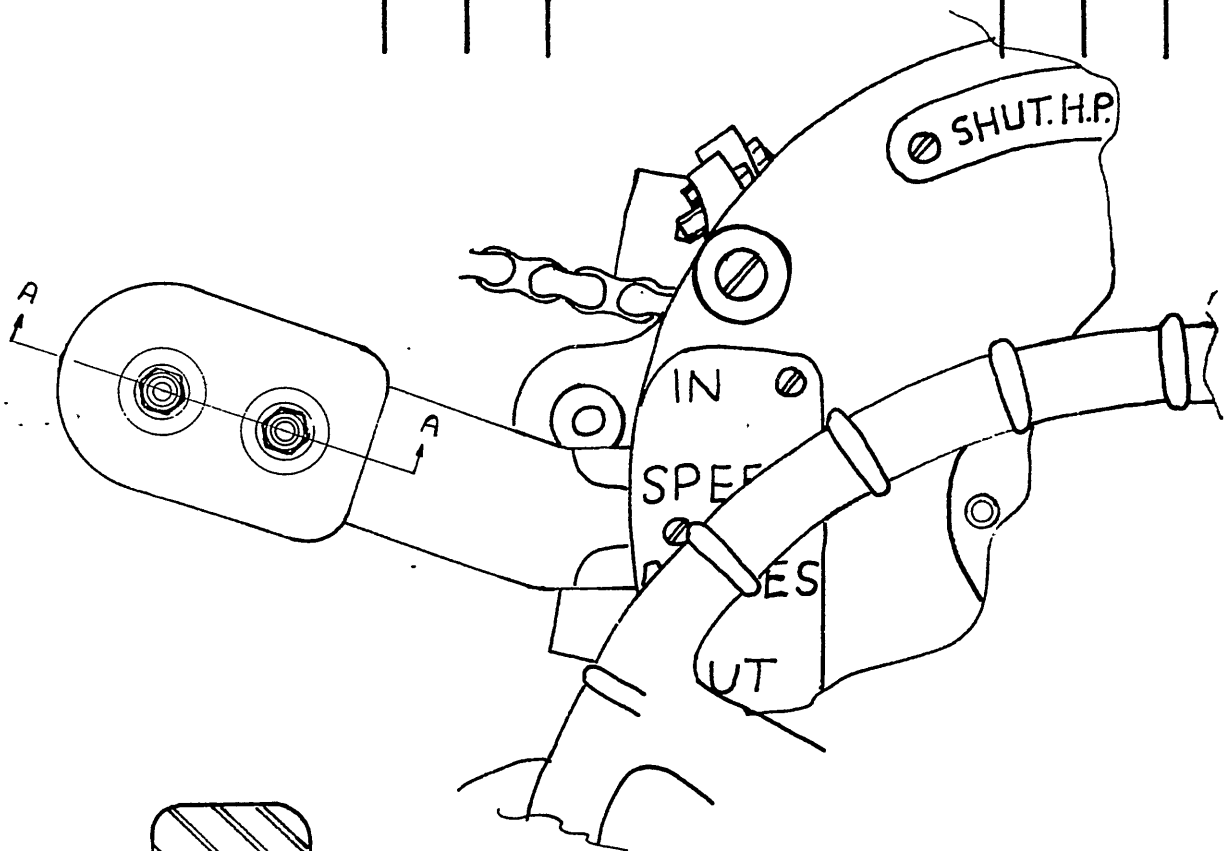
VIEW LOOKING OUTBOARD TOWARDS
PORT CONTROL BOX

REMOVE EXISTING TWO PIECE SPEED
BRAKE LEVER KNOB AND REPLACE, AS SHOWN,
WITH:

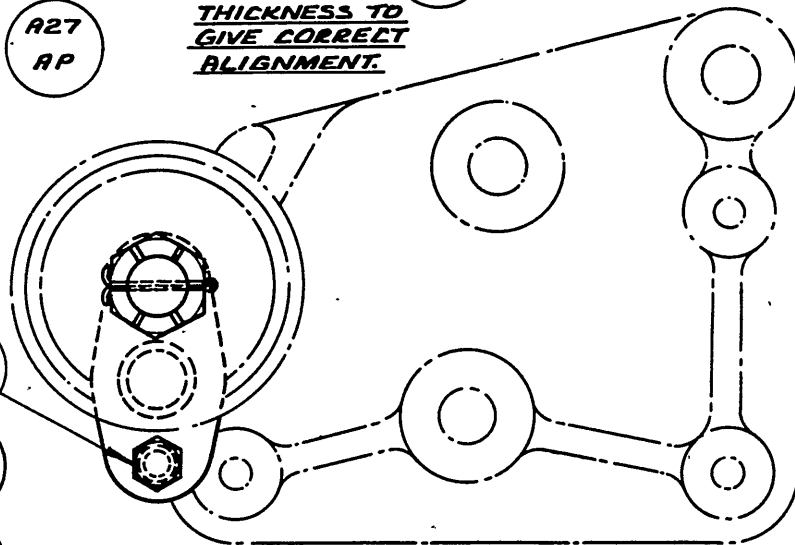
VIEW ON ARROW A

USE MINIMUM
THICKNESS TO
GIVE CORRECT
ALIGNMENT.

VIEW OF MODIFIED INTERMEDIATE PULLEY BRACKET
ASSEMBLY, SITUATED ON THE MAIN TANK BAY PORT WALL

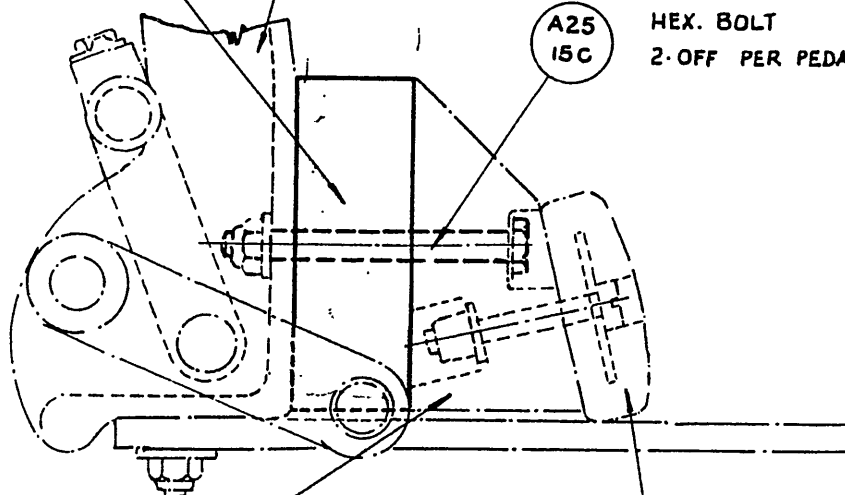
HEX. BOLT
2-OFF PER PEDAL

SPACING BLOCK
CF 15-317A-318 A REF

RUDDER PEDAL PAD
CF 15-121 REF.

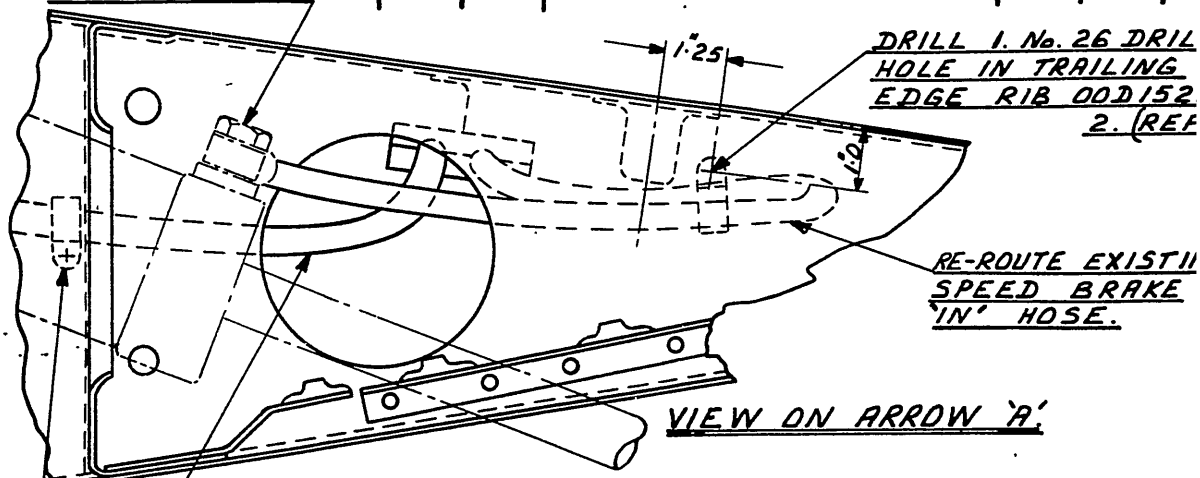
ADJUST BANJO TO
SUIT NEW RUN.

NEW SPEED BRAKE 'OUT'
HOSE (REF.)

EXISTING CLIP
AT FALSE SPAR.
(REF.)

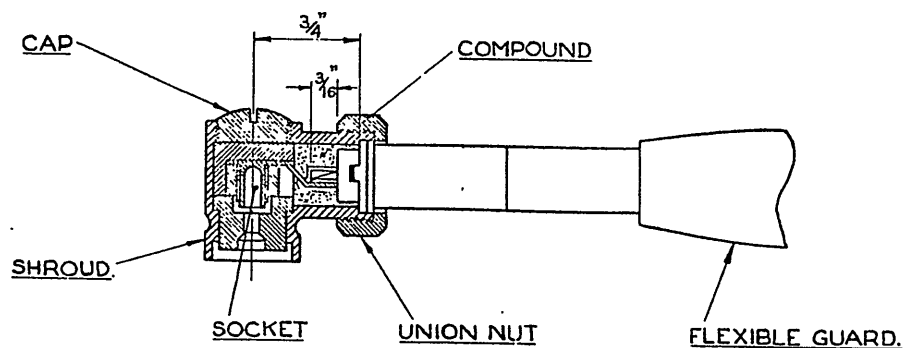
1. REMOVE EXISTING STRAIGHT END FITTING (IDENT NO. Y10H/18588) BUT LEAVE EXISTING FLEXIBLE GUARD ON CABLE.
2. CUT BACK EXISTING BARED CONDUCTOR TO SUIT $\frac{3}{16}$ " DIMENSION SHOWN.
3. ASSEMBLE UNION NUT AND INNER AND OUTER SLEEVES TO END OF CABLE.
4. SOLDER CONDUCTOR TO SOCKET INSERT TAKING CARE NOT TO BURN THE POLYTHENE PRIMARY INSULATION.
5. ASSEMBLE THE SOCKET INSERT WITH SHROUD INTO HOUSING AND TIGHTEN UNION NUT.
6. FILL SOCKET WITH COMPOUND PROTECTIVE INSULATING (IDENT NO. K4/887).
7. INSERT CAP AND SCREW ON TIGHT.
8. SLIDE FLEXIBLE GUARD BACK INTO POSITION.
9. ALTER PART NO. OF CABLE TO NI5-1355A.

METHOD OF REWORKING CONNECTOR GP733/OOI (IDENT No G6A/283) AT RECTIFIER END.

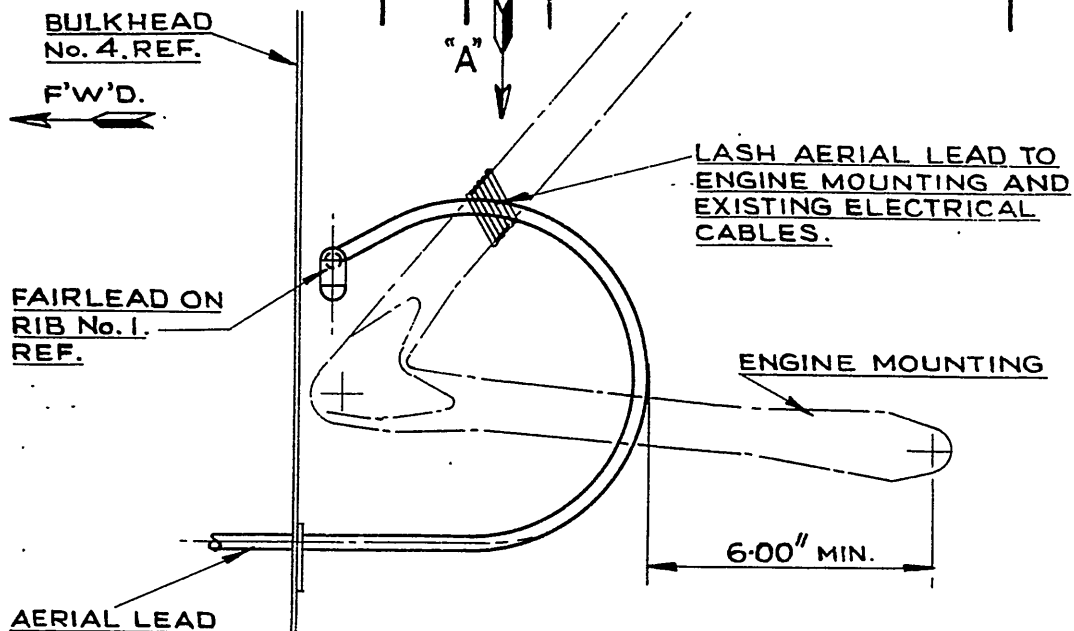
VIEW LOOKING IN'BD. ON PORT SIDE OF ENGINE MOUNTING.

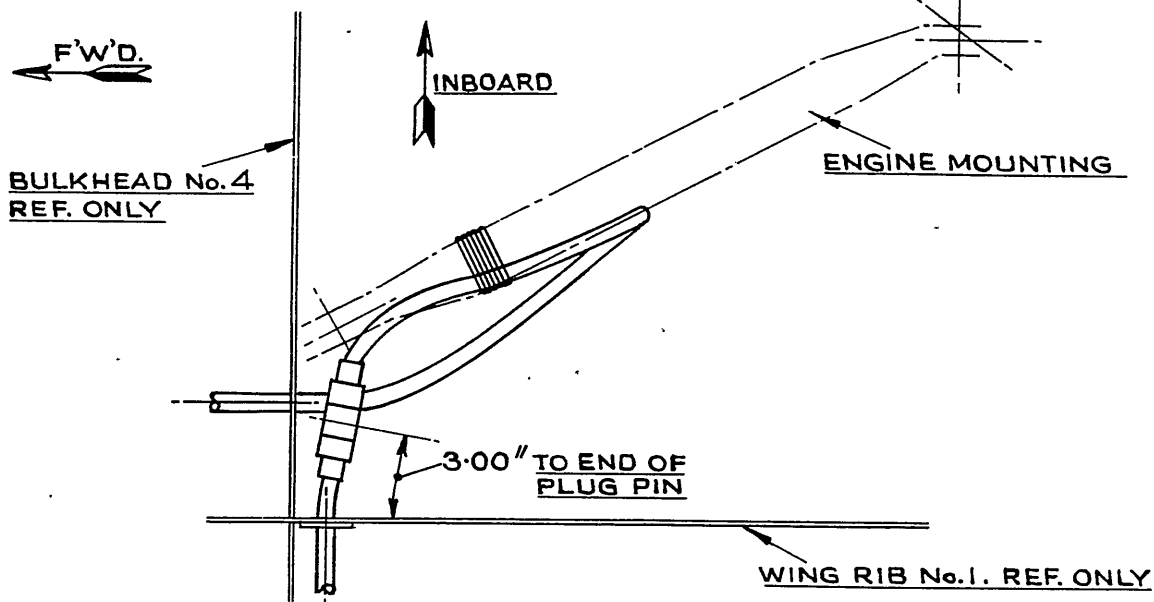
PLAN VIEW ON ARROW "A"

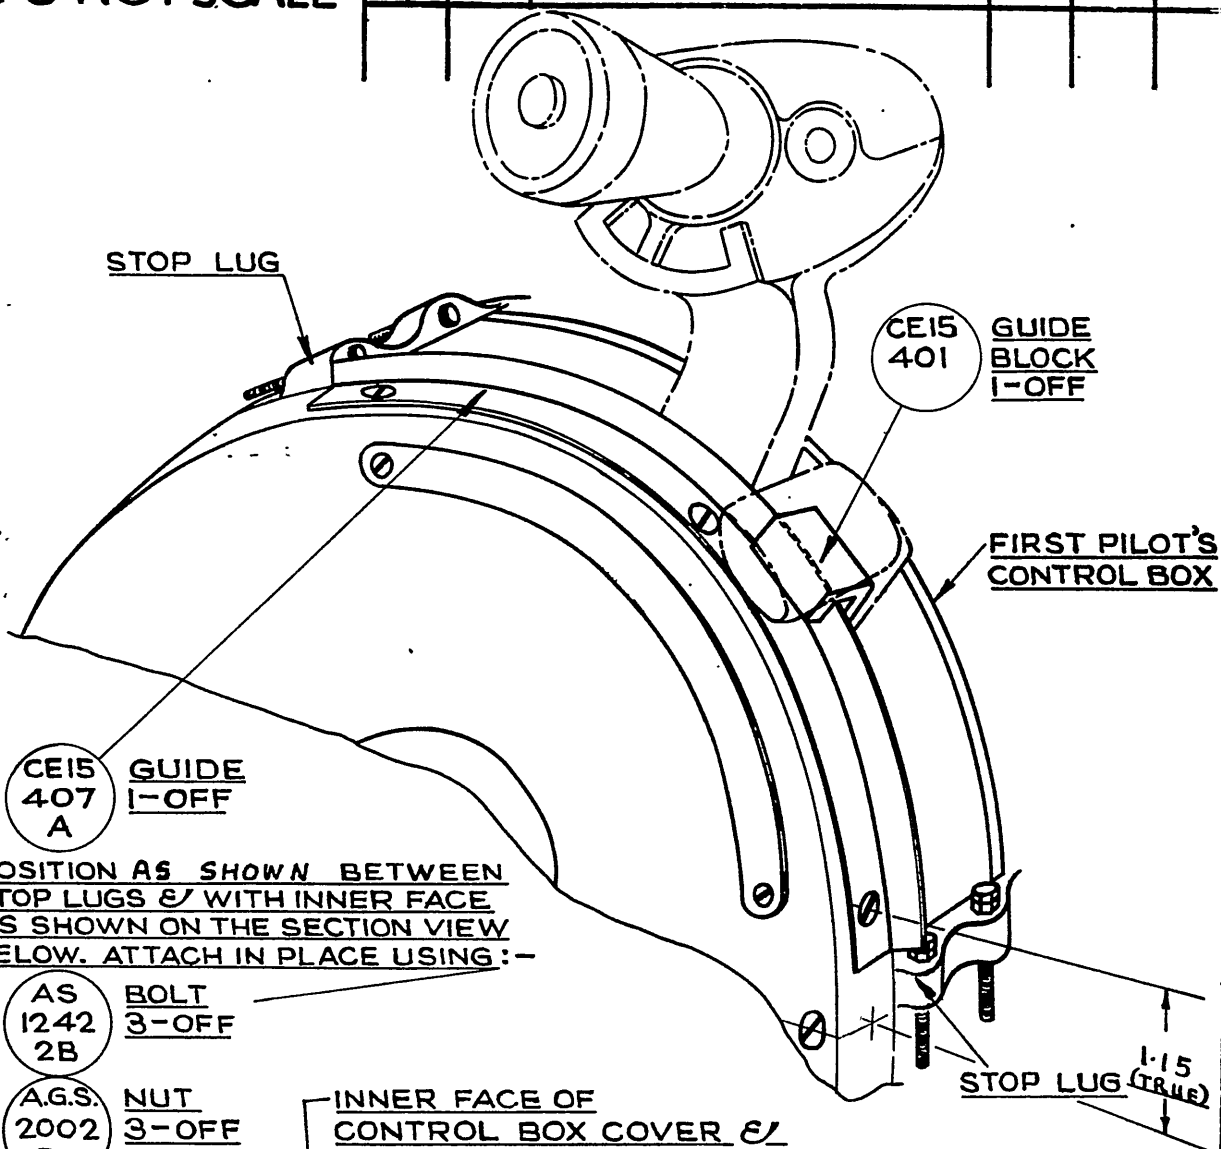
POSITION AS SHOWN BETWEEN STOP LUGS & WITH INNER FACE AS SHOWN ON THE SECTION VIEW BELOW. ATTACH IN PLACE USING :-

- AS BOLT 3-OFF
1242 2B
- A.G.S. NUT 3-OFF
2002 B1
- S.P. WASHER 3-OFF
13 B

INNER FACE OF CONTROL BOX COVER & CE15-407A GUIDE

SECTION VIEW, SHOWING SETTING OF LEVER IN FULLY OPEN POSITION

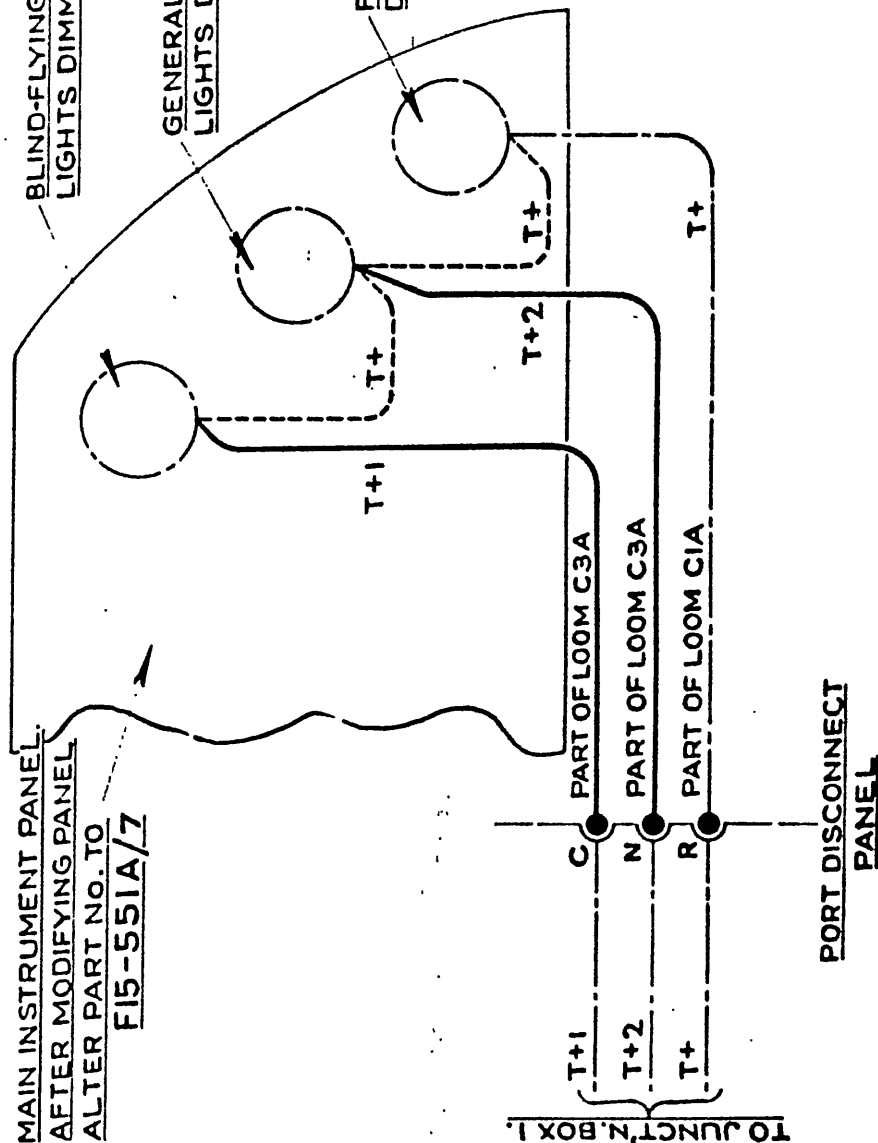
GENERAL INSTRUMENTS
LIGHTS DIMMER SWITCH

FLOOD LIGHTS
DIMMER SWITCH

MOD. TO INSTRUMENT PANEL WIRING.
(VIEW ON BACK OF PANEL)

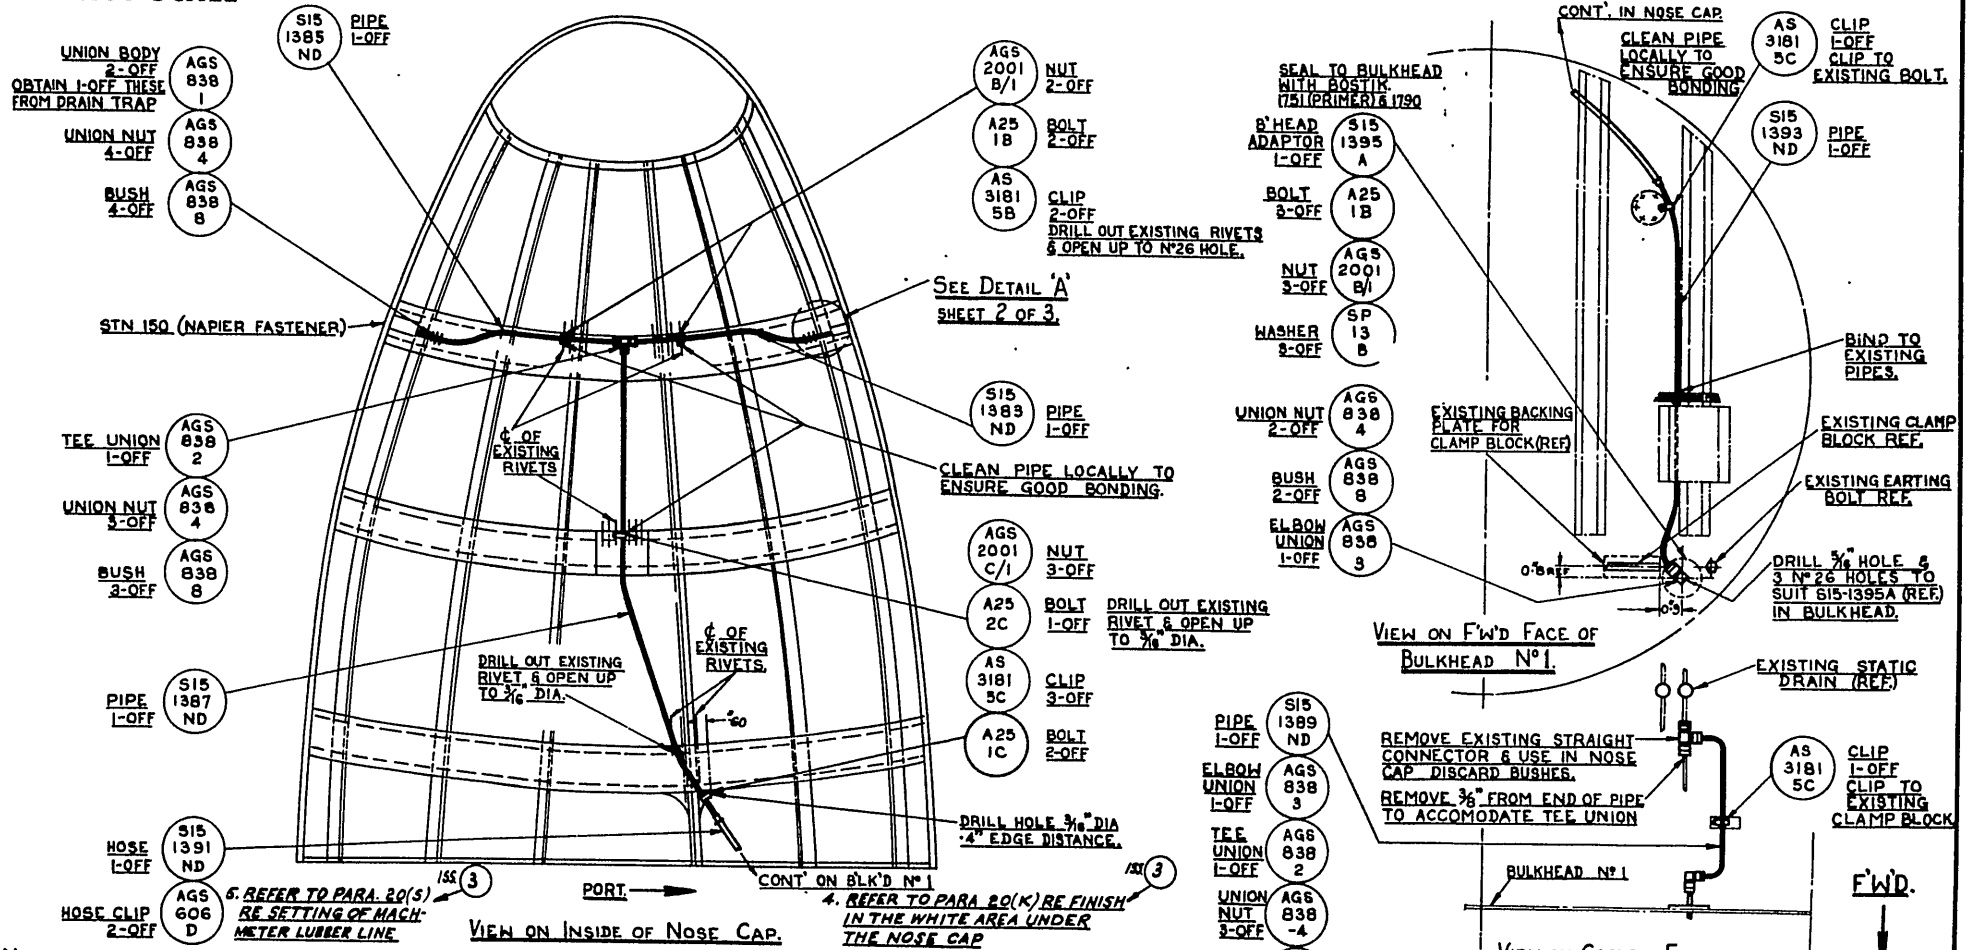
1. PIPE RUN TO BE SUCH THAT CONDENSED WATER WILL EITHER RUN OUT OF STATIC VENT OR INTO DRAIN TRAP. I.E. NO TRAPS ARE TO BE FORMED IN THE PIPE RUN.

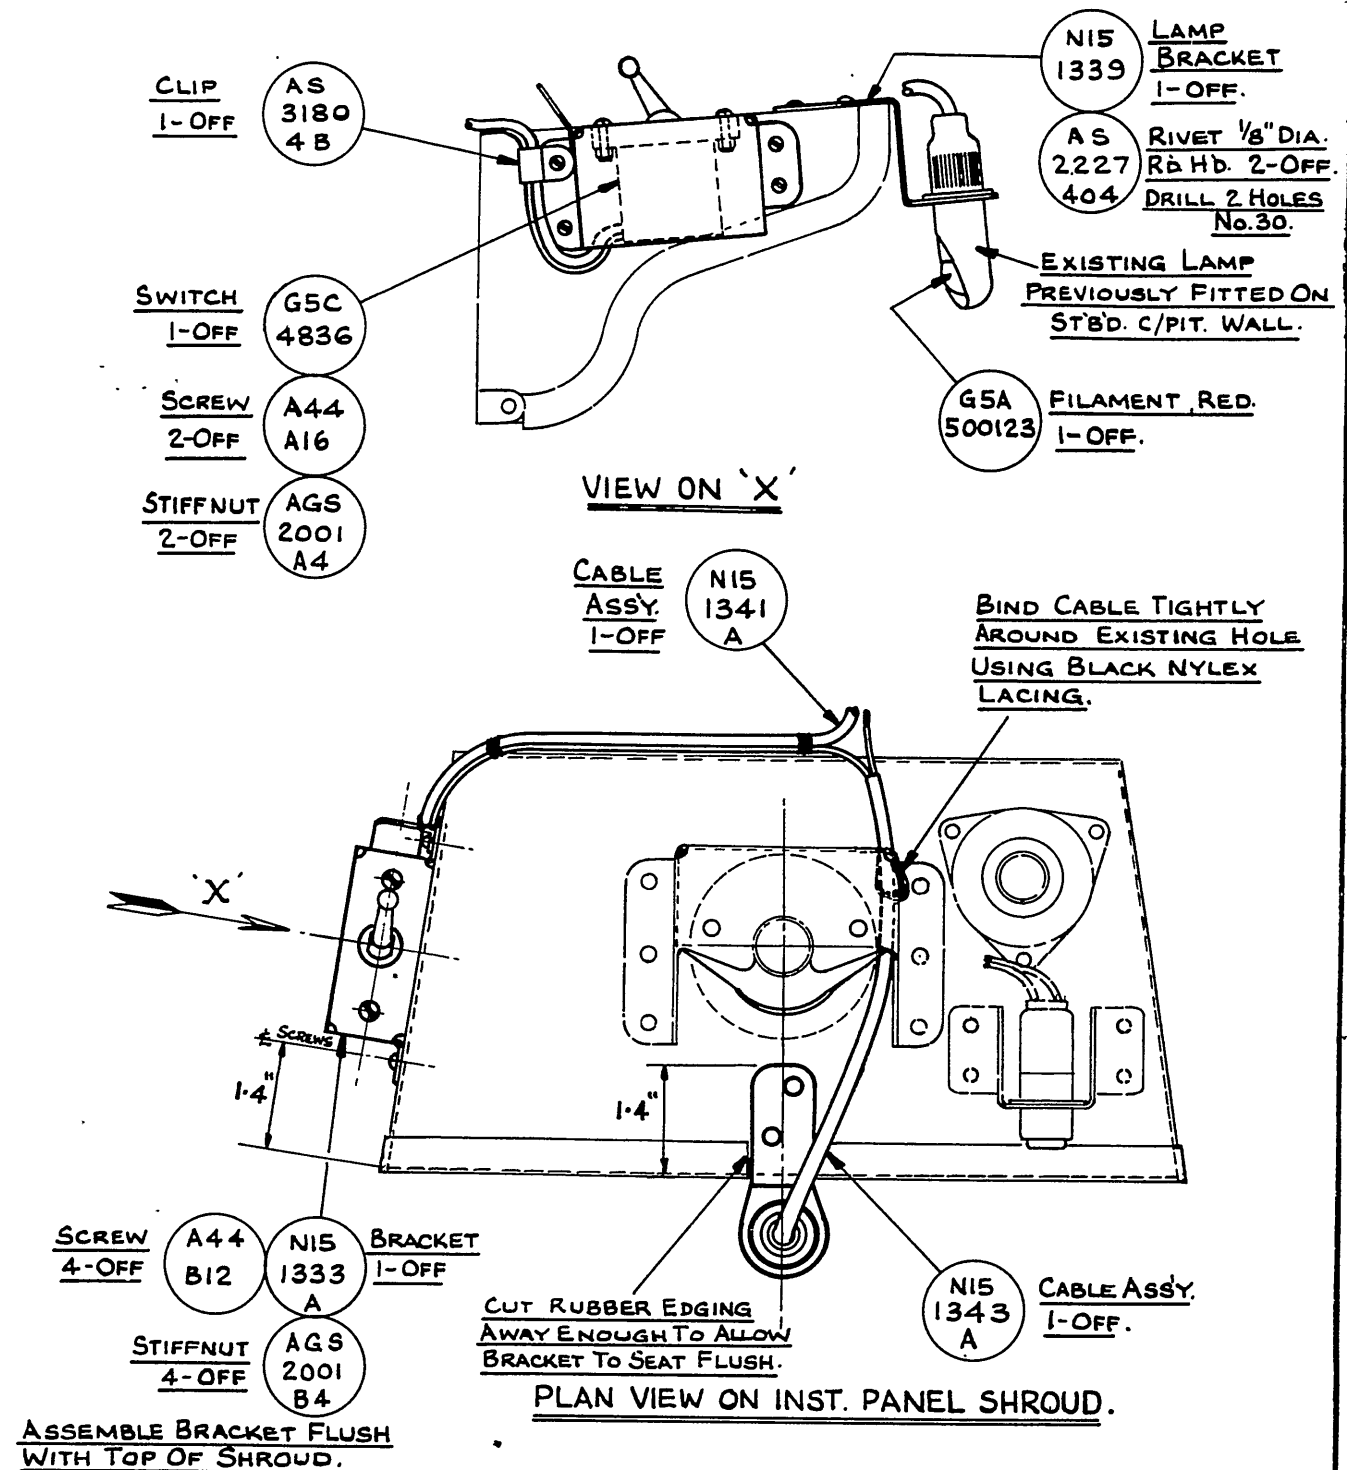
DE HAVILLAND DRG. No. 00M489 SHT. 1 OF 2.

REFERENCE		ISSUED BY		TITLE	
		DEPARTMENT OF AIR SENIOR TECHNICAL STAFF OFFICER SUPPORT COMMAND		EMERGENCY COCKPIT LIGHTING - REVISED INSTALLATION.	
LIMITS UNLESS STATED	MATERIAL			COMPONENT OF	
DECIMALS $\pm .010"$	SPEC.			MACHINE	
FRACTIONS $\pm \frac{1}{32}"$	TREATMENT			ENGINE	
ANGLES $\pm \frac{1}{2}^\circ$	FINISH			TECH. ORDER	VAMPIRE MOD 356.
SURFACE FINISH AUSTRALIAN STANDARD ENG. DRWG. PRACTICE A.3.21	SCALE			DRAWING NO.	A13956 SHEET 1 OF 2
	DRAWN	APPROVED			
	TRACED	CHECKED

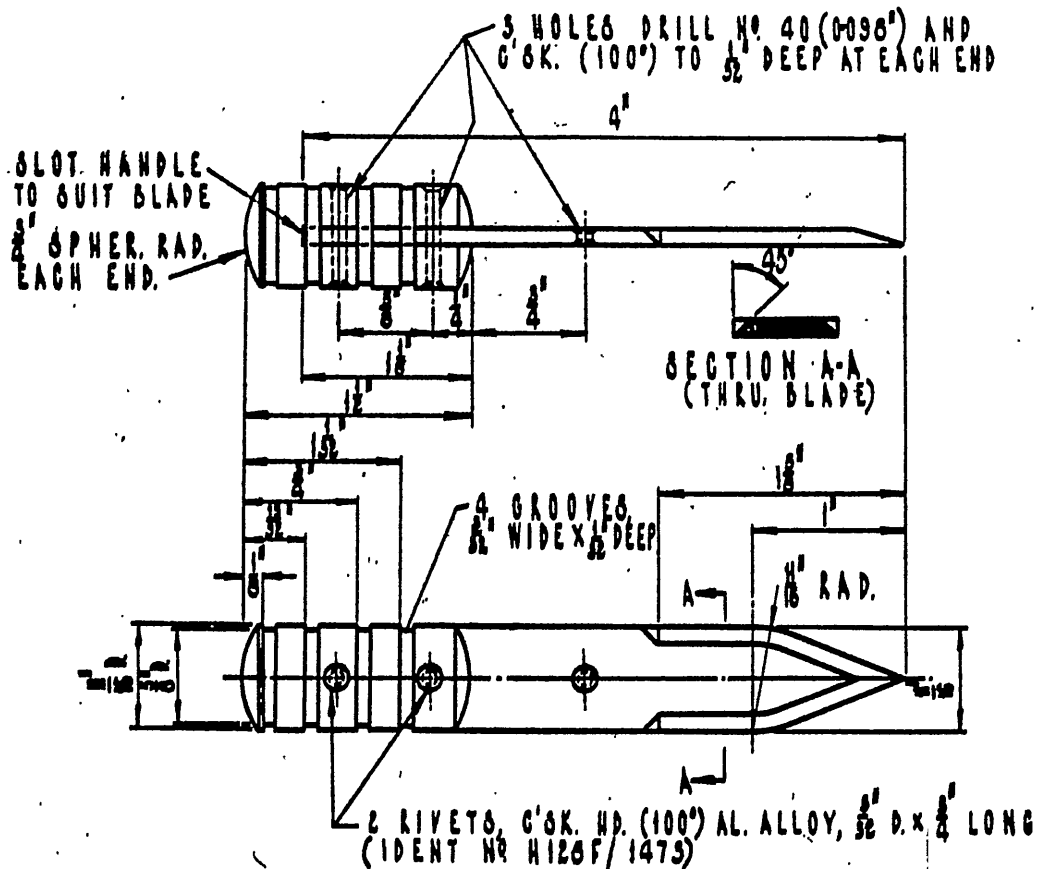
MATERIAL :- BLADE, AL. ALLOY - AL. COATED, 12 S.W.G.

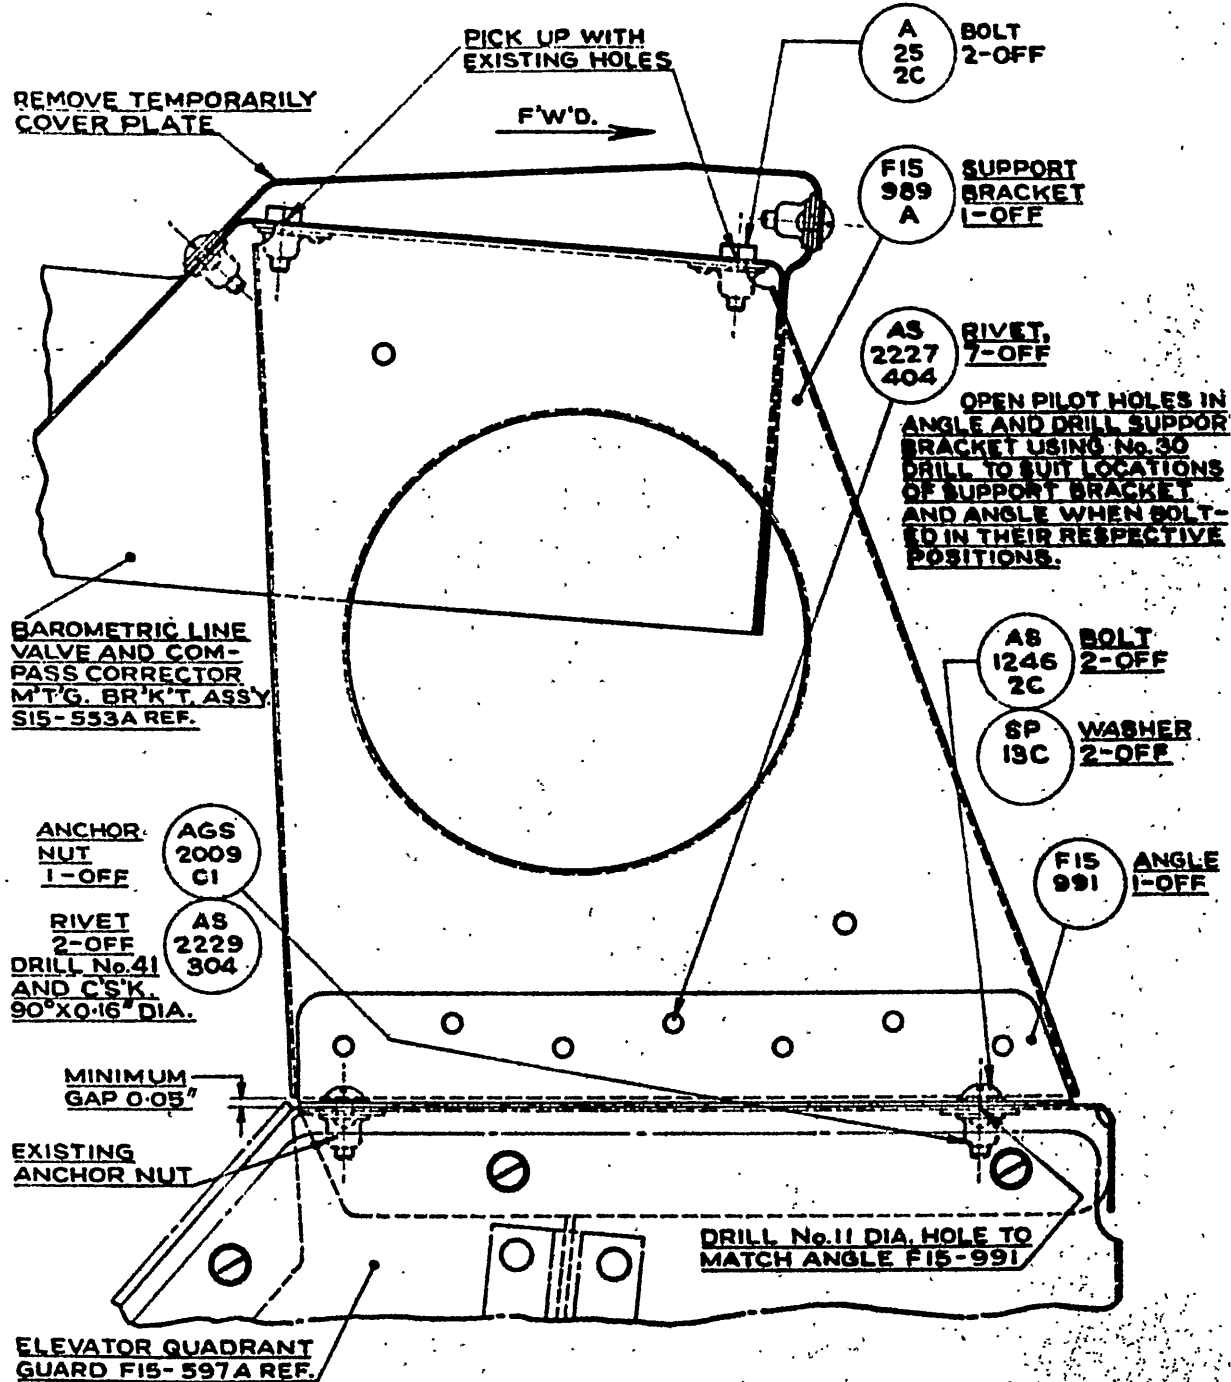
VIEW ON COCKPIT WALL - PORT
DE HAVILLAND DRAWING No. 00M493 SHEET 1 OF 1 SHEETS

REFERENCE	ISSUED BY		TITLE	
	DEPARTMENT OF AIR SENIOR TECHNICAL STAFF OFFICER SUPPORT COMMAND		SUPPORT BRACKET ASS'Y. FOR BARO- METRIC LINE VALVE & COMPASS CORRECTOR M'T'G. BR'K'T. ASS'Y.	
LIMITS UNLESS STATED	MATERIAL		COMPONENT OF	
DECIMALS $\pm .010"$	SPEC.		MACHINE	
FRACTIONS $\pm \frac{1}{32}"$	TREATMENT		ENGINE	
ANGLES $\pm 3^\circ$	FINISH		TECH. ORDER	VAMPIRE MOD.361
SURFACE FINISH AUSTRALIAN STANDARD ENC. DRWG. PRACTICE A.8.021	SCALE		DRAWING NO.	A-14034
	DRAWN	APPROVED		DRWG. A SIZE
	TRACED	CHECKED

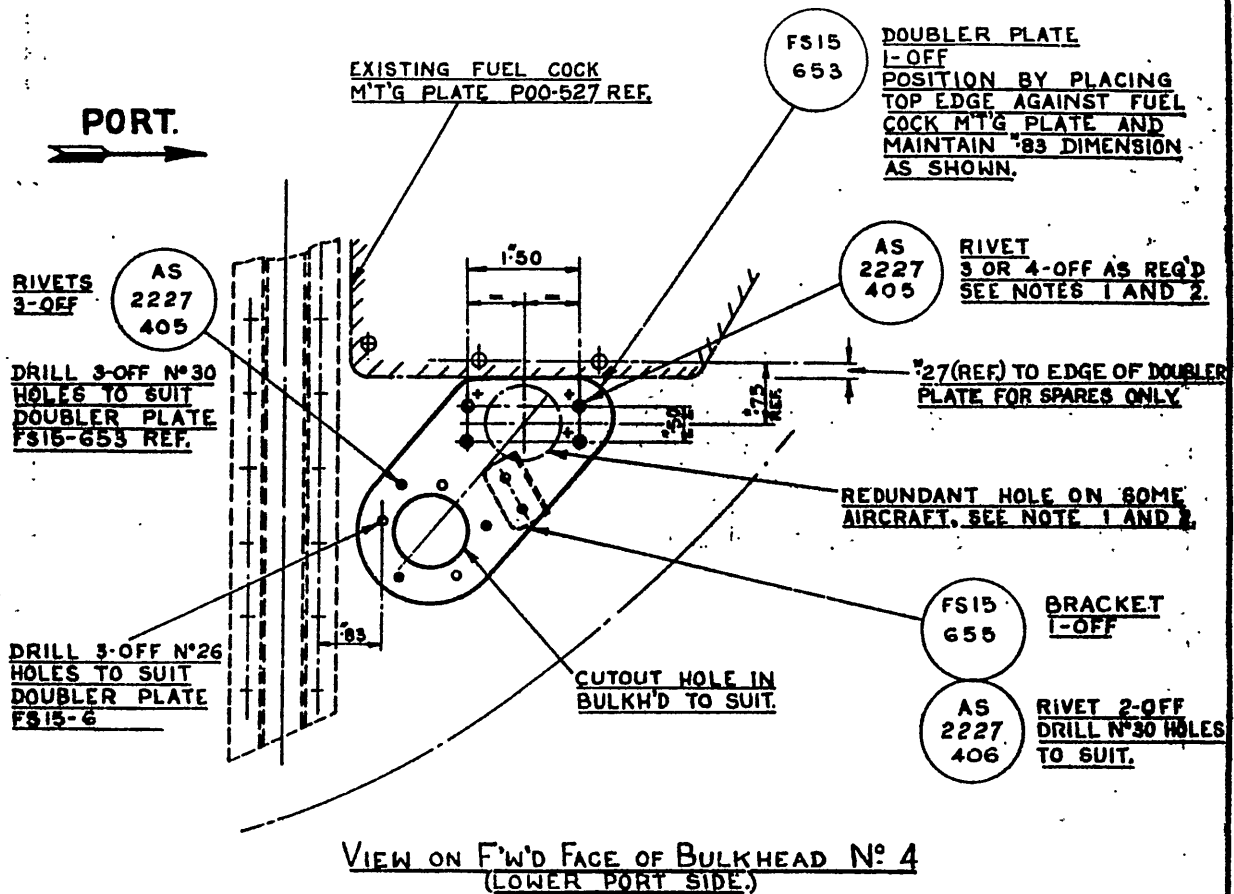
- NOTES**
1. IF BLANKING PLATE FS15-167ND IS FITTED, REMOVE & DISCARD IT & DRILL 4-OFF N° 30 HOLES CODED ① FROM EXISTING HOLES IN BULKHEAD.
 2. IF BLANKING PLATE FS15-167ND IS NOT FITTED, DRILL 3-OFF N° 30 HOLES CODED +.
 3. REMOVE EXISTING NOTE "WATER DRAIN PLUG INSIDE" STENCILLED ABOVE BOTH CANNON BAY DOORS.
 4. STENCIL IN $\frac{1}{2}$ " HIGH RED LETTERS ON THE PORT CANNON BAY DOOR IN LINE WITH THE DRAIN COCK "WATER DRAIN COCK INSIDE" → INSTALL LOCKING PIN AFTER USE. (THE HEAD OF THE ARROW TO INDICATE THE PORT LOWER INSPECTION DOOR.)
