Australian Air Publication **721.79**

VAMPIRE MODIFICATIONS

(Nos 301 to 400)

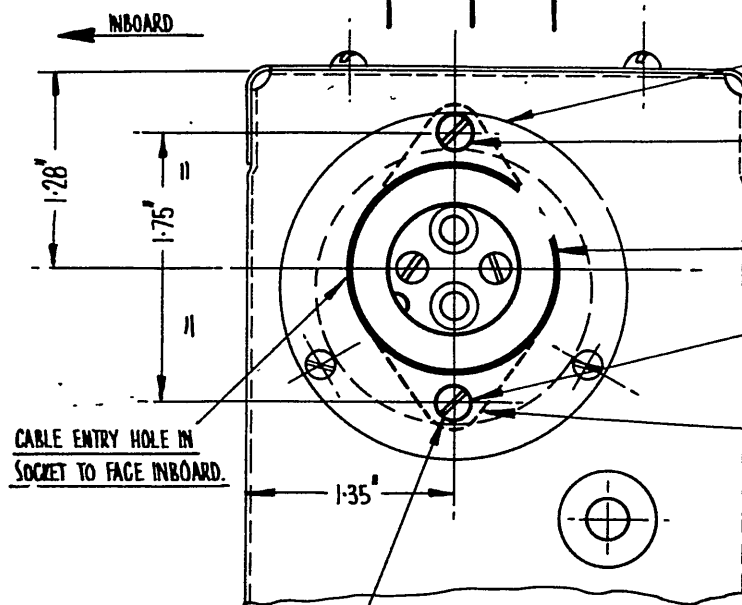
EXISTING BLANKING PLATE (ON MK.35A A/C ONLY) TO BE RETAINED.

ENLARGE EXISTING HOLE (MK.35A A/C ONLY) TO N° 27 DRILL OR ADD A NEW N° 27 DRILL HOLE (MK.35 A/C ONLY).

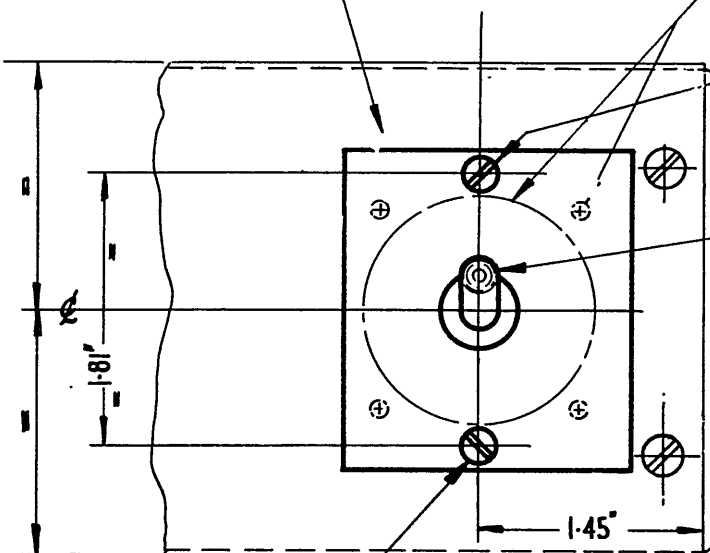
DRILL 2 HOLES N° 27 DRILL

- G105C/606 SWITCH - 1 OFF. (MOUNT FROM INSIDE OF JUNG. BOX WITH TOGGLE IN 'OFF' POSITION AS DRAWN)
- N15-1351 LABEL - 1 OFF.
- AN 515-6-6 SCREWS - 2 OFF.

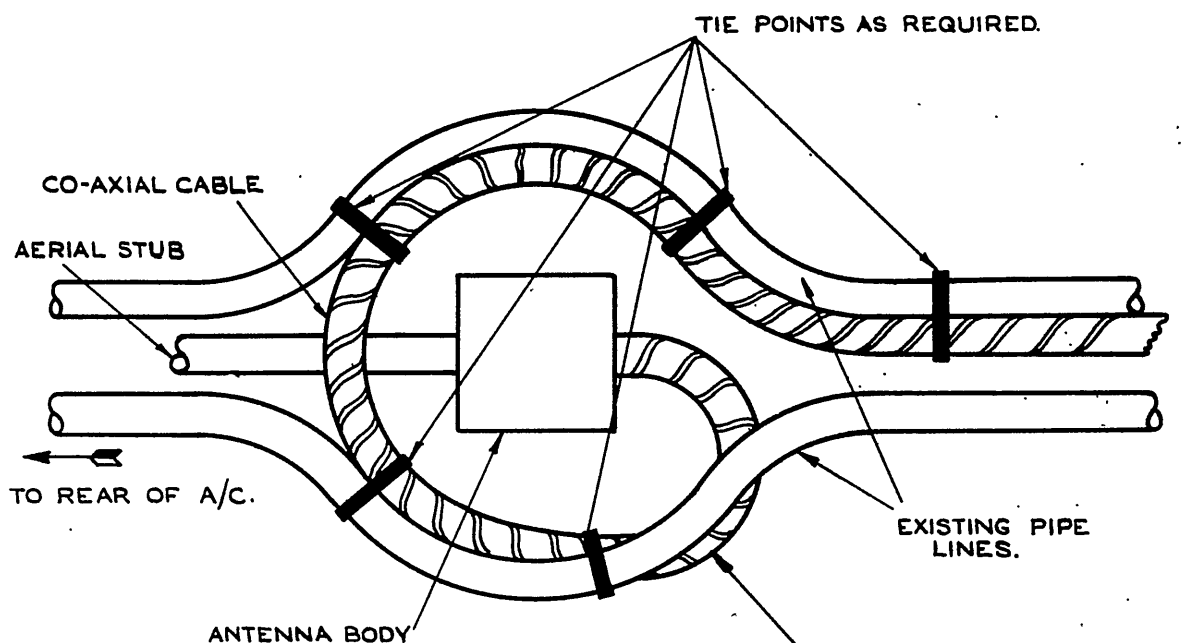
**NOTE :- TAKE CARE NOT TO BEND
CABLE UNDER A RADIUS OF 3-0"**

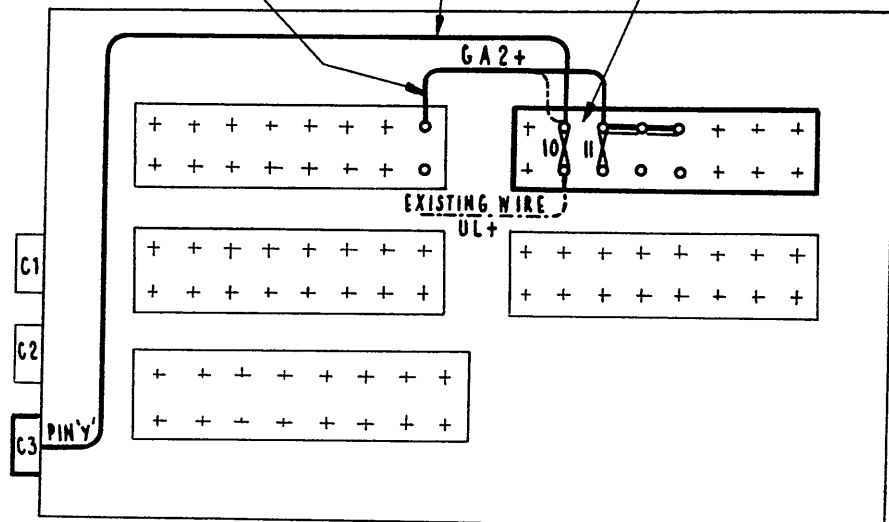
EXISTING WIRE CODED GA2+
CONNECTING BETWEEN FUSE 8 &
FUSE 10 IS TO BE RE-CONNECTED TO
FUSE 11 AS SHOWN.

REMOVE EXISTING LINK
BETWEEN FUSES NO. 10 & 11.

MODIFICATION TO JUNCTION BOX NO.1

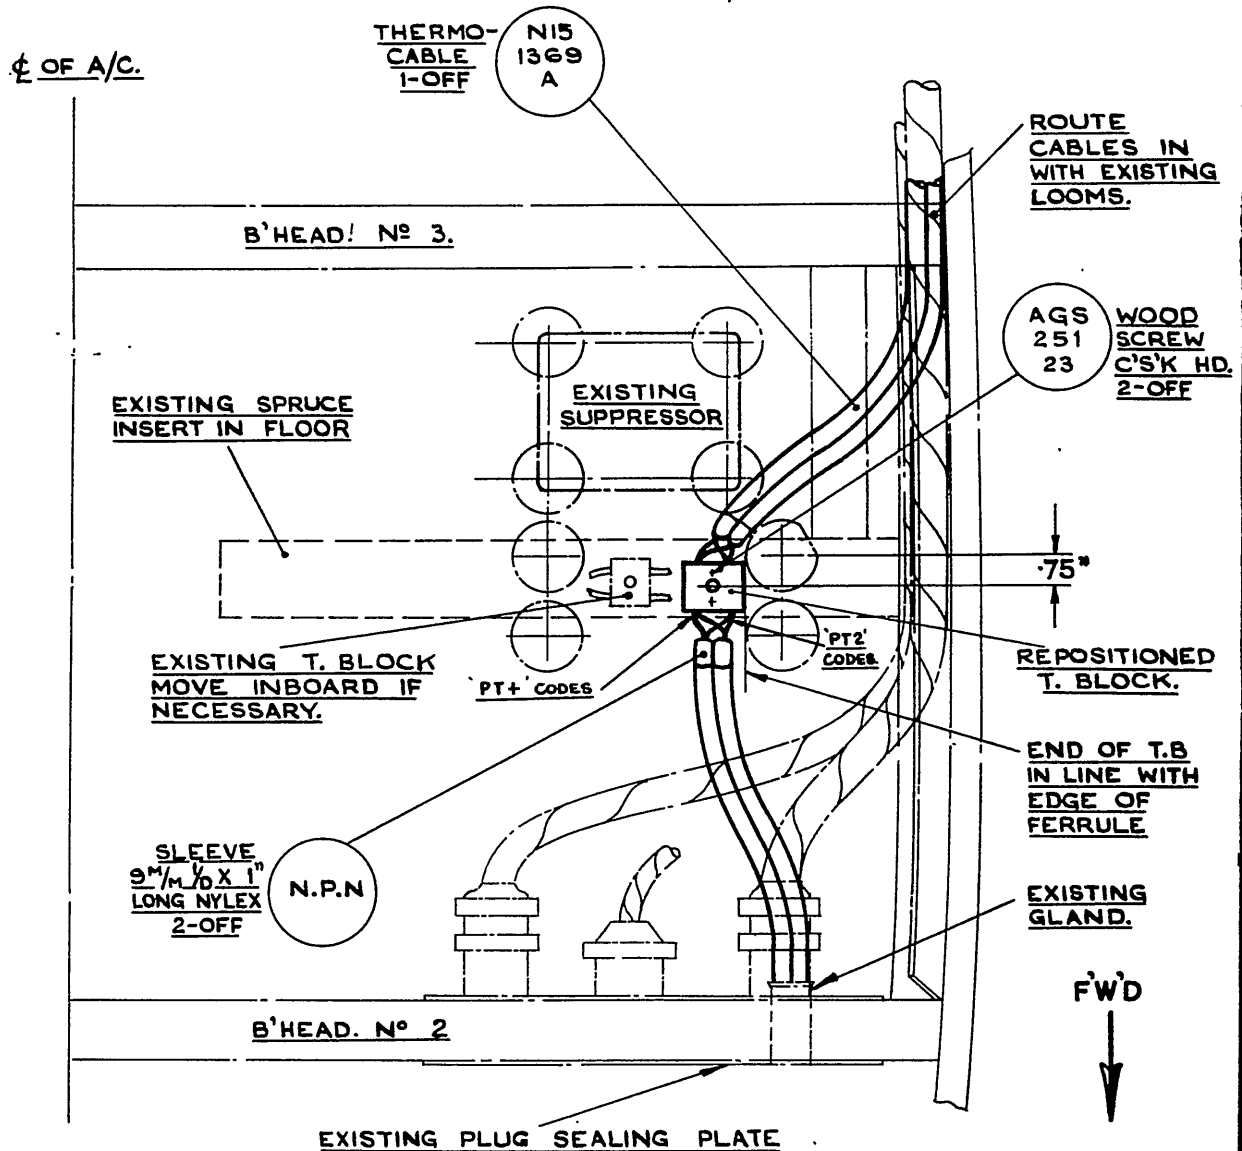
VIEW ON UNDERSIDE OF CANNON BAY FLOOR.

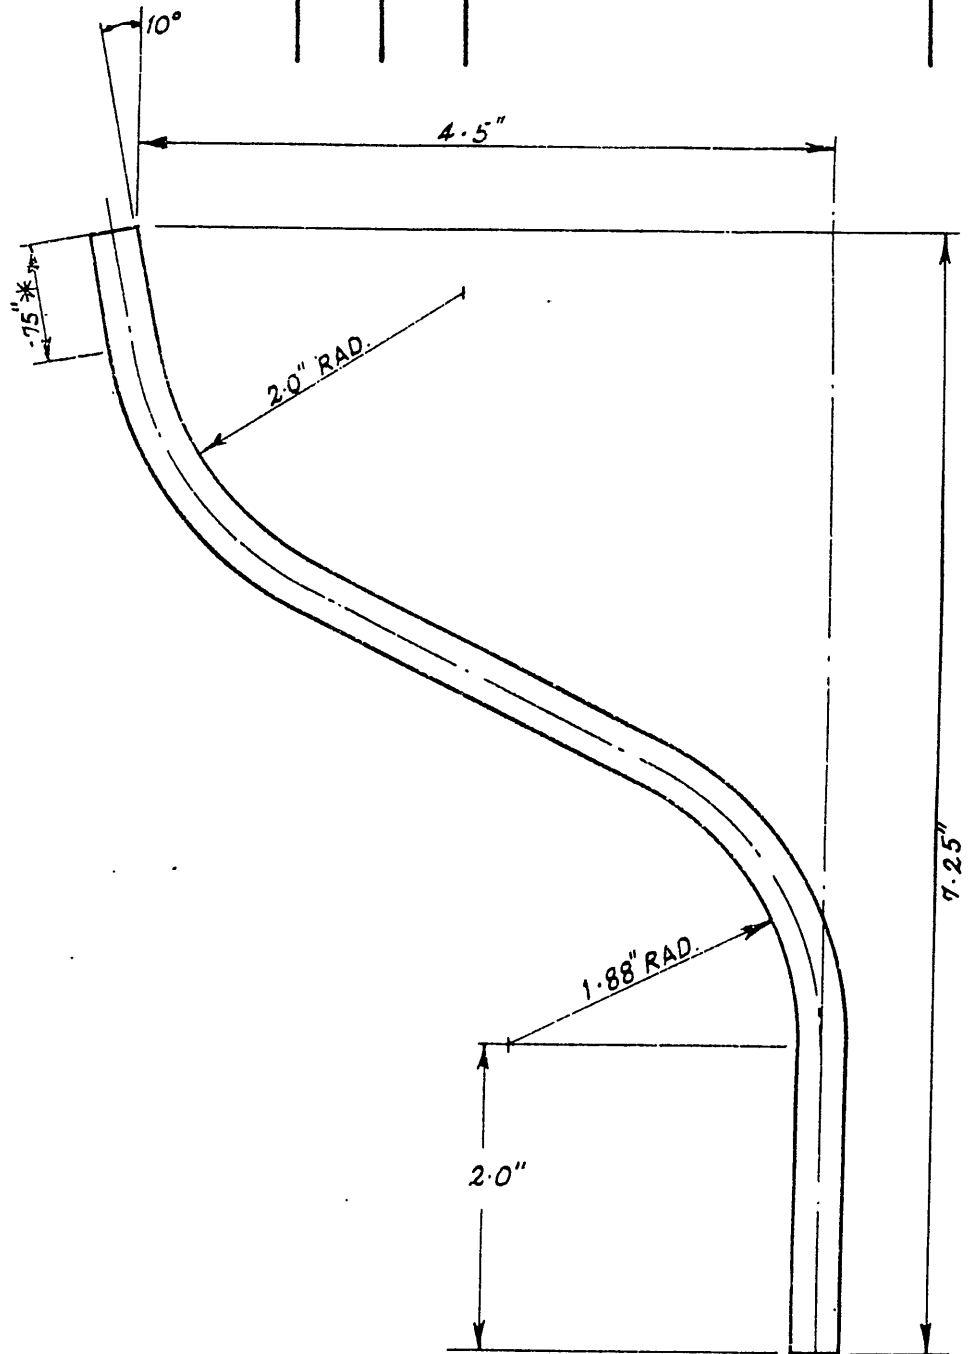
DIMENSIONS MARKED THUS * INCLUDE ALLOWANCE FOR FITTING ON AIRCRAFT

HAWKER DE HAVILLAND PART NO. F15-1041 ND.

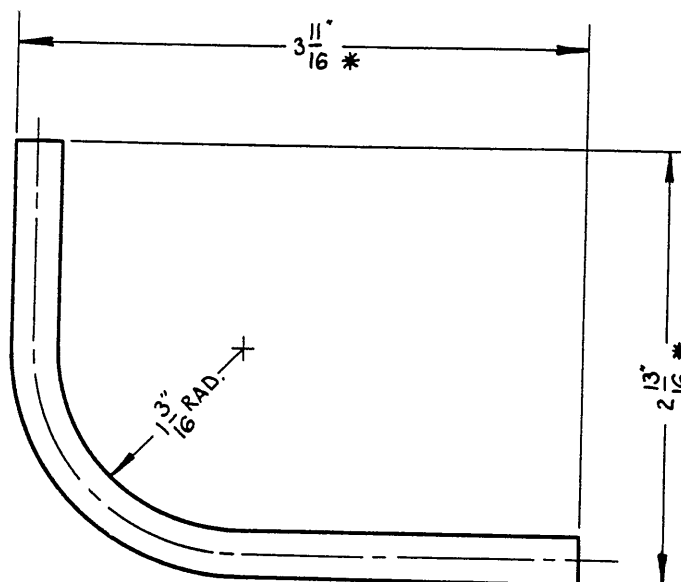
DIMENSIONS MARKED THUS * INCLUDES ALLOWANCE FOR FITTING ON AIRCRAFT

REFERENCE		IS. 800. 2.		TITLE	
		DEPARTMENT OF AIR		PIPE	
		SENIOR TECHNICAL STAFF OFFICER		ALTIMETER TO AIR SPEED INDICATOR	
		SUPPORT COMMAND			
LIMITS UNLESS STATED	MATERIAL	5/16" O.D. X 0.036" ALUM. TUBE		COMPONENT OF	
DECIMALS = ± 0.010"	SPEC.	DTD 310C, (E) D 619		MACHINE	VAMPIRE A/C
FRACTIONS = 1/32"	TREATMENT			ENGINE	
ANGLES = °	FINISH			TECH. ORDER	VAMPIRE MOD. 370
SURFACE FINISH	SCALE	FULL SIZE		DRAWING NO.	A-15088-2
AUSTRALIAN STANDARD	DRAWN	A. J. B.	APPROVED		DRWG A SIZE
ENG. DRWG. PRACTICE AS GZI	TRACED	M. I. F.	CHECKED

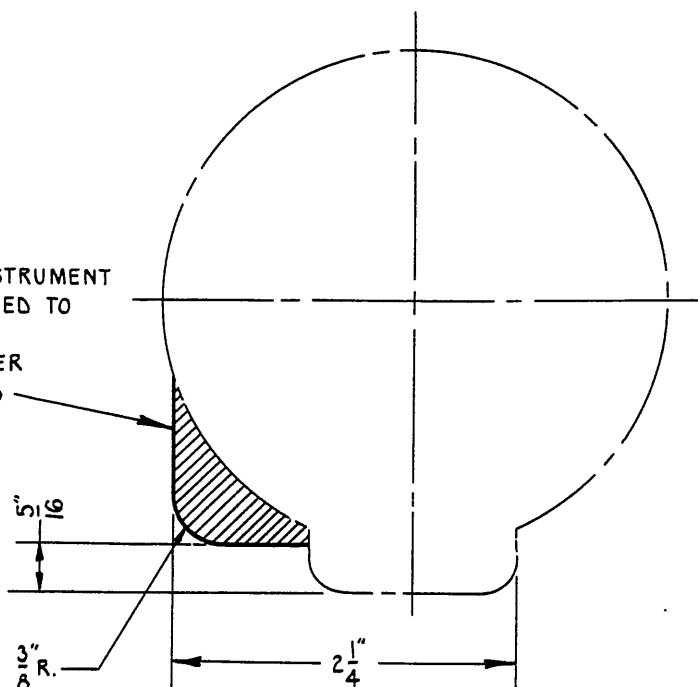
THIS PORTION OF INSTRUMENT
PANEL TO BE REMOVED TO
ALLOW FITMENT OF
KOLLSMAN ALTIMETER
TYPE E22061-04-018

REFERENCE		ISSUED BY			TITLE	
		DEPARTMENT OF AIR SENIOR TECHNICAL STAFF OFFICER SUPPORT COMMAND			REWORK OF INSTRUMENT PANEL	
LIMITS UNLESS STATED	MATERIAL				COMPONENT OF	
DECIMALS $\pm .010"$	SPEC.				MACHINE	VAMPIRE A/C
FRACTIONS $\pm \frac{1}{32}"$	TREATMENT				ENGINE	
ANGLES $\pm \frac{1}{2}^\circ$	FINISH				TECH. ORDER	VAMPIRE MOD 370
SURFACE FINISH	SCALE	FULL SIZE			DRAWING NO.	A-15088-3
AUSTRALIAN STANDARD	DRAWN	A. J. B.	APPROVED	<i>A.J.B.</i>		
ENG. DRWG. PRACTICE A.S.G21	TRACED	M. I. F.	CHECKED	<i>M.I.F.</i>		
					DRWG. A SIZE

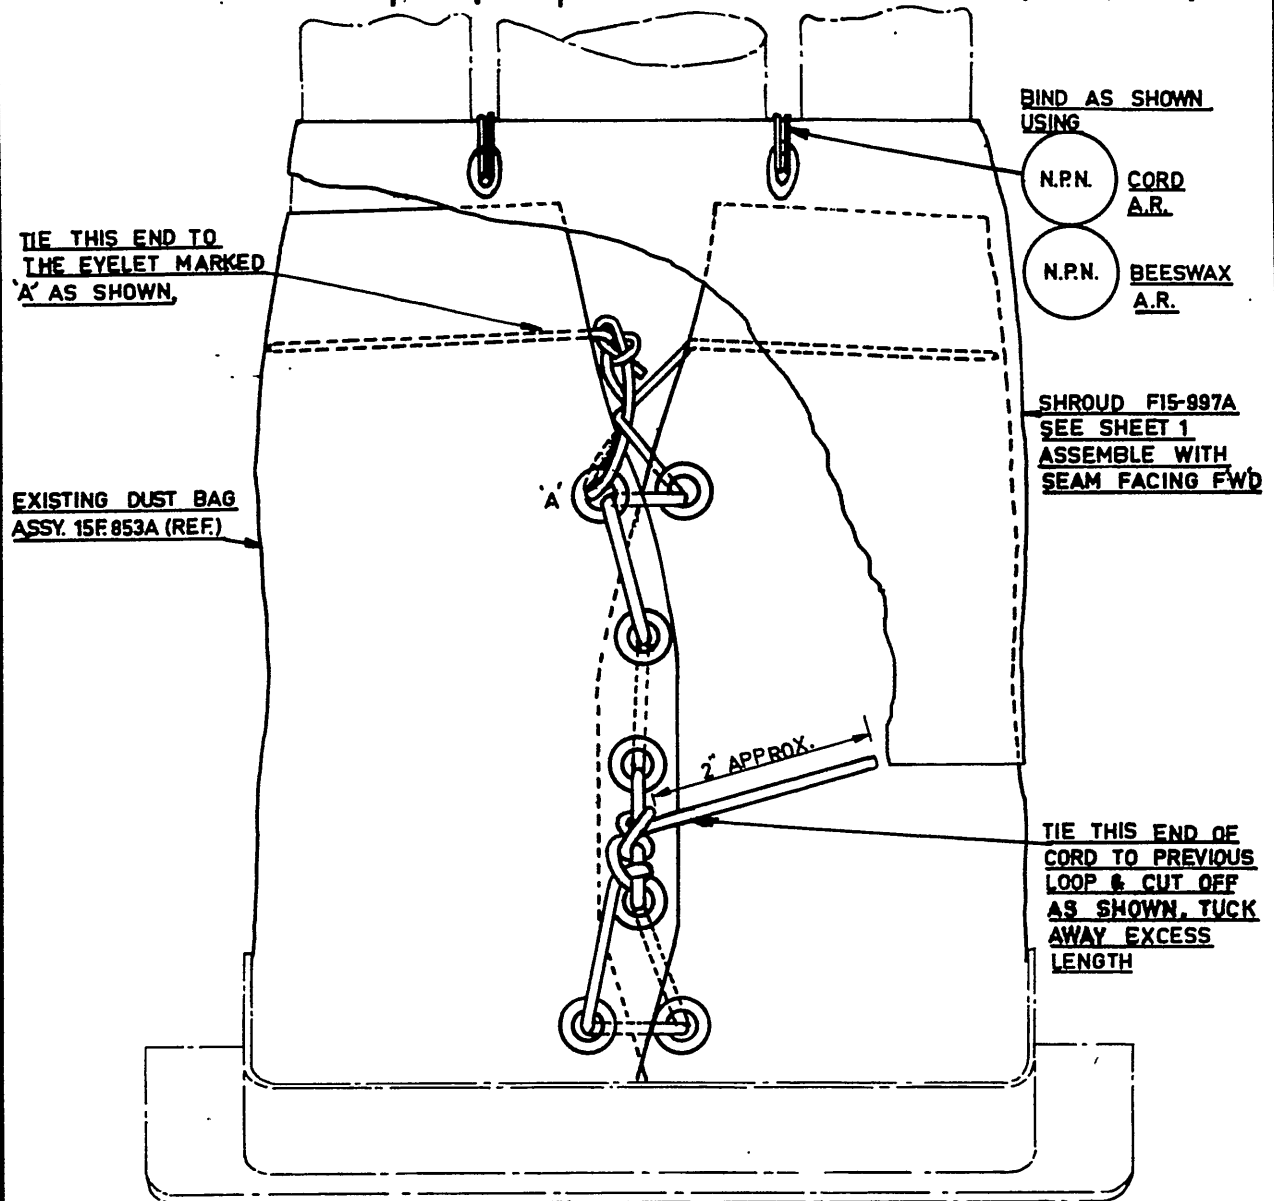
VIEW ON CONTROL COLUMN DUST BAG ASSEMBLY SHOWING NEW METHOD OF LACING
 &
 ASSEMBLY OF NEW SHROUD (PORTION OF WHICH IS CUT AWAY PICTLY FOR CLARITY)

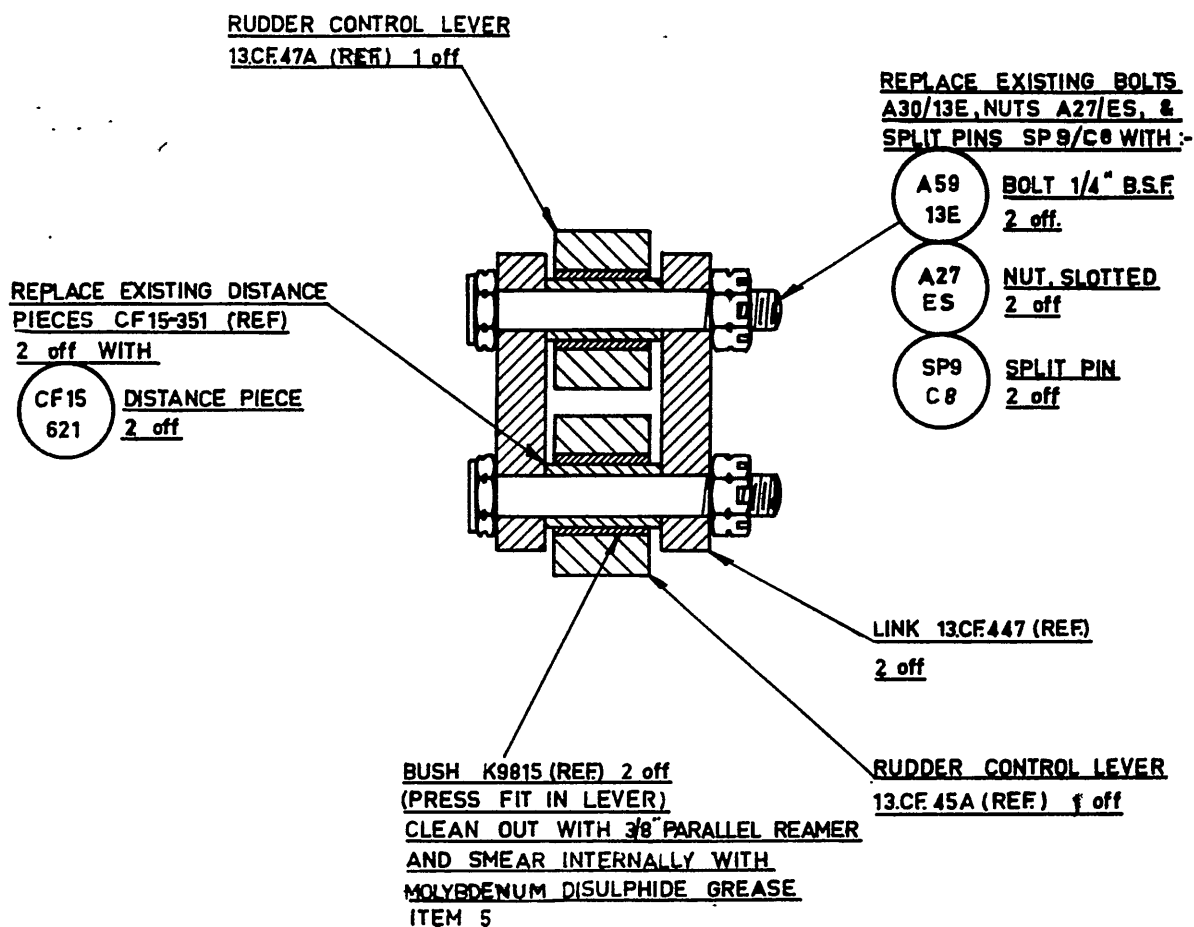
SECTION THROUGH RUDDER PEDAL CROSS TUBE LINKS

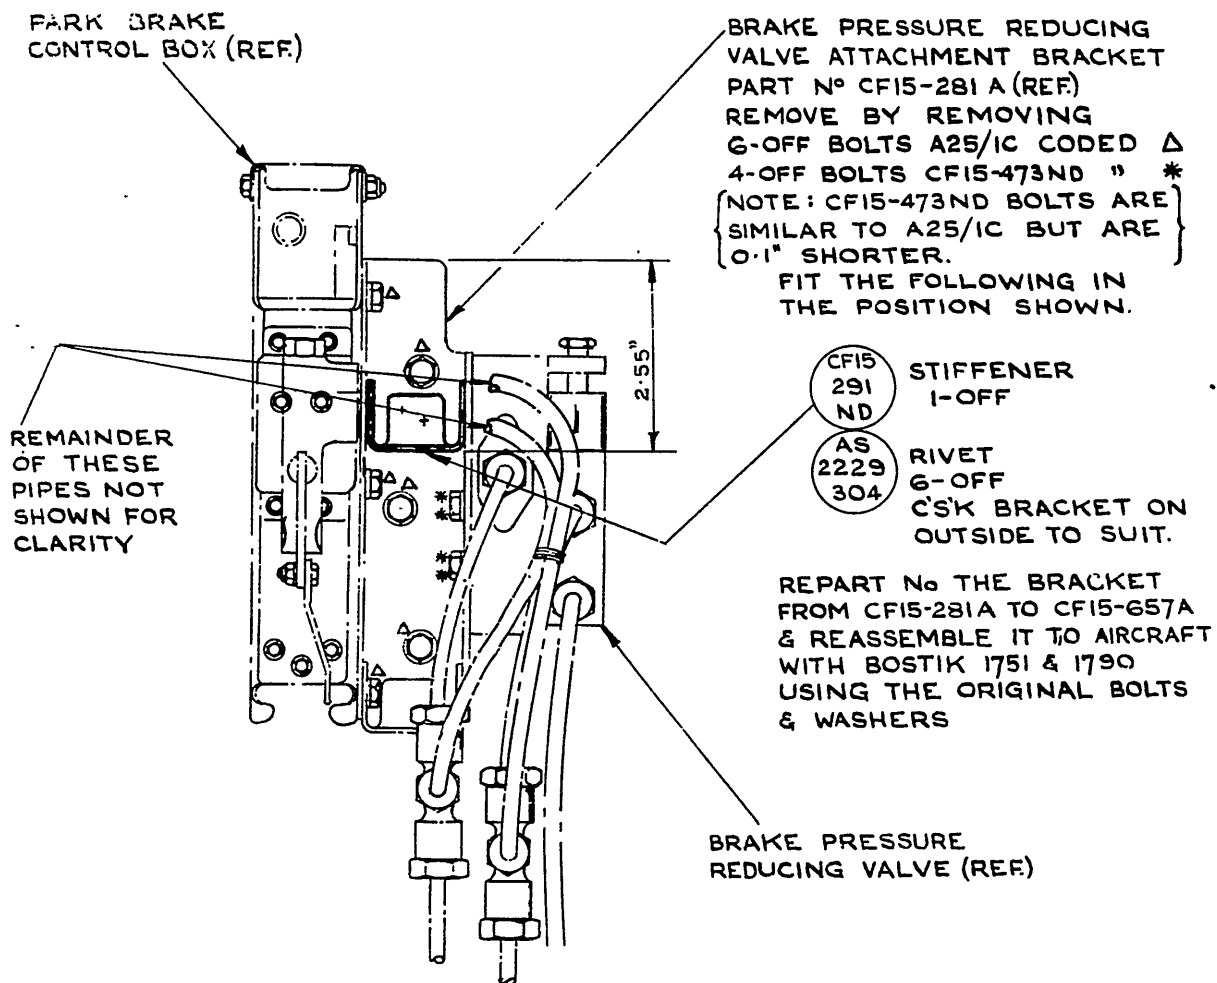
VIEW ON PORT SIDE OF BULKHEAD N° 1

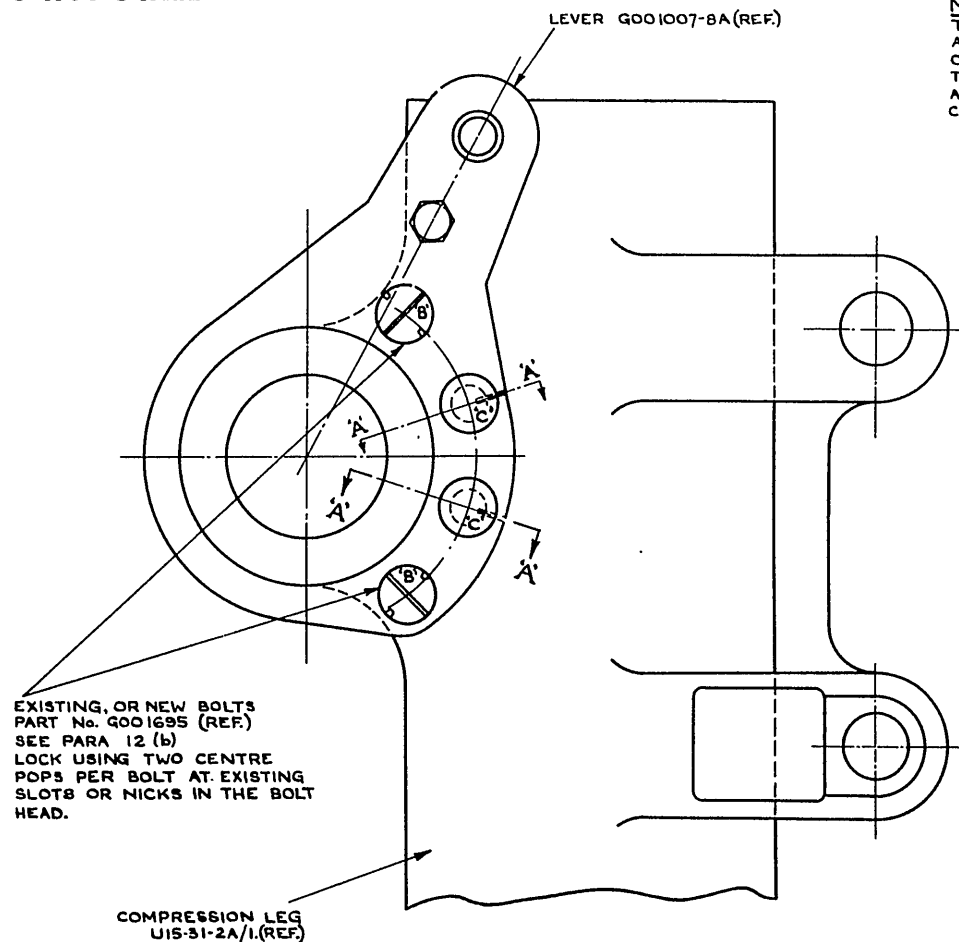
NOTE 1
THE LEVER 0001007A16
ASSEMBLED TO THE
COMPRESSION LEG U15-32A/1
THE LEVER 0001008A16
ASSEMBLED TO THE
COMPRESSION LEG U15-31A/1

REMOVE THE TWO BOLTS 'C'
PT. No. 0001695, WHICH ARE
TO BE DISCARDED OR RETURNED
TO STORES IN ACCORDANCE
WITH PARA 12 (b).
ENSURE THAT THE TWO BOLTS
'B' PT. No. 0001695 ARE FULLY
TIGHTENED, THEN OPEN OUT
THE BOLT HOLES 'C' .90" DEEP
WITH A LETTER 'R' DRILL.
REAM OUT TO .8432 DIA
FIT U15 DOWEL
113 2-OFF PER LEG.

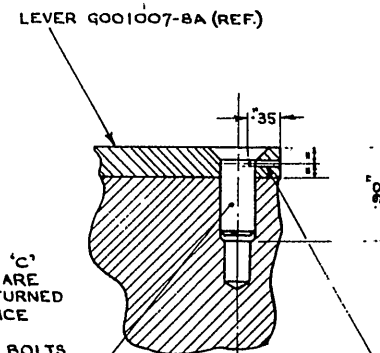
SECTION 'A-A'

DRILL THIS HOLE
No. 50 X .35" DEEP
AND OPEN OUT WITH
A No. 42 DRILL.
FIT U15 LOCK PIN
111 2-OFF PER LEG
ND AFTER FITMENT OF
DOWELS.

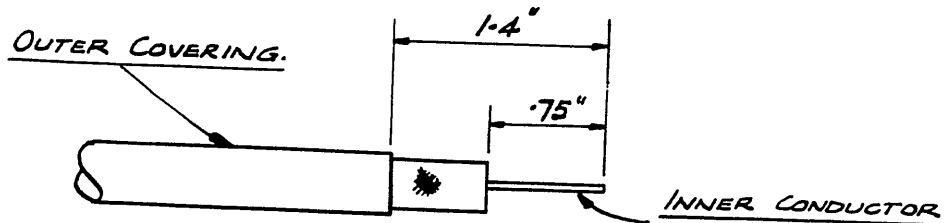
CABLE END DETAIL.

APPLICABLE TO ALL WING TANK UNIT CONNECTORS
IDENT. NOS. 2915-016-5041 & 2915-016-5043.

AFTER BARING BACK AS SHOWN, ASSEMBLE THE END
FITTING & FLEXIBLE GUARD AS SUPPLIED LOOSE WITH
EACH CONNECTOR.

Note: Do not cut back any of the conductor as the connector has been manufactured to the correct capacitance value allowing for the additional fitting to be soldered on in situ. However in the case where a bared end has been damaged a small length (no more than 1.5") of conductor could be trimmed off without greatly upsetting the capacitance tolerance of the connector as they have been cut nearer the top tolerance for this reason. When soldering the fittings to the co-axial cables care must be taken to prevent excess heat being applied to the polythene insulation of the cable. After finalising the end fittings, connect them to the junction box in each wheel well.

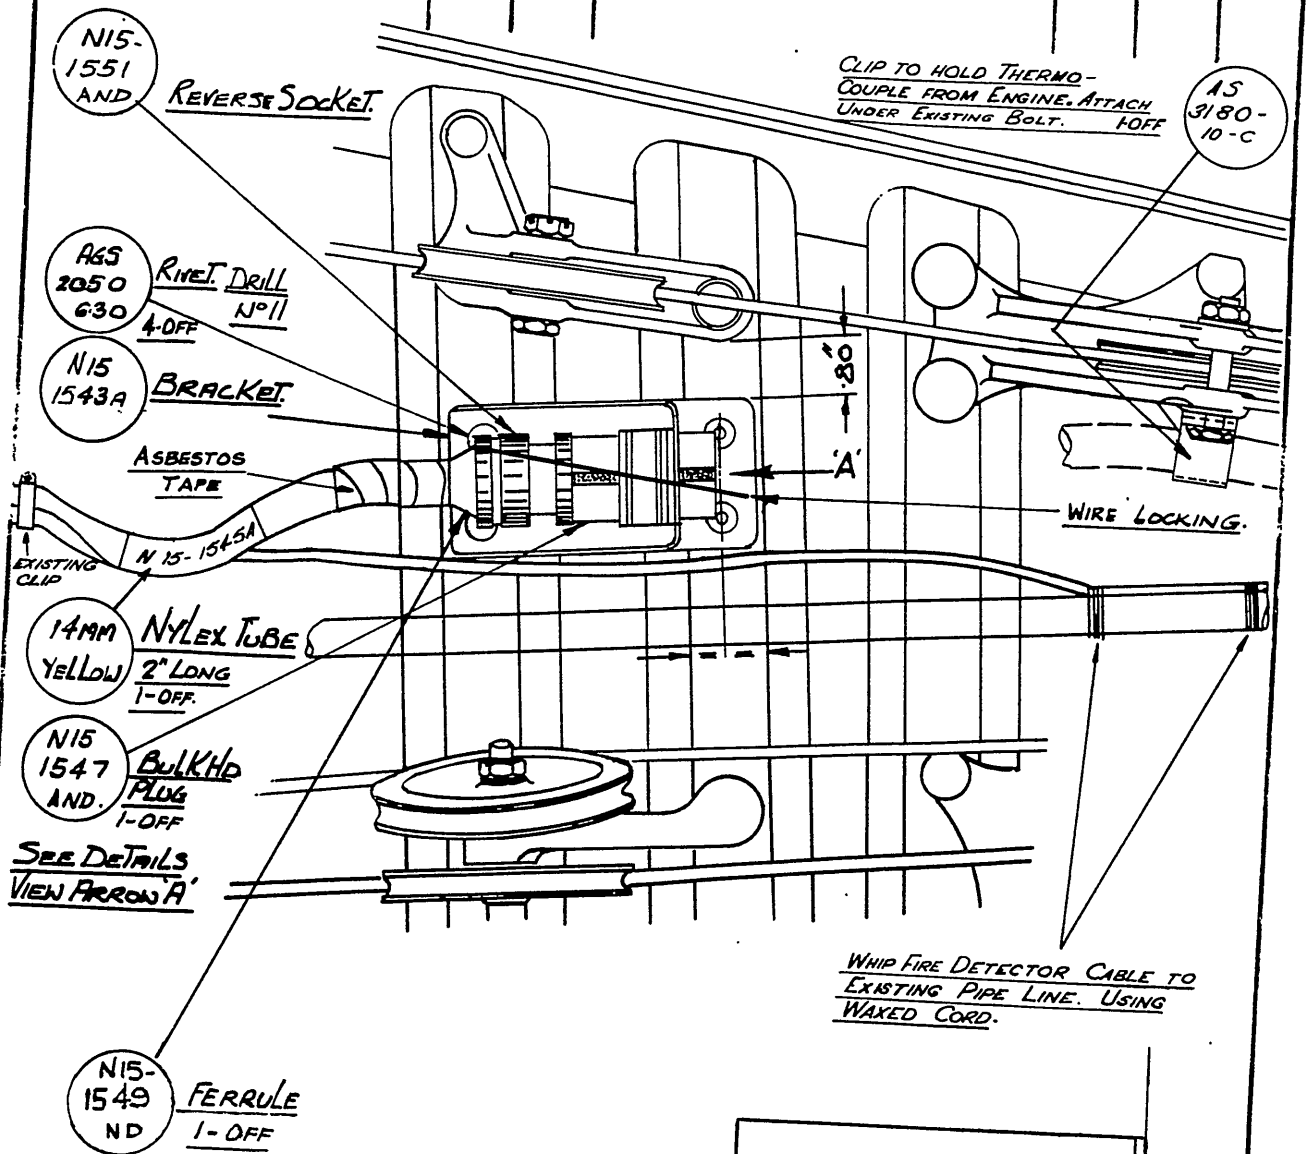
HANKER DE HAVILLAND DRG COM1380 SH. 1 of 2.

SEE DETAILS
VIEW ARROW 'A'

NOTE: REVERSE SIDE OF PLUG
IS IDENTIFIED BY A LETTER 'A'
STAMPED ON CENTRE Moulding
BETWEEN PINS 1 & 4

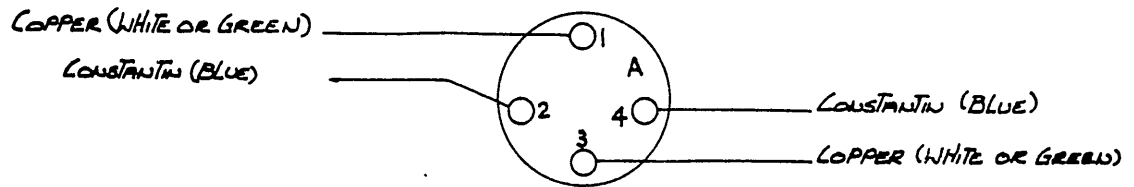
WIRING DETAILS FOR SOCKET

- NOTE:
1. BLUE WIRES (CONSTANTIN) MUST BE SOLDERED TO BLUE-BANDED PINS (ALUMEL)
 2. WHITE OR GREEN WIRES (COPPER) MUST BE SOLDERED TO RED-BANDED PINS (CHROMEL)
 3. RESIN-CORED SOLDER TO B.S.441 TO BE USED.
 4. SLIDE NYLEX SLEEVE OVER SOLDERED JOINT.

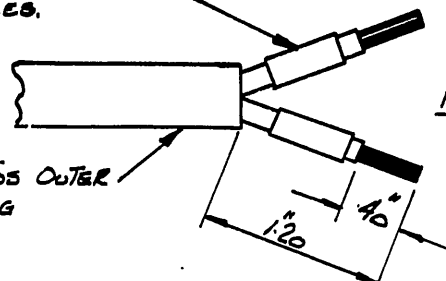
PREPARATION OF CABLE ENDS
FOR SOLDERING

CABLE STRIPPING DETAIL

NOTE: IT SHOULD NOT BE NECESSARY
TO STRIP BACK OUTER ASBESTOS
COVERING. NO MORE THAN 1 1/2"
OF WIRE IS TO BE REMOVED.

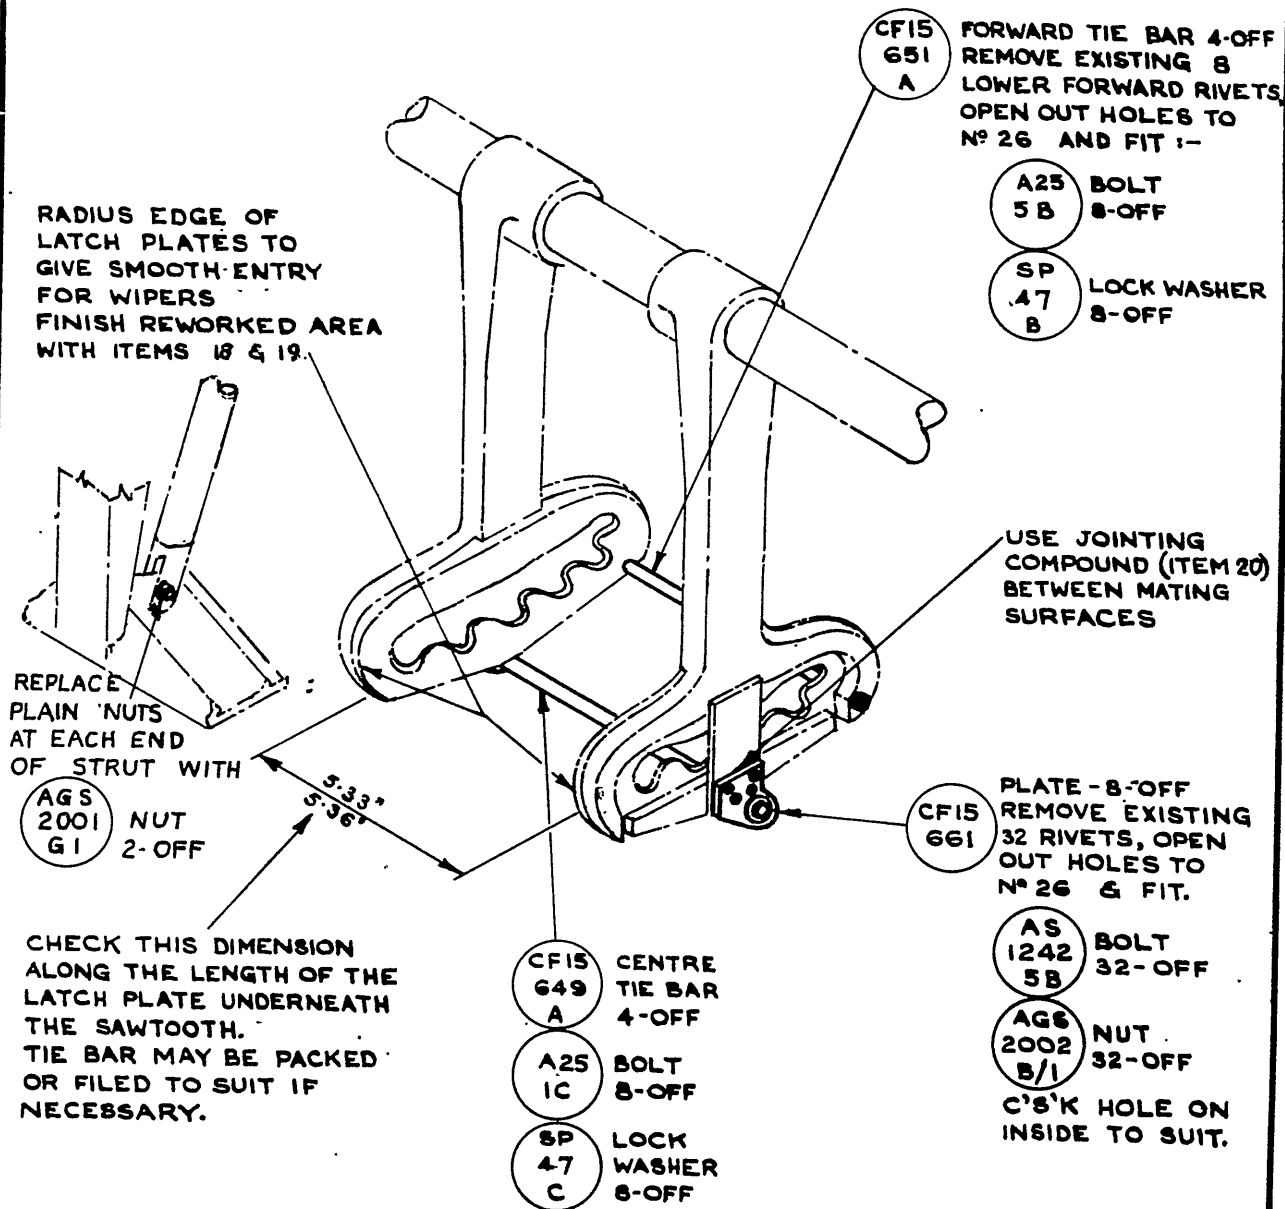
DE HAVILLAND DRAWING N° OOM1381 SHEET 1 OF 2

VIEW ON RUDDER PEDAL LATCH PLATES

- (k) The following operations (l) to (t) to be carried out on each rudder pedal assembly.
- (l) Remove the brake push rod, retaining the attaching items, but discarding the split pin. Refer to Sheet 2 of the drawing and replace the lower csk bolts, nuts and washers with csk bolts and nuts AS1242/1C and A27CT (2 off each). Peen to lock.

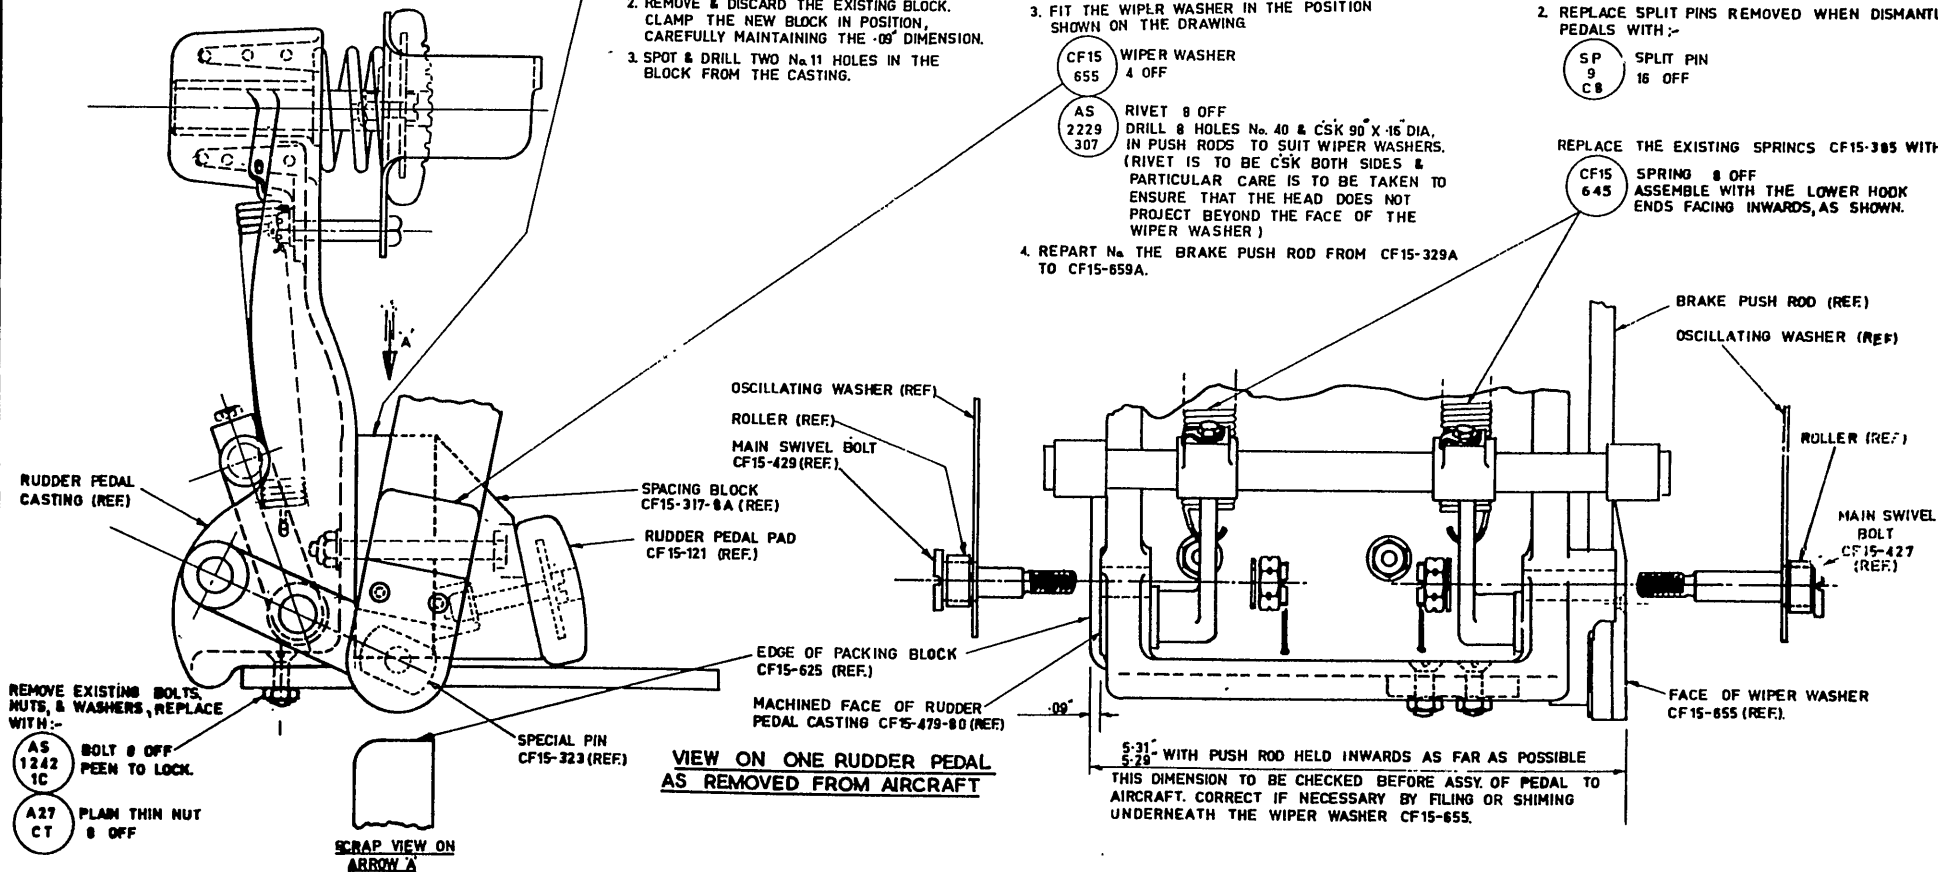
DE HAVILLAND DRAWING No. 00M1381 SHEET 2 OF 2

REPLACE THE EXISTING SPRINGS CF15-305 WITH:-

CF15 SPRING 8 OFF
645 ASSEMBLE WITH THE LOWER HOOK
ENDS FACING INWARDS, AS SHOWN.

- (s) Remove and discard the existing springs Part No CF15-385 and replace them with new springs Part No CF15-645. The lower end of the springs should be assembled with the hooks pointing inwards to prevent them from catching on the main swivel bolts.
- (t) Assemble the push rod to the rudder pedal and the rudder pedal to the aircraft, using items retained from operations (d) and (1) and split pins (item 15).

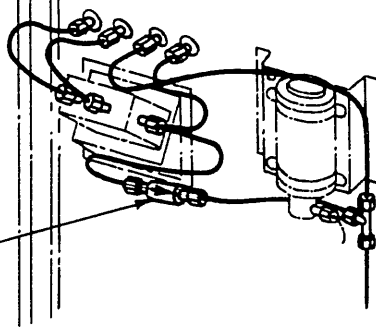
UMC703 NON RETURN
VALVE (I-OFF)
REMOVE, MODIFY TO
PARA'S 12 (d) & (e), &
REPLACE WITH ARROW
IN DIRECTION SHOWN

VIEW ON F'W'D FACE OF BULKHEAD N° 1
SHOWING WINDSCREEN WIPER SELECTOR VALVE
(POST MOD. 325 ONLY.)

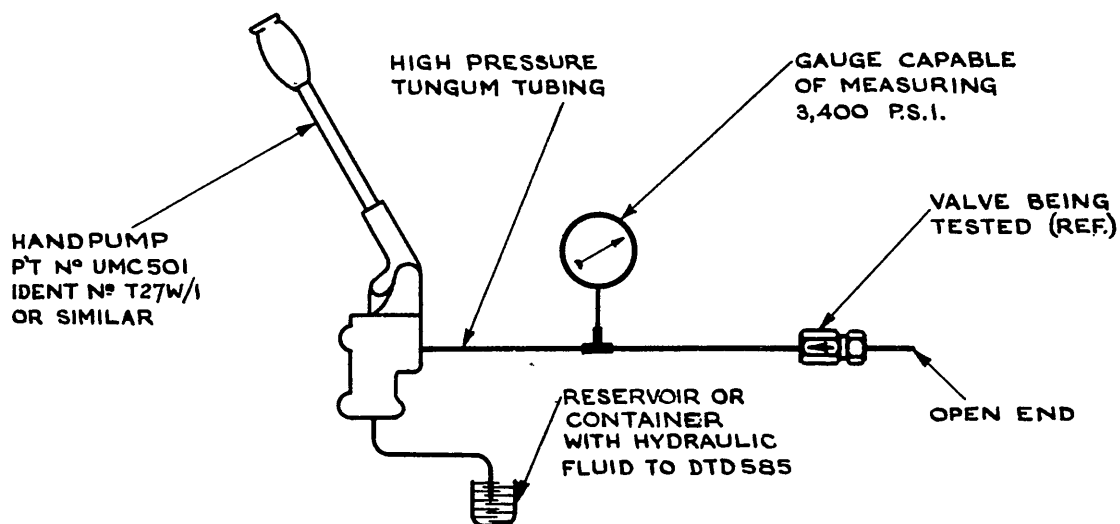
HAWKER DE HAVILLAND DRAWING N° 1382 SHEET 1 OF 3 SHEETS

DIAGRAMMATIC SKETCH OF HYDRAULIC TEST RIG
REQUIRED FOR TESTING VALVES

Apply 3,400 psi fluid pressure at the outlet connection for a minimum period of 2 minutes. There must be no leakage externally or through the open inlet connection.

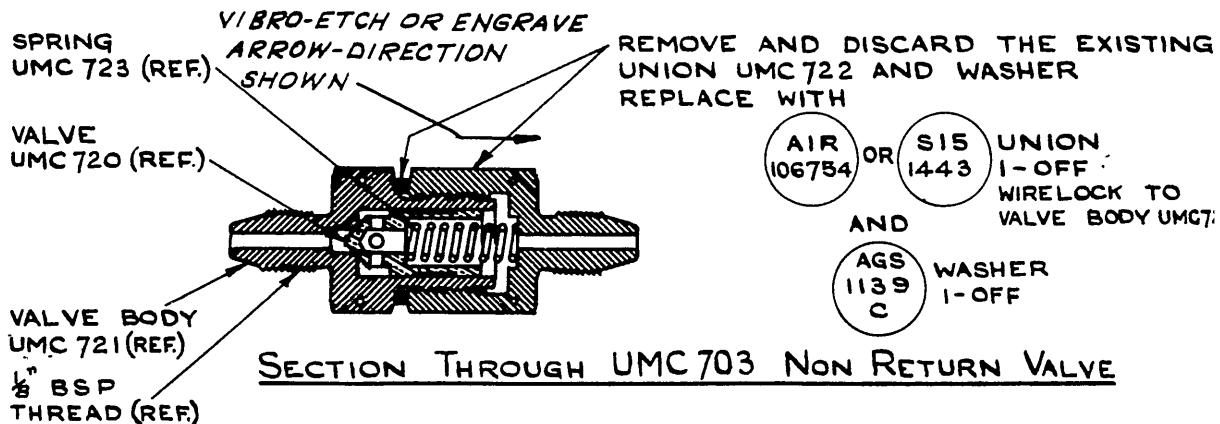
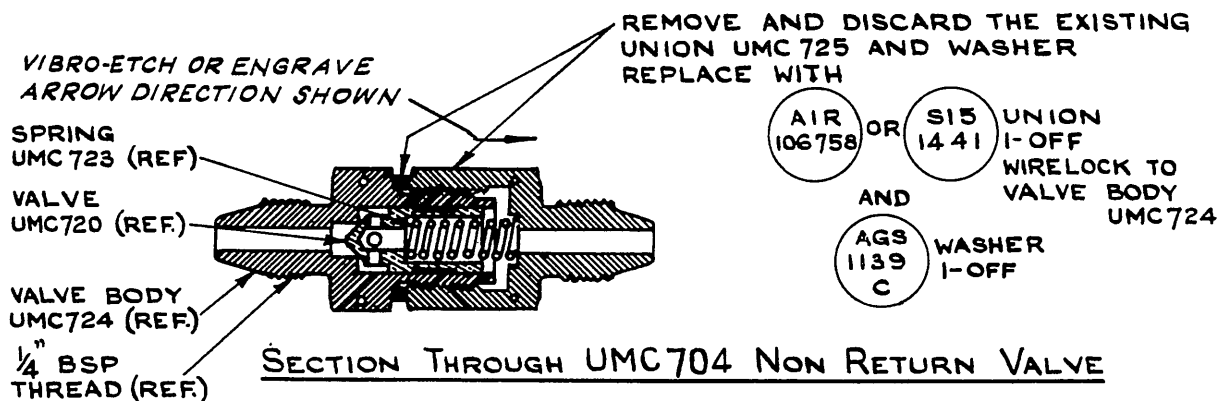
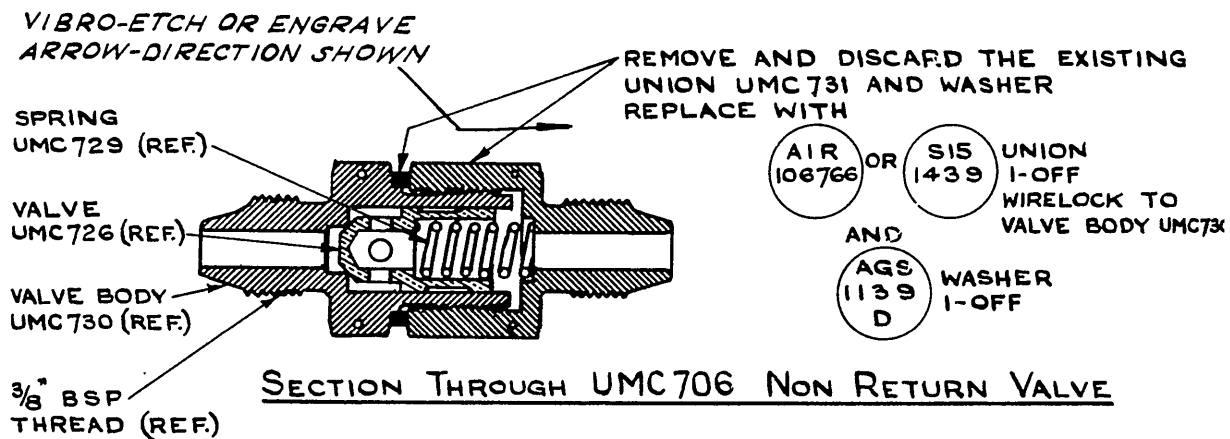
HAWKER DE HAVILLAND DRAWING No 00M1382 SHEET 3 OF 3 SHEETS

NOTE! ALL THE ABOVE VALVES TO BE RE PART No.'D TO PARA 12 (d)
AND INDIVIDUALLY TESTED TO PARA 12 (e)

Note: Leakage past the valve element (see Sheet 3 of the drawing) will necessitate dismantling and re-seating or renewing the valve element. The valve spring may also require renewal.

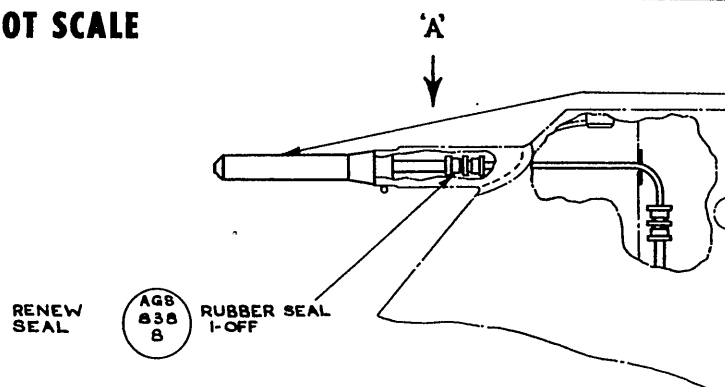
REPLACE EXISTING MK. 8T PITOT/STATIC HEAD WITH:-

6610 PN-G3 150-27 AVIMO PITOT HEAD 1-OFF
FIT SLEEVE AS SHOWN ON —VIEW ON ARROW 'A'—
CUT BOTH ELECTRICAL CABLES 1 FT. LONG, COVER WITH 5MM NYLEX TUBING AND CONNECT TO EXISTING TERMINAL BLOCK.

- (c) Replace the pitot head and remove portion of the existing static line as shown on the attached drawing.
- (d) Connect the electrical cables from the new pitot head to the existing terminal block on the fin.
- (e) Test the pitot pressure system in accordance with AAP 750:0 Volume 2, Part 1, Instrument Instruction No 0/0/4.
- (f) Replace the port rear fairing, rudder and the rear inspection panel on the port boom in accordance with current authorised procedure.

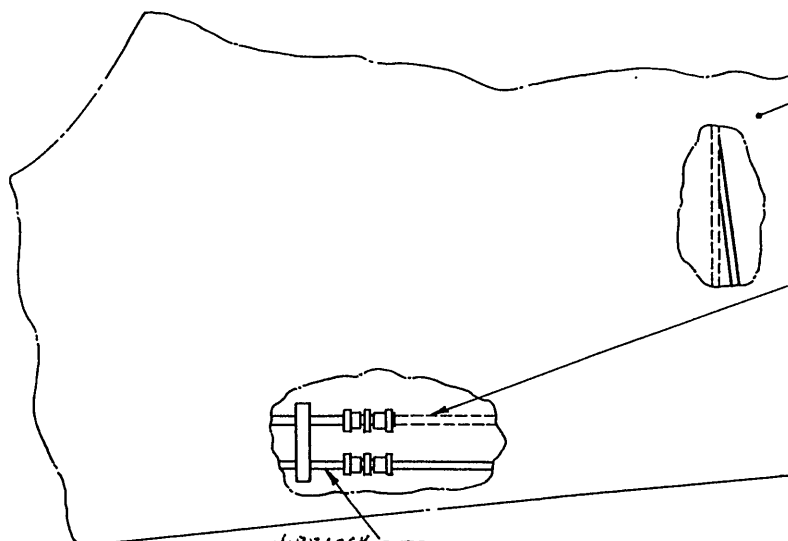
VIEW ON ARROW 'A' SHOWING
RELATIVE POSITION OF SCREW HOLDING
SLEEVE ON TO PITOT HEAD.

REMOVE REDUNDANT STATIC PIPES (SHOWN DOTTED) BETWEEN THIS POINT AND THE PRESSURE HEAD. SALVAGE. ONE AGS. 904/BB UNION NUT FROM THESE PIPES AND DISCARD REMAINDER. BLANK OFF REMAINING REDUNDANT STATIC LINE WITH THE SALVAGED NUT AND :-

AGS 1159 BB OR AGS 1236 BB SP 9 CB
CONE CAP 1-OFF SPLIT PIN 1-OFF
WIRE LOCK WITH ITEM 8.

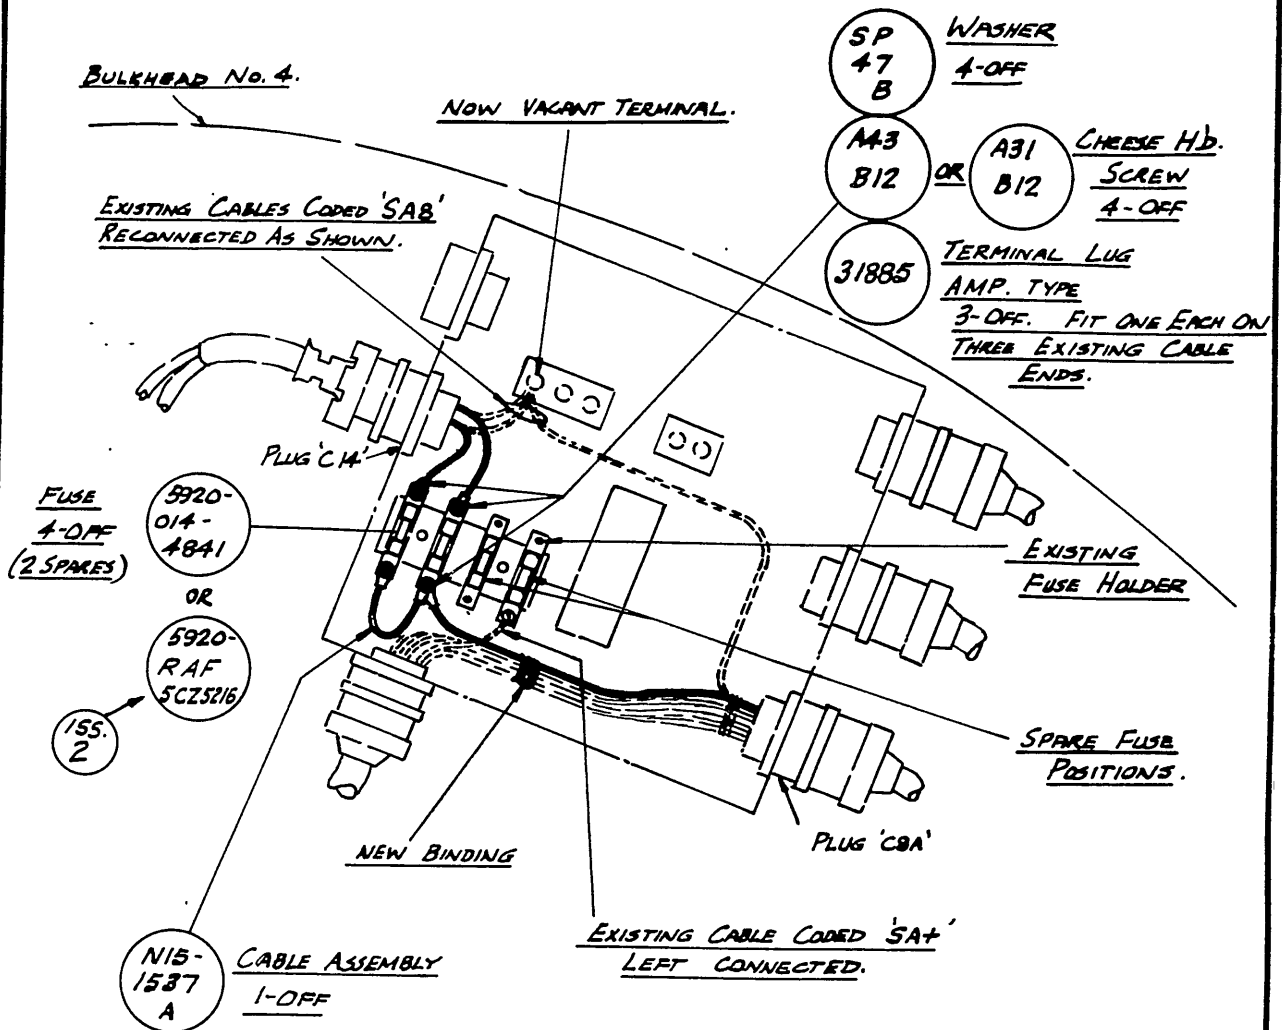
MODIFICATION TO JUNCTION BOX No. 2

AFTER MODIFICATION IS CARRIED OUT REPART NUMBER THE BOX TO N15-155A/4.

- (d) Locate plugs "C14" and "C8A" on the box and observe that one cable coded "SA8" from pin "F" of plug "C8A" and two cables coded "SA8" from pins "P" and "K" of plug "C14" meet at a terminal block.
- (e) Remove terminal block cover and disconnect the three cables. Replace terminal block cover.
- (f) Using items 1, 2, 3, 4 and 5, fit fuses and modify the junction box wiring as shown in attached drawing. After re-routing the cable "SA8" from plug "C8A" to the new fuse position, secure with existing cables using item 6 treated with item 7.
- (g) Refit the junction box lid and repart number the box "N15-155A-4". Reconnect plugs to RP relay and resistance box.
- (h) Refit the engine cowls and reconnect batteries.
