Australian Air Publication **721.79**

VAMPIRE MODIFICATIONS

(Nos 301 to 400)

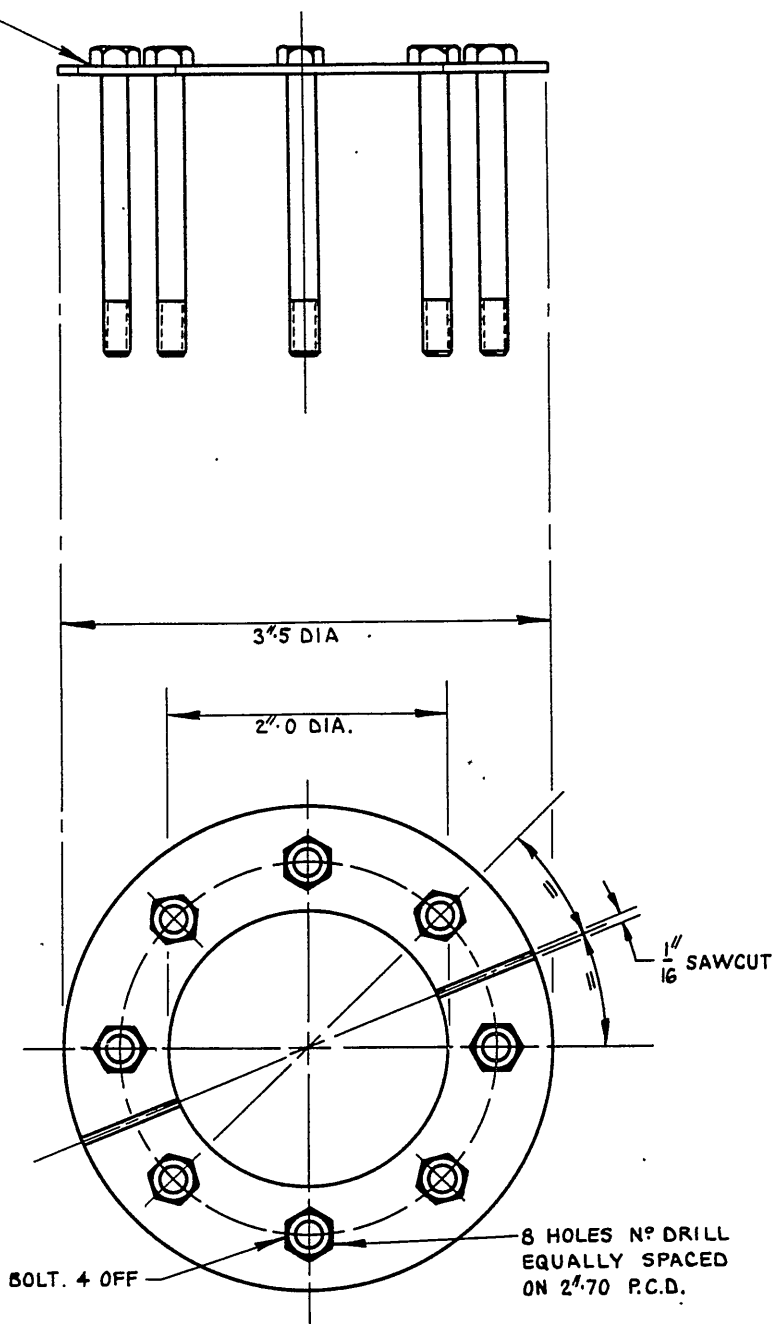
SILVER BRAZE
(C.I.G. ROD N° 245
C.I.G. FLUX N° 3

PLATE MAY BE MADE IN
ONE PIECE AND CUT
IN HALVES TO MAKE
2 OFF

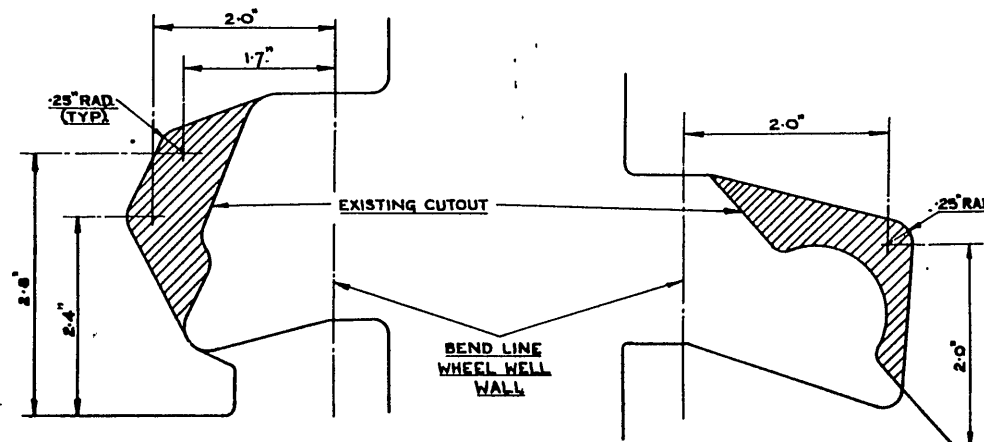
DETAIL 'A'

REMOVE THE SHADED PORTION. REFER TO PARAGRAPH 12 (e).

ADJUST THE GREASE NIPPLE TO BE AS FAR FROM THE WHEEL WELL WALL AS POSSIBLE.

TRUE VIEW ON F'W'D CUTOUT IN WHEEL WELL-REMOVE SHADED PORTION.

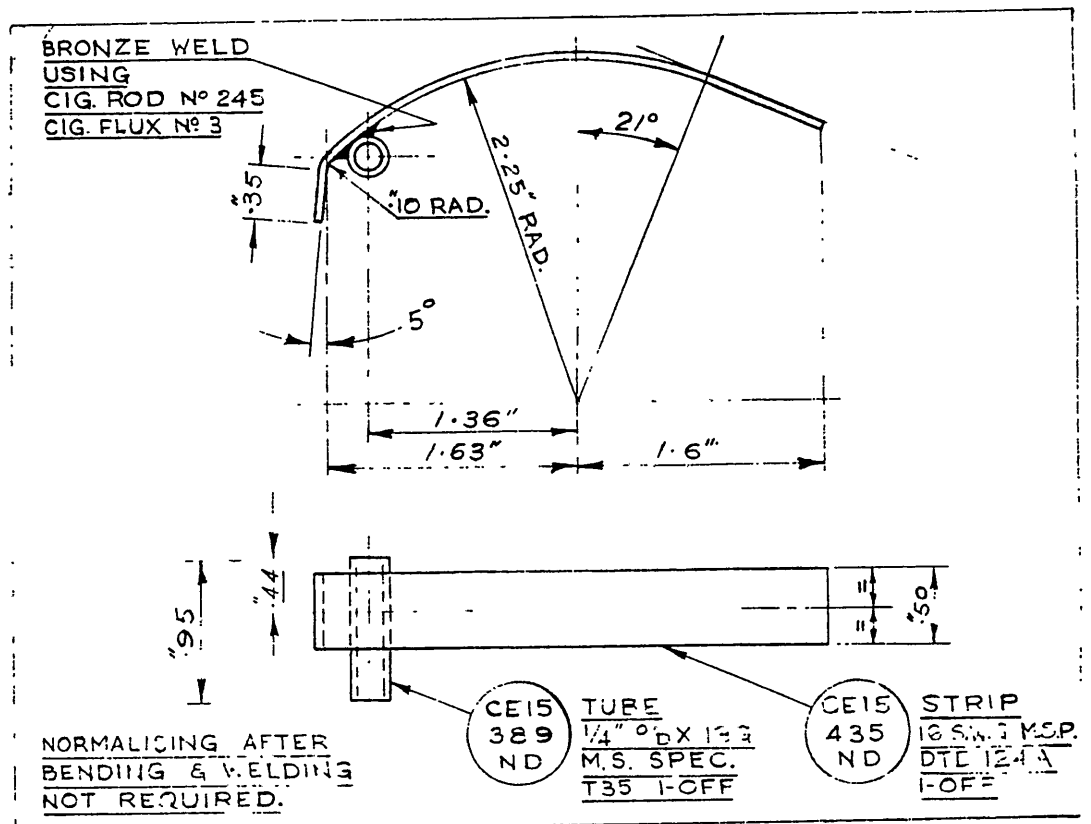
TO BE USED TO CARRY OUT DRILLING OPERATION
FOR ADDITION GREASE NIPPLE - MAIN U/C RADIUS ROD
DRG. A-15167 REFERS

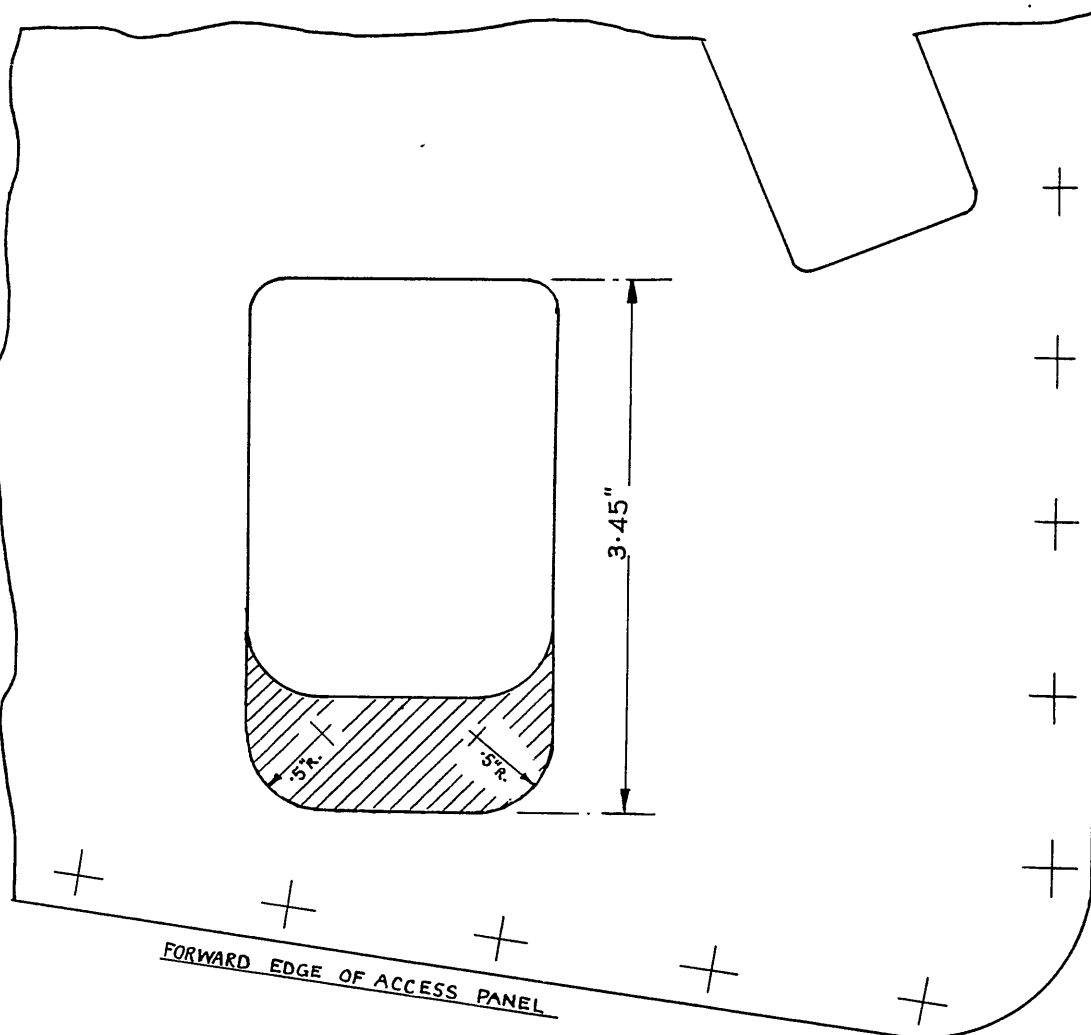
REMOVE SECTION SHOWN SHADED

ACCESS PANEL D004933-4ND (D004925-6)

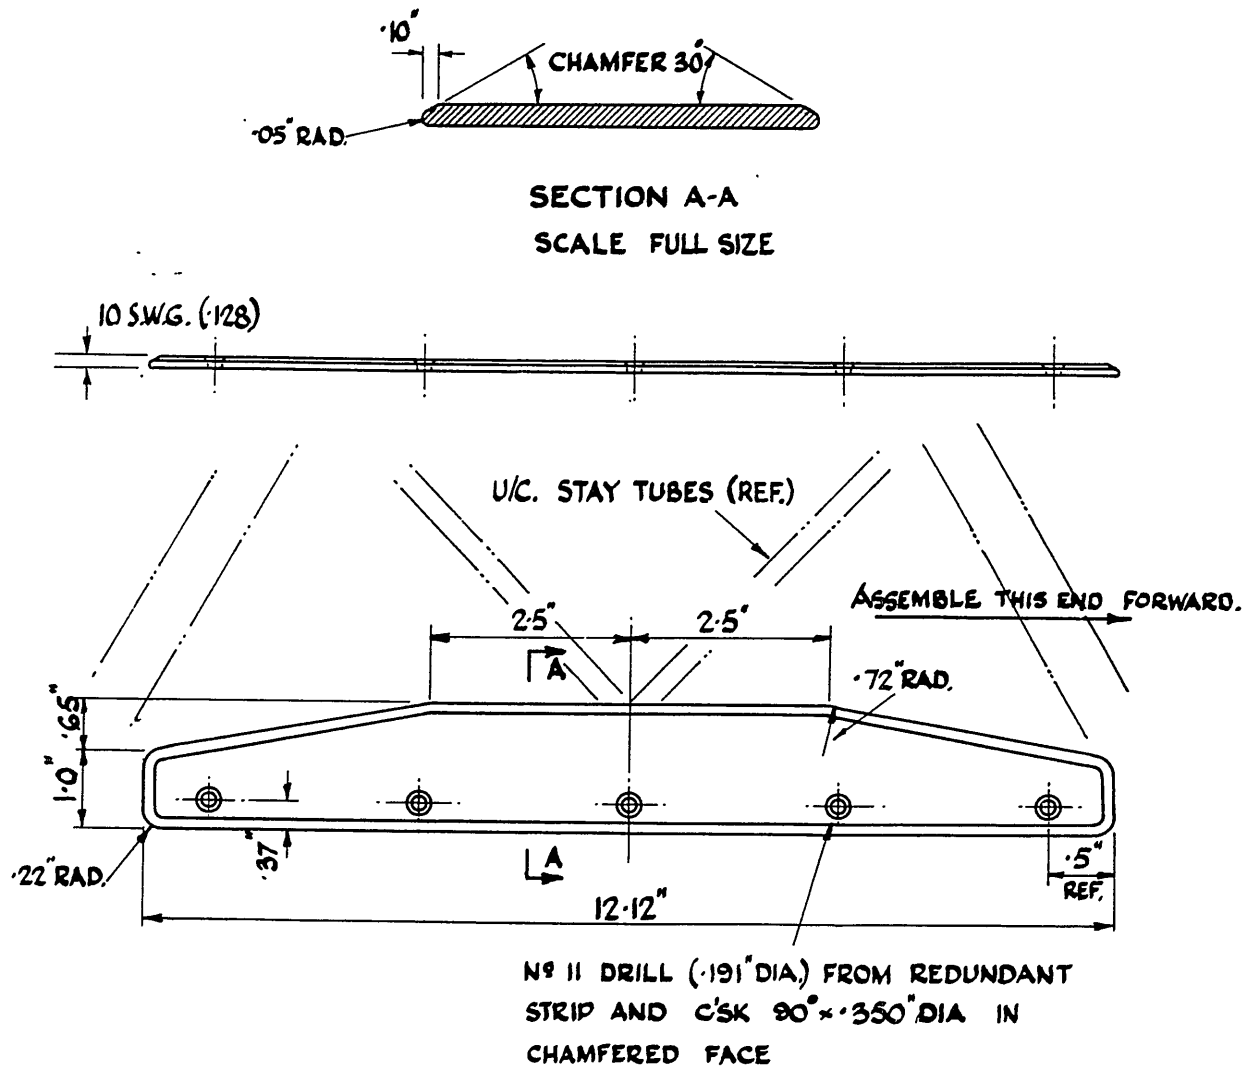
L.H. DRAWN R.H. SIMILAR

PART Nº STRIPS U15-119 L.H.
U15-120 R.H.
