Australian Air Publication 721.79

Volume 2, Part 2  
Book 5

# VAMPIRE MODIFICATIONS

(Nos 401 to 500)

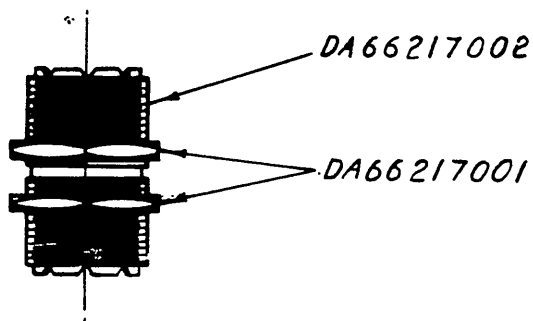
MODIFICATION NUMBER <b>VAMPIRE MOD 451</b>	DRAWING NUMBER <b>DA66217000</b>

<b>DEPARTMENT OF AIR</b> ISSUED BY <b>SENIOR TECHNICAL STAFF OFFICER</b> <b>SUPPORT COMMAND</b>			TITLE <b>PACITOR FUEL GAUGE SYSTEM</b> <b>INTRODUCTION OF CONNECTOR</b> <b>LOCK NUTS</b>	
DRAWN <b>H. WOLFE</b>	CHECKED

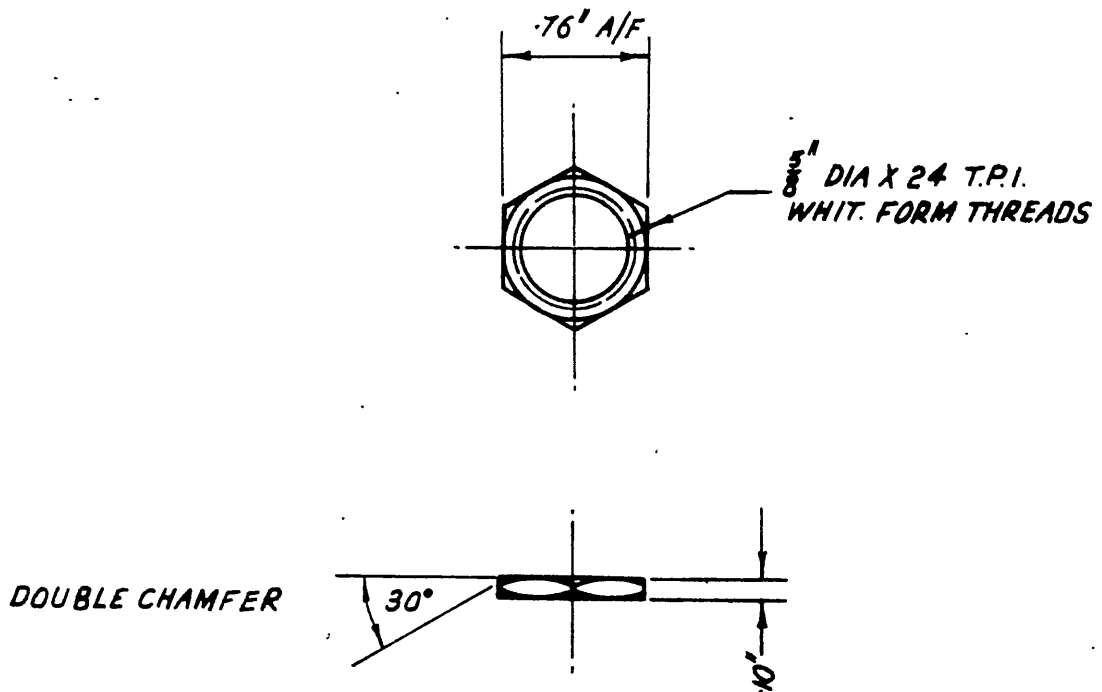
MODIFICATION NUMBER <b>VAMPIRE MOD 451</b>	DRAWING NUMBER <b>DA 66217001</b>

MATERIAL :- BRASS HEX. TO B.S.B. 11(E) D703 IDENT. 11/8035  
 ALTERNATIVE :- B.S. 251 AS H3 IDENT. 11/817  
FINISH :- CAD. PLATE TO D.T.D. 904 C

<b>DEPARTMENT OF AIR</b> ISSUED BY <b>SENIOR TECHNICAL STAFF OFFICER</b> <b>SUPPORT COMMAND</b>			TITLE  <b>LOCK NUT</b>	
DRAWN <b>H WOLFE</b>	CHECKED

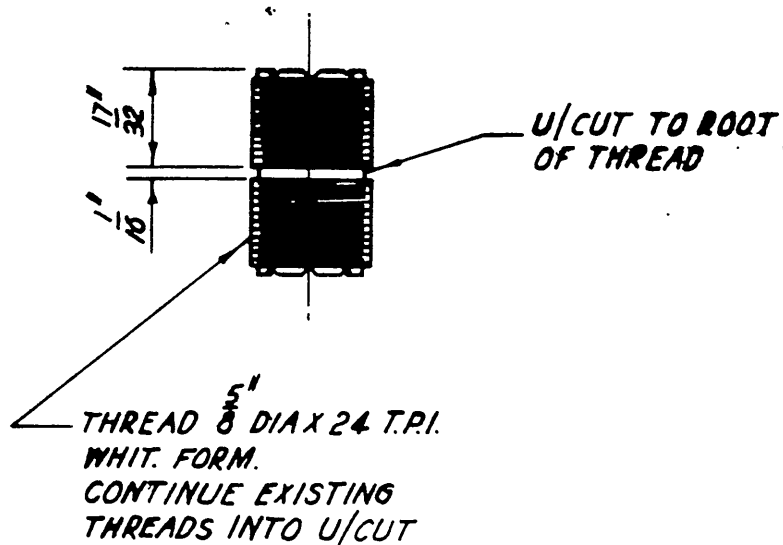
MODIFY CONNECTOR IDENT. NO. 5935 -PN-C32-14

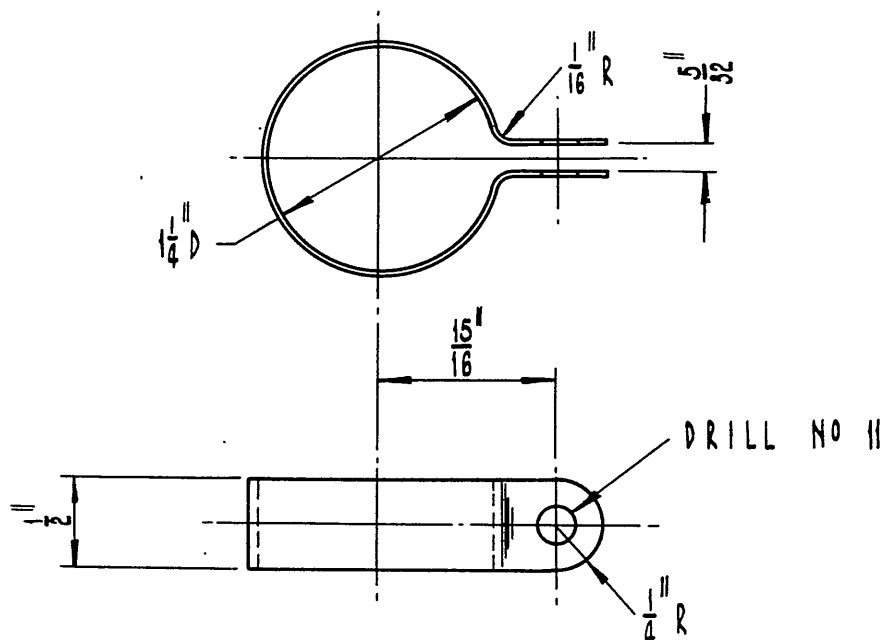
<b>DEPARTMENT OF AIR</b> ISSUED BY SENIOR TECHNICAL STAFF OFFICER SUPPORT COMMAND			TITLE FITMENT OF MK35A WINGS TO MK35 AIRCRAFT	
DRAWN L.O.W.	CHECKED <i>Hutchins</i>	APPROVED <i>[Signature]</i>	MODIFICATION NUMBER VAMPIRE NO 449	DRAWING NUMBER DA66190000

DETAIL OF CLIP P00127  
MATL. MSP 20 SWG SPEC 83  
FINISH. CADMIUM PLATE  
 1 COAT OF ZINC CHROMATE  
 PRIMER  
 2 COATS COCKPIT GREEN  
 LACQUER

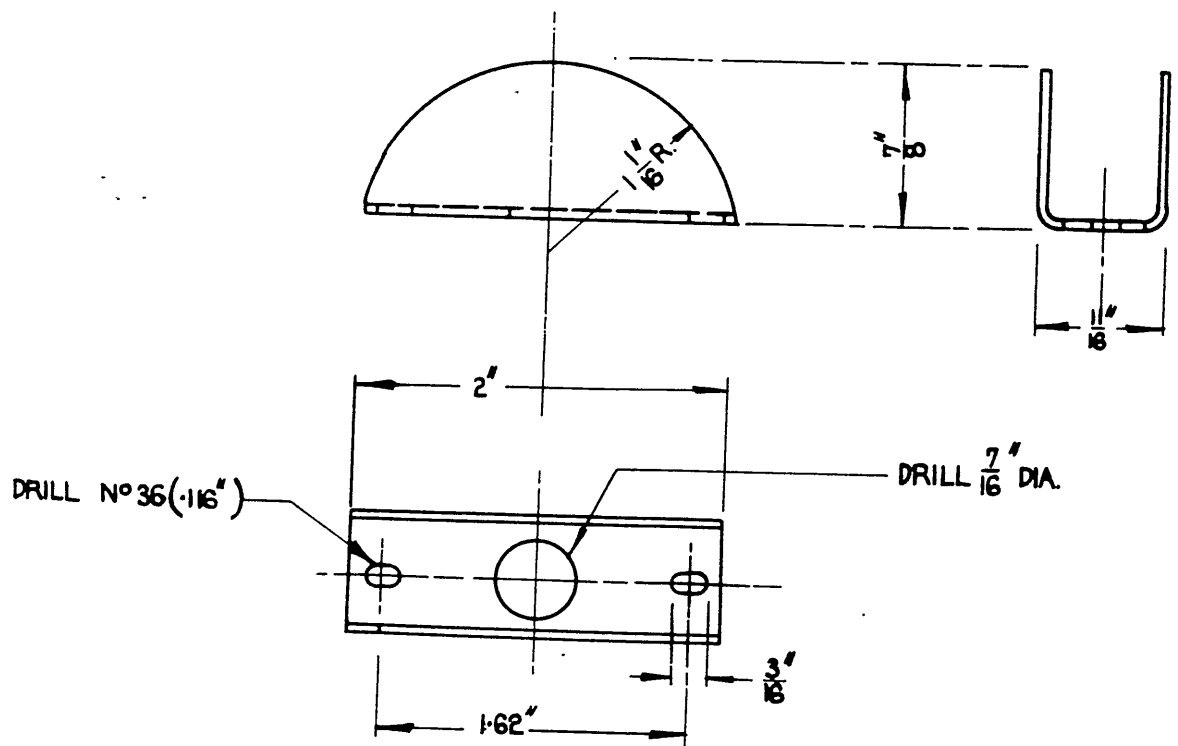
<b>DEPARTMENT OF AIR</b> ISSUED BY <b>SENIOR TECHNICAL STAFF OFFICER</b> <b>SUPPORT COMMAND</b>			TITLE SWITCH GUARD EMERGENCY LIGHT	
DRAWN  	CHECKED <i>[Signature]</i>	APPROVED <i>[Signature]</i>	MODIFICATION NUMBER VAMPIRE MOD 448	DRAWING NUMBER DA66123 000

MATERIAL : .048" ALUM. ALLOY SHEET  
 SPEC : QQ - A - 362 T3  
 FINISH : ZINC CHROMATE. PAINT MATT BLACK.

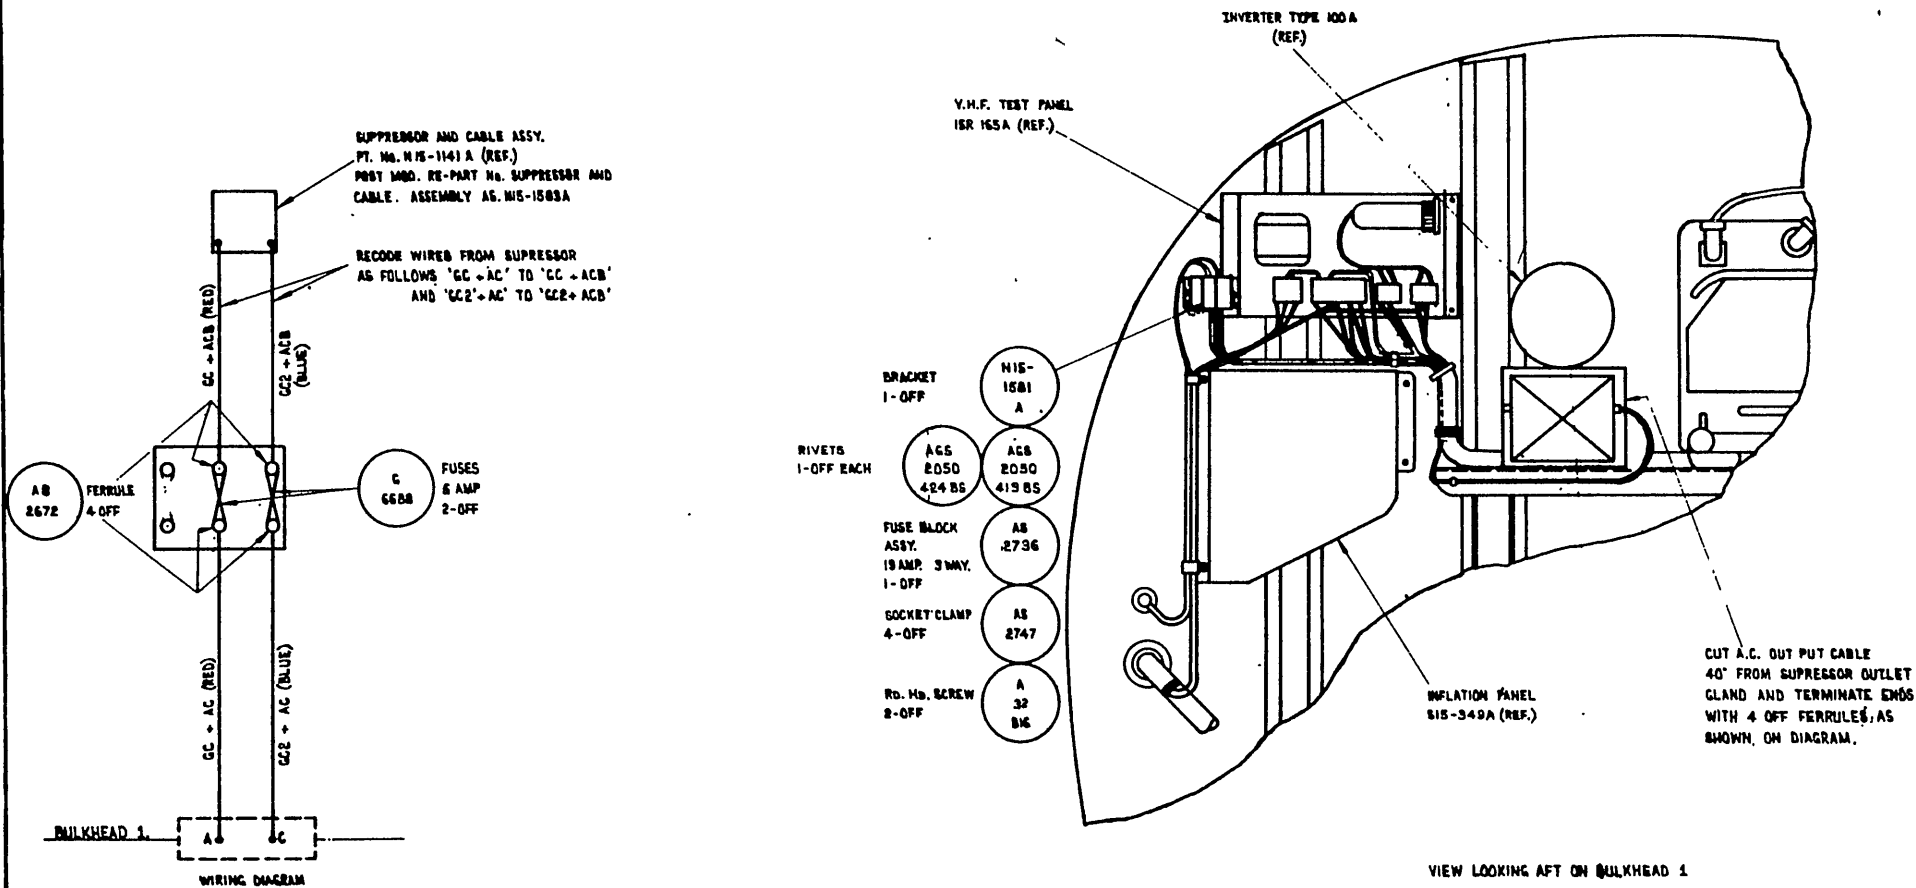
ISSUE NO	DATE	ALTERATION	D.T.L.	INITIALS	APPROVED	REFERENCE	ISSUED BY	TITLE
1	FEB 6			P.L.			DEPARTMENT OF AIR SENIOR TECHNICAL STAFF OFFICER SUPPORT COMMAND	115 VOLT A.C. CIRCUIT PROTECTION
						LIMITS UNLESS STATED	MATERIAL	COMPONENT
						DECIMALS $\pm .010$	SPEC.	MACHINE
						FRACTIONS $\pm \frac{1}{32}$	TREATMENT	ENGINE
						ANGLES $\pm \frac{1}{2}^\circ$	FINISH	TECH. ORDER
						SURFACE FINISH	SCALE	
						AUSTRALIAN STANDARD	DRAWN	DRAWING NO.
						END DIMS. PRACTICE AS 21	TRACED	DA67 40000
							APPROVED	DRWG.
							CHECKER

To eliminate a possible fire hazard arising in the event of a short circuit in the instrument inverter leads.

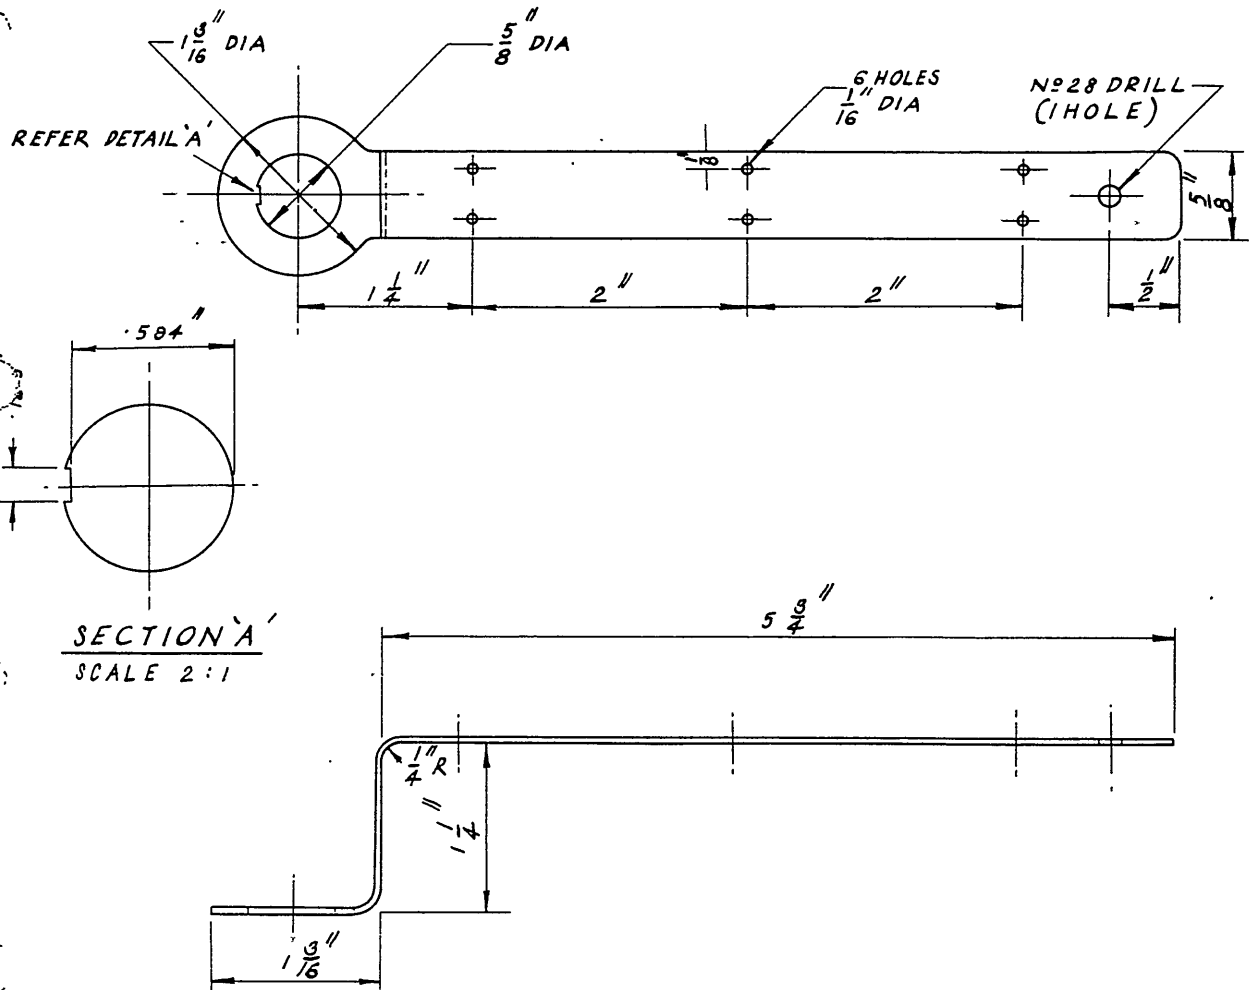
**DO NOT SCALE****THIRD ANGLE PROJECTION**DRAWING NUMBER  
**A 16237-1**

RADIUS ALL EDGES & CORNERS

ITEM	PART	IDENT	DESCRIPTION	QTY REQ	ZONE
<b>DEPARTMENT OF AIR</b> ISSUED BY SENIOR TECHNICAL STAFF OFFICER SUPPORT COMMAND			REFERENCE 1 DIM'S IN 2 DEF (AUST) - 85 3 DEF (AUST) - 46 4 5	MODIFICATION <b>Nº 442</b> EFFECTIVE ON <b>VAMPIRE</b> COMPONENT OF	
DRAWN <b>J.H.</b> CHECKED DESIGNED <b>H.R.P.</b> APPROVED <i>[Signature]</i> UNLESS STATED DECIMALS $\pm .010$ FRACTIONS $\pm \frac{1}{32}$ ANGLES $\pm 0^\circ 30'$			TREATMENT <b>ZINC CHROMATE</b> MATERIAL <b>036 AL ALLOY SHEET</b>	FINISH <b>MATT BLACK</b> SPECIFICATION <b>BS L 70</b>	
<b>REPOSITIONING OF CENTRE EMERGENCY LIGHT</b>			SCALE <b>1/1</b>	NEXT ASSEMBLY	DRAWING NUMBER <b>A 16237-1</b>
					SIZE <b>A</b>

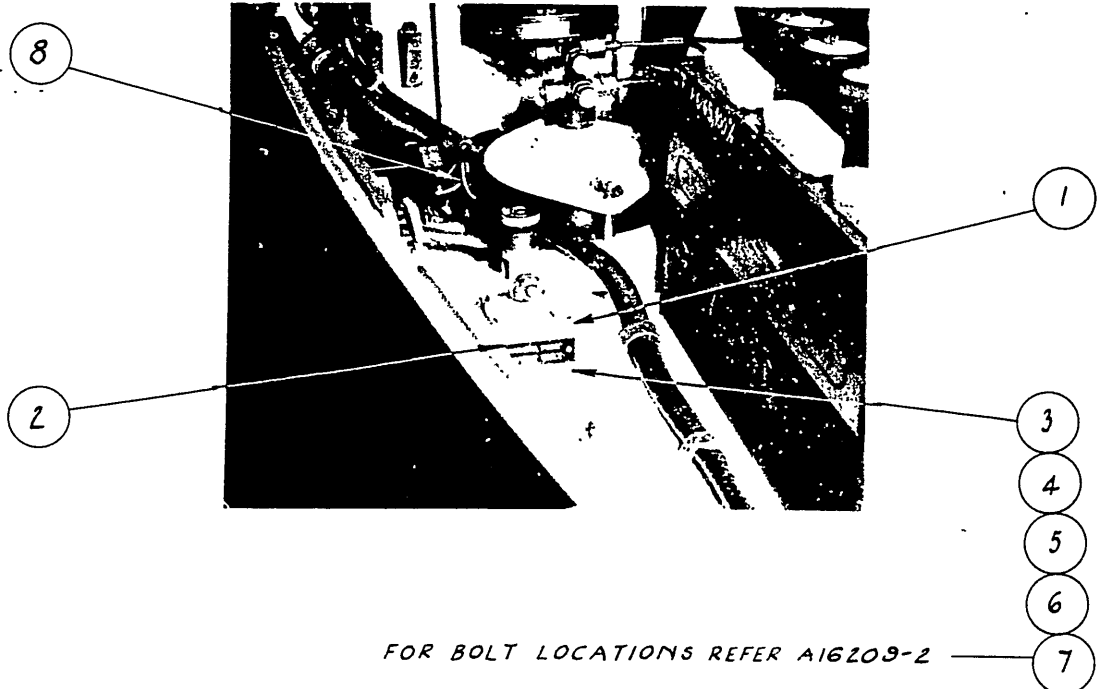
**DO NOT SCALE****THIRD ANGLE PROJECTION**DRAWING NUMBER  
**A16209**

FOR BOLT LOCATIONS REFER A16209-2

8		7510-014-5770	TAPE AIRCRAFT TUBING IDENT. MARKER	A.R.	
7		5310-PN2001C1	NUTS 2BA NYLOC	4	
6		A79-504297	WASHER 2BA	4	
5	SP13-6	5310-941-9402	WASHER 2BA	4	
4		5306-101-1305	BOLT HEX STEEL 2BA X.95"L	3	
3		5305-RAF2BD12515	BOLT HEX STEEL 2BA X1.45"L	1	
2		7510-014-5780	WARNING SYMBOL	1	
1	A16209-1		BRACKET MOUNTING	1	
ITEM	PART	IDENT	DESCRIPTION	QTY REQ	ZONE

- (g) Fit charging valve to mounting bracket using the four 2BA bolts and the washers retained from the operation at paragraph 12(d).
- (h) Fit pipeline to the charging valve and re-route to the 3 way connector, replace oxygen cylinder, check all connections. Purge and recharge the oxygen system after ensuring there is no oil or grease present.

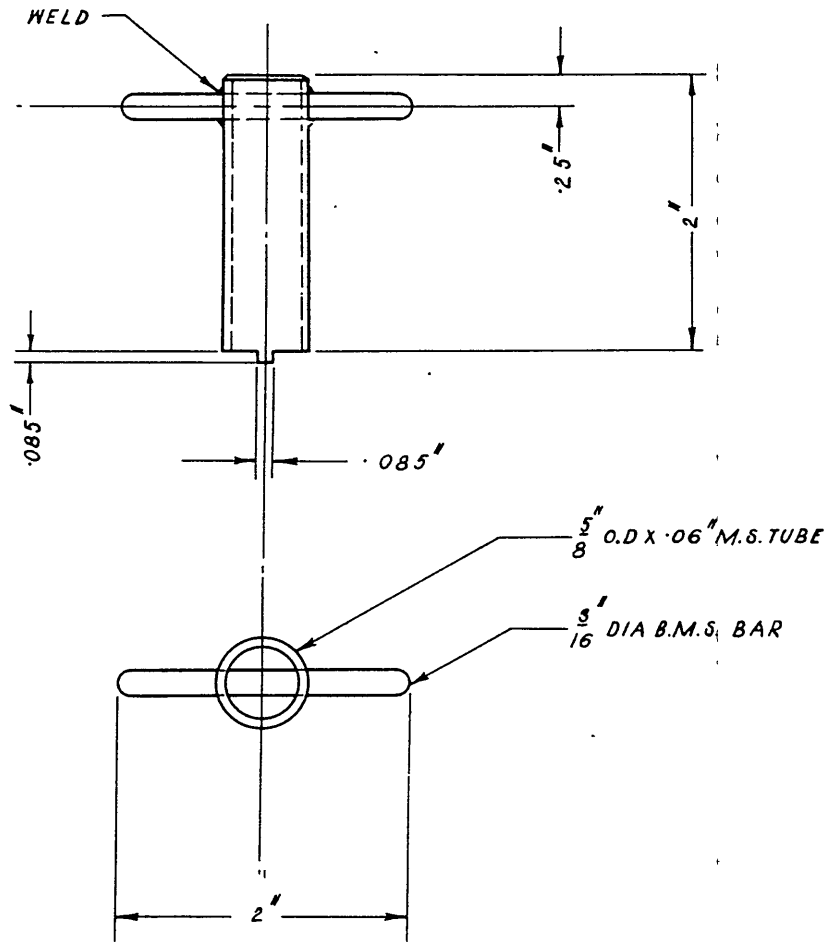
**DO NOT SCALE****THIRD ANGLE PROJECTION**DRAWING NUMBER  
D-15824

ITEM	PART	IDENT	DESCRIPTION	QTY REQ	ZONE
<b>DEPARTMENT OF AIR</b>			REFERENCE	MODIFICATION <i>VAMPIRE 439</i>	
ISSUED BY SENIOR TECHNICAL STAFF OFFICER SUPPORT COMMAND			1 DIM'S IN	EFFECTIVE ON	
DRAWN <i>CASTLE</i>			2 DEF (AUST) - 85	COMPONENT OF	
CHECKED <i>[Signature]</i>			3 DEF (AUST) - 46	TITLE	
TRACED <i>H.R.P.</i>			4	TUBULAR KEY SPANNER	
APPROVED <i>[Signature]</i>			5	(INSTLN. SWITCH MOUNTING RING)	
LIMITS UNLESS STATED			FINISH	SCALE	NEXT ASSEMBLY
DECIMALS $\pm .010$			CAD PLATE	1:1	
FRACTIONS $\pm \frac{1}{32}$			SPECIFICATION	DRAWING NUMBER	SIZE
ANGLES $\pm 0^{\circ}30'$			COMMERCIAL	D-15824	A
TREATMENT			MATERIAL	SECURITY CLASSIFICATION	
CASE HARDEN			NOTED

- (r) Unscrew and remove the top section of the switch (item 1), discard the loose plastic button, locknut and washer. From this top section manufacture the mounting ring in accordance with HQSUPCOM Drawing No D15824.
- (s) Manufacture the "key" in accordance with HQSUPCOM Drawing No D15824.
- (t) Cut a 9/16" hole in the control handle as shown in HQSUPCOM Drawing No A15822/2. Tap this hole using  $\frac{5}{8}$  inch brass thread taps.

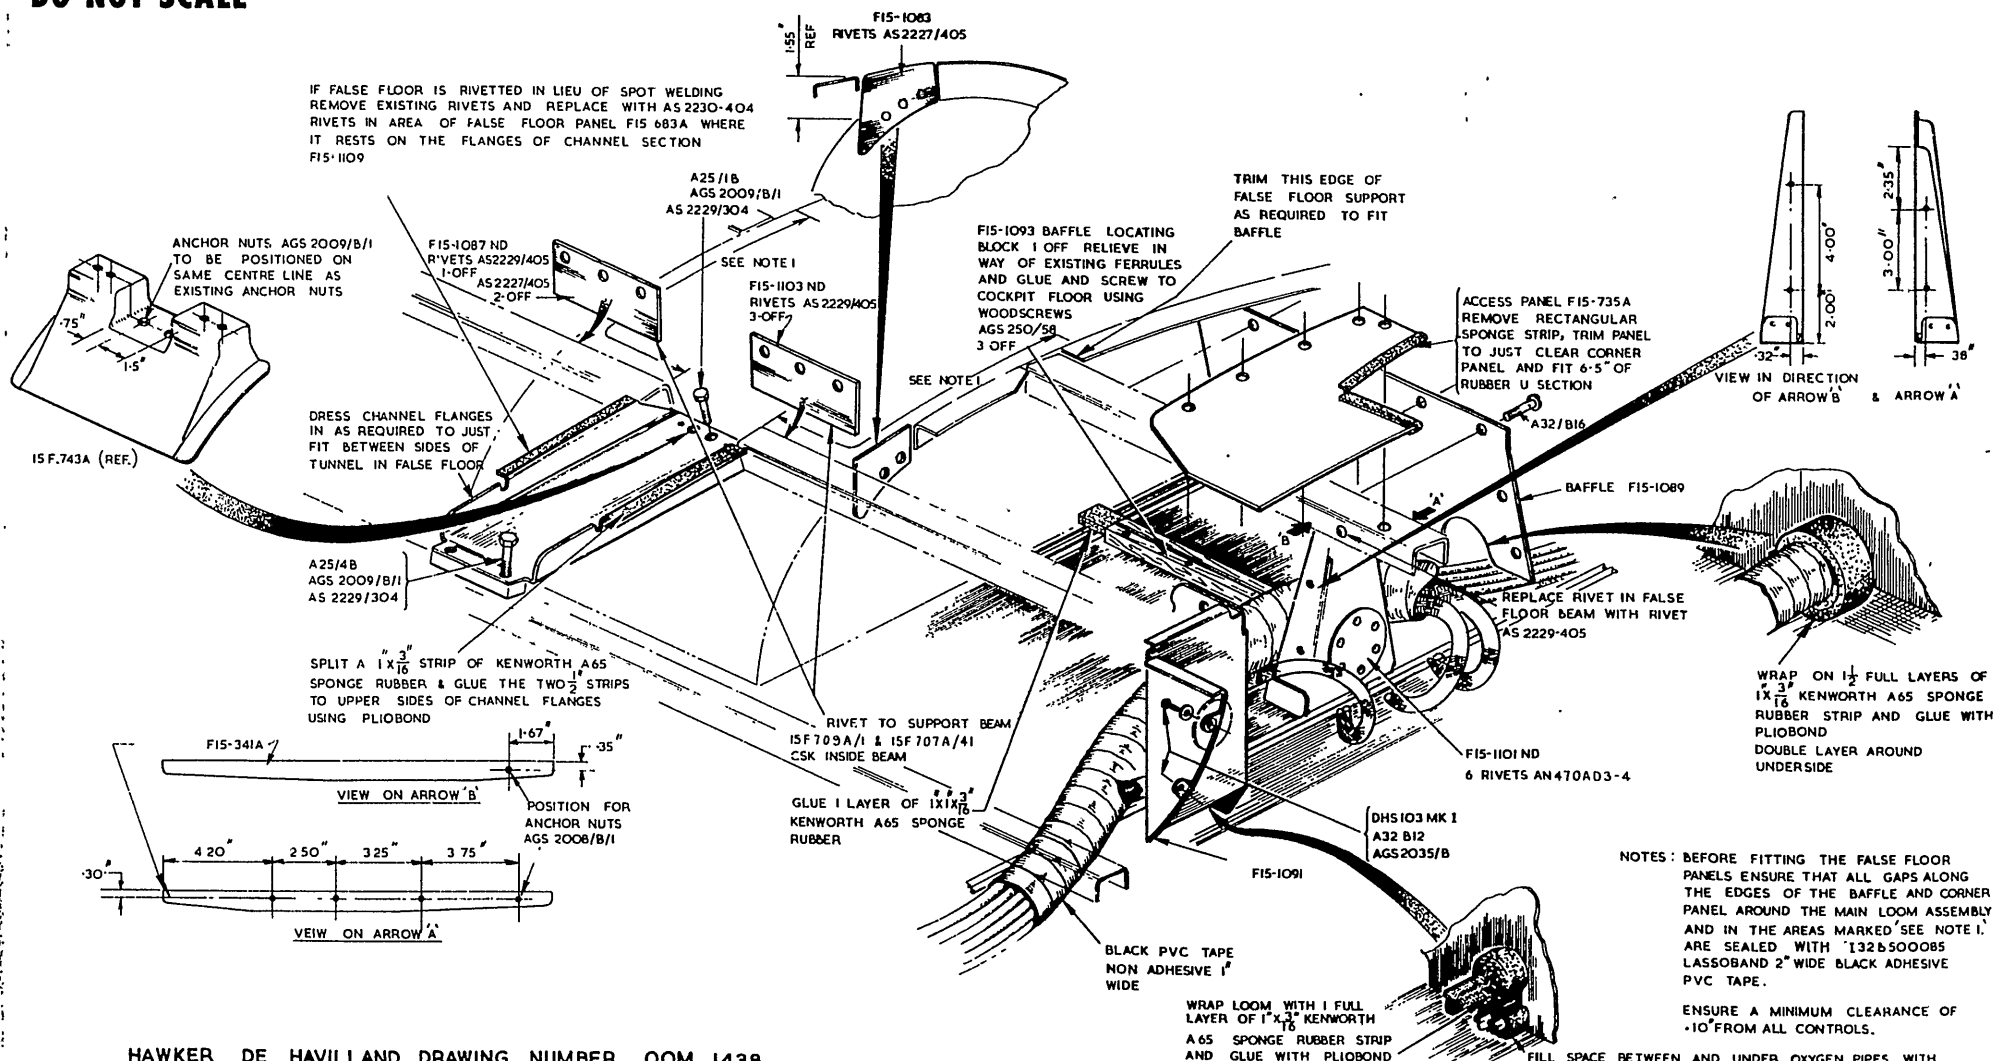
IF FALSE FLOOR IS RIVETTED IN LIEU OF SPOT WELDING  
REMOVE EXISTING RIVETS AND REPLACE WITH AS2230-404  
RIVETS IN AREA OF FALSE FLOOR PANEL F15 683A WHERE  
IT RESTS ON THE FLANGES OF CHANNEL SECTION  
F15-1109

NOTES: BEFORE FITTING THE FALSE FLOOR  
PANELS ENSURE THAT ALL GAPS ALONG  
THE EDGES OF THE BAFFLE AND CORNER  
PANEL AROUND THE MAIN LOOM ASSEMBLY  
AND IN THE AREAS MARKED SEE NOTE 1  
ARE SEALED WITH 1325500085  
LASSOBAND 2" WIDE BLACK ADHESIVE  
PVC TAPE.

ENSURE A MINIMUM CLEARANCE OF  
•10' FROM ALL CONTROLS.

- (t) Refer to the attached drawing and seal all gaps along the edges of the baffle and corner panel, around the main loom assembly and in the areas marked "See Note 1" with tape (item 28). To ensure good adhesion the contact area must be perfectly clean. To avoid the possibility of the tape becoming loose in the critical area around the controls, the tape should be applied preferably outside the area and wherever possible held securely by an overlying panel.

- (u) Obtain the false floor rear centre panel P/No F15-683A. If the panel is riveted in lieu of spot welding at the sections where the panel rests on the flanges of the channel assembly fitted in operation (s) remove the ten existing rivets and replace with rivets (item 20), the countersunk heads of the rivets on the underside. Cut a strip of rubber sponge (item 23), approximately 5.6" long, into two  $\frac{1}{2}$ " strips. Glue the strips to the upper surface of the flanges of the channel section fitted in operation (s). Affix the strips to the flanges using adhesive (item 26).

- (w) Check and ensure that all controls adjacent to items fitted in the preceding paragraphs have a minimum clearance of 0.10". Rectify as required.
- (x) Carry out a loose article check of the cockpit floor.
- (y) Refit false floor panels.
- (z) Refit both ejection seats in accordance with current authorized procedure.
- (ab) Refit the canopy hatch in accordance with current authorized procedure.

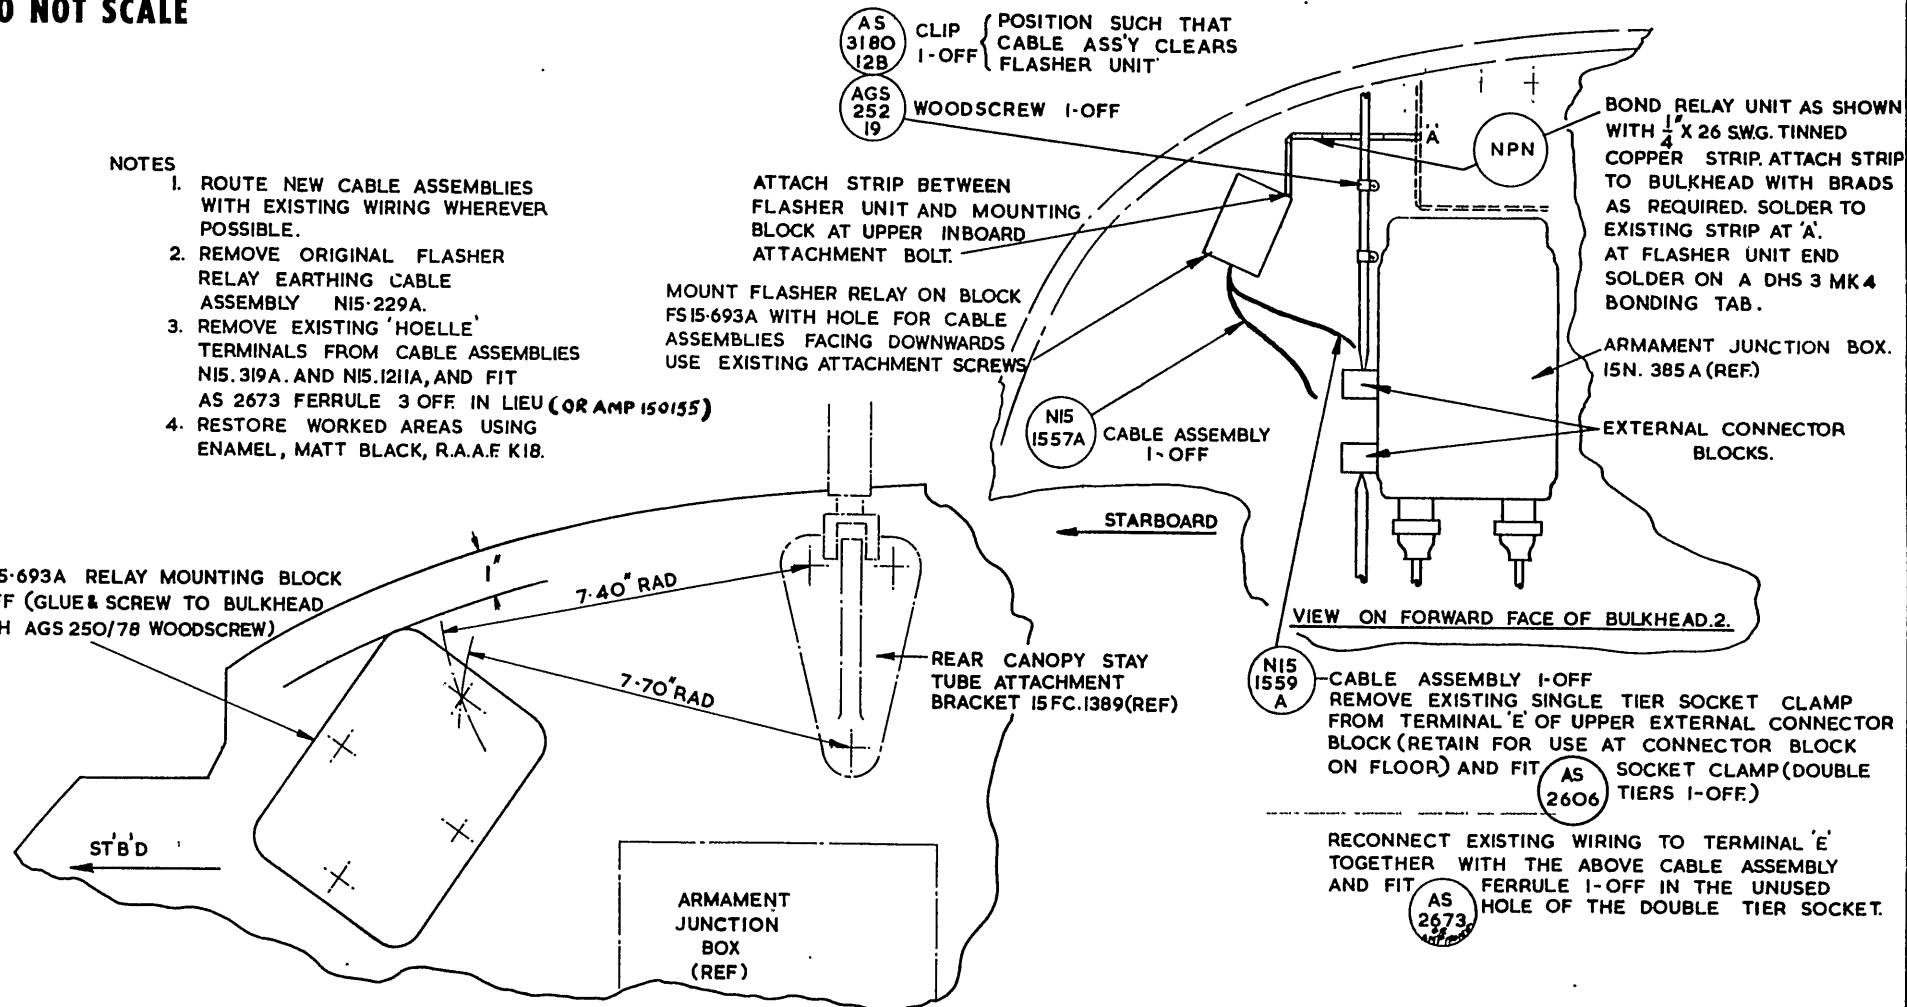
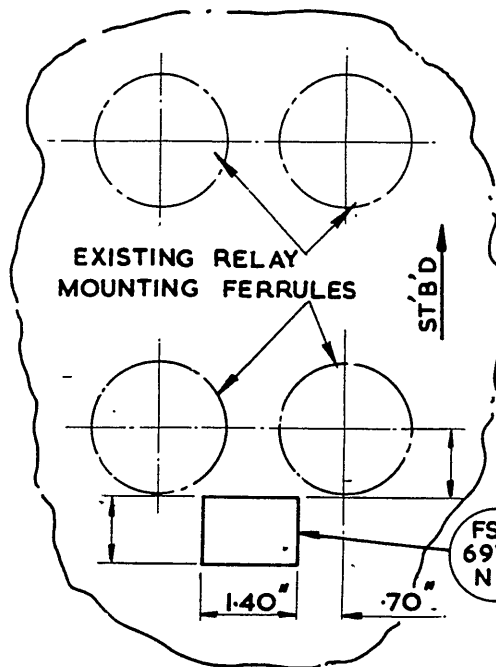
HAWKER DE HAVILLAND DRAWING No.00M1437 SHEET 1 OF 2.

1. ROUTE NEW CABLE ASSEMBLIES WITH EXISTING WIRING WHEREVER POSSIBLE.
2. REMOVE ORIGINAL FLASHER RELAY RELAY EARTHING CABLE ASSEMBLY N15-229A.
3. REMOVE EXISTING 'HOELLE' TERMINALS FROM CABLE ASSEMBLIES N15-319A AND N15-1211A, AND FIT AS 2673 FERRULE 3 OFF IN LIEU (OR AMP 150155)
4. RESTORE WORKED AREAS USING ENAMEL, MATT BLACK, R.A.A.F K18.

FS15-693A RELAY MOUNTING BLOCK  
1-OFF (GLUE & SCREW TO BULKHEAD  
WITH AGS 250/78 WOODSCREW)

LOCATION OF RELAY MOUNTING BLOCK ON BULKHEAD.2

SPRUCE BLOCK  $\frac{1}{4}$ " THICK  
1-OFF (GLUE & BRAD TO FLOOR.)

VIEW ON UPPER SURFACE OF COCKPIT FLOOR

- (f) Remove the Hoelle terminals from cables Part Nos N15-319A and N15-1211A which were connected to the flasher unit and replace them with ferrules (item 8).

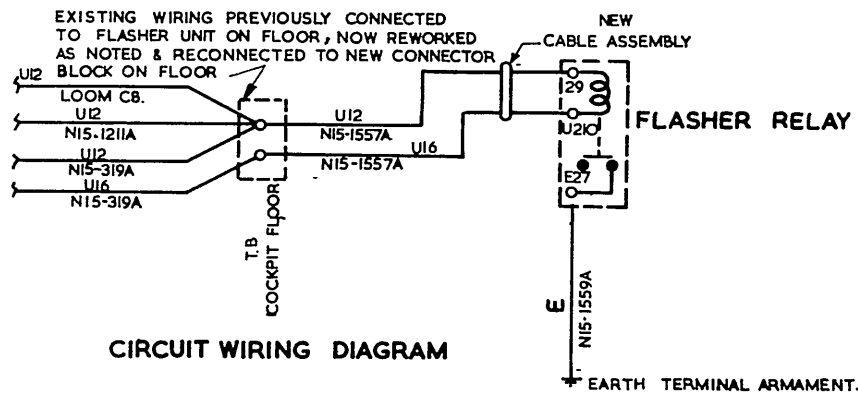
**HAWKER DE HAVILLAND DRAWING No. OOM 1437 SHEET 2 OF 2.**

**CIRCUIT WIRING DIAGRAM**

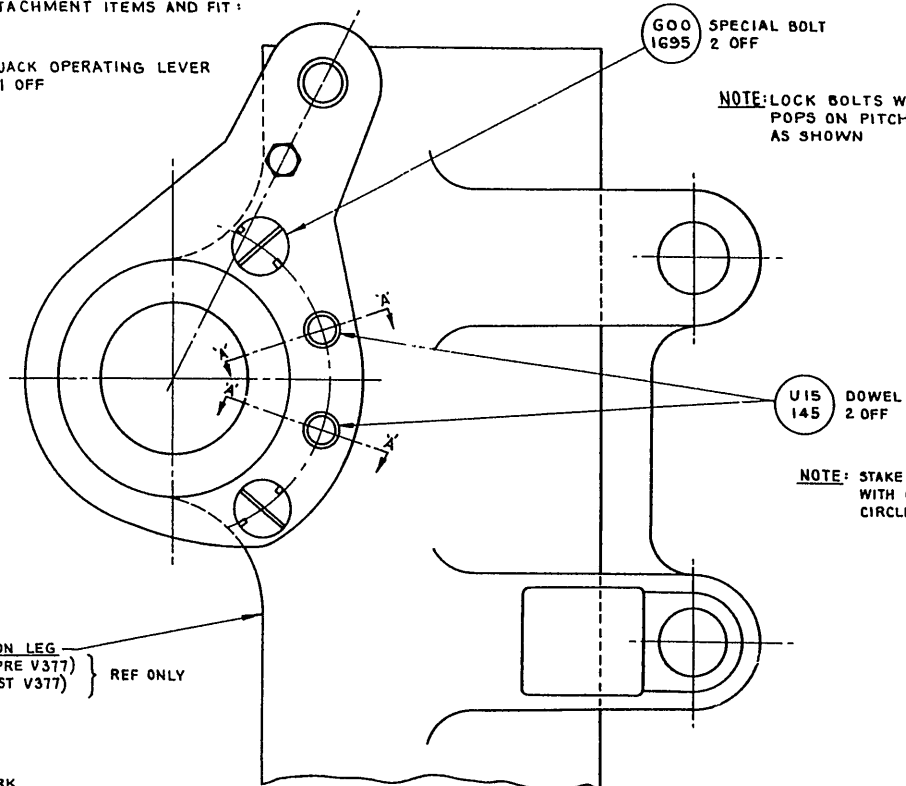
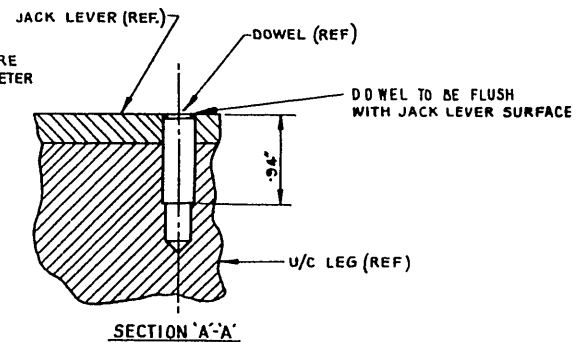
1. REPART NUMBER THE COMPRESSION LEG FROM U15-31A/1 OR U15-115A TO U15-149A FROM U15-32A/1 OR U15-116A TO U15-150A
2. REPART NUMBER THE COMPRESSION LEG ASSEMBLY FROM U15-25A/1 OR U15-117A TO U15-151A FROM U15-26A/1 OR U15-118A TO U15-152A

OPEN OUT THE BOLT HOLES WITH A LETTER 'S' DRILL

AND REAM TO  $.3594''$  DIA X  $.03''$   
FILLET RAD

The two centre jack lever attachment bolts or countersunk dowels are replaced by HT parallel locating pins which are locked to the lever arm with araldite and staking.

- (b) Applicable to legs and leg assemblies Pre-Mod 377 Part Nos U15-25A/1, U15-26A/1 only. Remove the four countersunk head bolts, Part No G001695, Ident No A79/501511, which secure the jack operating lever to the compression leg. Remove the jack operating lever from the leg. Examine the four securing bolts for signs of bending or shearing. If any one bolt shows signs of such damage discard all four bolts and obtain two new bolts from stores. If all four bolts are serviceable return two to stores for future re-use and retain the remaining two.

- (c) Applicable to legs and leg assemblies Post-Mod 377 Part Nos U15-117A, U15-118A, U15-115A, U15-116A only. Remove the two countersunk head bolts, Part No G001695, Ident No A79/501511, which secure the jack operating lever to the compression leg. Remove the jack operating lever, complete with dowels and lock pins, from the leg. Do not use force during this operation as use of force is liable to cause damage to the dowel holes in the leg. If the lever complete with dowels will not detach easily the countersunk heads of the dowels, and that part of the lock pin in the dowels, should be removed by drilling. The lever should now be removed from the leg and dowels and then the remaining portions of the dowels removed from the holes in the leg. Examine the two securing bolts for signs of bending and shearing. If either bolt shows signs of such damage discard both and obtain two new bolts from stores. If both are serviceable retain them for later use.

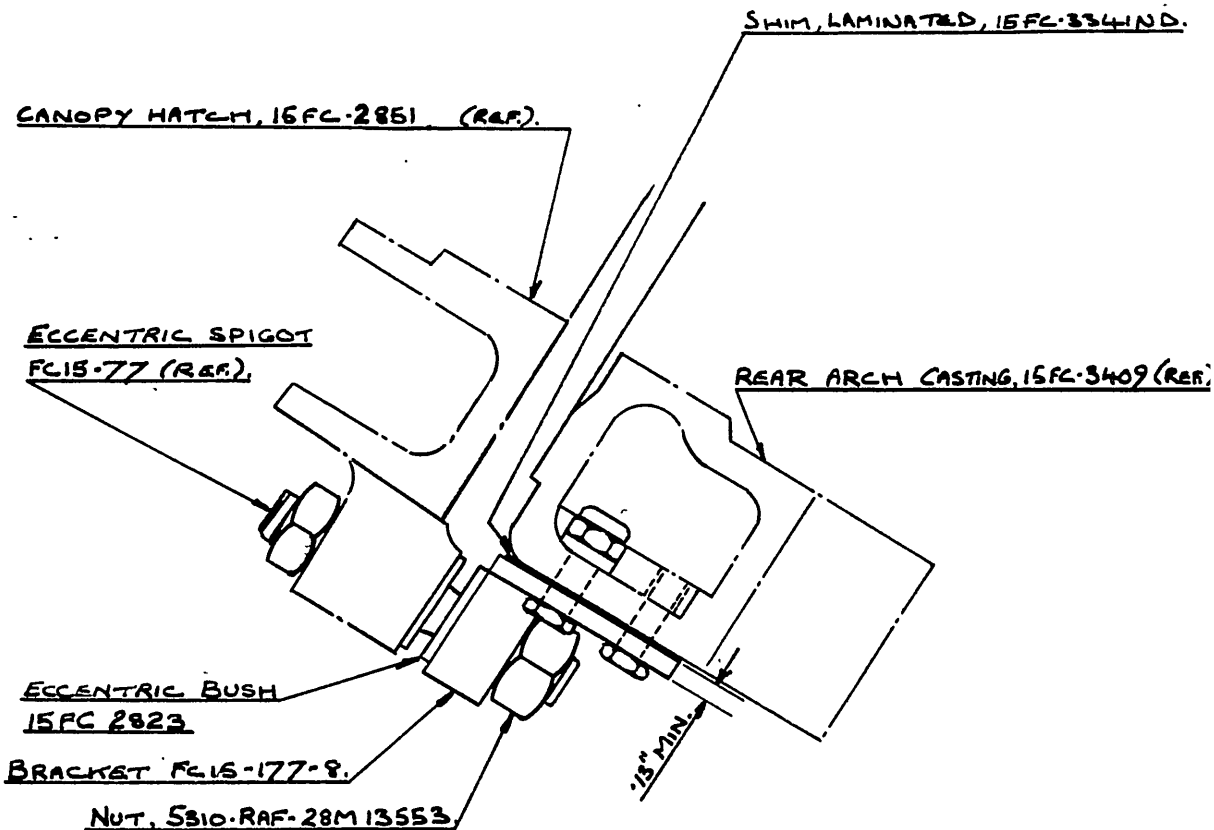
CORRECT ADJUSTMENT MAY BE OBTAINED BY:

1. ADJUSTMENT OF ECCENTRIC BUSH AND/OR SPIGOT.
2. INTRODUCTION OF ATTWELL SHIMS AS SHOWN.

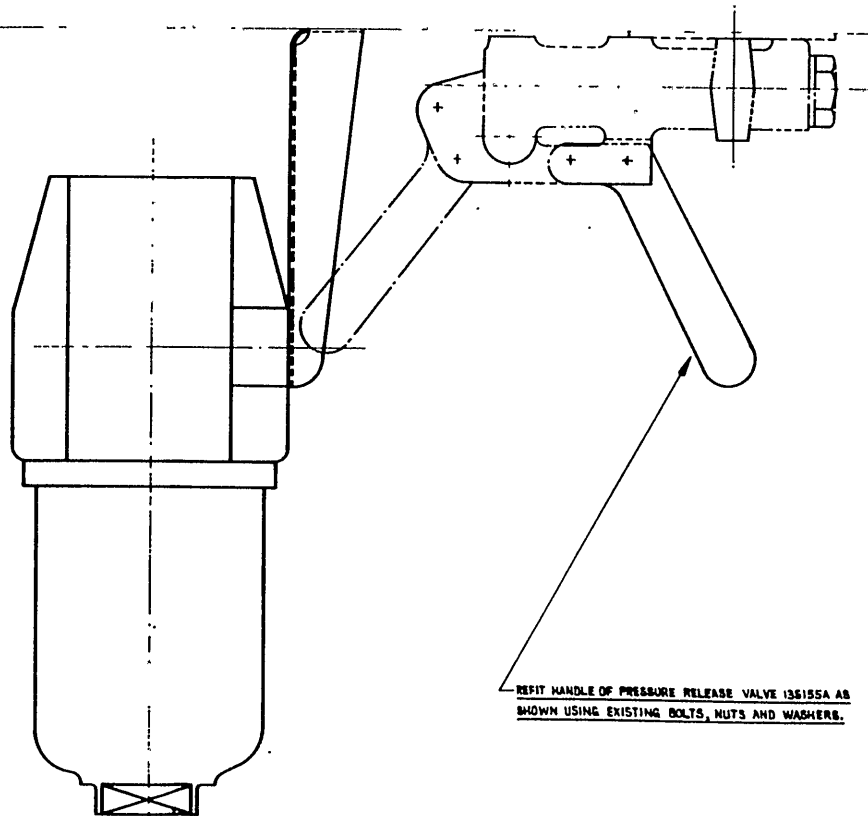
HAWKER DE HAVILLAND DRAWING No. OOM 1431 SHEET 3 OF 3

VIEW LOOKING FORWARD

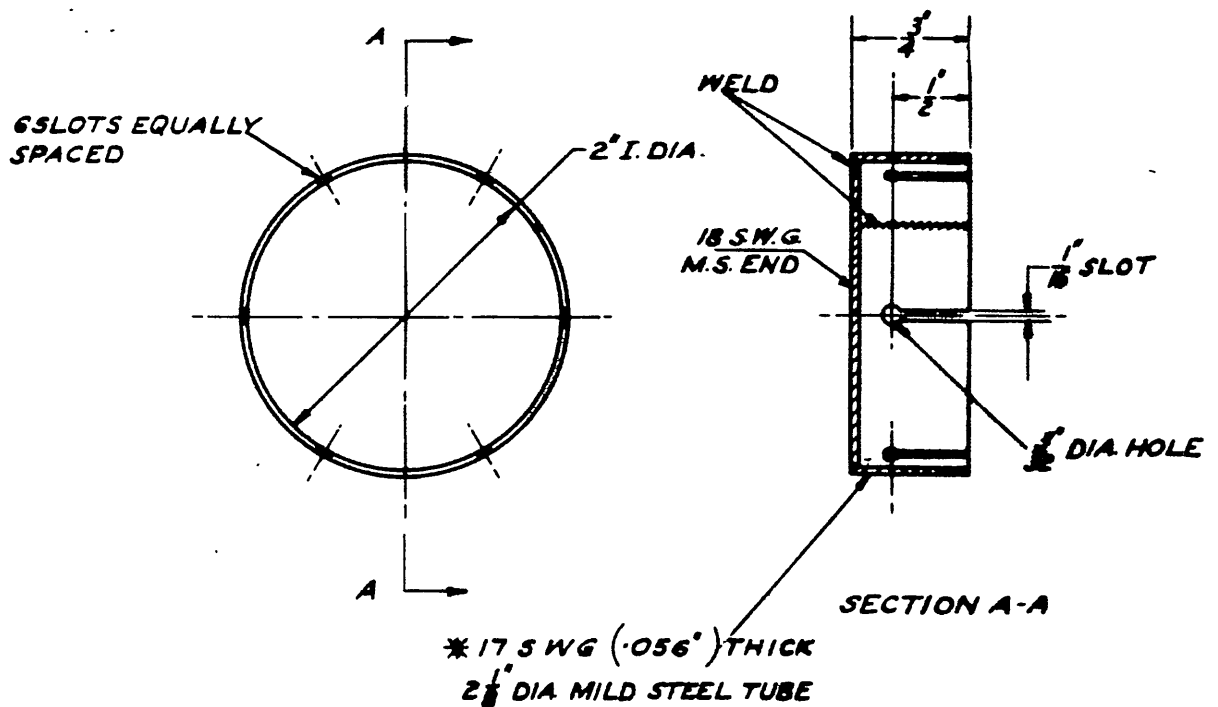
MATERIAL \* IF TUBE SIZE NOT AVAILABLE, FOLD FROM  
1/2" M.S. STRIP & WELD AS INDICATED.

REFERENCE		ISSUED BY			TITLE		
		DEPARTMENT OF AIR SENIOR TECHNICAL STAFF OFFICER SUPPORT COMMAND			BLANKING CAP - GUN HEATER PIPES		
LIMITS UNLESS STATED		MATERIAL	AS ABOVE		COMPONENT OF		
DECIMALS	± .010"	SPEC.	APPROVED COMMERCIAL		MACHINE		
FRACTIONS	± 1/32"	TREATMENT	BREAK SHARP EDGES		ENGINE	GOBLIN	
ANGLES	± 1°	FINISH	CAD. PLATE		TECH. ORDER	S.T.I. GOBLIN/46	
SURFACE FINISH		SCALE	FULL SIZE		DRAWING NO.	B14595	
AUSTRALIAN STANDARD		DRAWN	CDULSON	APPROVED			
ENR. DOW. PRACTICE A.S. 621		TRACED	E. MCK.	CHECKED			
							DWG. A SIZE

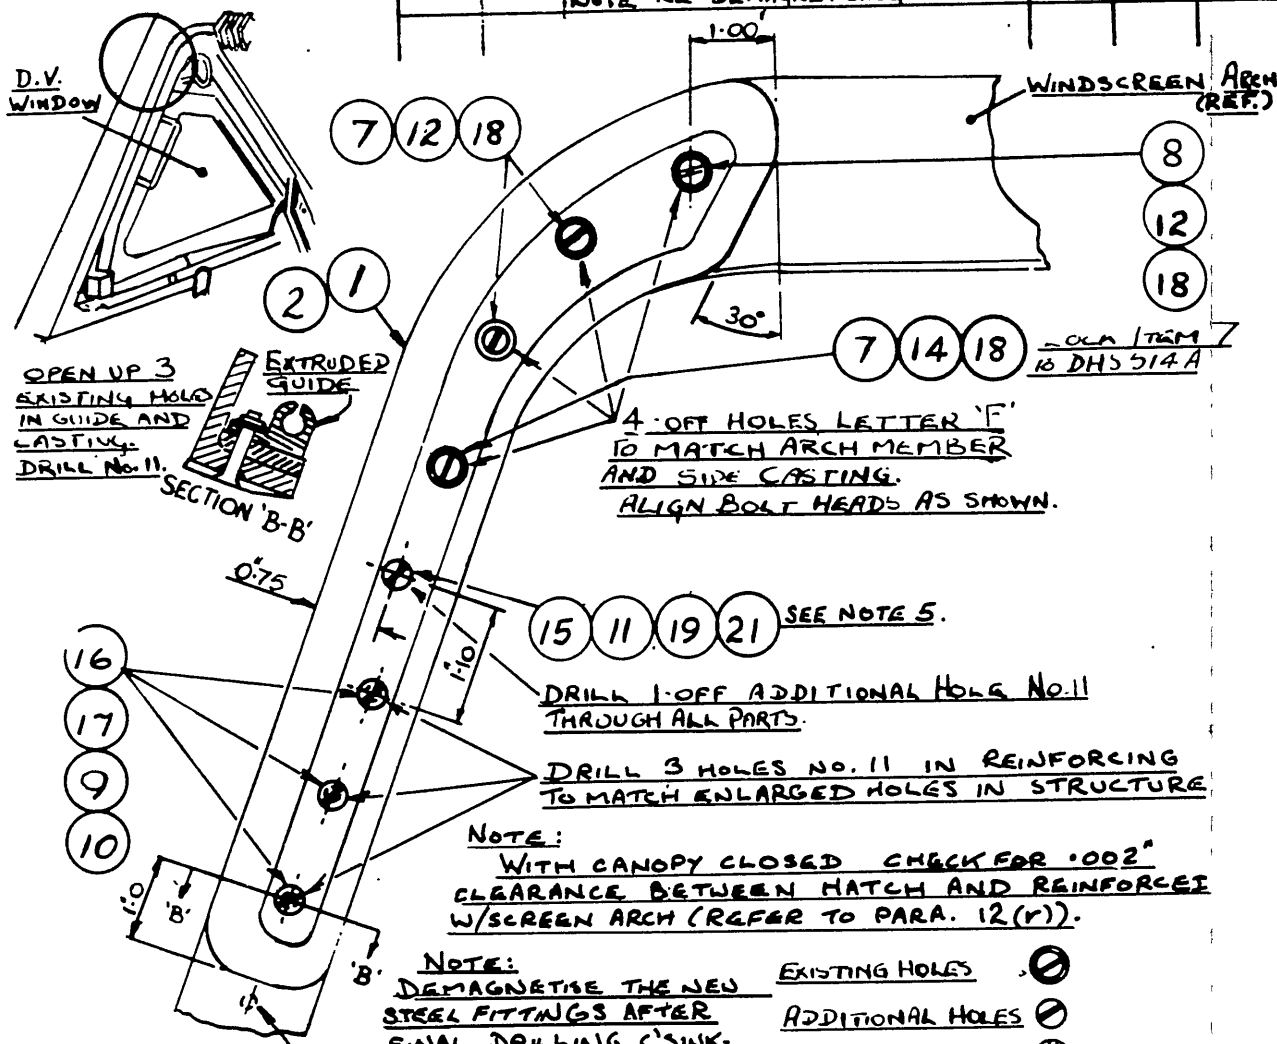
EXISTING 4BA BOLT.

NOTE:  
A FILLET OF  
EPAPTOP, EPOXY  
RESIN MAY BE  
APPLIED BETWEEN  
REINFORCING AND  
W/SCREEN STRUCTURE  
TO REDUCE LOSS OF  
COCKPIT PRESSURE.

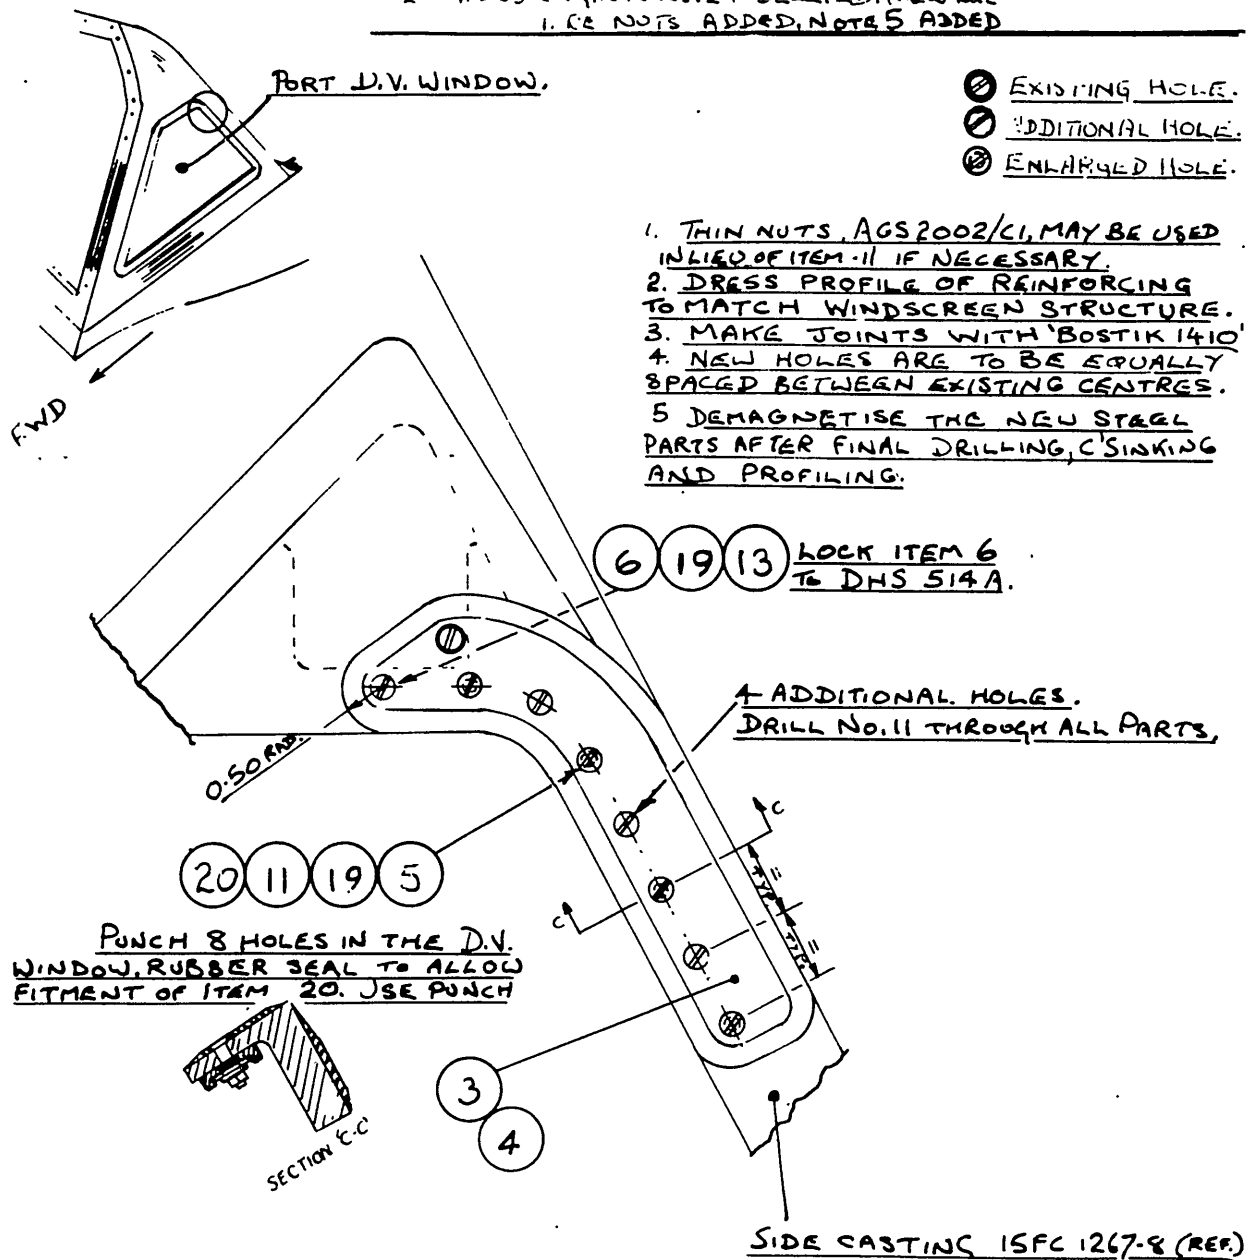
HAWKER DE HAVILLAND DRAWING No. OOM 1426 SHEET 2

THIS DRAWING SHOWS INSTALLATION OF ITEM 3  
INSTALLATION OF ITEM 4 IS SIMILAR.

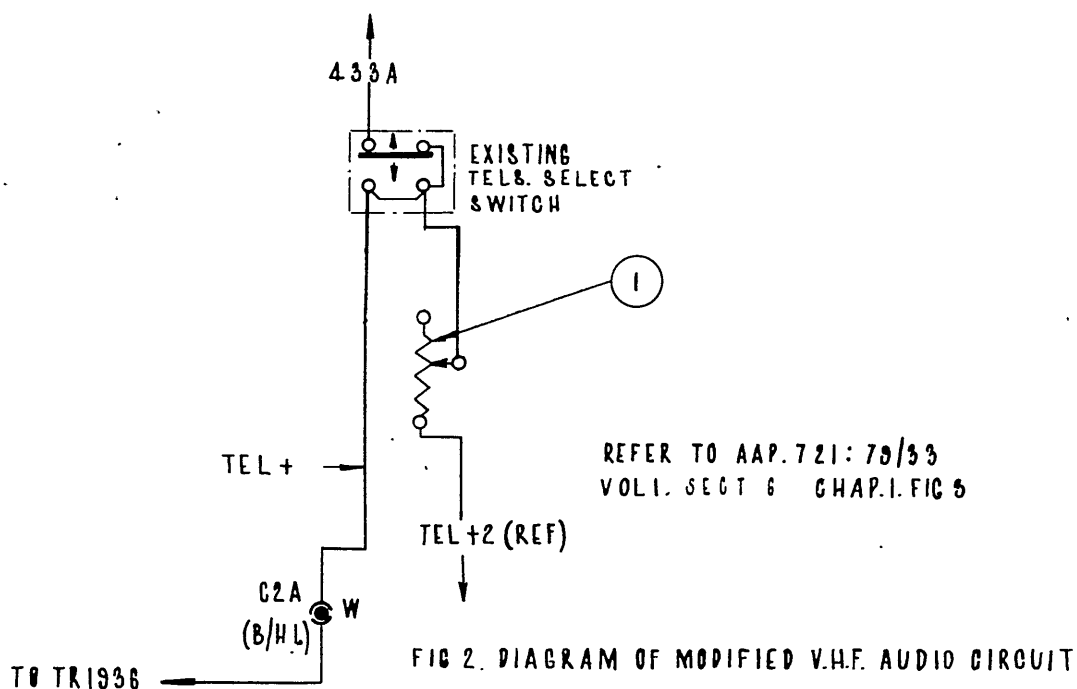
1	501423	5905-011-9859	RESISTOR VARIABLE - 1000 OHM	1	
ITEM	PART	IDENT	DESCRIPTION	QTY REQ	ZONE

<b>DEPARTMENT OF AIR</b>		REFERENCE		MODIFICATION VAMPIRE MOD: NO 420	
ISSUED BY SENIOR TECHNICAL STAFF OFFICER SUPPORT COMMAND		1 DIM'S IN		EFFECTIVE ON	
2 DEF (AUST) - 85		3 DEF (AUST) - 46		COMPONENT OF	
4				TR1936	
5				TITLE	
DRAWN F. A. B.		CHECKED <i>F. A. B.</i>		DRILLING DETAIL & WIRING DIAGRAM	
TRACED H. R. P.		APPROVED <i>[Signature]</i>		SCALE	
LIMITS UNLESS STATED		TREATMENT		NEXT ASSEMBLY	
DECIMALS $\pm .010"$		FINISH		DRAWING NUMBER	
FRACTIONS $\pm \frac{1}{32}$		MATERIAL		A15441 SHEET 1.	
ANGLES $\pm 0^{\circ}30'$		SPECIFICATION		SIZE	
				A
