Australian Air Publication 721.79

Volume 2, Part 2  
Book 5

# VAMPIRE MODIFICATIONS

(Nos 401 to 500)

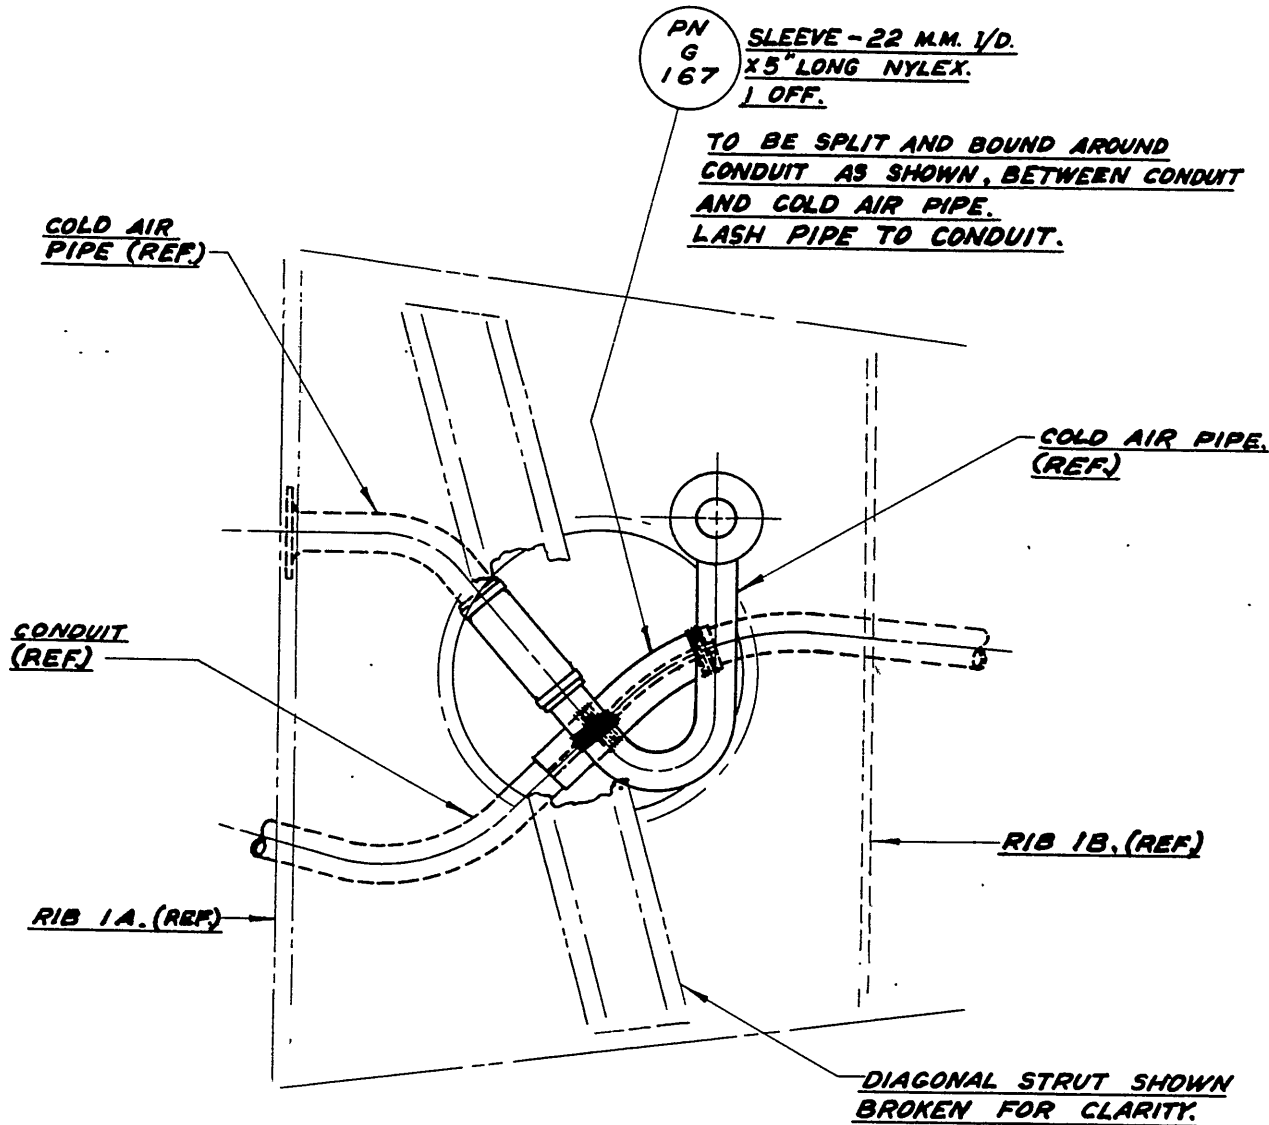
HAWKER DE HAVILLAND DRAWING N2 OOM 1416 SHEET 1 OF 3.

VIEW LOOKING AFT ON MAIN SPAR WEB,  
WITH COLD AIR UNIT REMOVED.

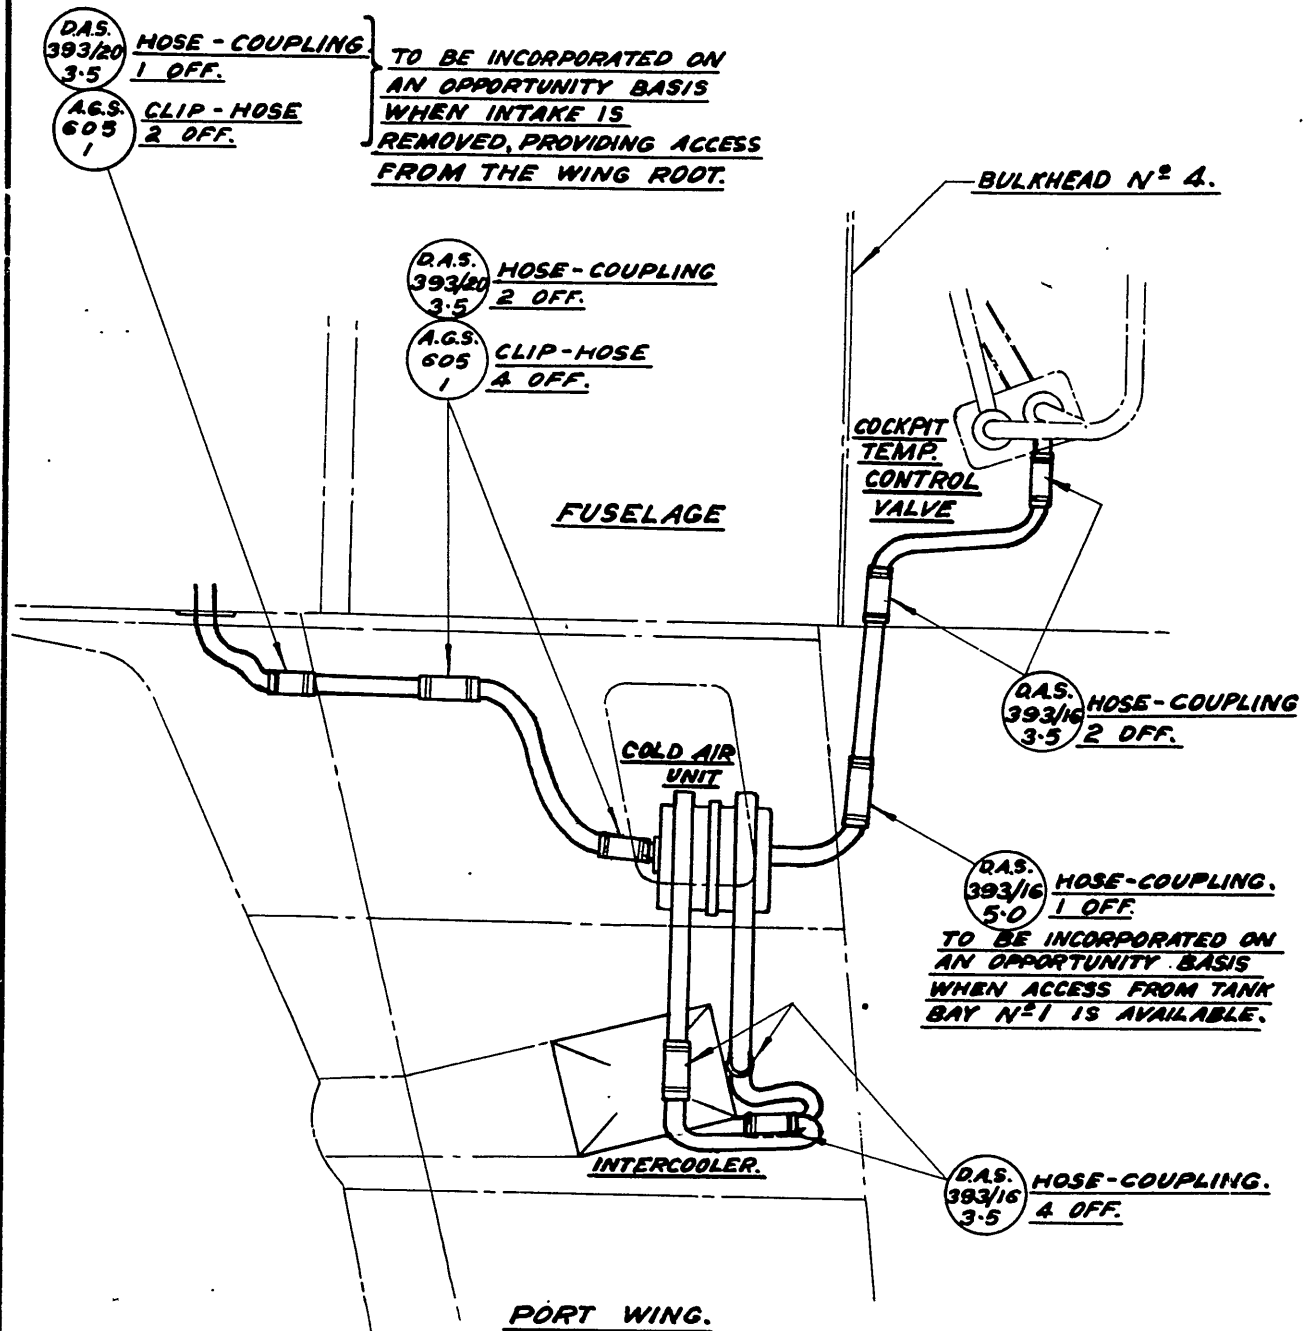
HAWKER DE HAVILLAND DRAWING N° 00M 1416 SHEET 2

REFERENCE	ISSUED BY	TITLE
	DEPARTMENT OF AIR. SENIOR TECHNICAL STAFF OFFICER, SUPPORT COMMAND.	INCREASE CAPACITY OF C. A. U. OIL TANK AND INTRODUCE NEW DIPSTICK.
LIMITS UNLESS STATED	MATERIAL	COMPONENT OF
DECIMALS ± 0.1"	SPEC.	MACHINE
FRACTIONS ± 1/16"	TREATMENT	ENGINE
ANGLES ± 1°	FINISH	TECH. ORDER
SURFACE FINISH	SCALE 1/8 FULL SIZE	VAMPIRE MOD. 416.
AUSTRALIAN STANDARD	DRAWN	
ENC DRWG PRACTICE	TRACE

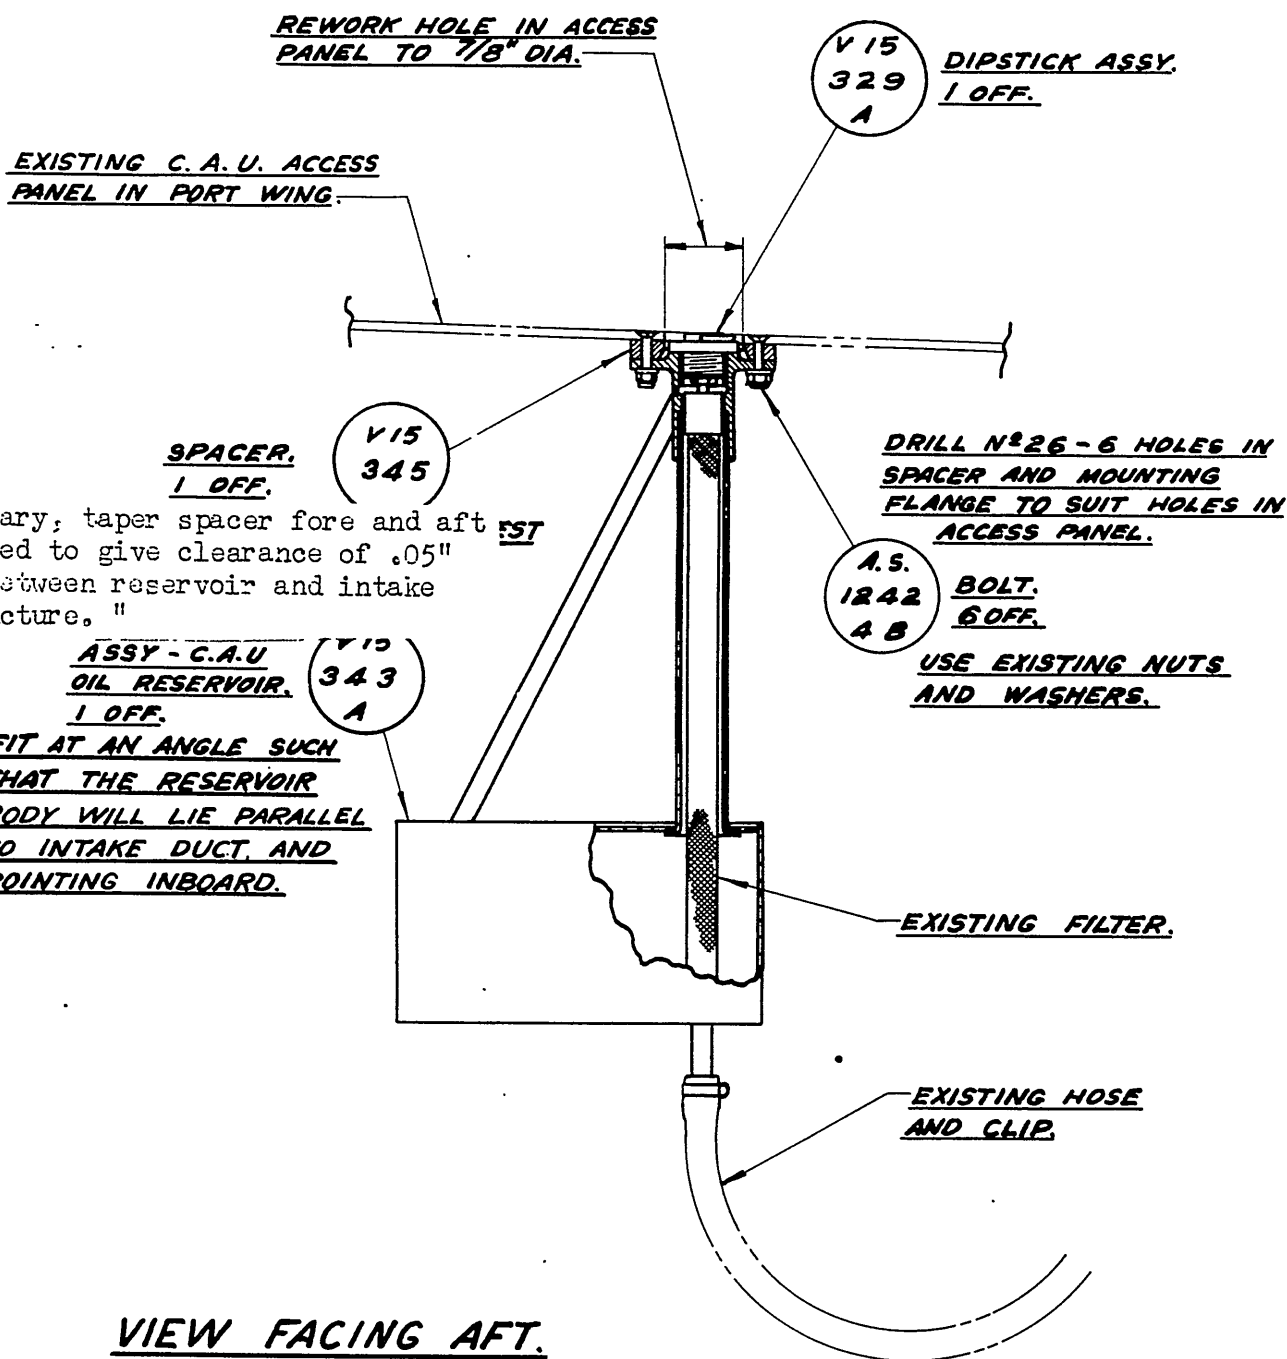
HAWKER DE HAVILLAND DRAWING NO. DDM 1416 SHEET 3

REFERENCE	ISSUED BY		TITLE	
	DEPARTMENT OF AIR. SENIOR TECHNICAL STAFF OFFICER, SUPPORT COMMAND.		INCREASE CAPACITY OF C.A.U. OIL TANK AND INTRODUCE NEW DIPSTICK.	
LIMITS UNLESS STATED	MATERIAL		COMPONENT OF	
DECIMALS ± .010"	SPEC.		MACHINE	VAMPIRE MK. 35, 35A.
FRACTIONS ± 1/32"	TREATMENT		ENGINE	
ANGLES ± 1/2°	FINISH		TECH. ORDER	VAMPIRE MOD. 416.
SURFACE FINISH	SCALE	1/2 FULL SIZE.		
AUSTRALIAN STANDARD	DRAWN	JFH	DRAWN	A 15888
ENG. DRWG. PRACTICE A.S. 521	TRACED		CHECKED	SHEET 3

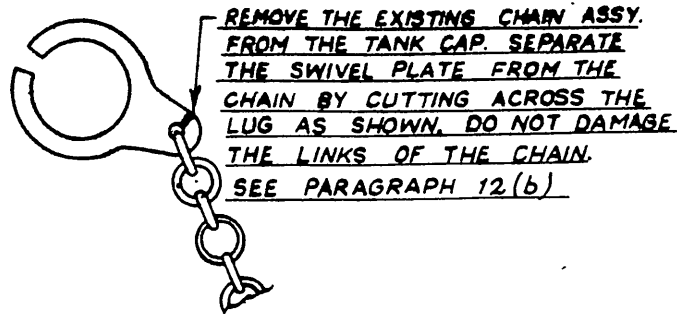
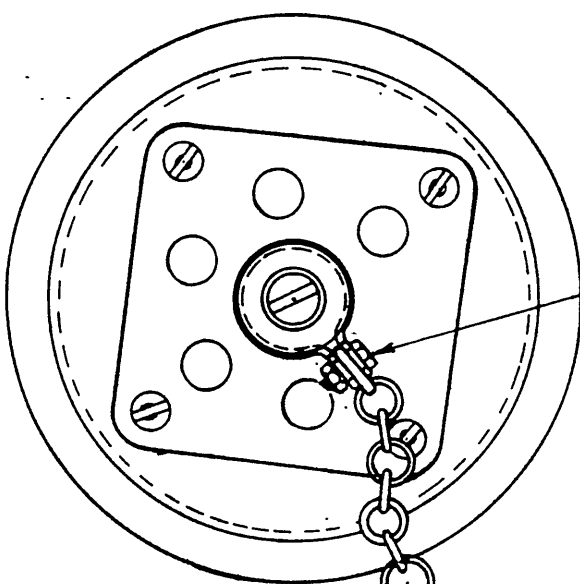
VIEW ON INSIDE FACE  
OF MAIN FUEL TANK CAP ASSEMBLY  
PART NUMBER P15-G27A  
SEE PARAGRAPH 12(d)

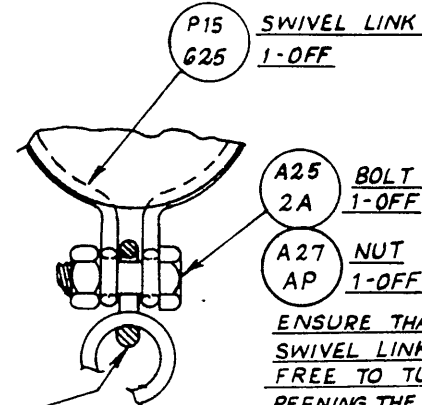
ATTACH EXISTING  
CHAIN THROUGH END  
LINK AS SHOWN.  
(LINK SHOWN IN SECTION)

DETAIL 'A'  
SHOWING NEW SWIVEL ATTACHMENT  
DRAWN TWICE FULL SIZE  
SEE PARAGRAPH 12(C)

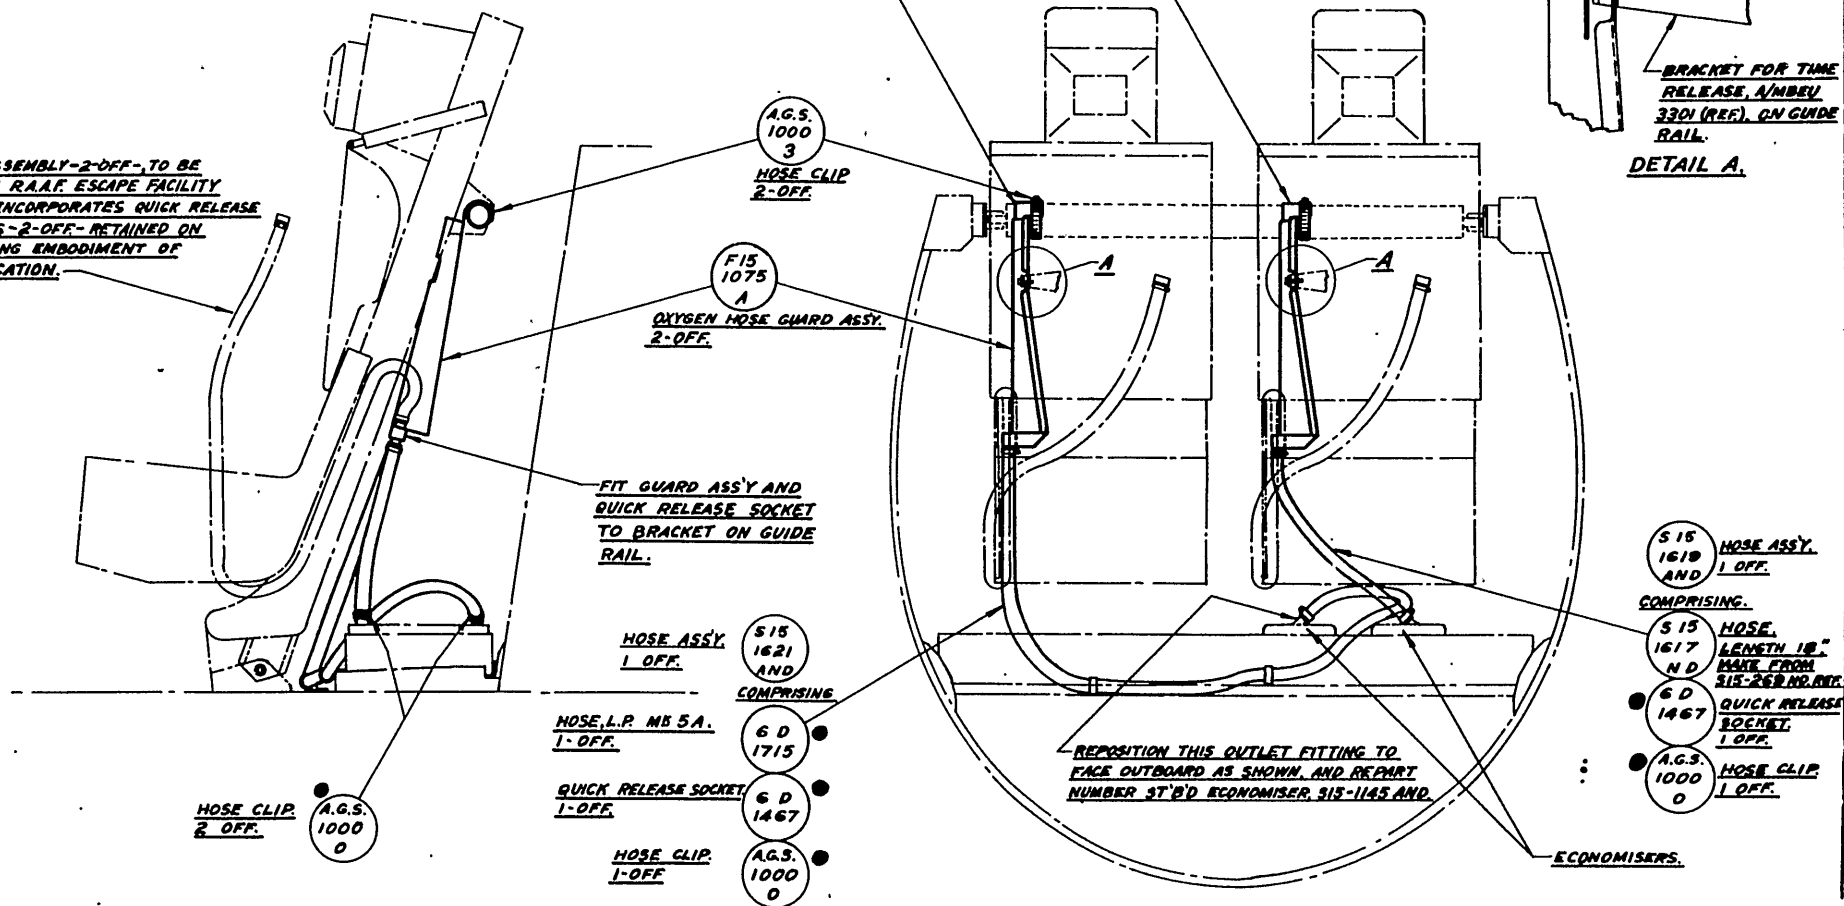
HAWKER DE HAVILLAND DRAWING N° OQM 409. SHEET 1 OF 1.

BRACKET FOR TIME  
RELEASE, A/MBEV  
3301 (REF.) ON GUIDE  
RAIL.

DETAIL A.

IMAGE NO.	DATE	ALTERATION	B.I.L.	INITIALS	APPROVED	REFERENCE	ISSUED BY	TITLE
							DEPARTMENT OF AIR. SENIOR TECHNICAL STAFF OFFICER SUPPORT COMMAND.	OXYGEN SYSTEM - GUARDS FOR FLEXIBLE HOSES ON MARTIN BAKER EJECTION SEATS.
						LIMITS UNLESS STATED	MATERIAL	COMPONENT
						DECIMALS ± .010"	SPEC.	MACHINE
						FRACTIONS ± 1/32"	TREATMENT	ENGINE
						ANGLES ± 1°	FINISH	TECH. ORDER
						SURFACE FINISH	SCALE	
						AUSTRALIAN STANDARD	DRAWN	
							APPROVED	
								DRAWING NO.
								A16071
								DWG. B

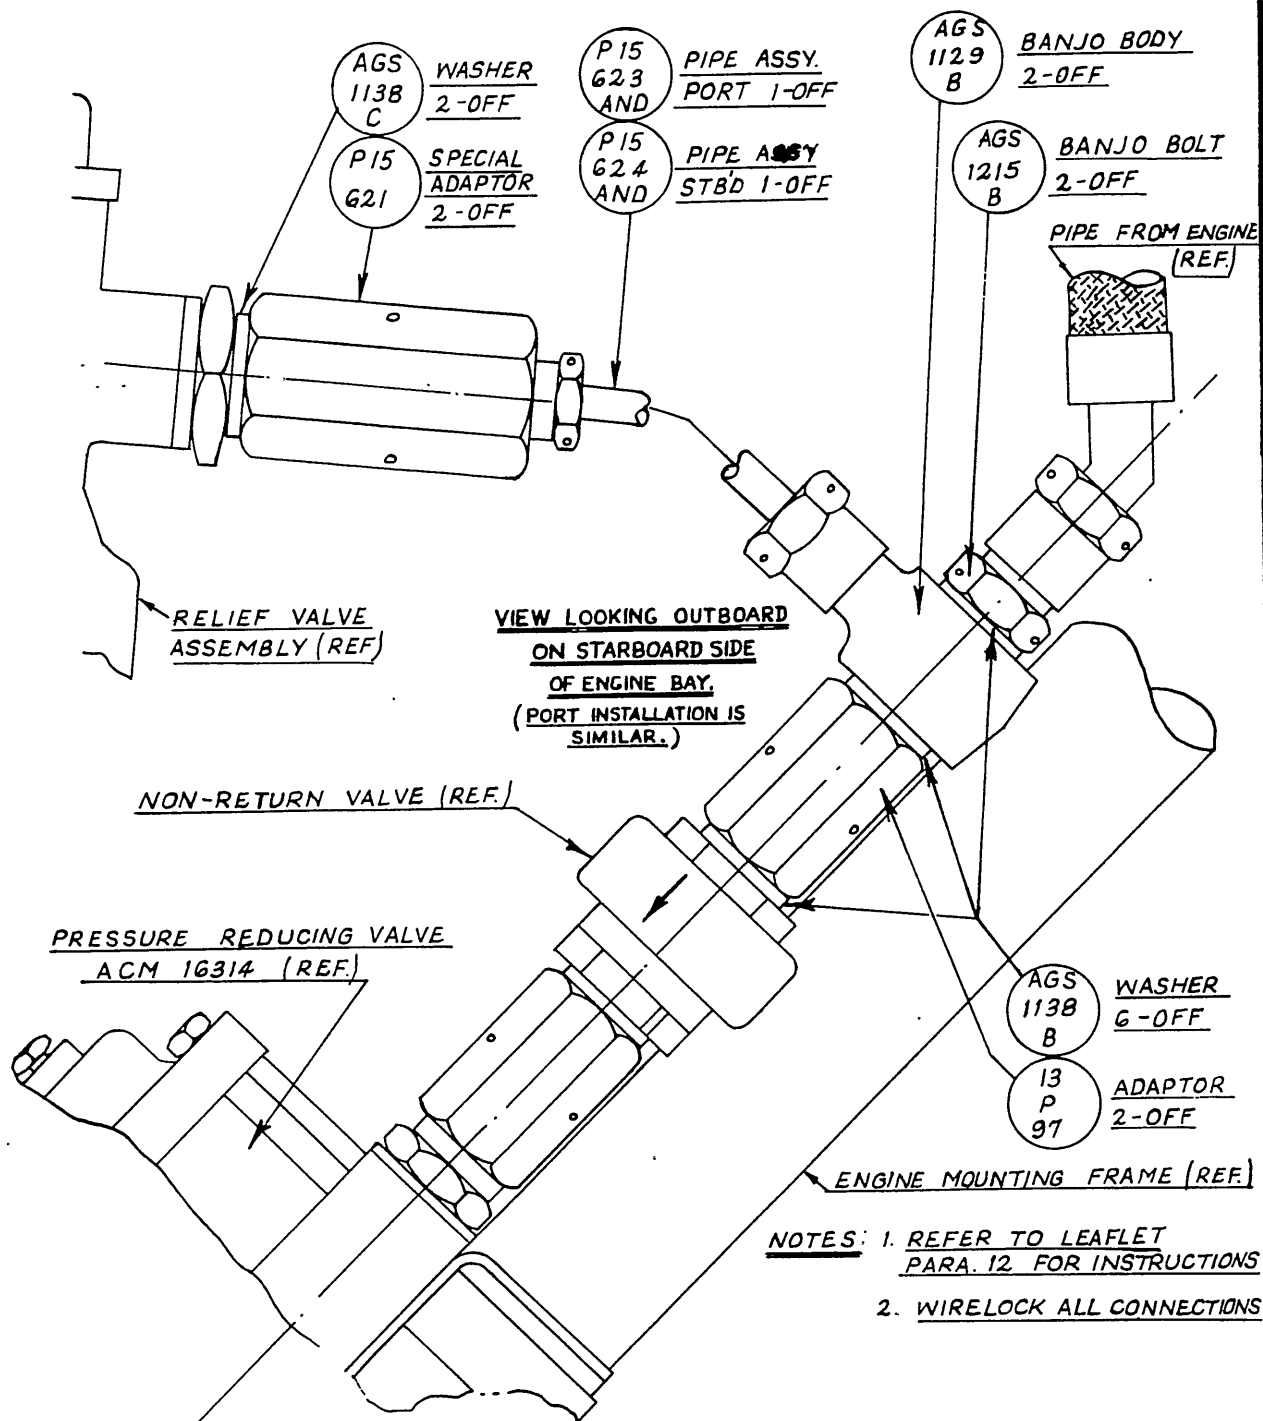
HAWKER DE HAVILLAND DRAWING DDM 1408 SHEET 1 OF 1

REFERENCE		ISSUED BY		TITLE	
		DEPARTMENT OF AIR SENIOR TECHNICAL STAFF OFFICER SUPPORT COMMAND		FUEL SYSTEM - TO INTRODUCE A NEW TANK PRESSURING PIPE LINE ASSEMBLY AND FITTINGS	
LIMITS UNLESS STATED		MATERIAL		COMPONENT OF	
DECIMALS	$\pm 0.10$	SPEC		MACHINE	VAMPIRE MK.35
FRACTIONS	$\pm \frac{1}{32}$	TREATMENT		ENGINE	
ANGLES	$\pm 1^\circ$	FINISH		TECH ORDER	VAMPIRE MOD. N°408
NEXT ASSEMBLY		SCALE		DRAWING No A 15636	
		DRAWN		DRWG A SIZE	
		TRACED			
			APPROVED		
			CHECKED

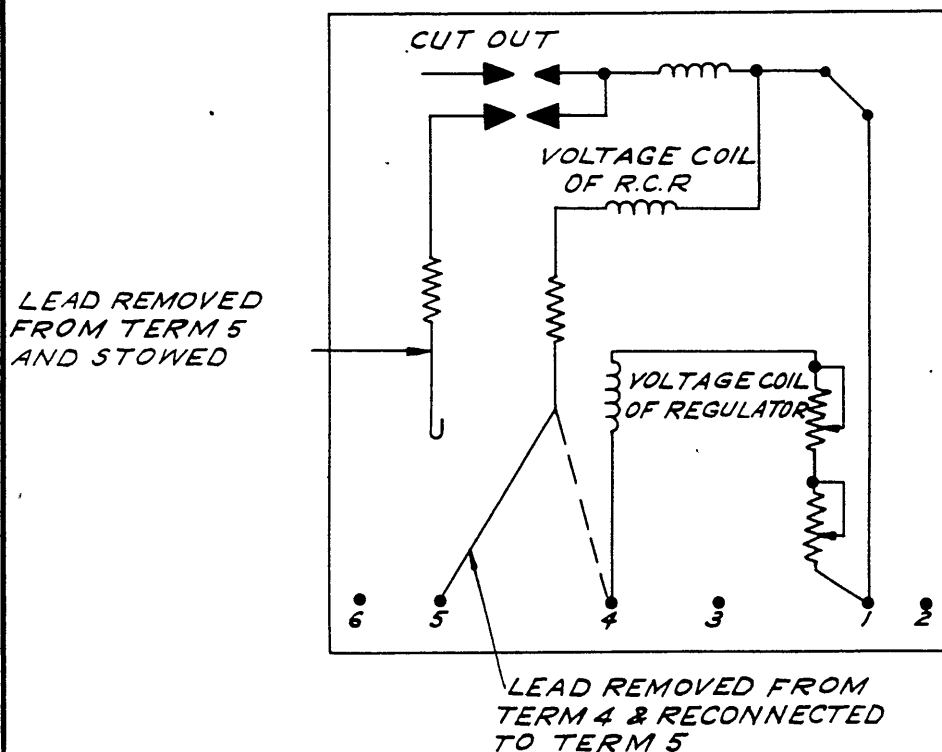
MODS TO REGULATOR-R.C.R. UNIT  
WIRING DIAGRAM

SCHEMATIC DIAGRAM OF MICRO S/W CIRCUITS

NOTE - SEE CAM - PART No A/5072-1  
FOR PART OF THIS MODIFICATION.

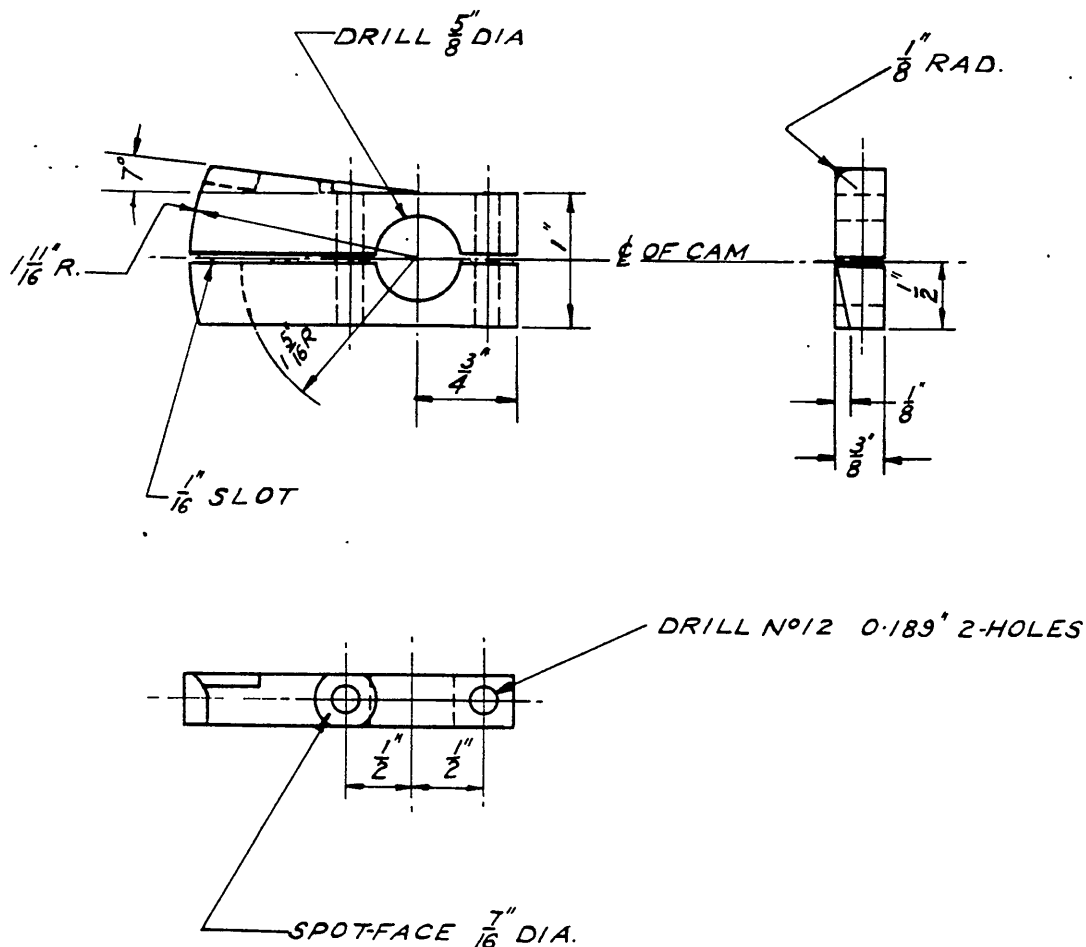
REFERENCE		ISSUED BY		TIT E	
		DEPARTMENT OF AIR		CAM-ISOLATION OF GENERATOR	
		SENIOR TECHNICAL STAFF OFFICER		POWER AT LOW ENGINE RPM	
		SUPPORT COMMAND			
LIMITS UNLESS STATED	MATERIAL	MILD STEEL BAR		GENERATOR MODIF.	
DECIMALS ± .010"	SPEC.	COMMERCIAL		VAMPIRE MK35	
FRACTIONS ± 1/32"	TREATM.	CAD PLATE		TECH. ORDER	
ANGLES ± 1°	FINISH			VAMPIRE MOD 403	
SURFACE FINISH	SCALE	FULL SIZE		DRAWING NO	
AUSTRALIAN STANDARD	DRAWN			A 15072-1	
ENG DRWG. PRACTICE A S.021	TRACE	E.M.K.

- (k) Replace all covers, fairings and equipment removed for access.
- " (l) Fit Cam (Item 1) loosely on throttle shaft using items 2, 3 and 4. Position the cam laterally on the shaft such that when the leading edge of cam is just level with the centre of the micro switch plunger, a gap of approximately 0.050" exists between the cam and plunger. Mark the position on the shaft. " ~~position on micro switch,~~ 27.5 volts. until generator operate the
